Bridge of the Month No 113, May 2020 Lexden viaduct, Colchester.

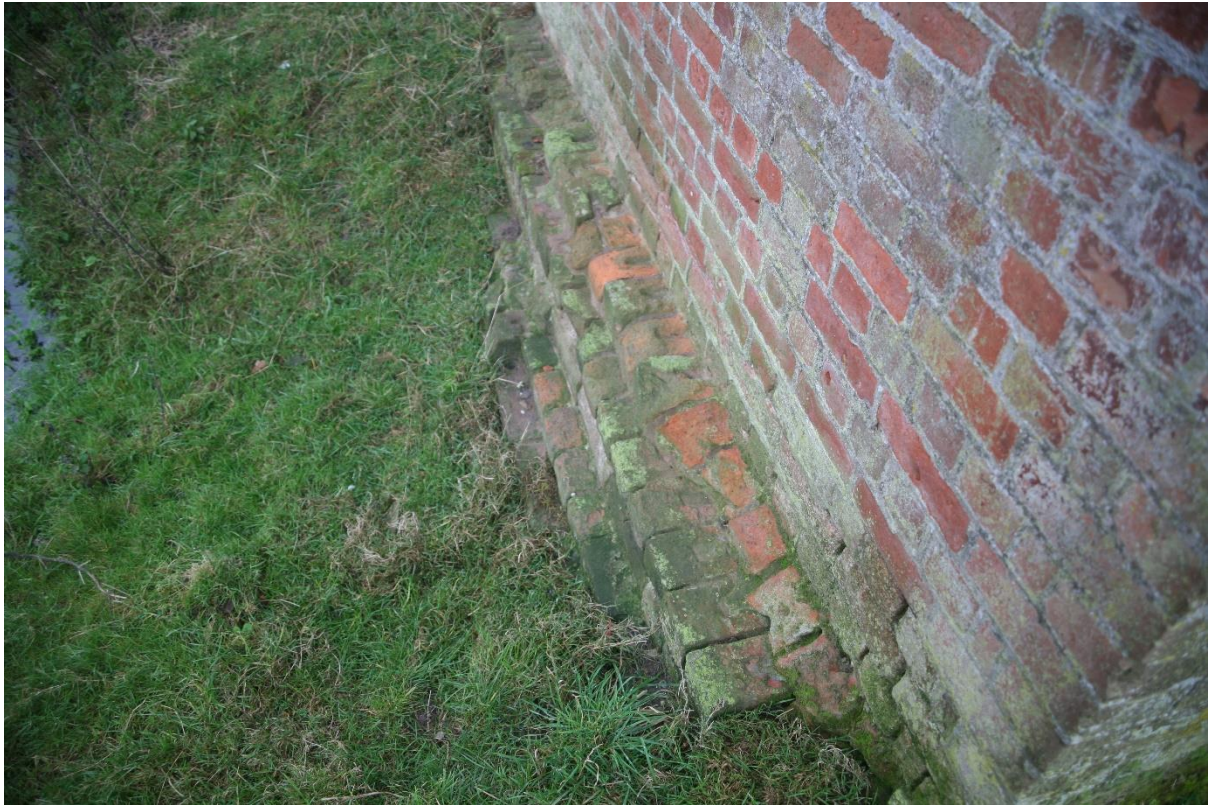
The fact that the foundation corbel was exposed on the riverbank did provide a degree of justification for the assumption there might be more movement there.

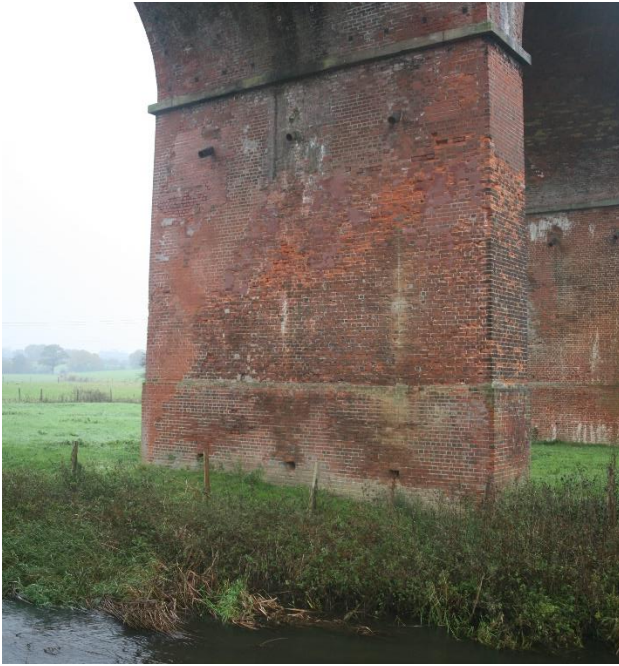
The drainage is interesting as can be seen in this elevation of the pier. Note that there are three drainpipes near the base and three directly above near the top of the pier. The original drains were 9 inch square chimneys down through the pier and out above ground level, These seem to have become blocked at some stage and bypassed by drilling a diversion in near the pier top.

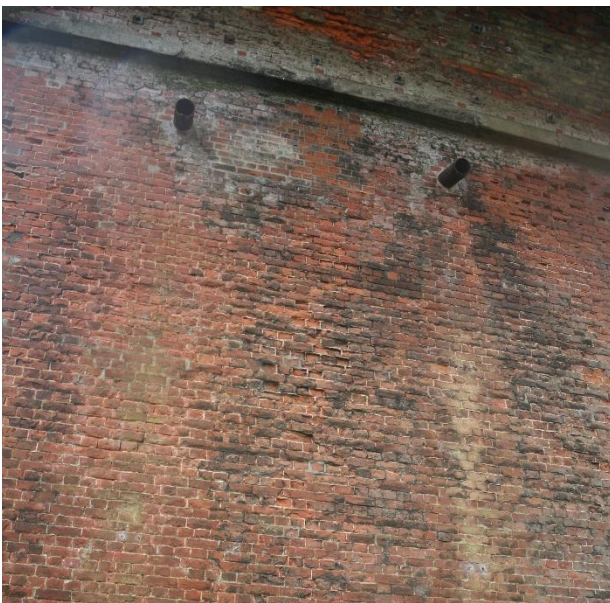
The resulting weathering from windblown spatter was a sight to be seen.

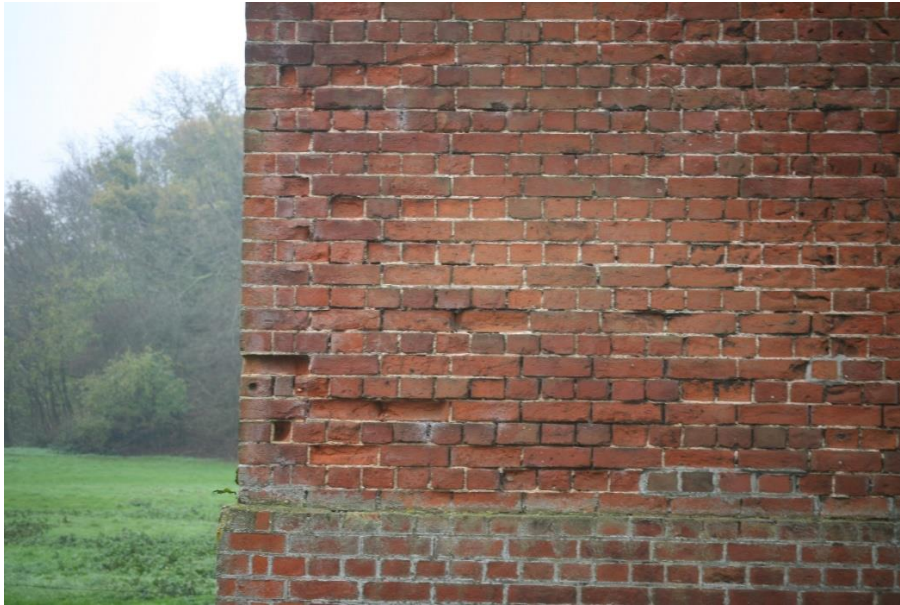
Though there was plenty of weathering lower down too.

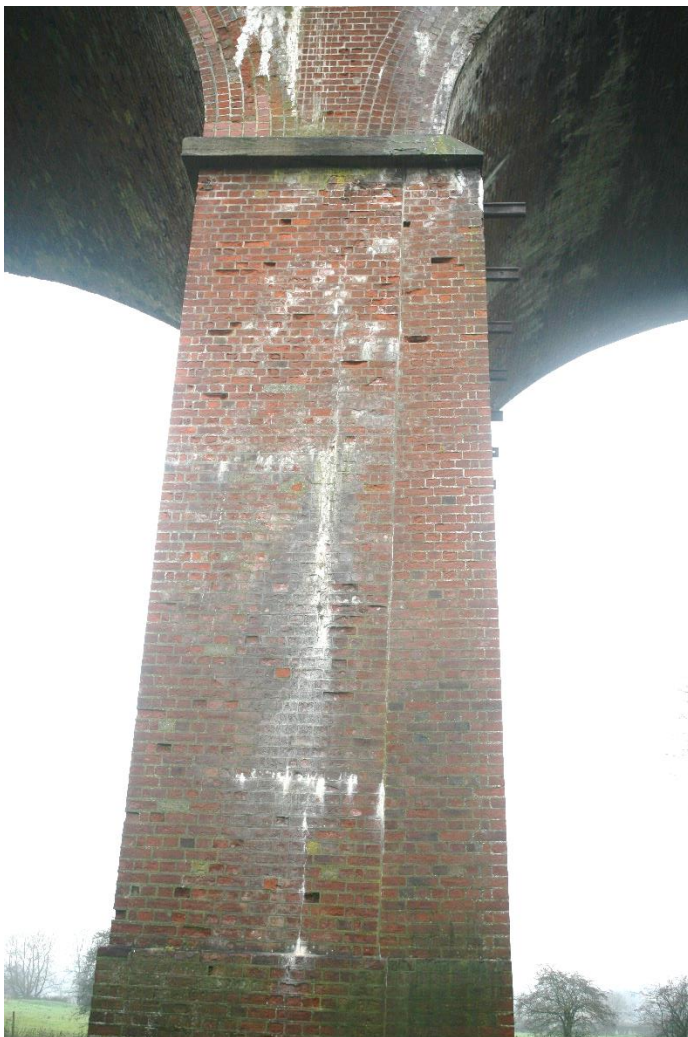
The eastern span provided some interest as well. It's obviously smaller in that first picture. A closer look shows more interest.

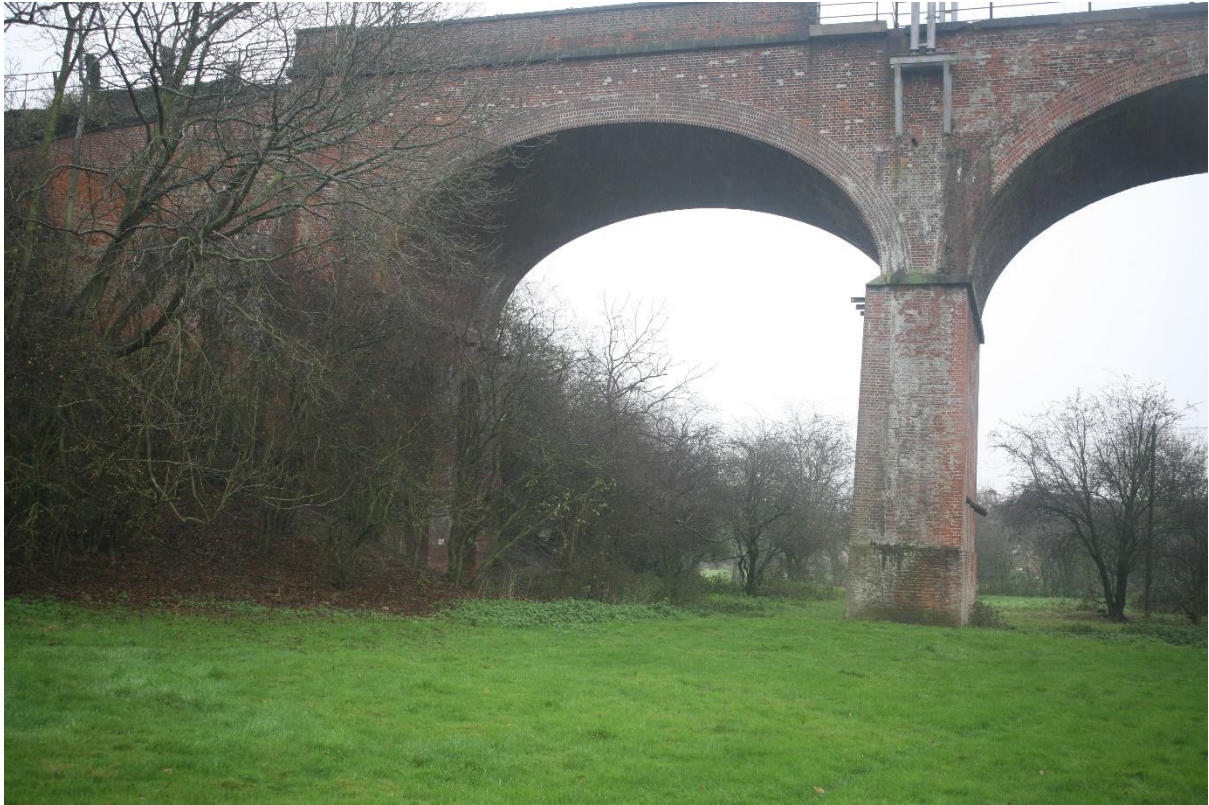
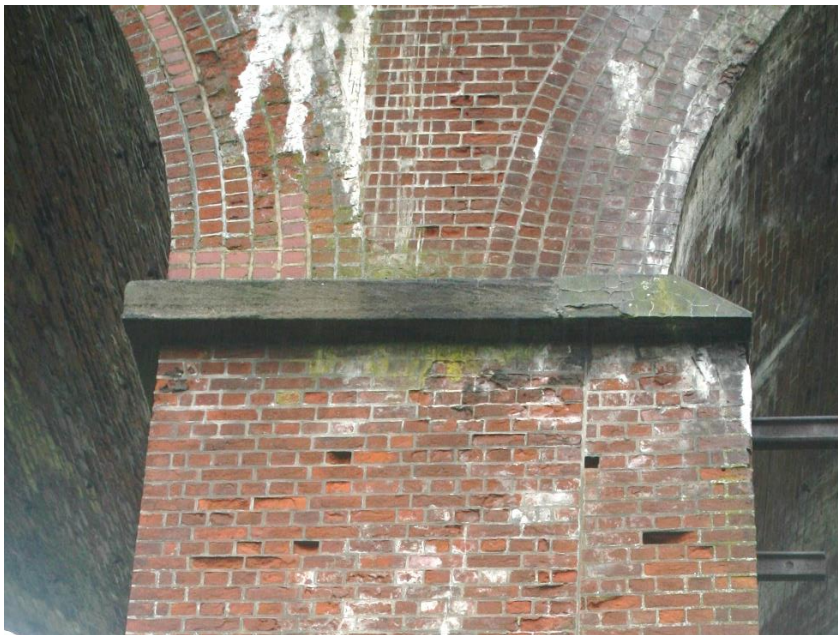
We can see here that the pier was obviously built complete, then added to. Also, the span was reduced, actually from both sides, since the abutment has a false front on it too.

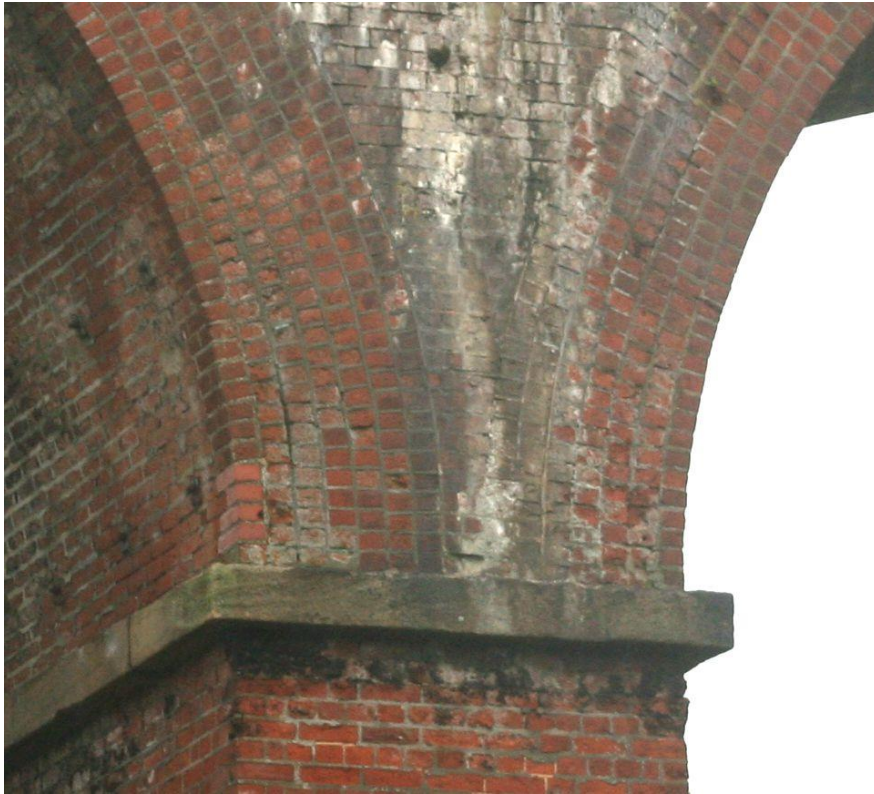
Looking closely at the top of the widened pier and comparing it with standard we can see that the springing has been moved three rings forward. What hadn't occurred to me till now was that might have been done by cutting off the base of the centre. The right-hand arch definitely does not land vertically on the pier.

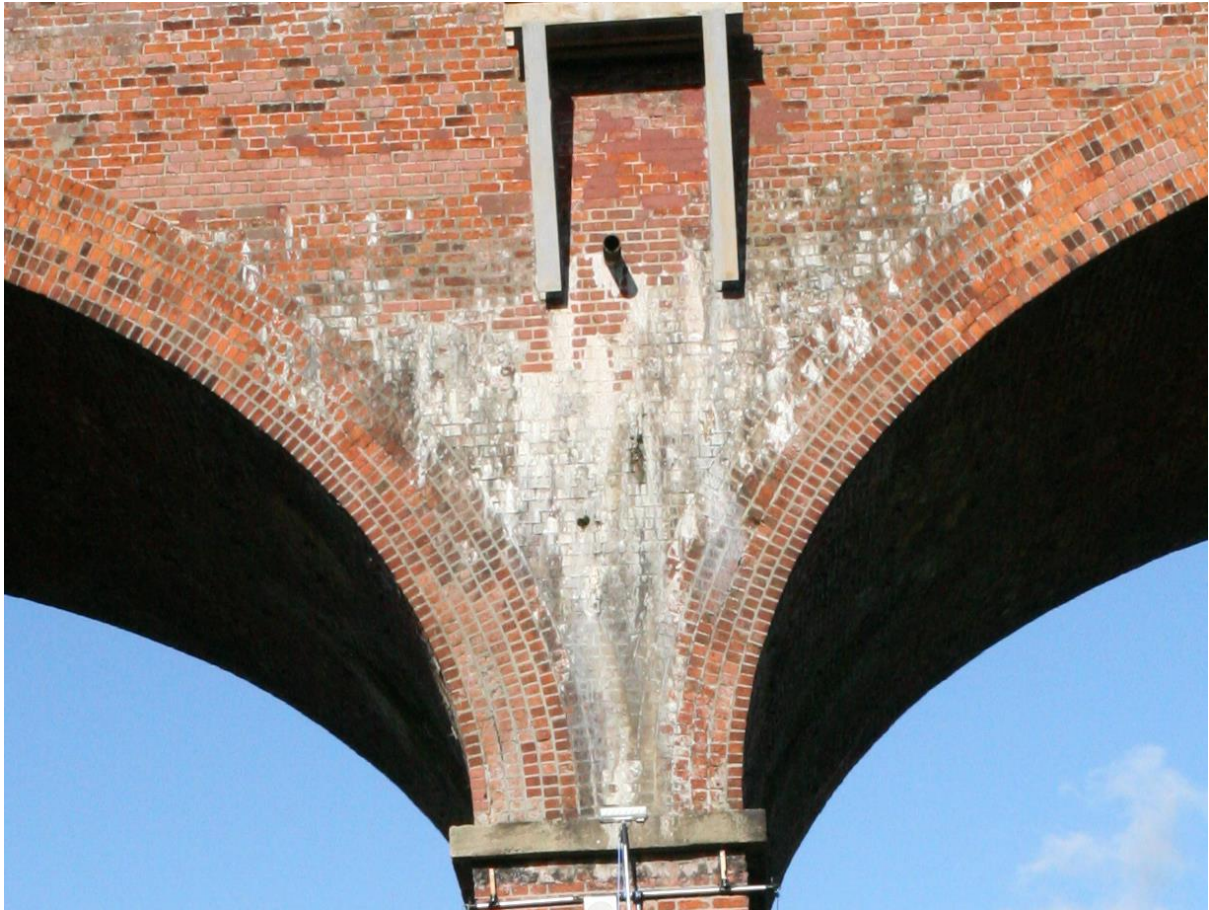
I never found time to dig deeply into what had happened to necessitate the reduction of the end span. It seems reasonable to assume that there was some sort of ground movement around that pier.

But I have come to wonder about a strange set of damage that appears in viaducts. Looking a little higher above this pier, there are lime runs and a drain indicating something about the level of the backing, though the top of the backing is surely above the topmost lime runs. If so, there is a line of patched brickwork much of the way across the pier at that level. Perhaps I need to go back when this lockdown is over.

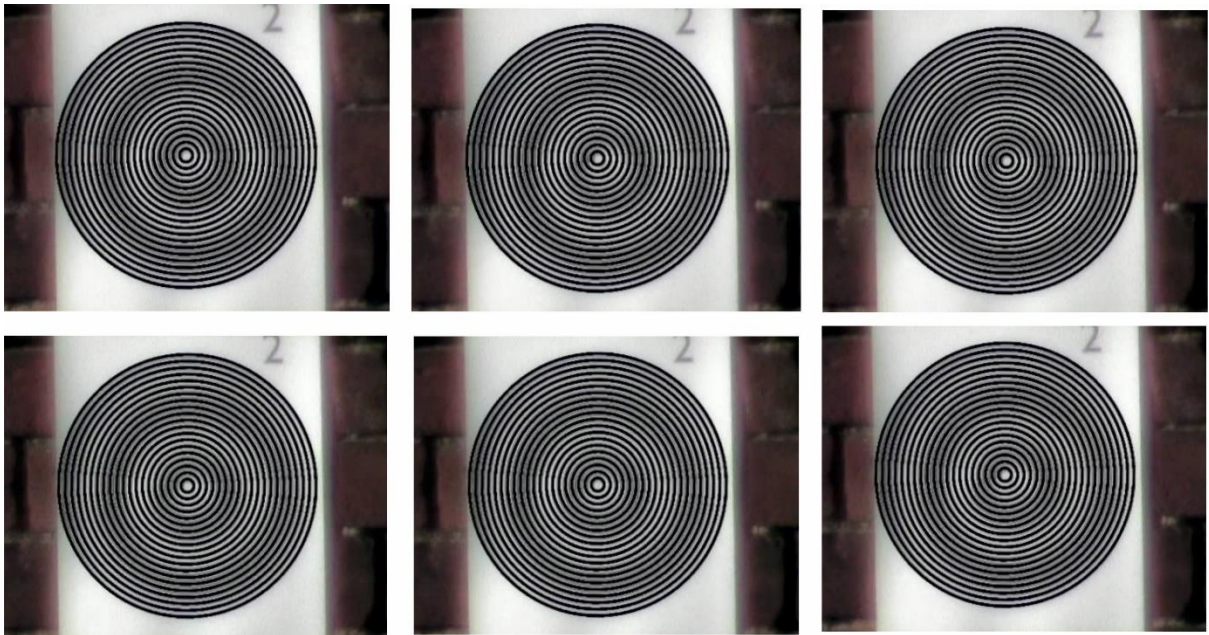
The first set of images is from the bottom target and the differences are very small indeed. It is most readily detected in the size and position of the slight dark part fringe at the left of the image.

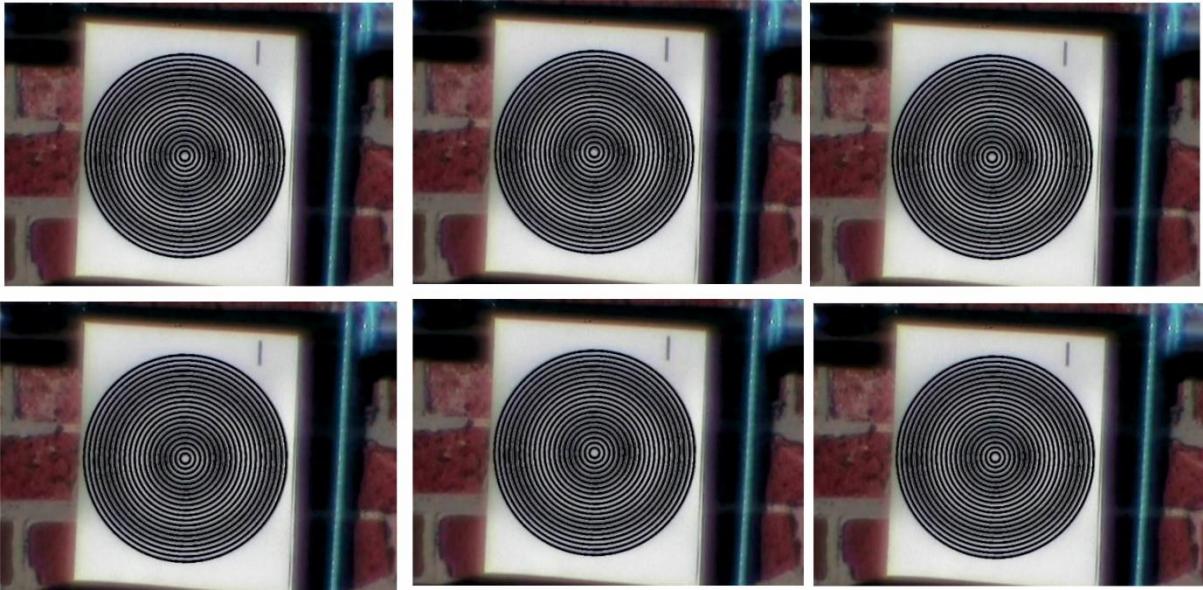
The movement at the top of the pier is slightly more visible.

Notice particularly that the dark rings are almost exactly central in the bottom right, slightly to the left and low at top centre and and slightly to the right and high bottom centre. It wasn't possible to synchronise these measurements. The range of movement was about 0.3mm in the lower set and 0.6mm in the upper.
