Bridge of the Month 116. Aug 2020 Trenance Viaduct, Newquay

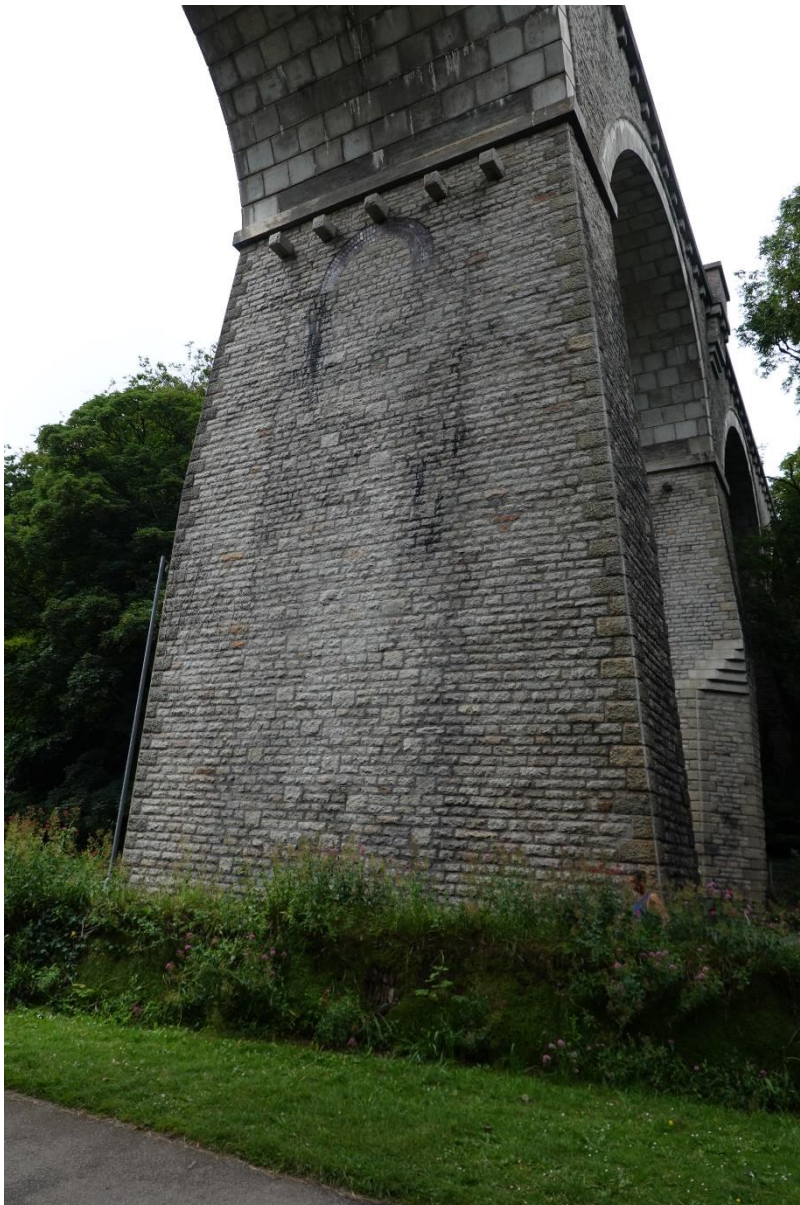
There are so many odd details even in this one picture. Notice how the near edge of the pier slopes uniformly from springing to ground while the one behind turns vertical and has a corbel. Look to the left and the near pier is also vertical on the left. Also, there is a little arch, almost like a relieving arch near the top with water marks and cracks coming downwards from it.

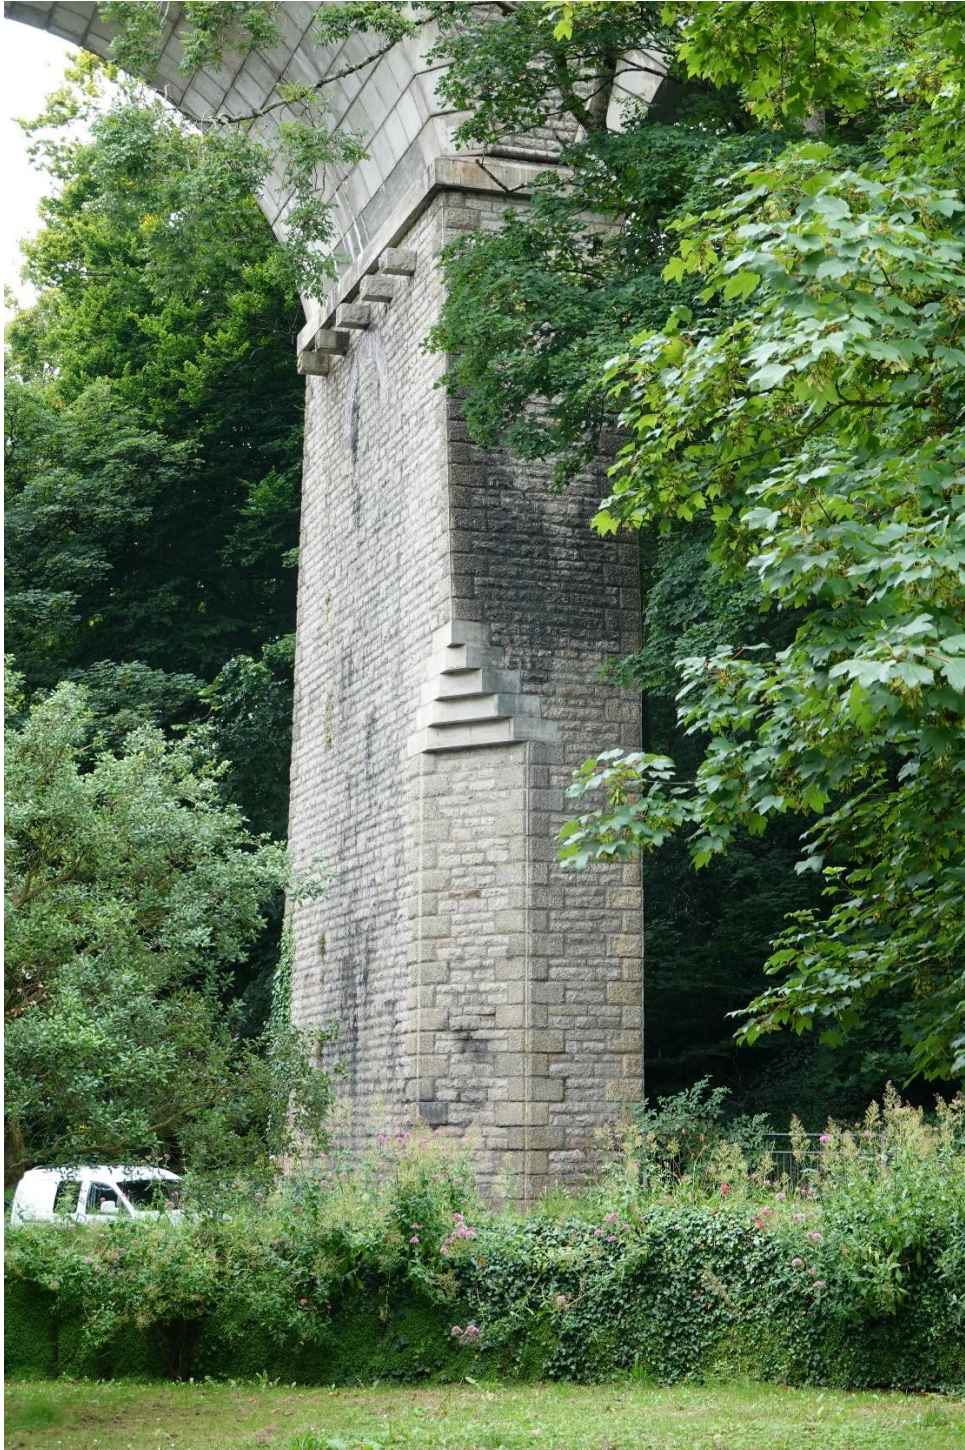
Here is a clearer view of the corbel. Perhaps the vehicle indicates why it is there. The visible stonework is granite, but the corbel pieces are precast concrete.

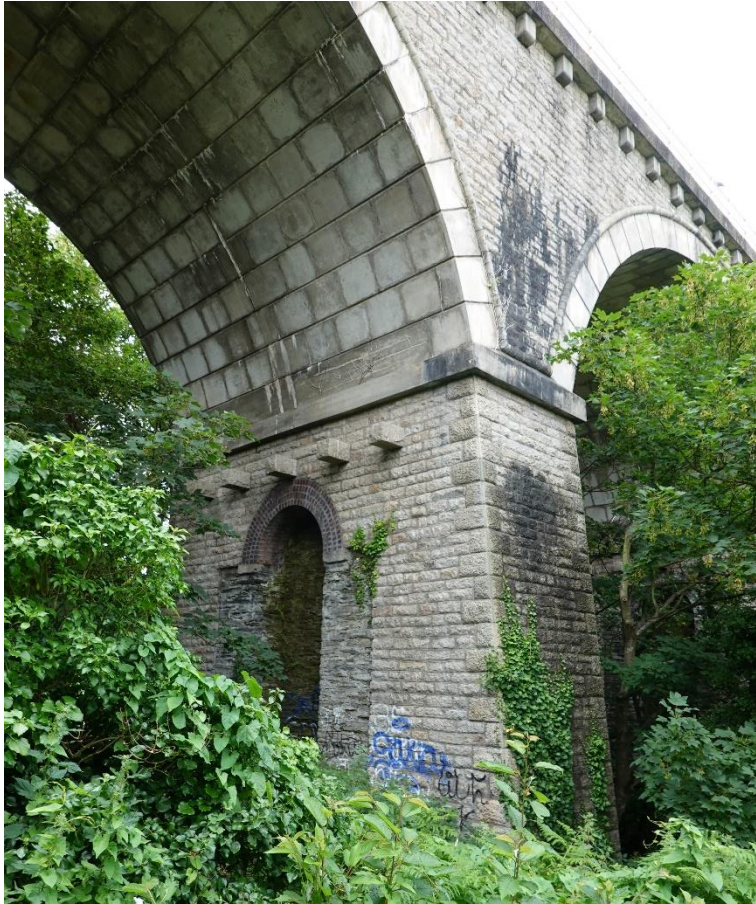
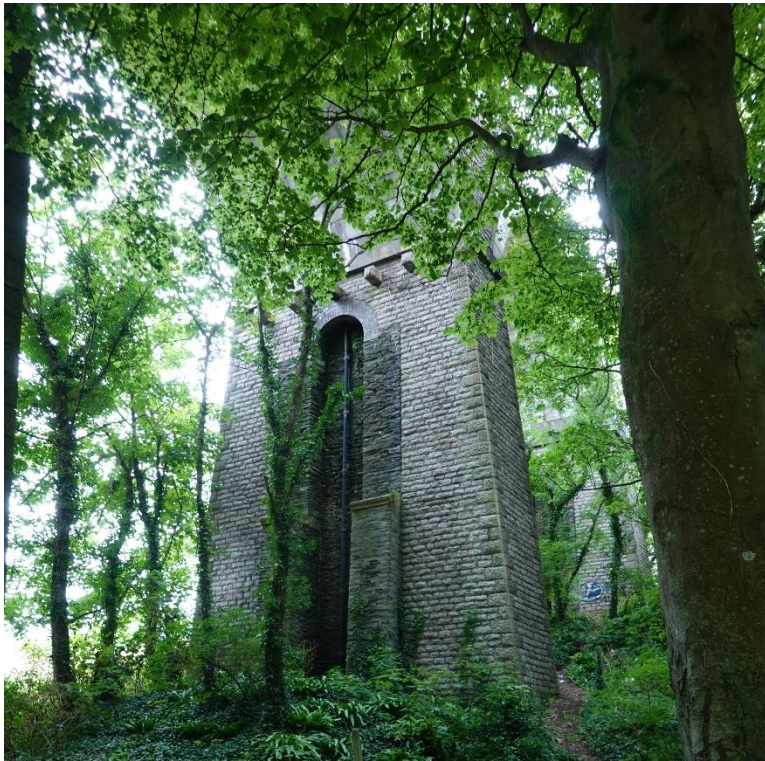
Below we move to the back of one of the other piers and a little more is revealed. The very different stone in the middle is the pier of Brunel's original viaduct. The "relieving" arch may belong to that, though I think they often stood on independent legs.

The spans have been adjusted from Brunel's original layout. Varying spans are easy in Timber or steel but rather more expensive in stone, though in this case the arches are of precast concrete voussoirs. Making different moulds for different spans would have been even more expensive.

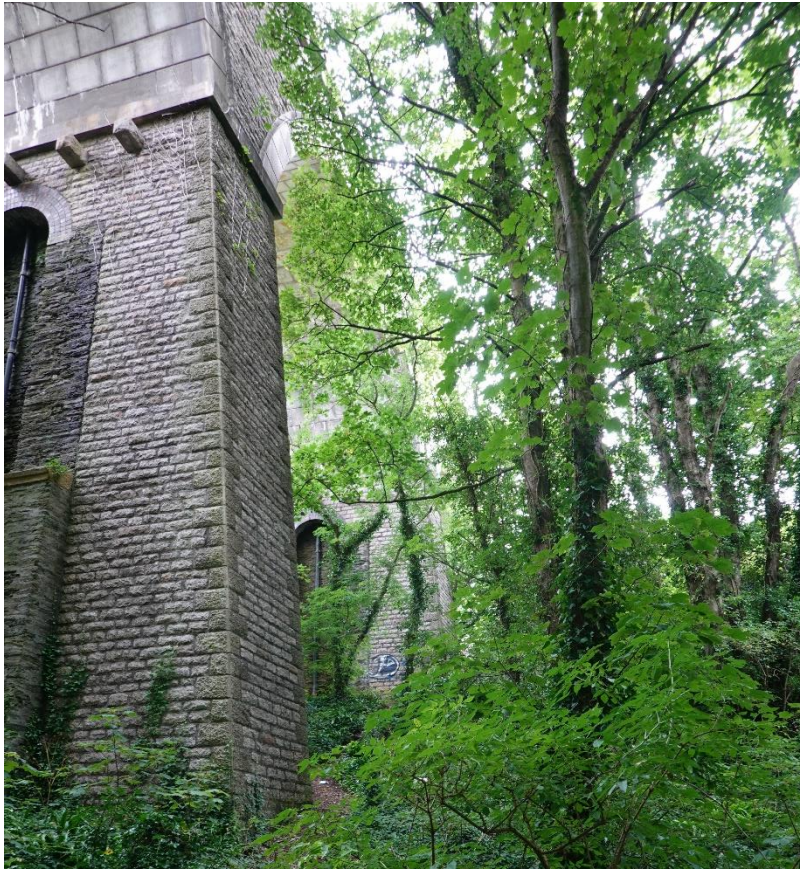
Here, the upper part of the original pier is flush with the face of the new.

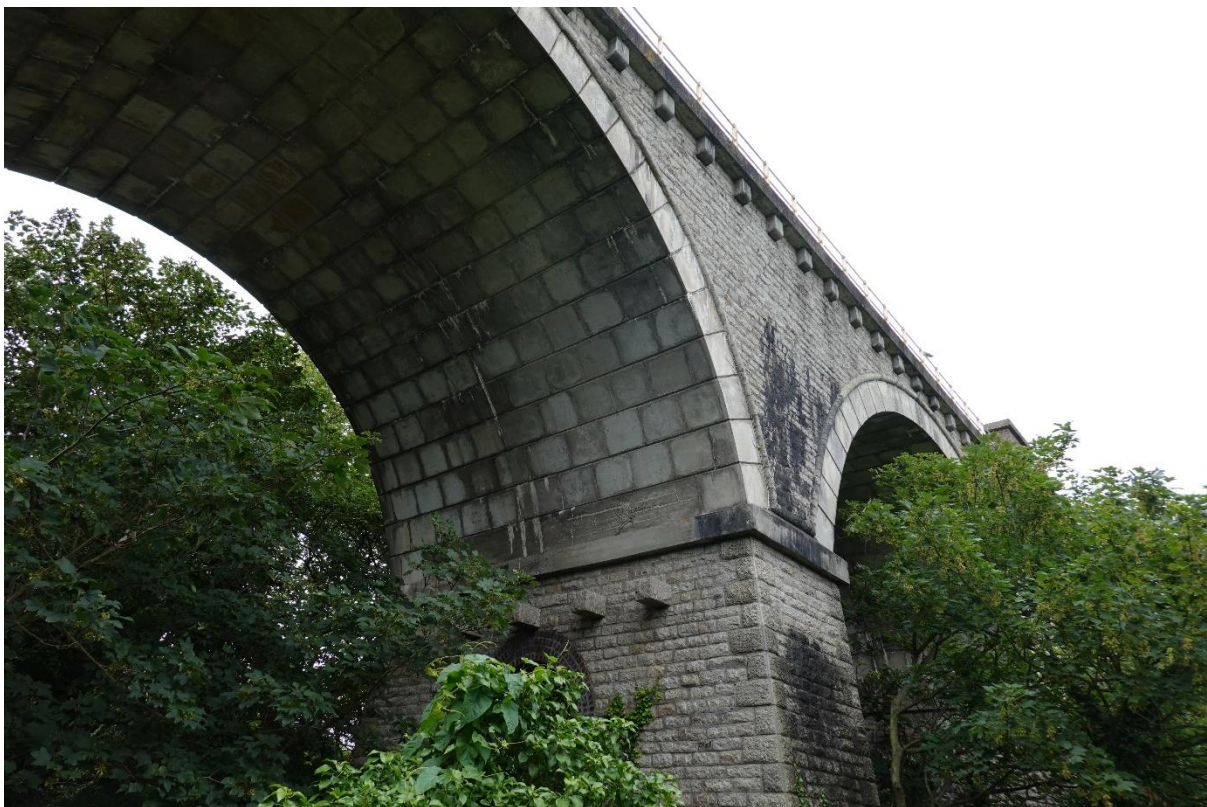
From a slightly different angle we can see that the next pier is similarly flush. So the new spans are slight shorter than the originals and offset to one side of the original piers.

The spandrel wall is vertical, so the water marks there relate to the level of backing inside. The overhanging string course at springing level means that dripping water reaches the inclined face of the pier some way down and creates a stain there too.

There is lots more in this picture but let's take a patch out of it to make that clearer.

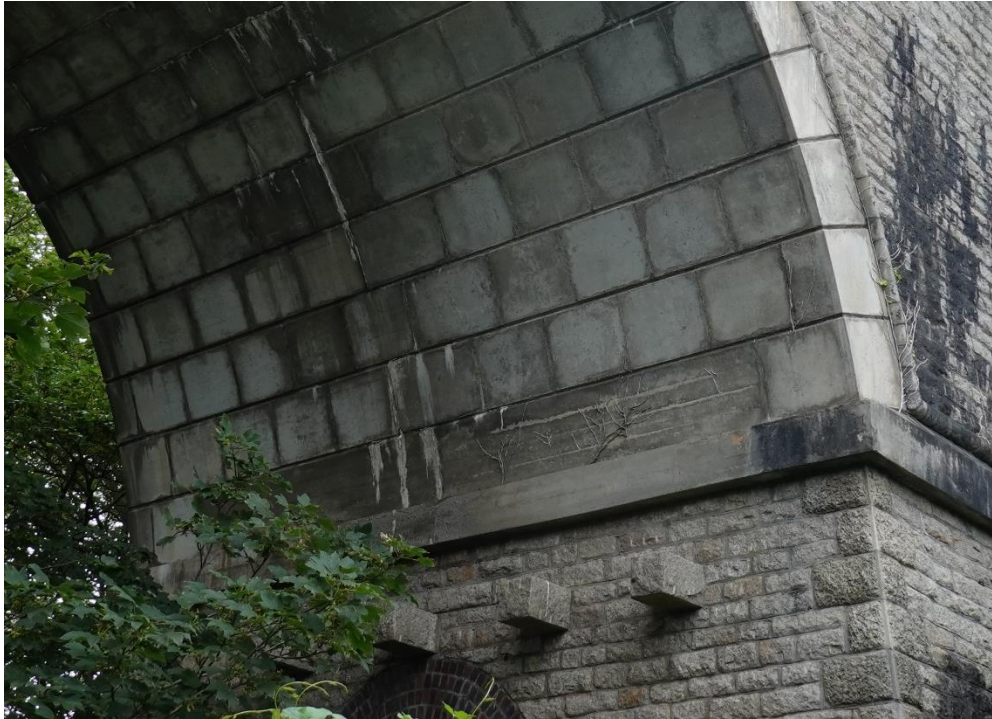
The first thing is that (sensibly) the precast voussoirs come in full and half lengths. The half goes at alternate sides. Then there is the fact that the inner part (at least) of the string course is almost certainly cast in-situ as is that first course of arch above over much of its length. There is just one voussoir at the near side and one and a half at the other.

There is a nosing above the voussoirs which also turns across the top of the pier. Bricks were often made for this purpose and these are probably of that material.

Finally, we should note those fine granite corbels to carry the centring. Interesting how far from the edge the outer one is.

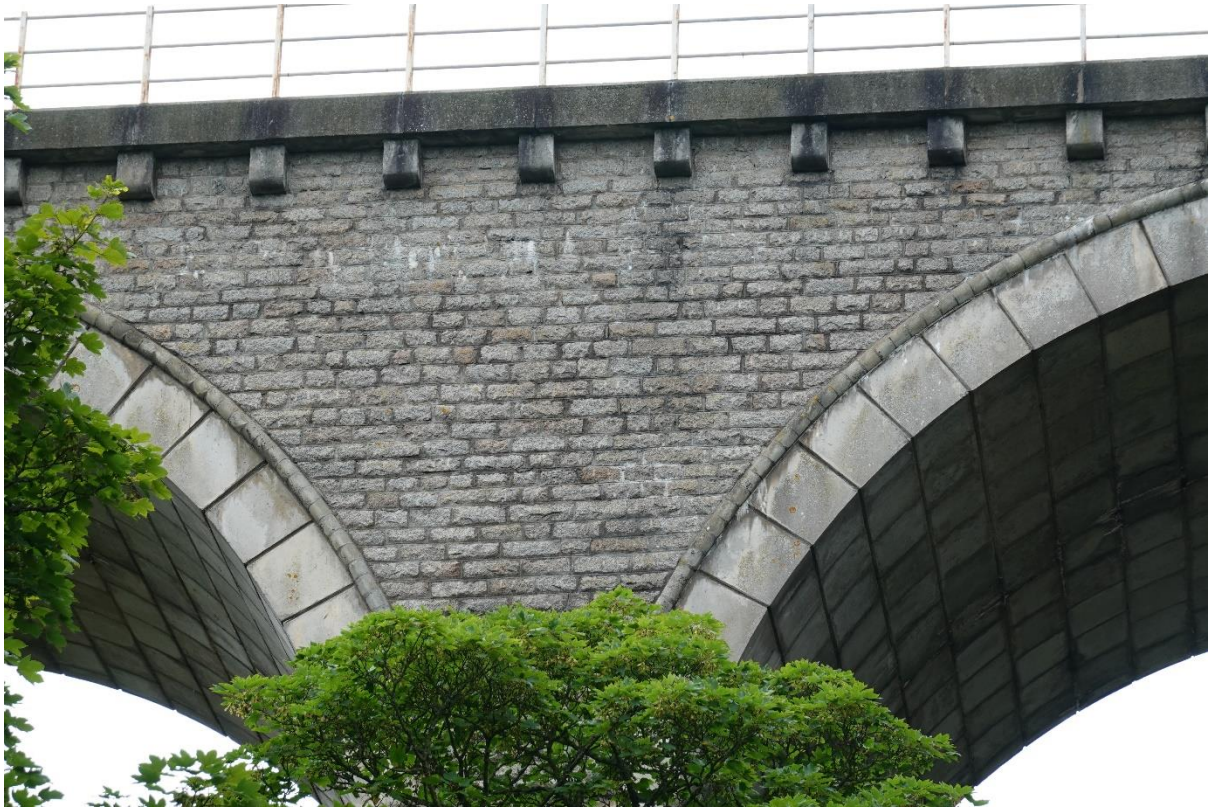
Not all the spandrels have that dark stain. Here, there is a trace of a line with lime runs. It looks as though it is level with the crown extrados. There is a less obvious line further down and a change in general colour which suggests to me that there are internal walls, closed with arches, sitting on solid backing at a lower level.

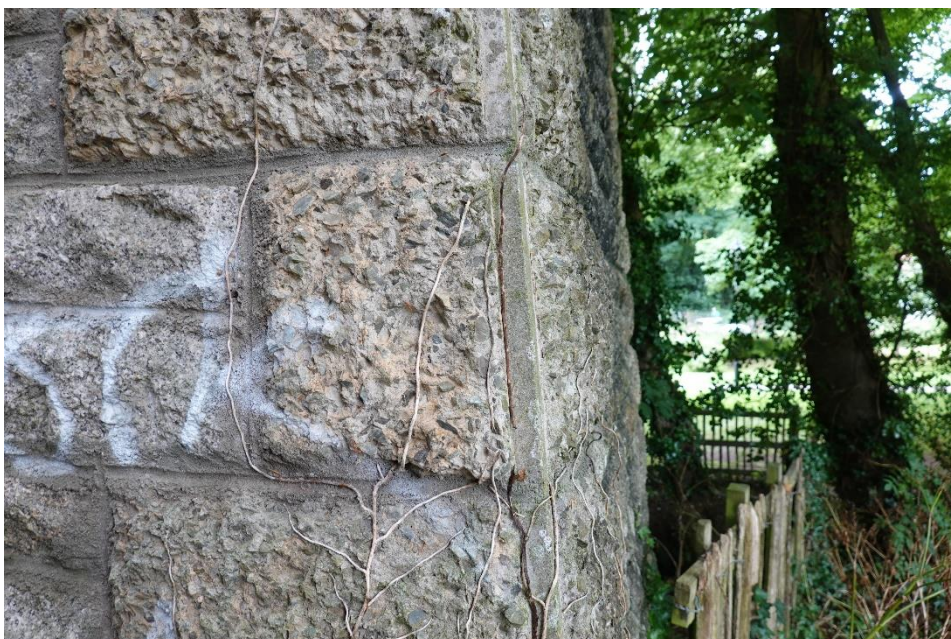
Oh but look! The quoins are precast concrete too, with a face tooled to look like the granite unless you get close.

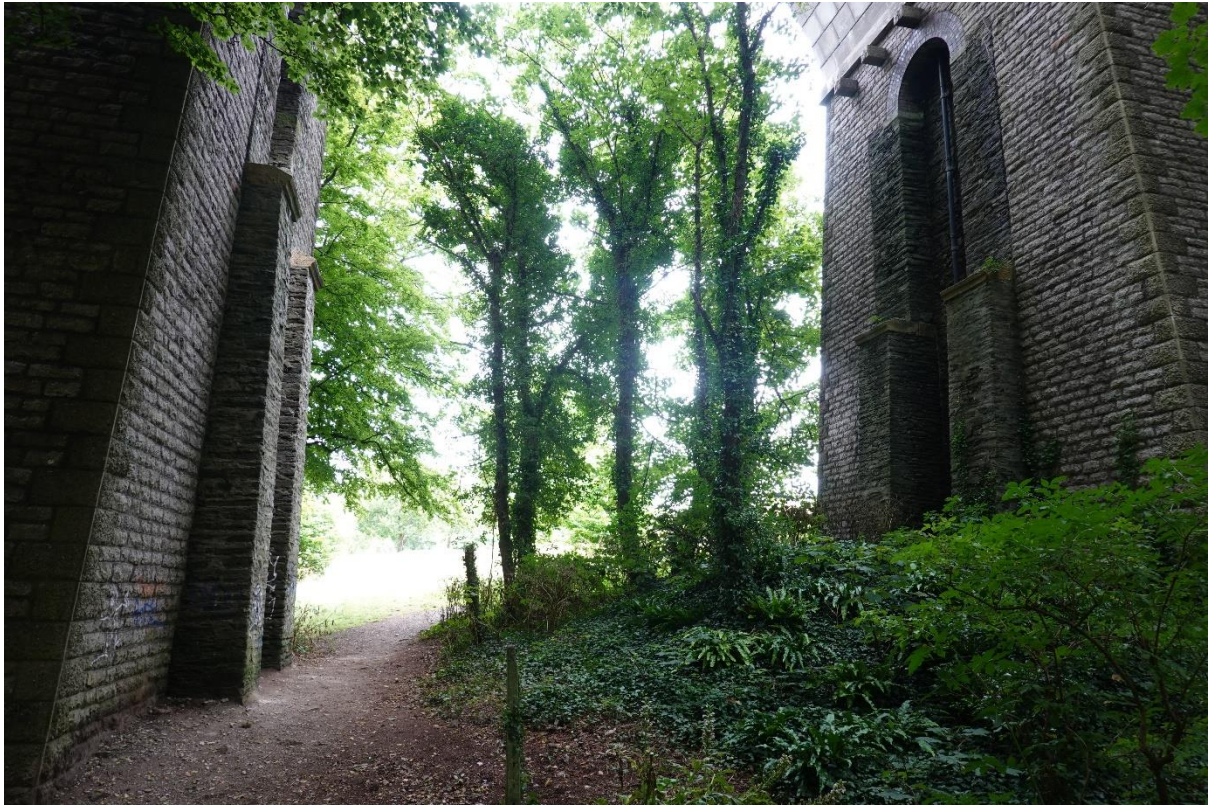
Here we see the old piers projecting on both inner faces. The new piers are thicker than the originals so the span to the left was almost certainly bigger originally. To the right, up the banks, it is much less likely to be so.

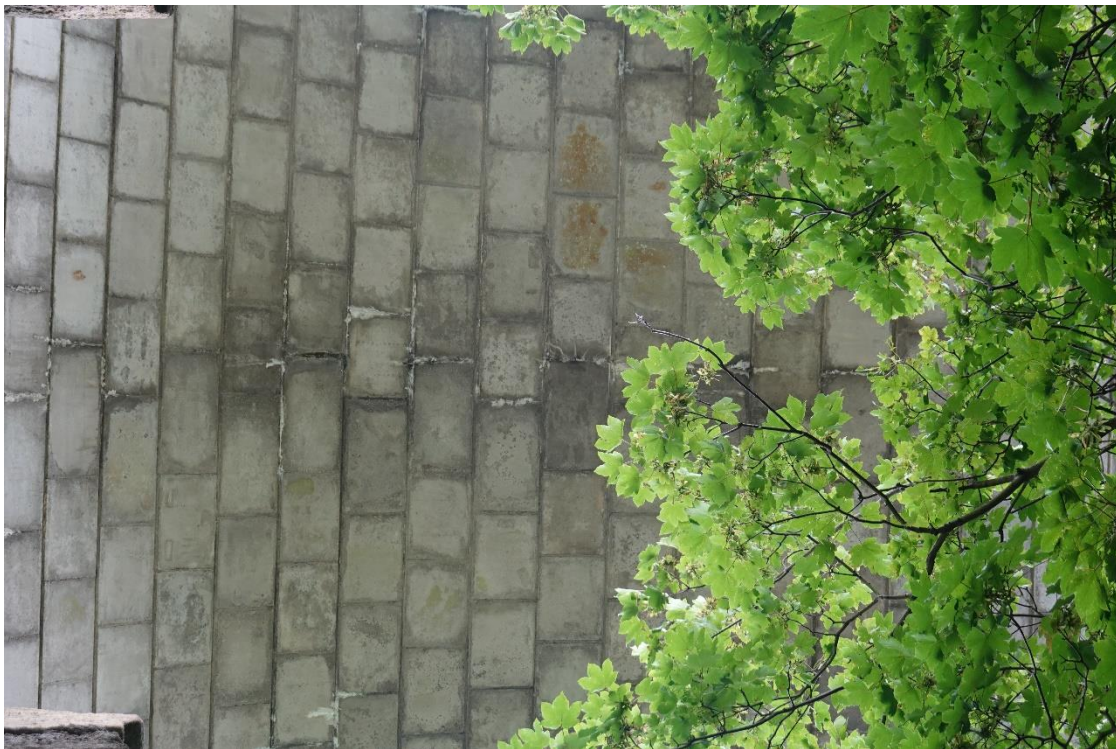
Looking up, there is a crack along the arch centre line. An explanation for that would also require a further visit.

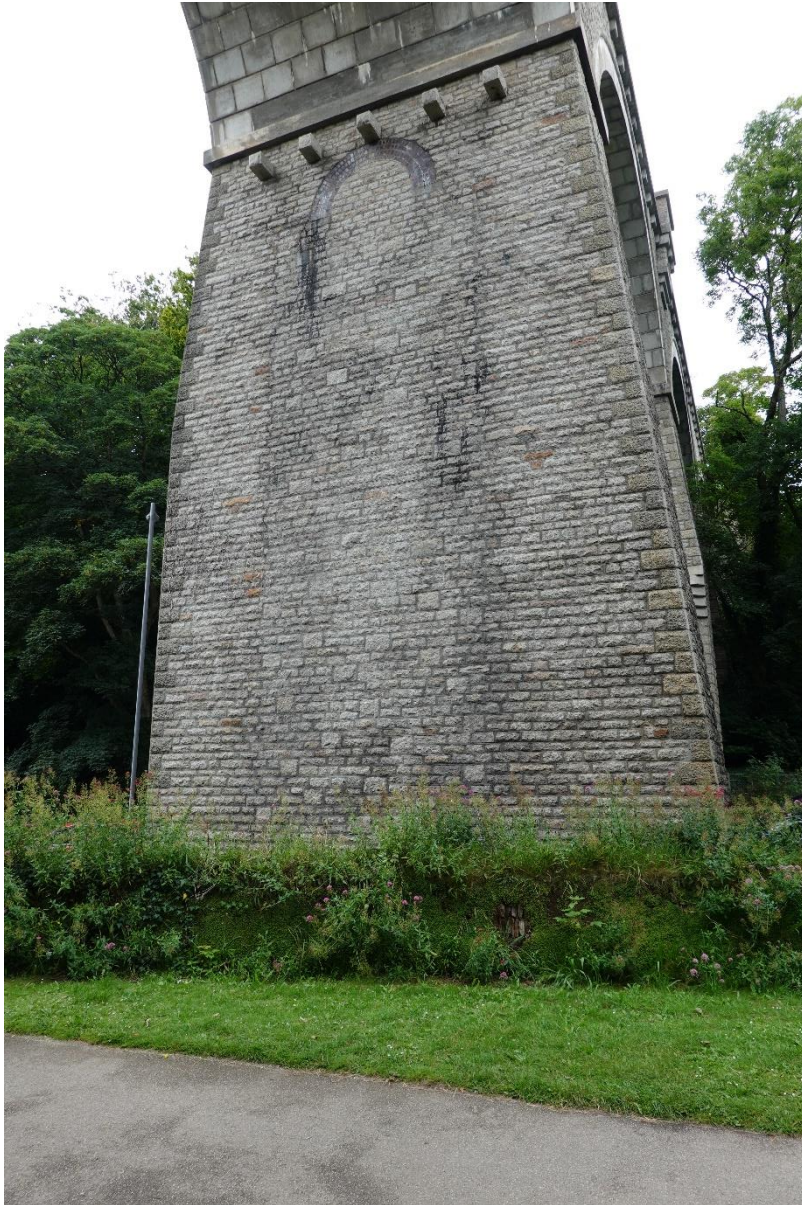
This is the back face of the pier at the road. We know that the original pier does not protrude on the road side either but it must be close to the surface here because there is a very clear movement at the outer edge of the original buttresses. The inner edge is demarked by the springing of the little brick arch but there is no crack below.

There is damage above the arch to the left though, so it seems there may be some modest movement.
