Bridge of the Month 122. Feb 2021 Monklands Glen, Airdrie

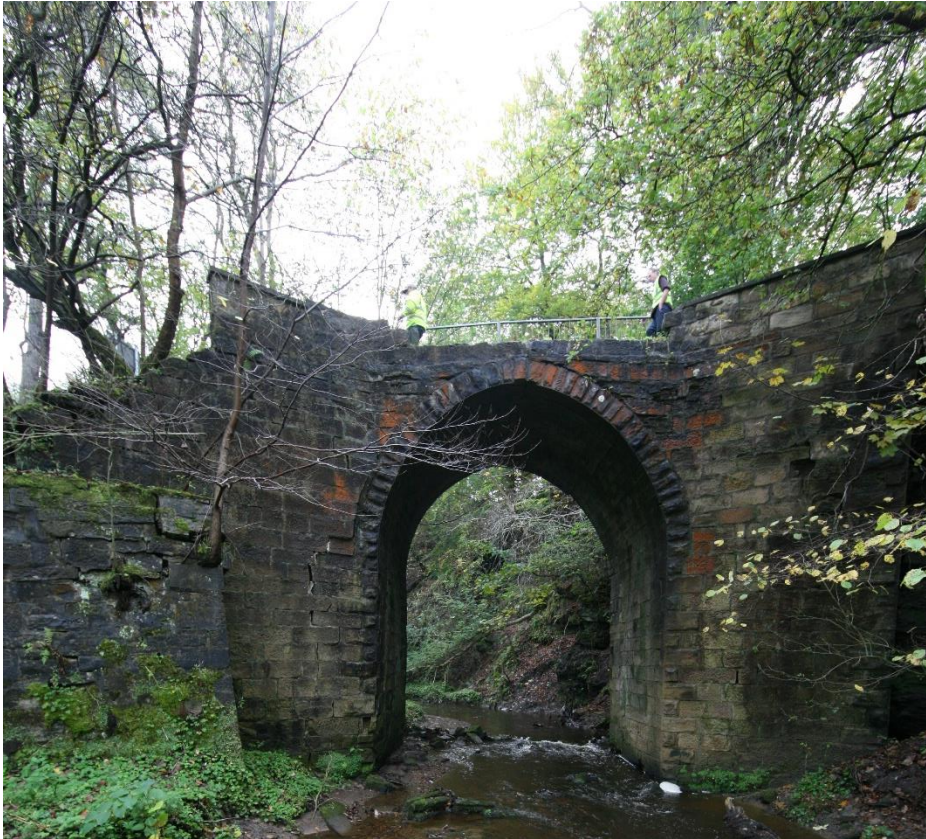
A pointed arch? Not originally, that's for sure. This is on a flood plain, but the river is right at one side against a cliff so the road comes across at high level and has to be approached on a high embankment (to the left in this picture).

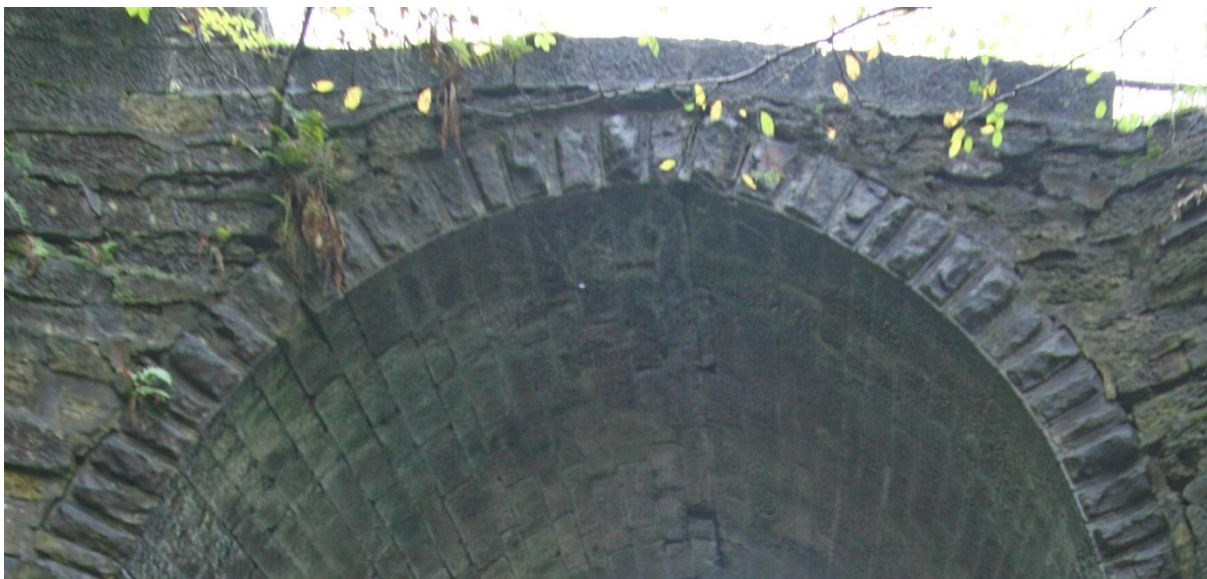
Now we can see clearly what is happening. Just to the right of the crown there are two joints wide open at the top. There are two diagonal cracks going up from the arch at the right where the wall has lifted on the arch. At the left, the stones are better bedded and the pattern is rather different.

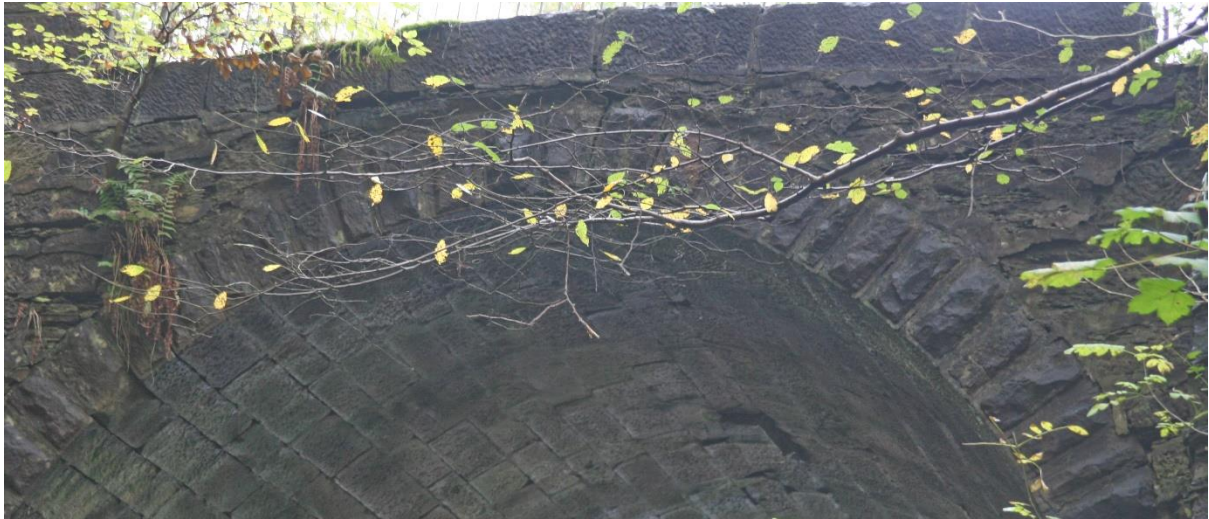
Here, we can also see a dropped stone. How does that happen?

What I think is happening (if I were there again I would take more photos and get a 3D model to test) is that the arch is humping through the span as a result of the span being squeezed. The edges are held down by the spandrel walls, so there is a hump across the width too. The large stones means that the dome can open certain joints and allow a stone to drop.

Also here, you can see very clearly the hump in that top row of dressed stones which were the bottom course of the parapet. The hump opened up the joints and broke the mortar so the stones were much easier to push off. I am sure they made a lovely clunking splash when they landed.

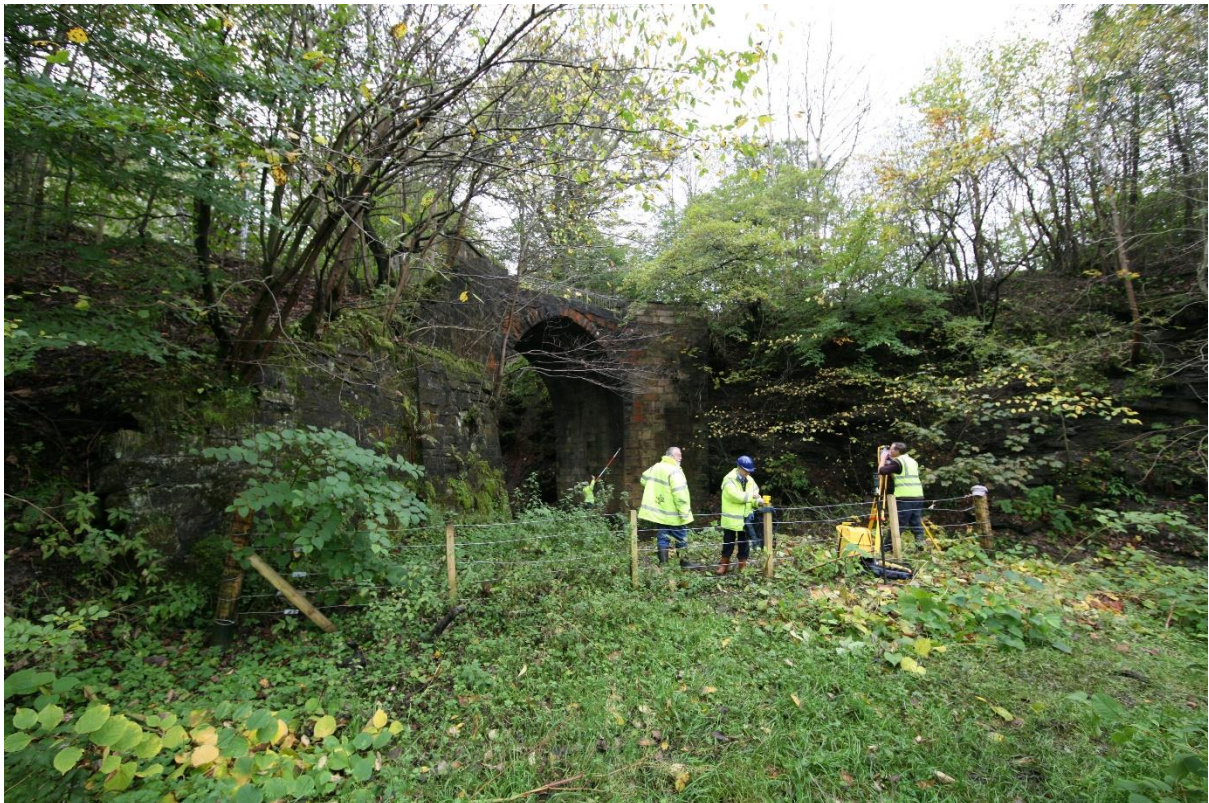
There is the cliff on the right and a rather high approach embankment on the left. The embankment was certainly just tipped and not compacted. If I remember rightly it was mostly ash.

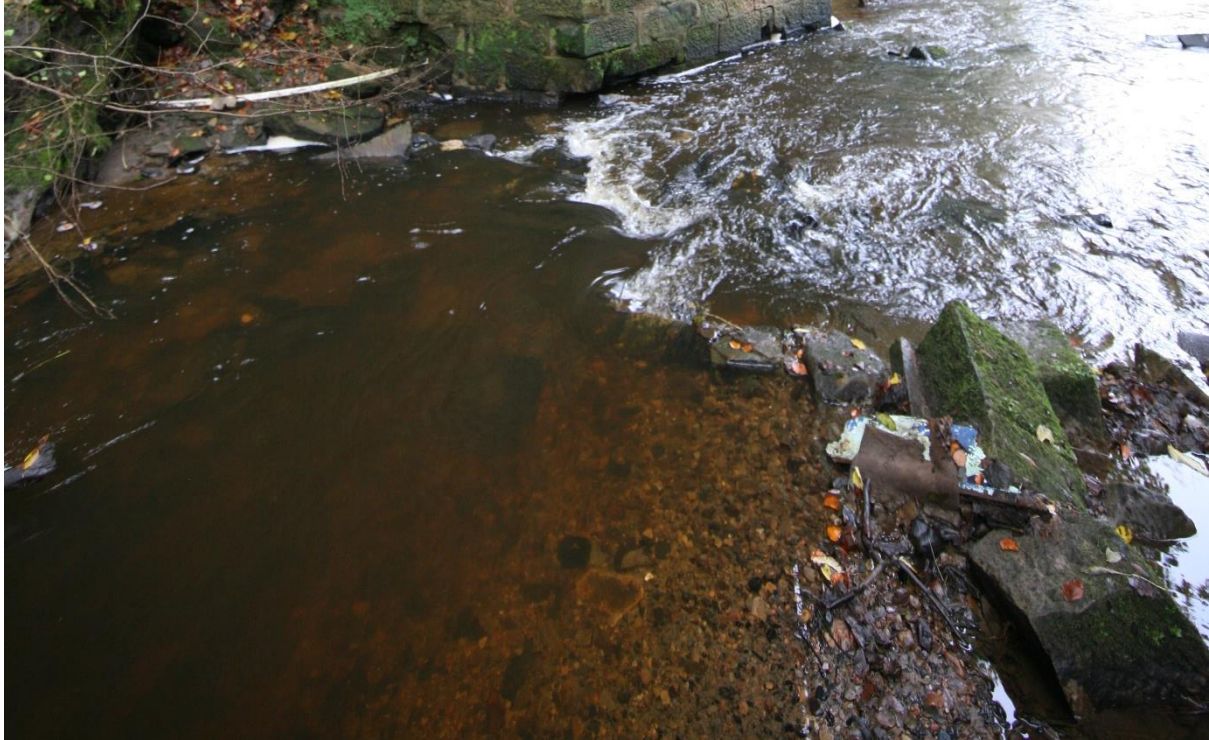
Can we be sure that only one abutment moved? I was going to crop the bottom off the next picture but let's just note that there are the parapet stones!

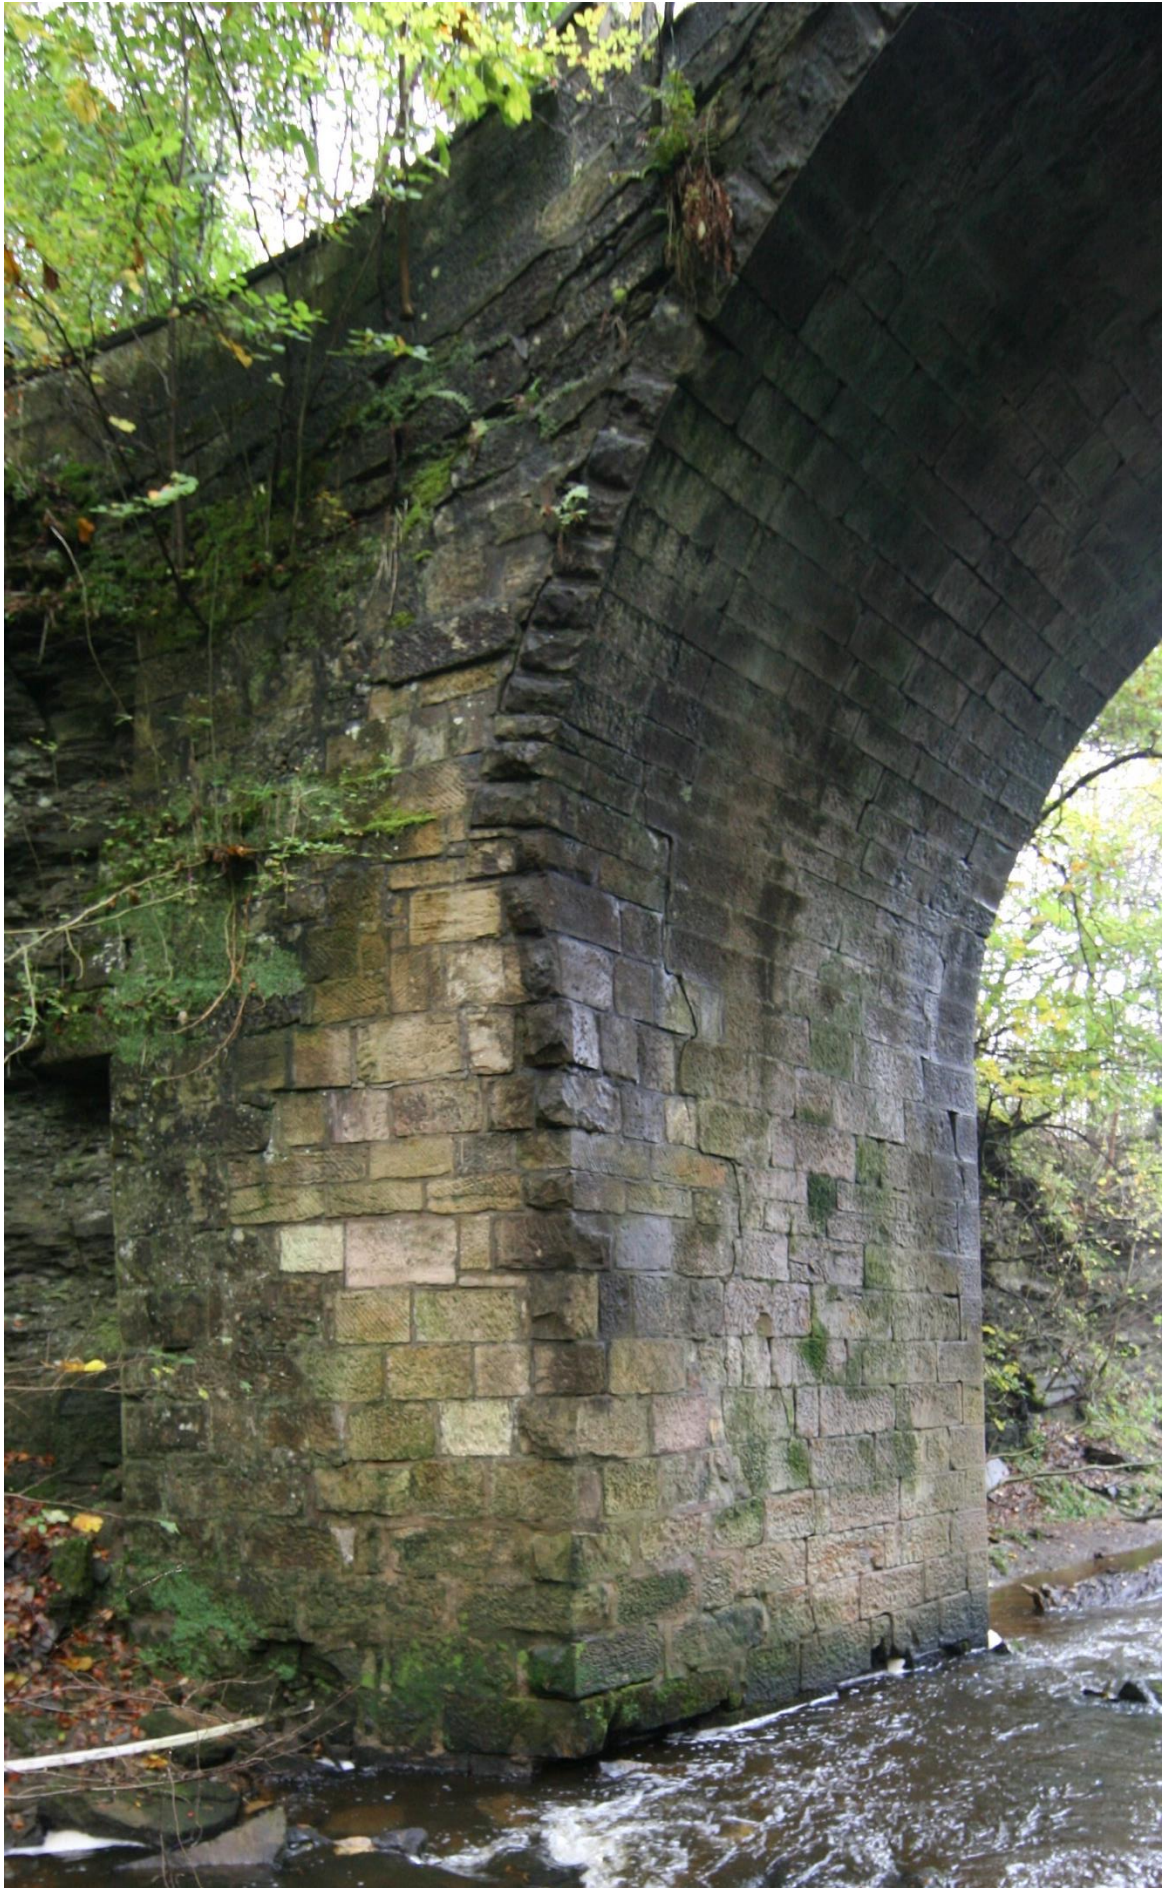
This is the abutment against the rock face. There is a crack up the centre but otherwise very little damage until well up into the arch.

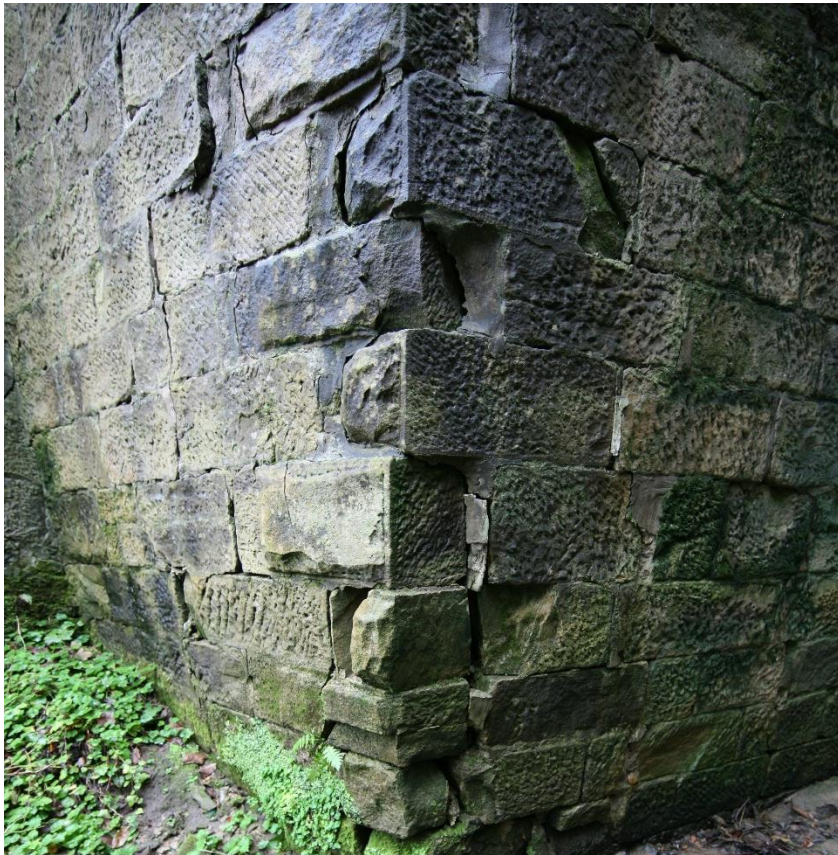
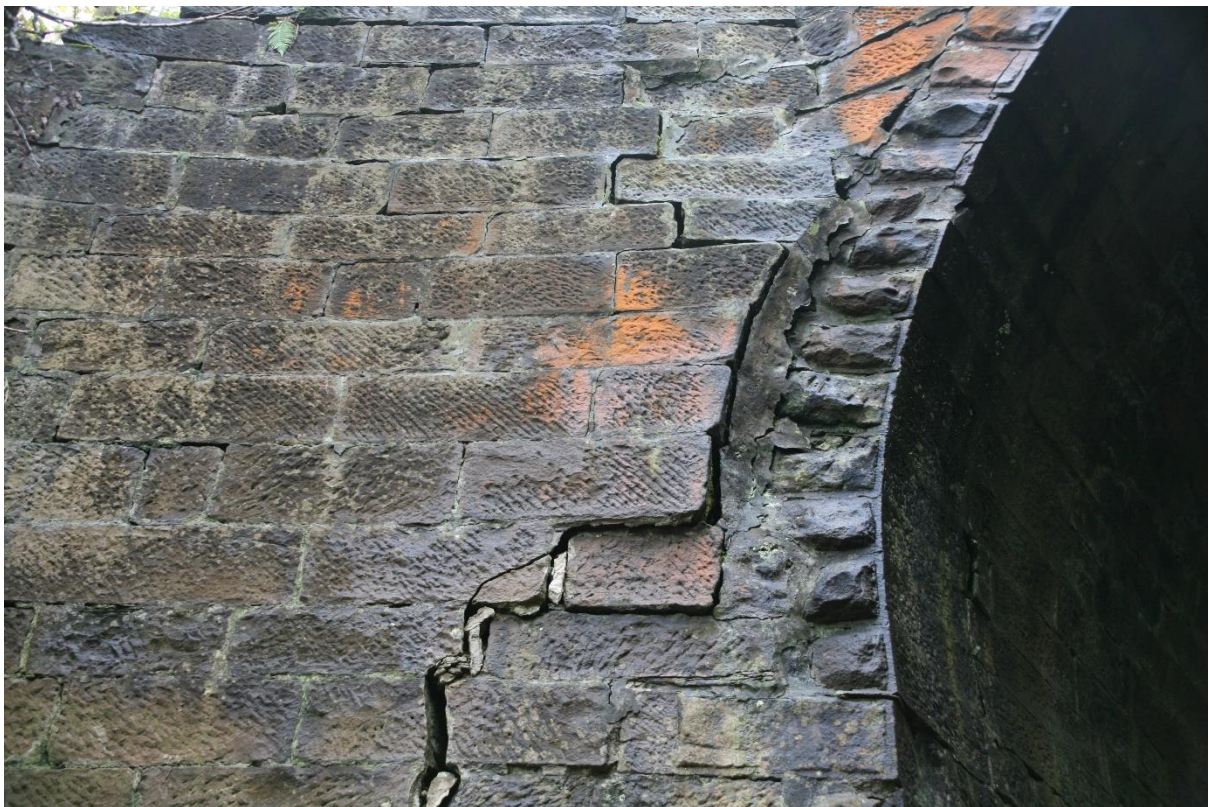
The front of the other abutment is actually tearing away from the sides.

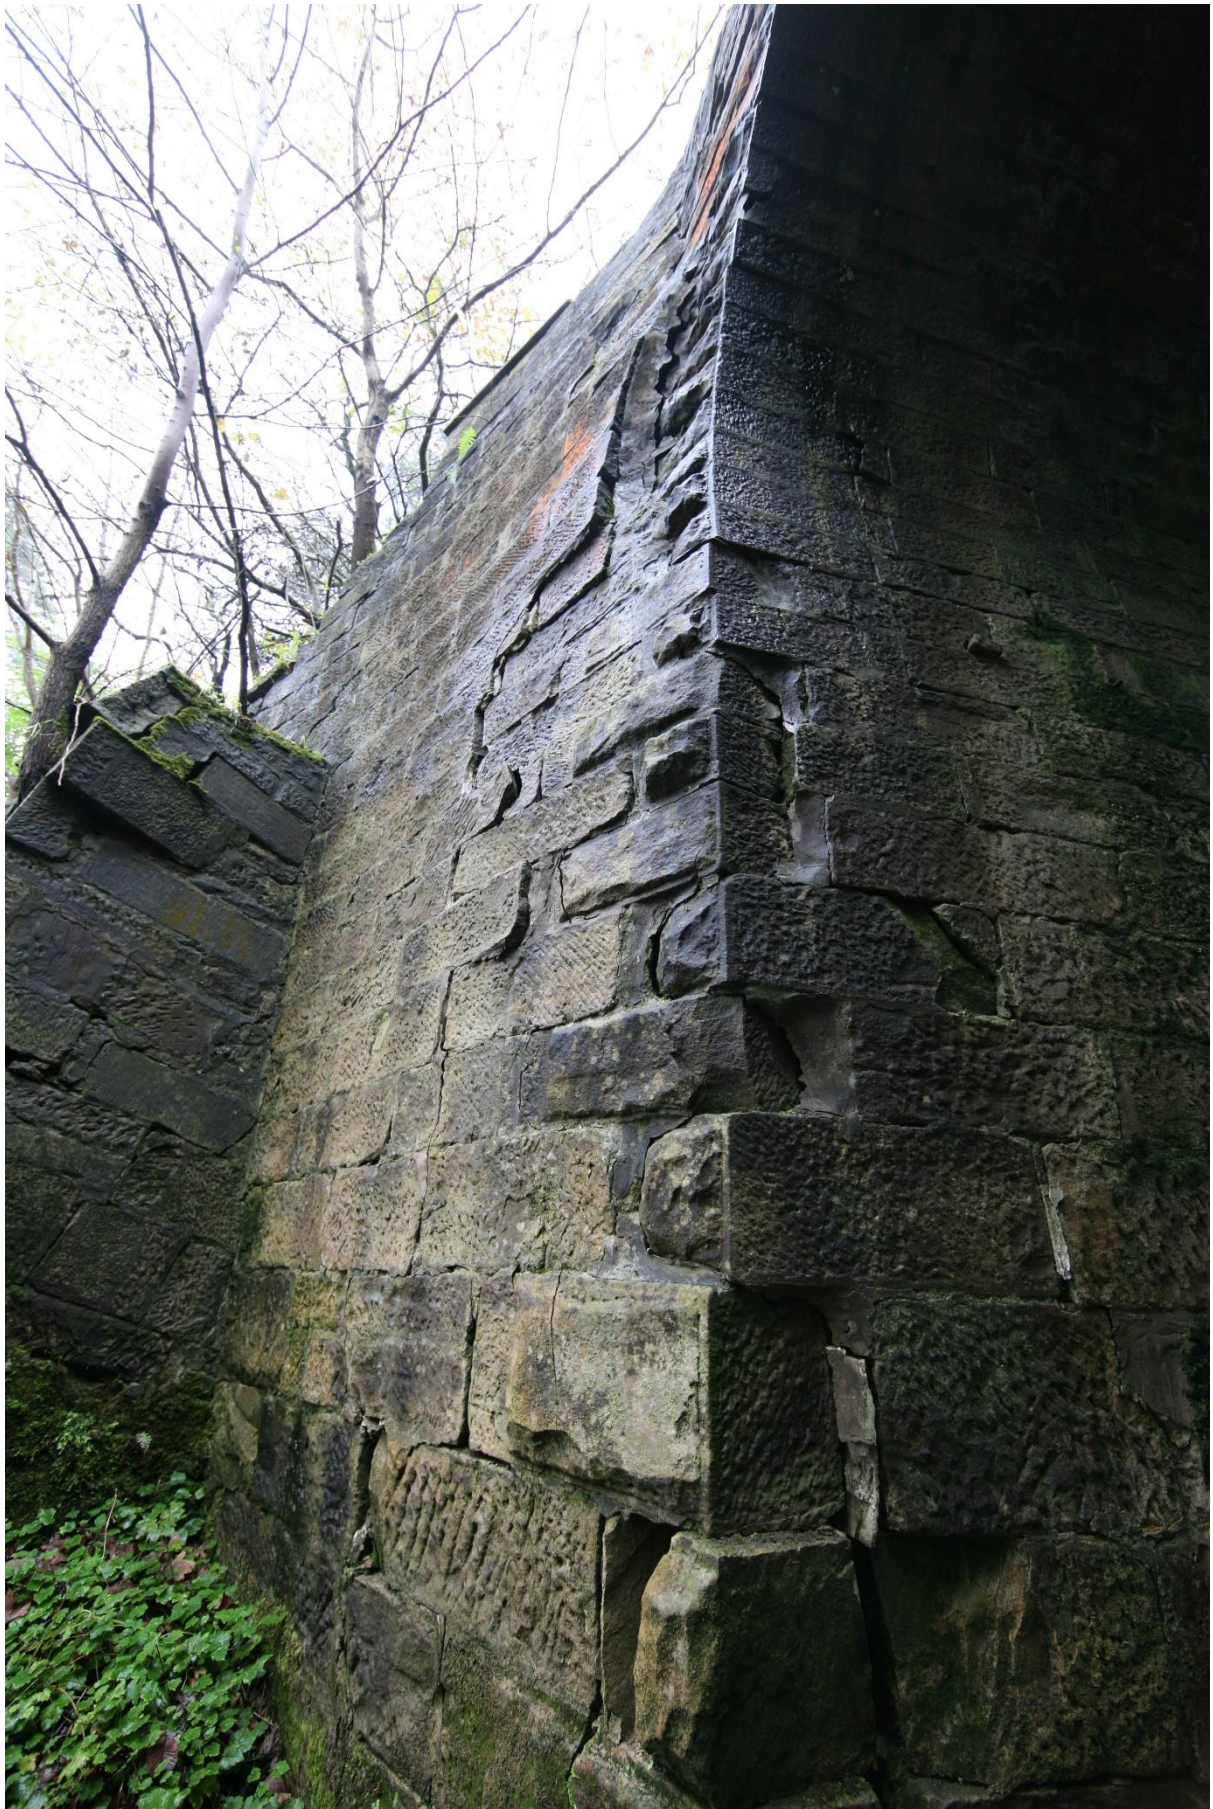
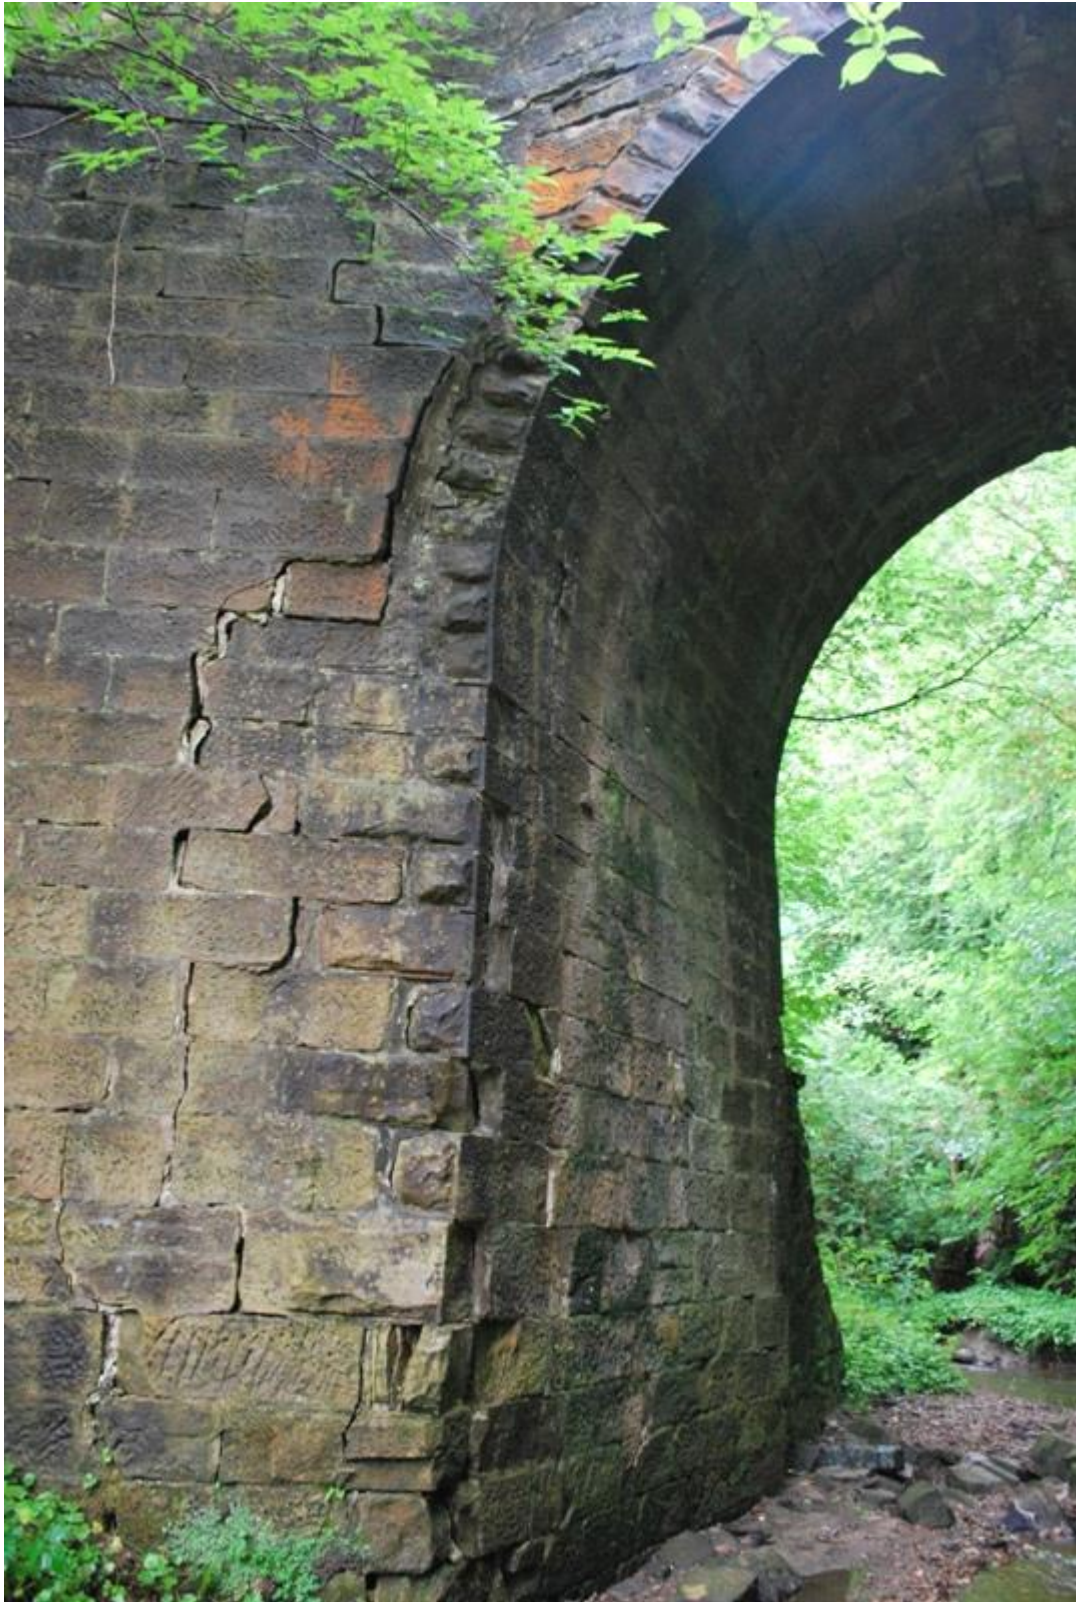
And further up the wing wall is pushing out past the edge of the arch. A look further back shows how that fits together with the rest of the wing wall and an added buttress.

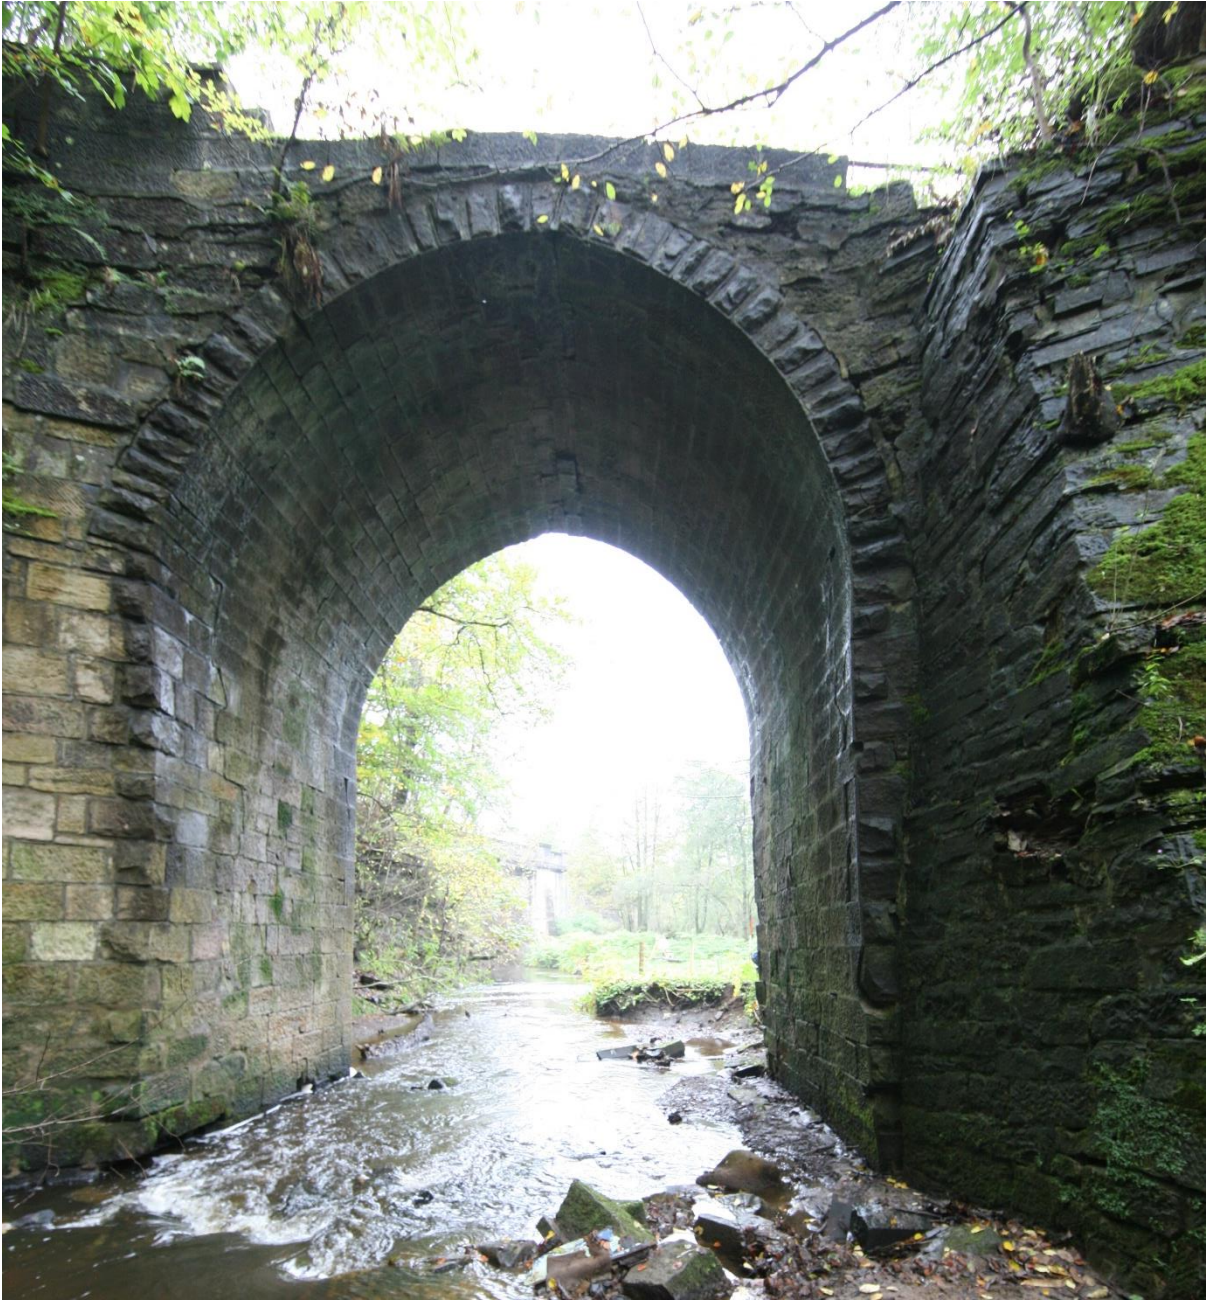
There is something of a belly in the abutment face too.

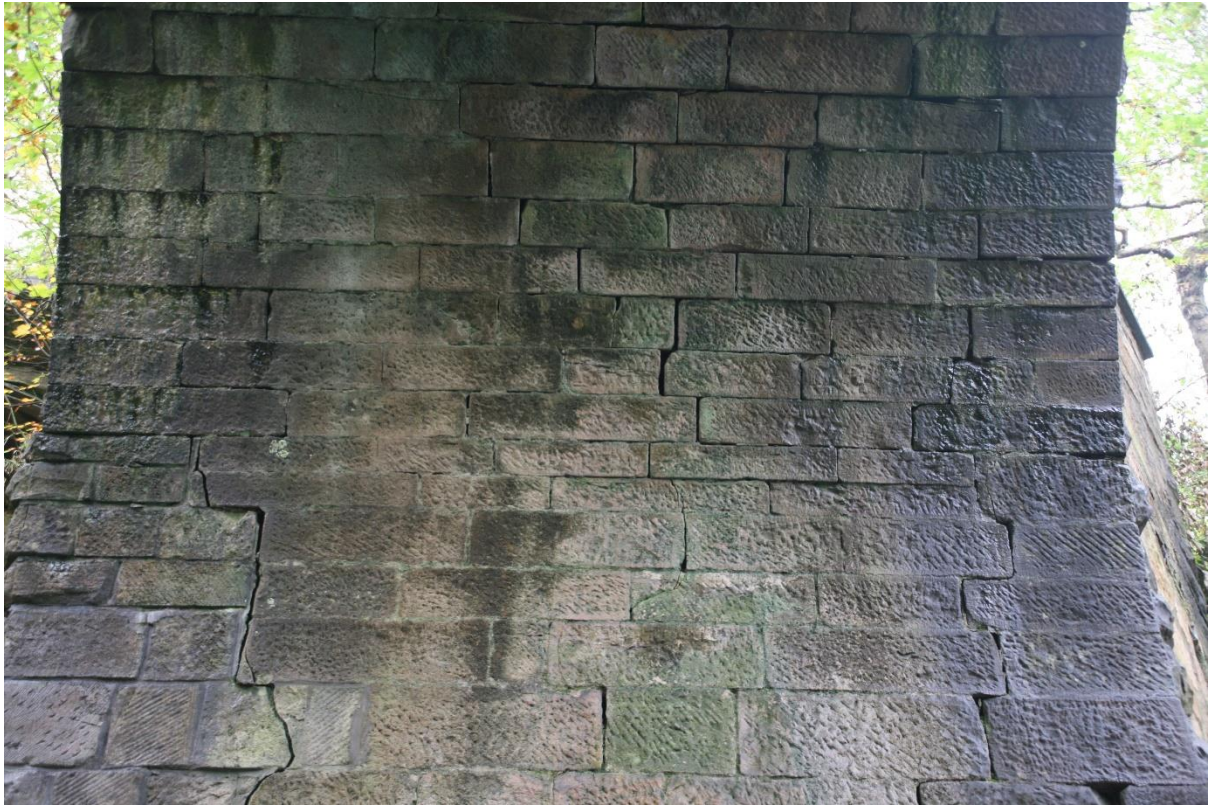
That's a massive buttress added to the other wing wall.

What's going on here? The beds don't come near to matching to the left of the left hand crack. Has that bit been rebuilt?
