Bridge of the Month 125. May 2021 Merry Harriers flood Damage

BILL HARVEY ASSOCIATES LTD

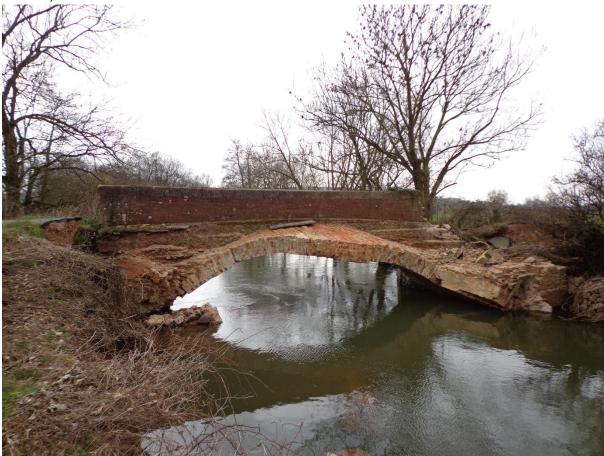
Sadly, I never got to see this little bridge intact. I heard about the flood damage and went to see what there was to see. I think it has now been replaced but it was <u>here</u>. Even in the tattered remains, there is a lot to see.

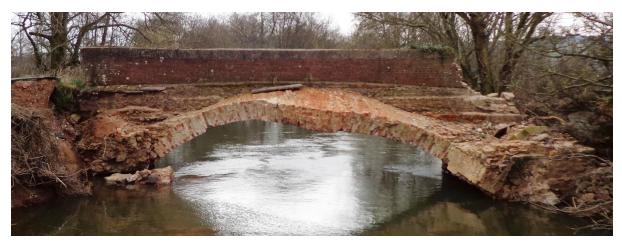
What is left is rather less than half a bridge. The break is remarkably clean.

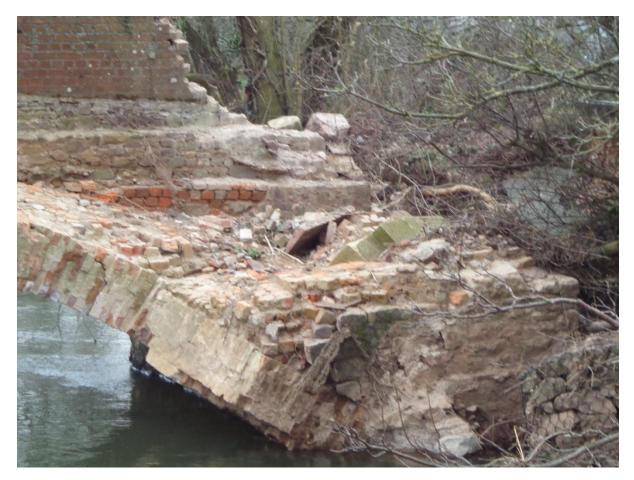
Look at that sag. The abutments have moved back more, nearer to the camera.

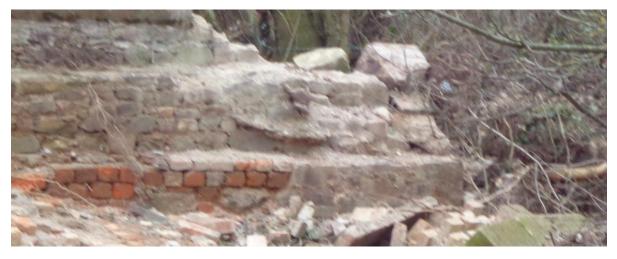
Here we get to see some details of construction. An arch ring two bricks thick. The relatively shallow curve may have allowed the engineer to bond through. There is a goodly layer of brick backing, which was surely rather deeper before the washout.

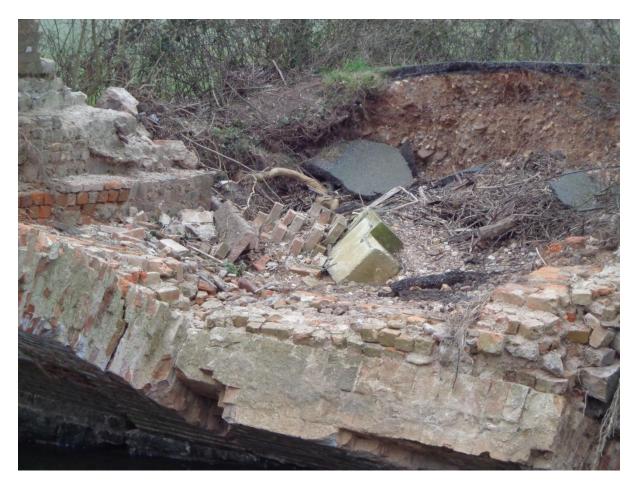
Looking closer, the spandrel wall is stepped and the lowest level is rendered.

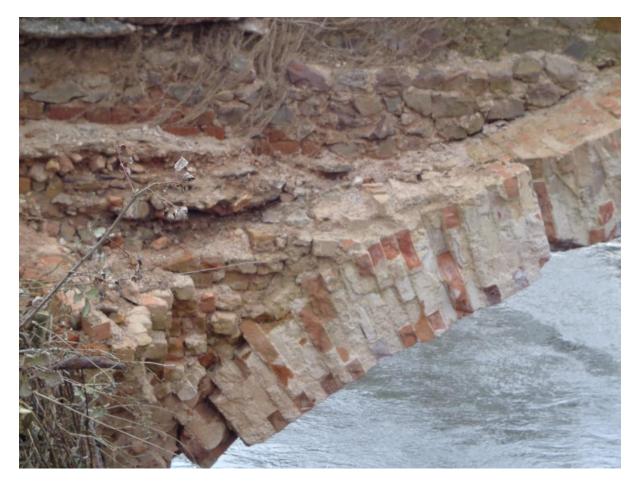
From a different angle, there is a lump of displaced brick sitting at a jaunty angle. Form here it is also clear we have 2.5 bricks or about 565mm in the ring.

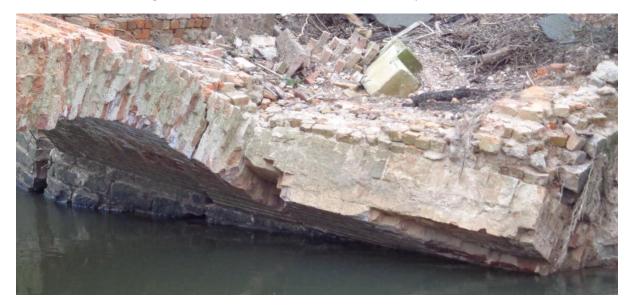
The other half has some very different construction. First though, notice how few bricks have fractured on the longitudinal face. Most was just a butt joint with mortar.

Above the brick backing, there is a rubble stone inside face to the spandrel wall.

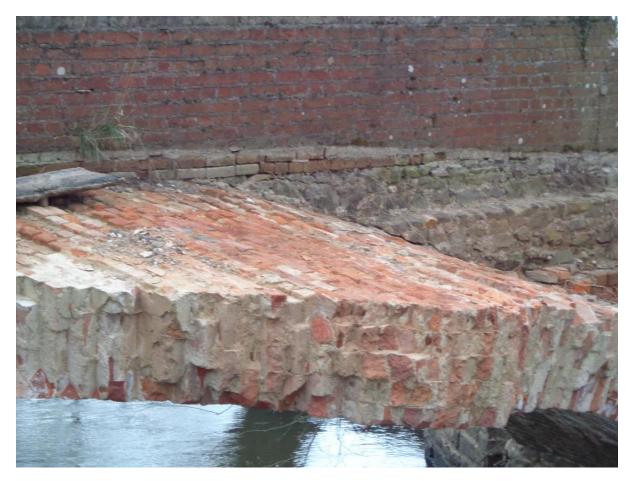
From here we can begin to see the extent of movement in the abutment.

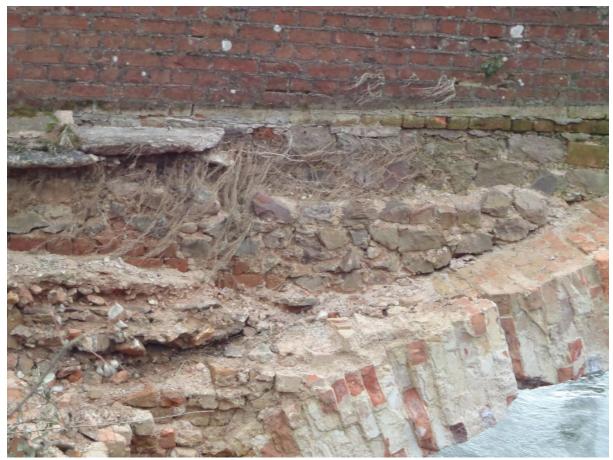
Here, at around ¼ span, there seems to be an area better bonded across the width. Notice that gap between arch and spandrel, I suspect it is tight at the outside edge.

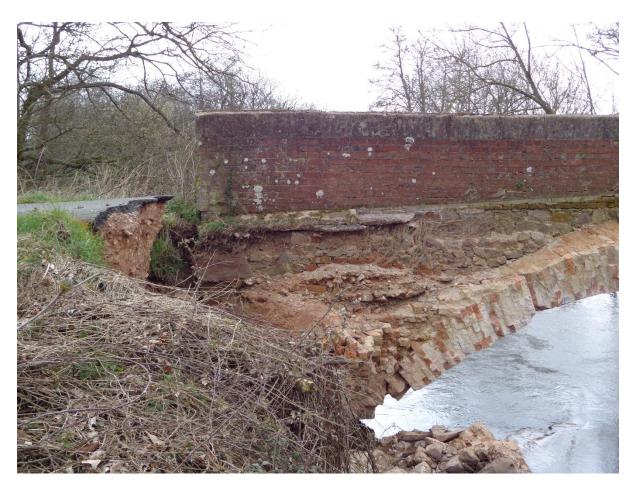
Is that very hard fill or rough concrete centre left?

And the surfacing is on a level with the last step in width as the spandrel reduces to the parapet.

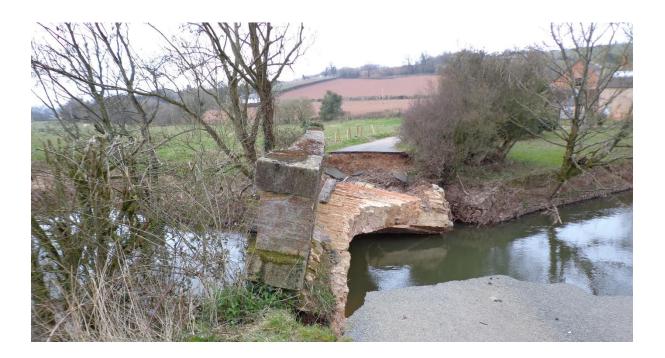
A more general picture shows that this abutment, too, has dropped considerably. Look at the surfacing levels.

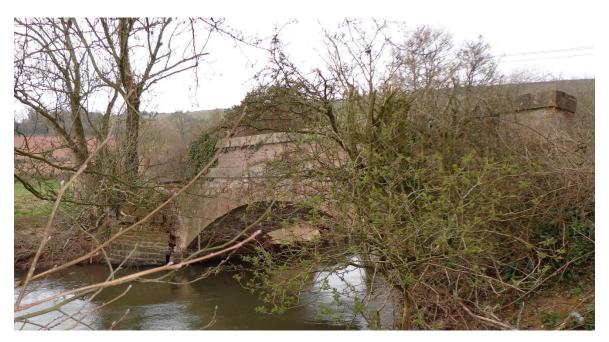
Viewed end on, the scale of the twist is impressive. I have heard the plastic theorems expressed in terms a structure will not fall down until it has exhausted all possible ways of standing up. Of course, that tells you nothing about serviceability.

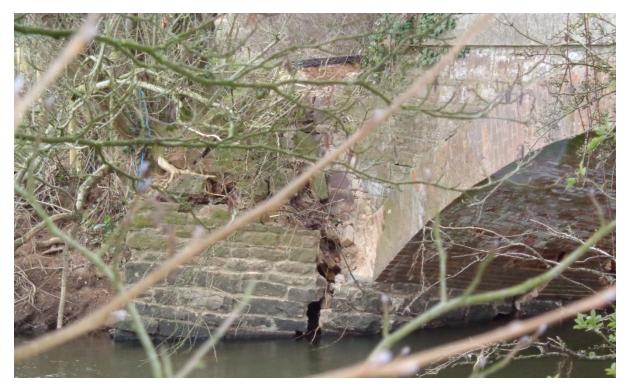
Looking from the other side the view is not clear.

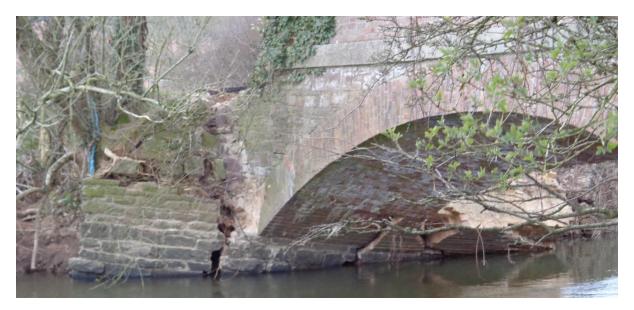
There is, though, a spectacular tilt on what remains of that abutment.

This view shows more. The abutment has completely broken up. Poor bridge didn't stand a chance.
