Bridge of the Month 129. Sept 2021 Hillworth Road, Devizes

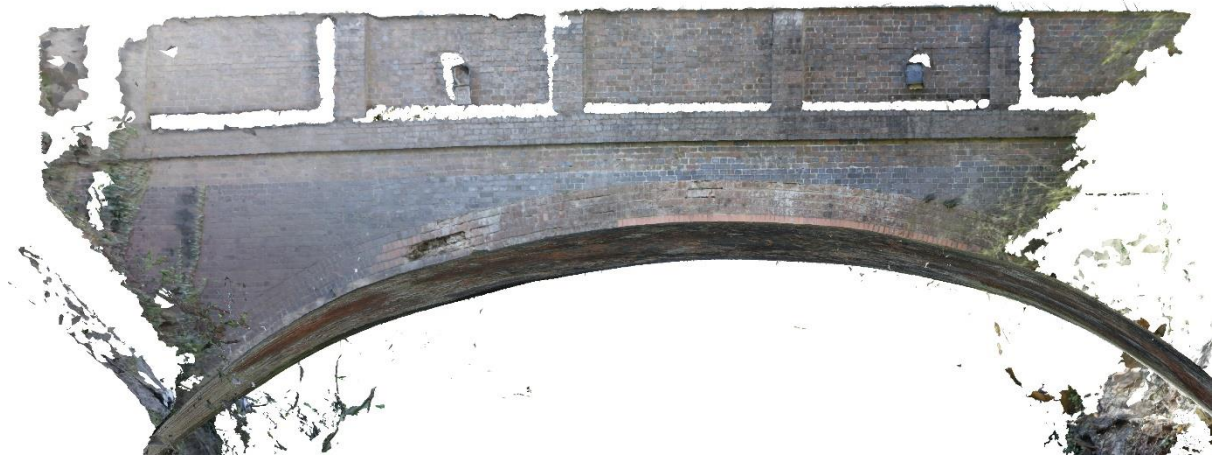
The white patches are bits that don't appear in any photographs.

The first thing to notice here is that patch of broken bricks at the third point.

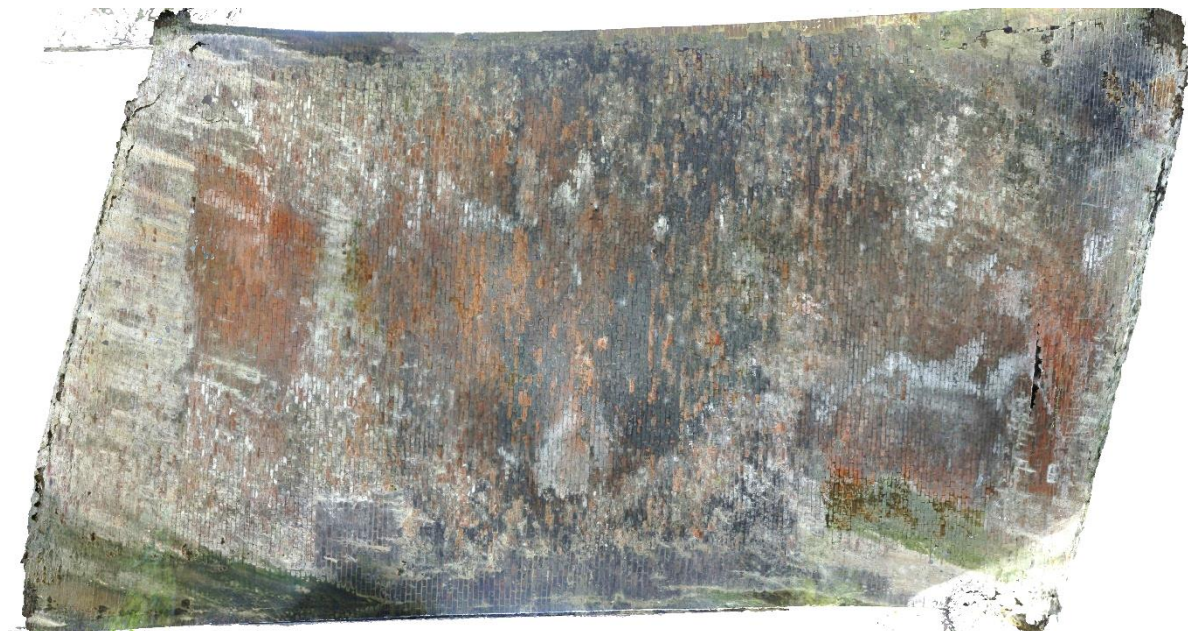
The bridge is skew! You can see the lime runs following the steepest slope. Even at this scale, there looks to be damage top right and bottom left in the acute corners.

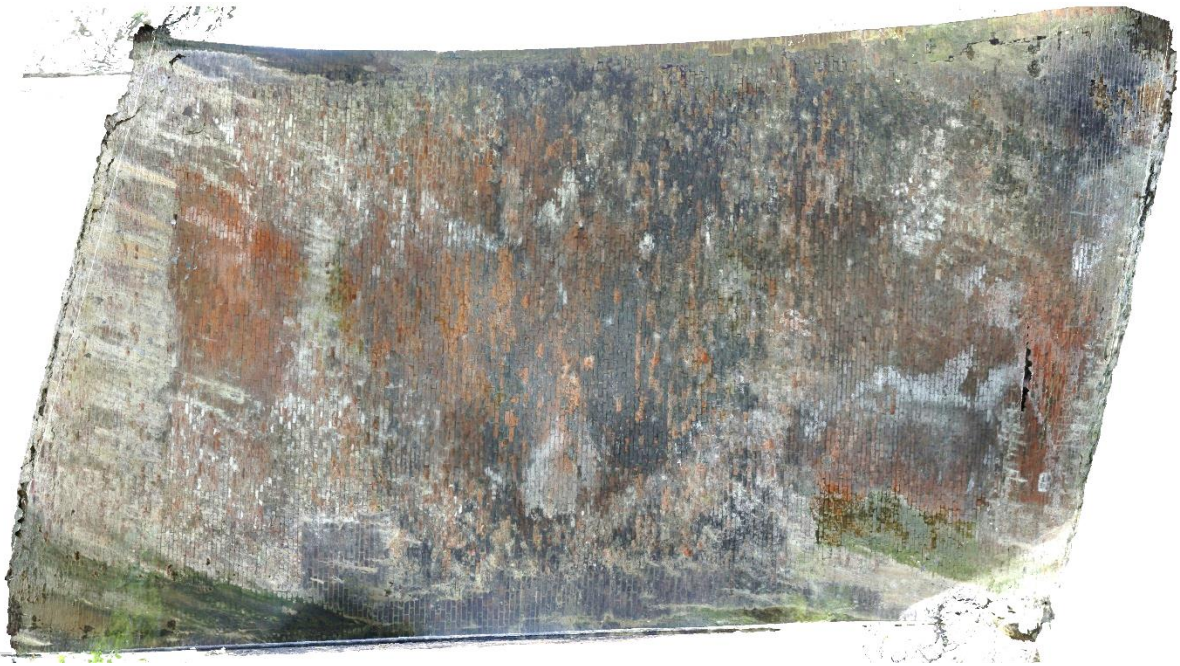
horizontal. Dragging that down on to the arch shows the springing pretty much level. The faint white lines at each end are straight and parallel.

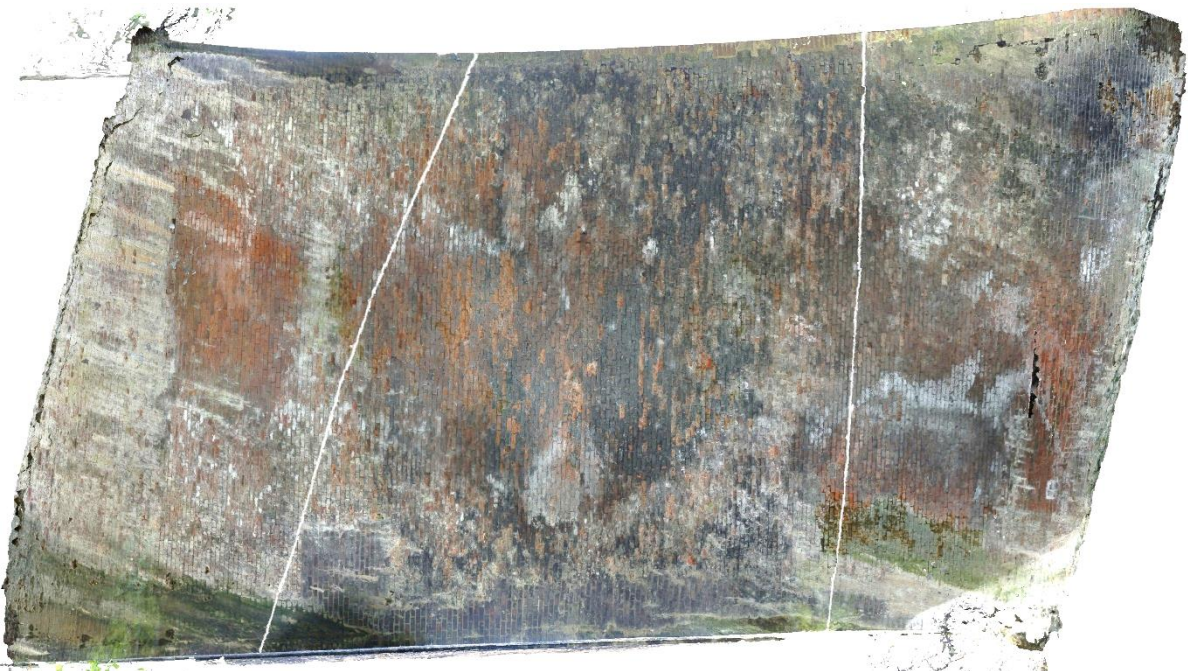
Lifting the plane to cut the arch shows some distortion.

These lines are contours so here we have the top edge lower than the bottom and the left hand line has a king which means a crack. Perhaps there is one to the right too.

Note the solid lime band above the left hand springing then a gap and another line of lime runs. For straight lines like that there has to be something in the construction and it seems likely that there is solid backing below the lower line and hollow between that and the upper.

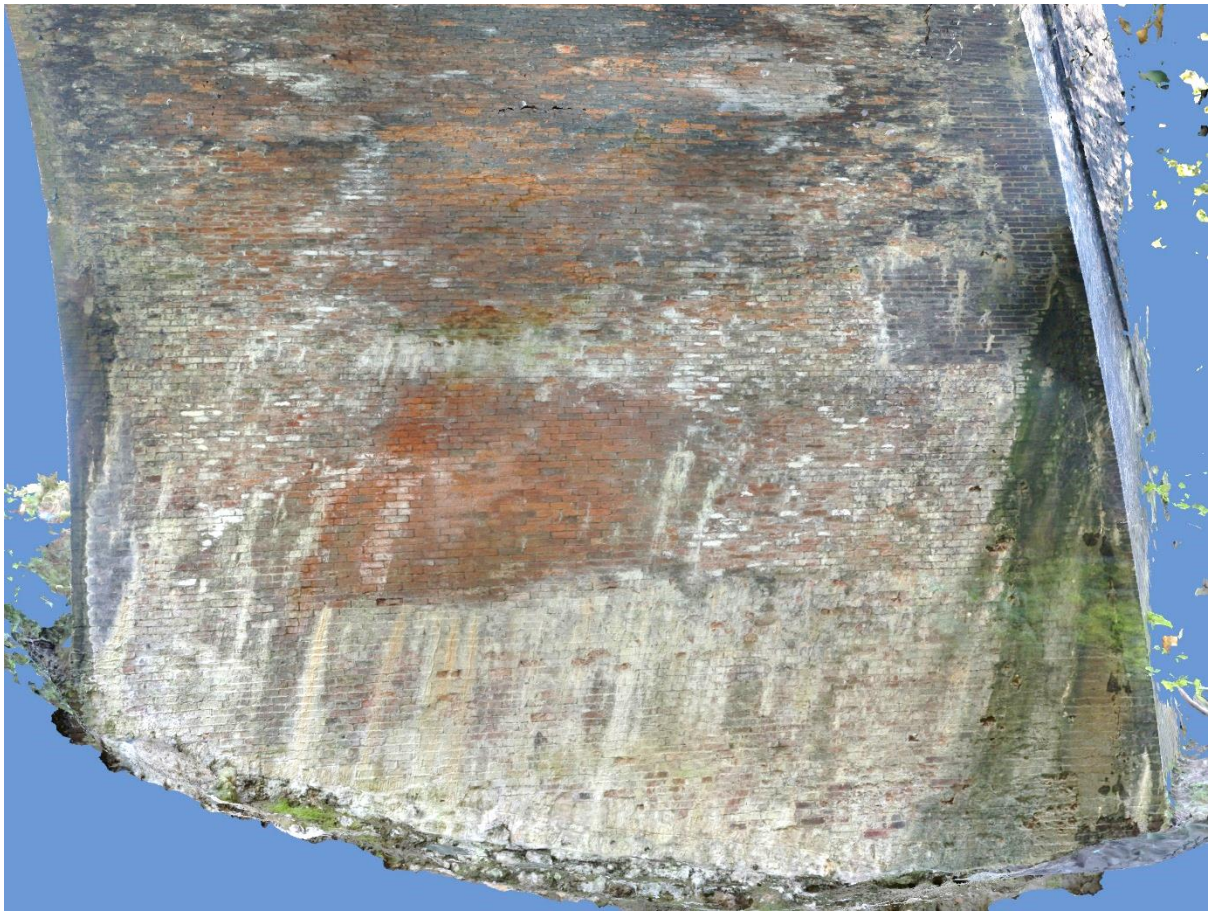
There is a lot of mortar erosion in the clean band and that is often caused by hollows behind which enable the arch to change temperature more rapidly.

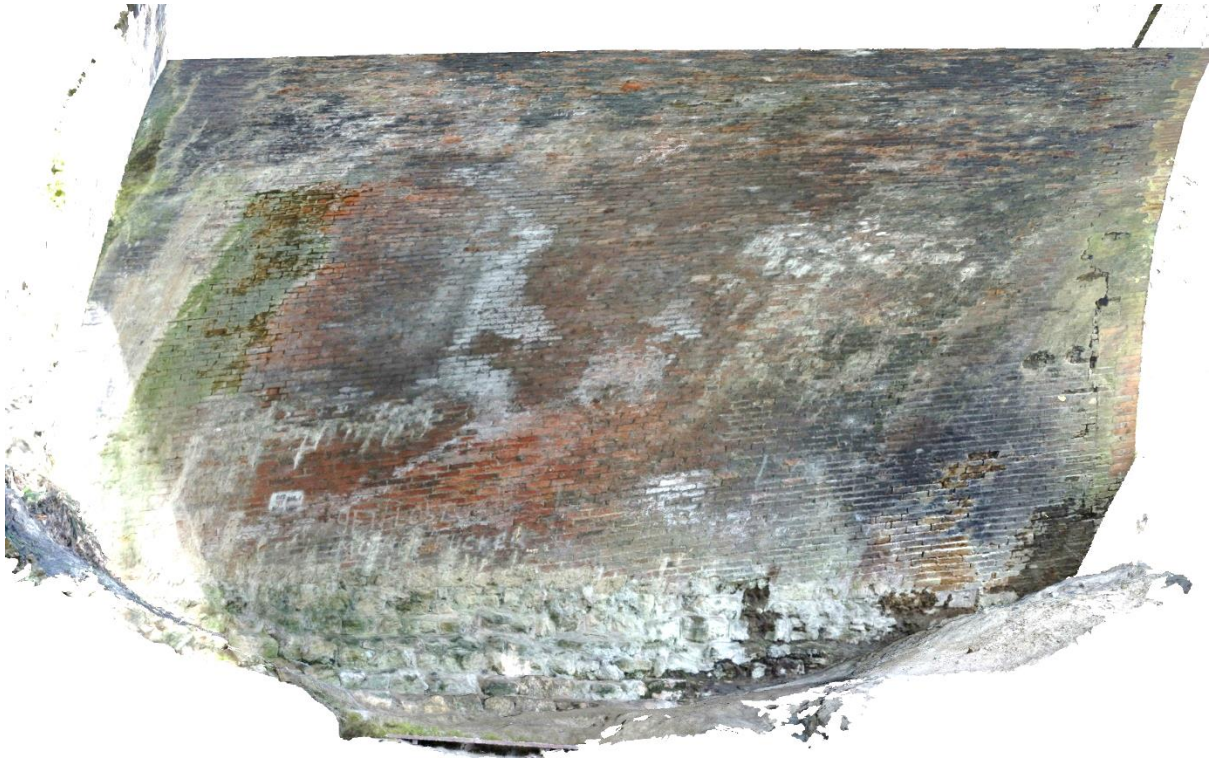
Strangely, the other end of the span doesn't show this banding. What this image does show, though is rubble stone below the springing. I suspect that is rough and ready foundation construction (perfectly adequate as such) which was intended to be buried and probably was originally.

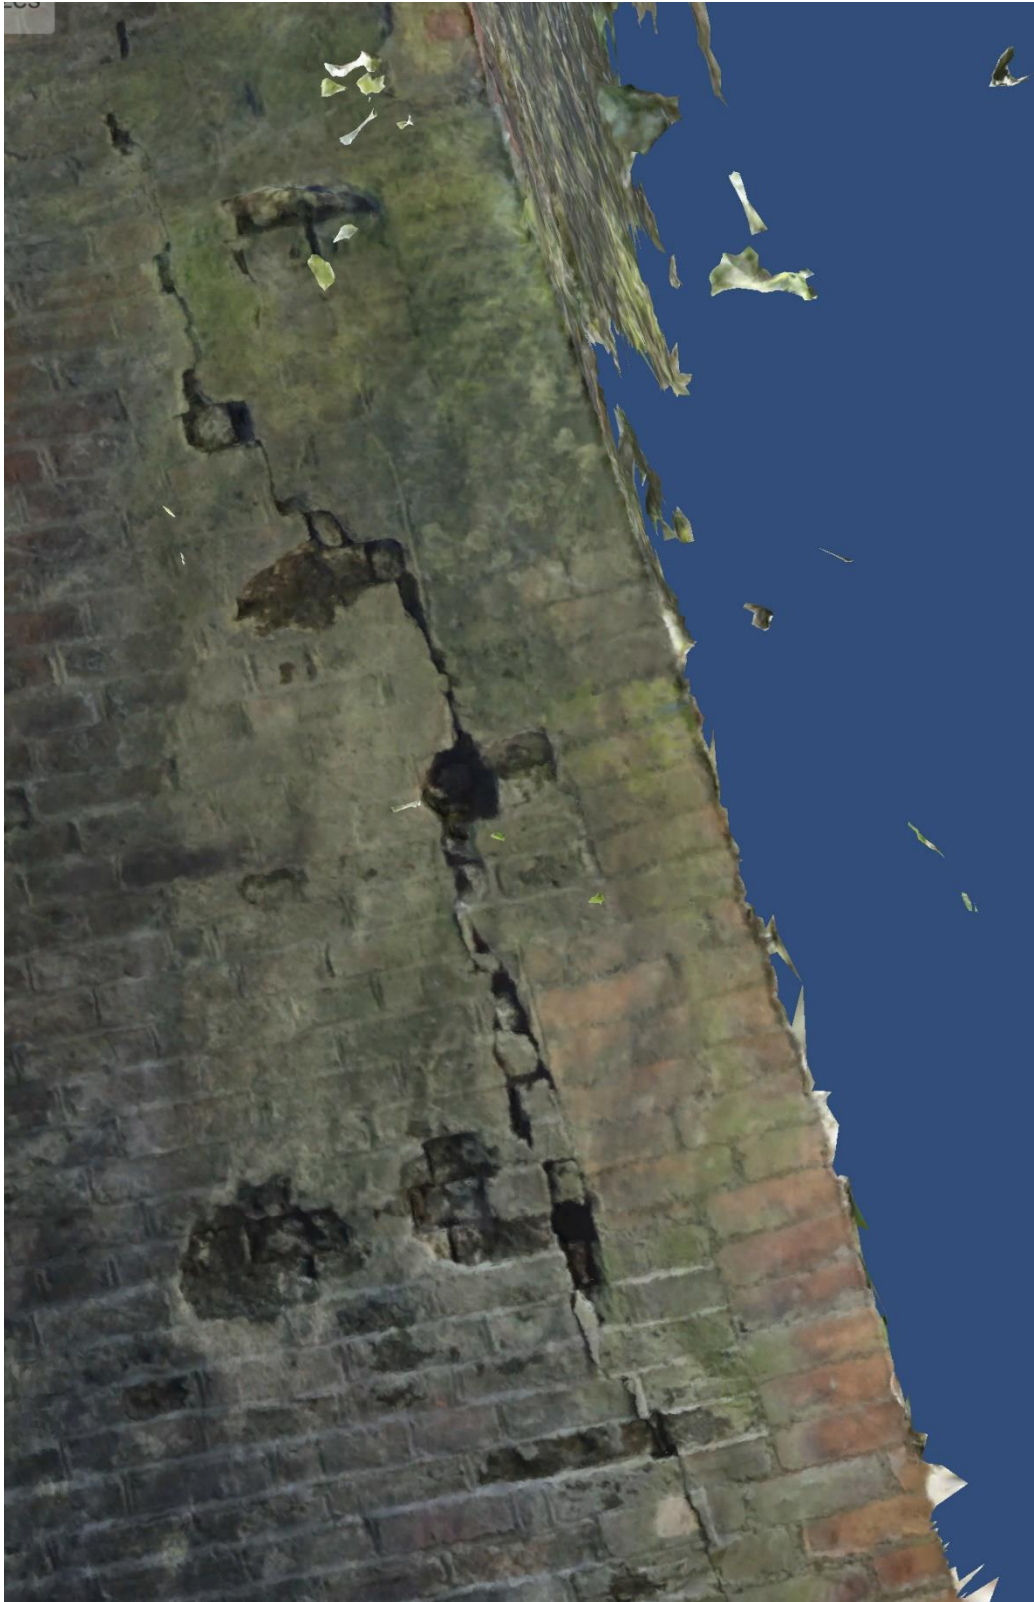
Here is the acute corner at the unbanded end.

That crack has formed as a result of shear between the arch and the spandrel wall. There has been regular movement over a sustained period to create a crack of that width. To the left of this in the obtuse corner there is no such crack.

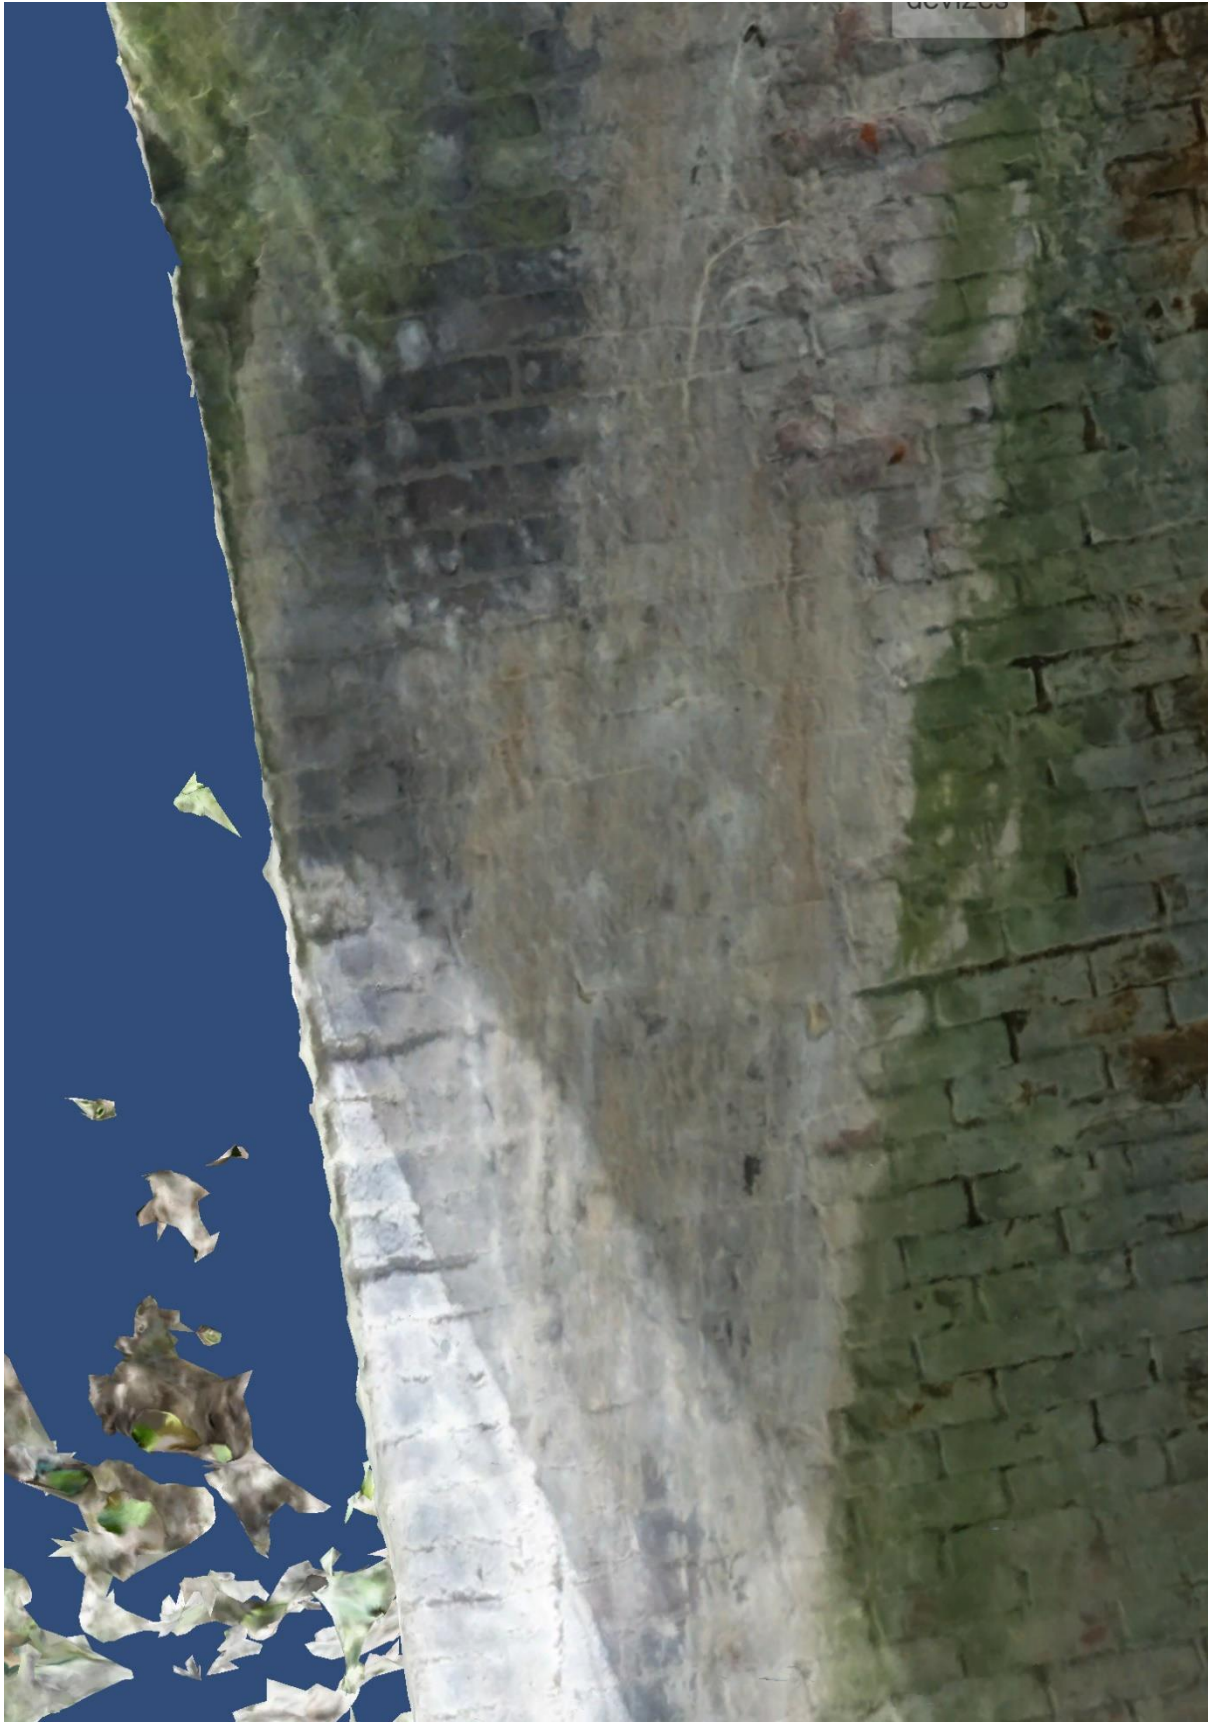
The obtuse corner at the banded end. Shows no crack.

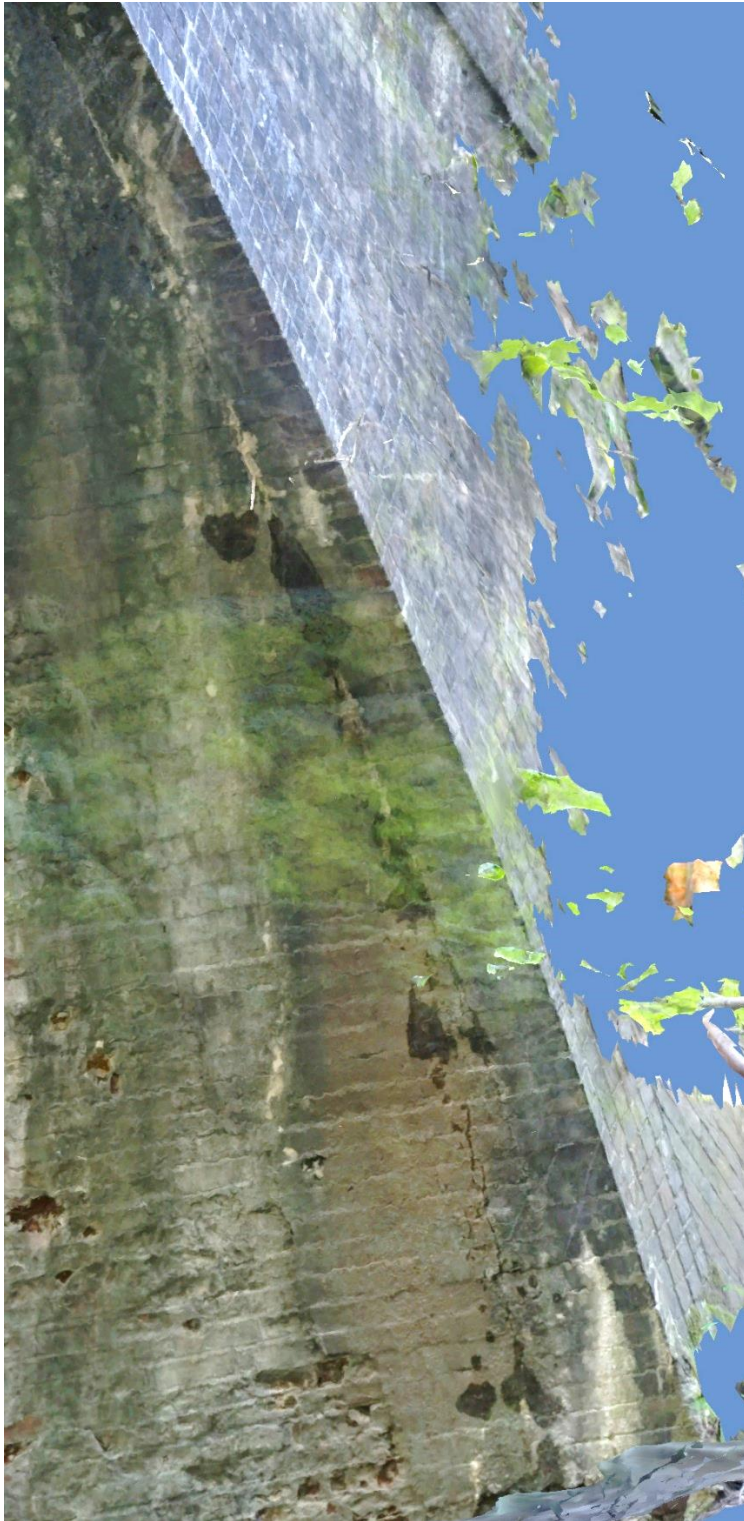
At the banded end there has been a lot of patching, but the crack has just come through. Papering over the cracks is NOT a cure. It's a temporary disguise.

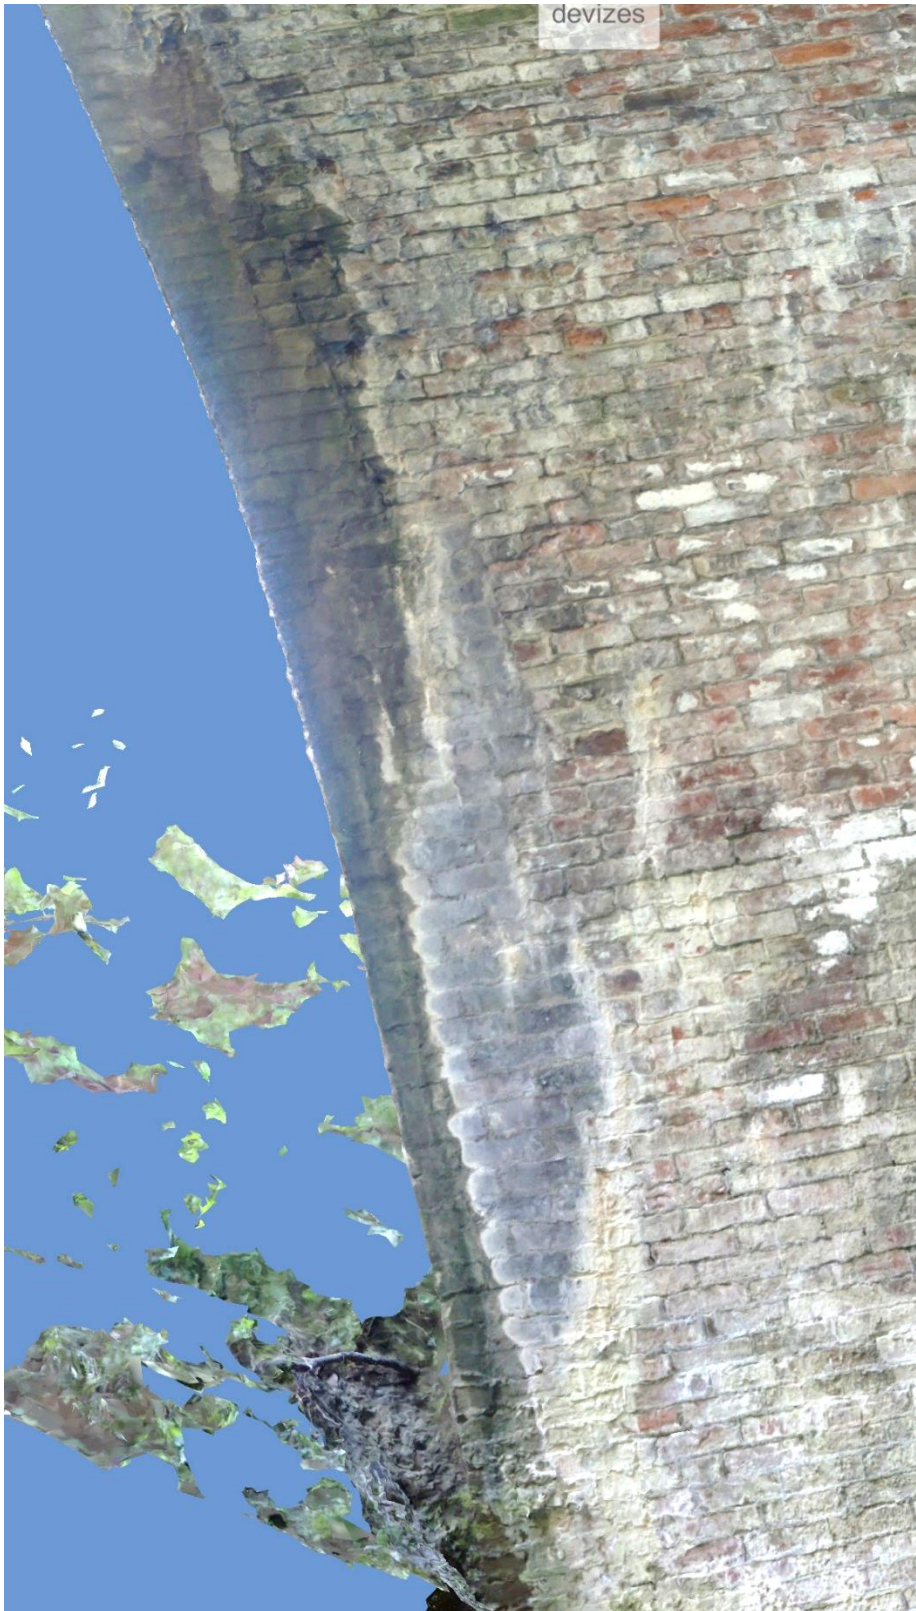
There is undoubtedly some cracking at the obtuse corner here.

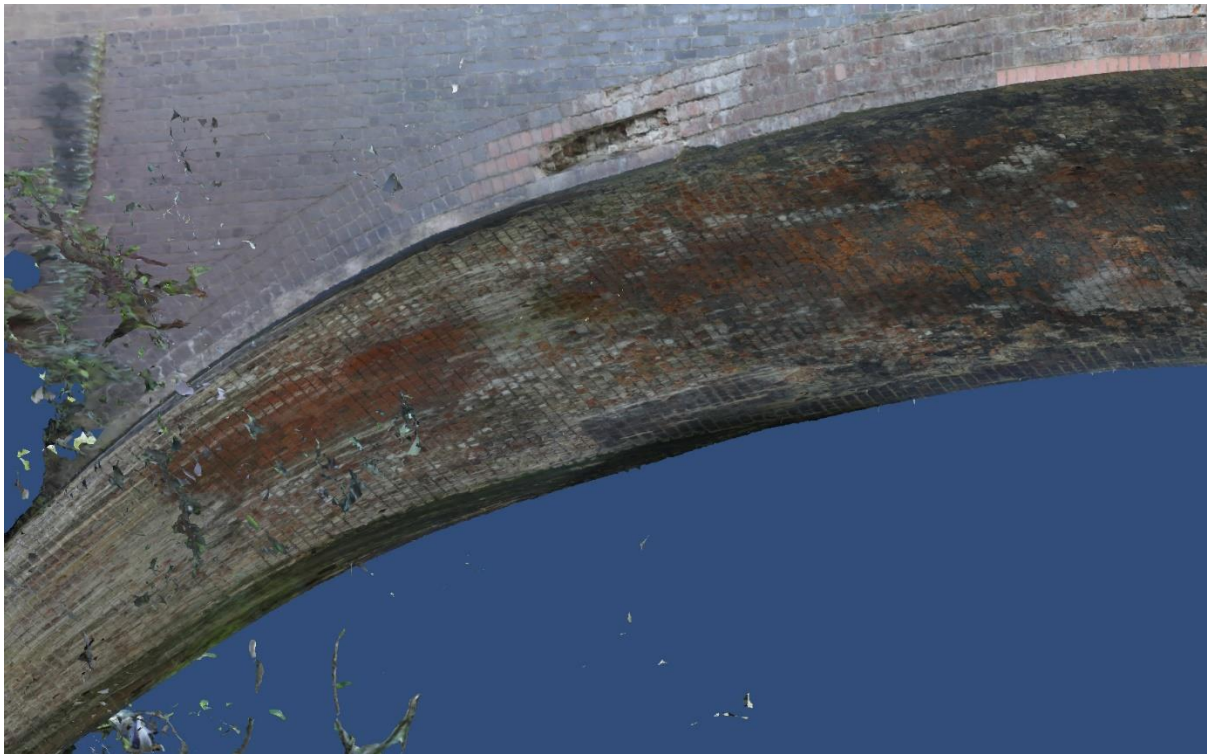
If we look a little closer at the crushed bricks on the edge of the arch at the third point, we can see they are surrounded by patching. This suggests that the damage was not in this location when the hard brick patches were installed. I hope we have learnt a little since those days about not using

hard bricks to patch into soft brick structures. It is the same issue as not using hard mortar and soft bricks.

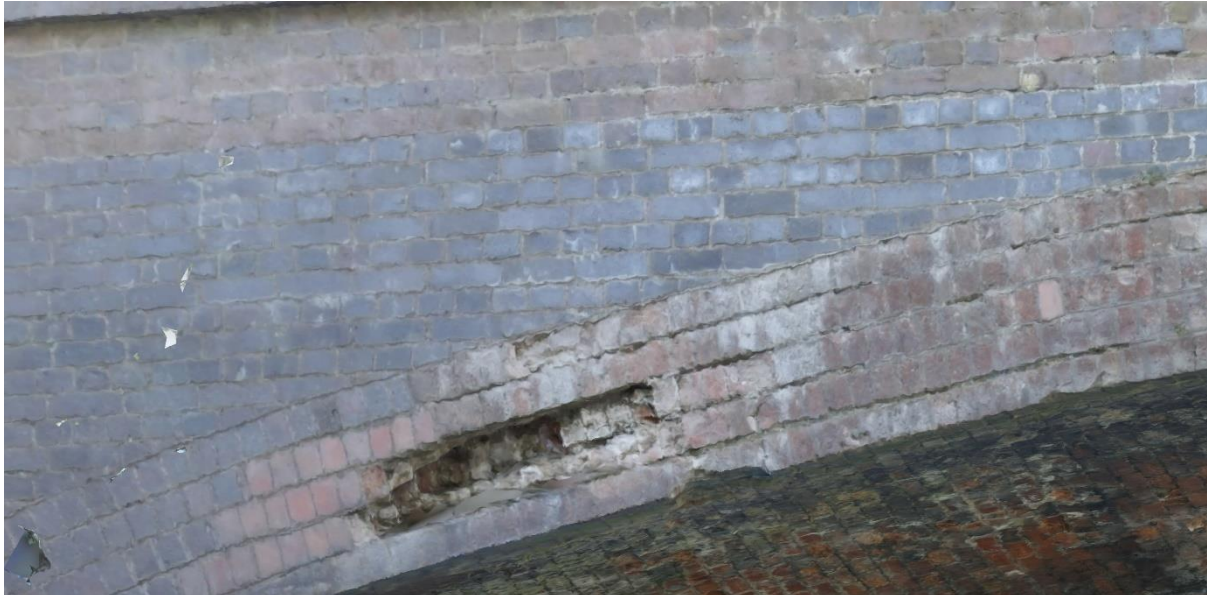
We can look closer yet and see the nature of the damage better.

I would expect to see either or both of a horizontal or vertical crack in the spandrel leading to this crushing point. Perhaps there is one just above. There is certainly a small crack tracking round the outside of the arch.

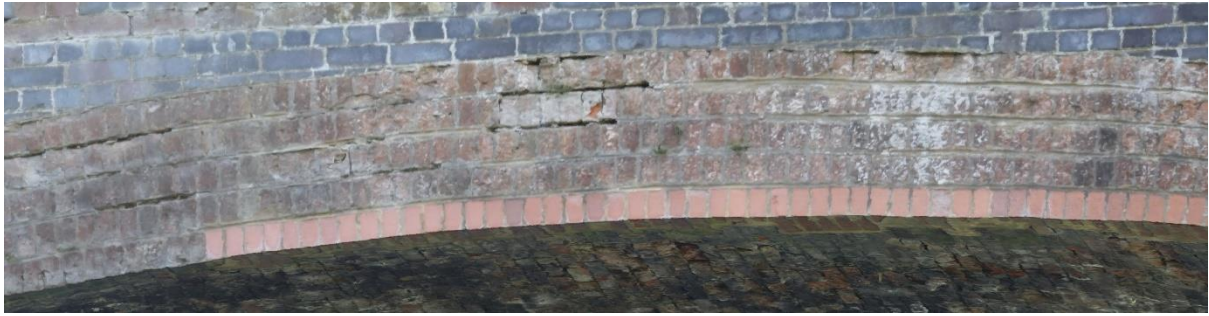
Following round the arch there is interesting damage at the crown too.

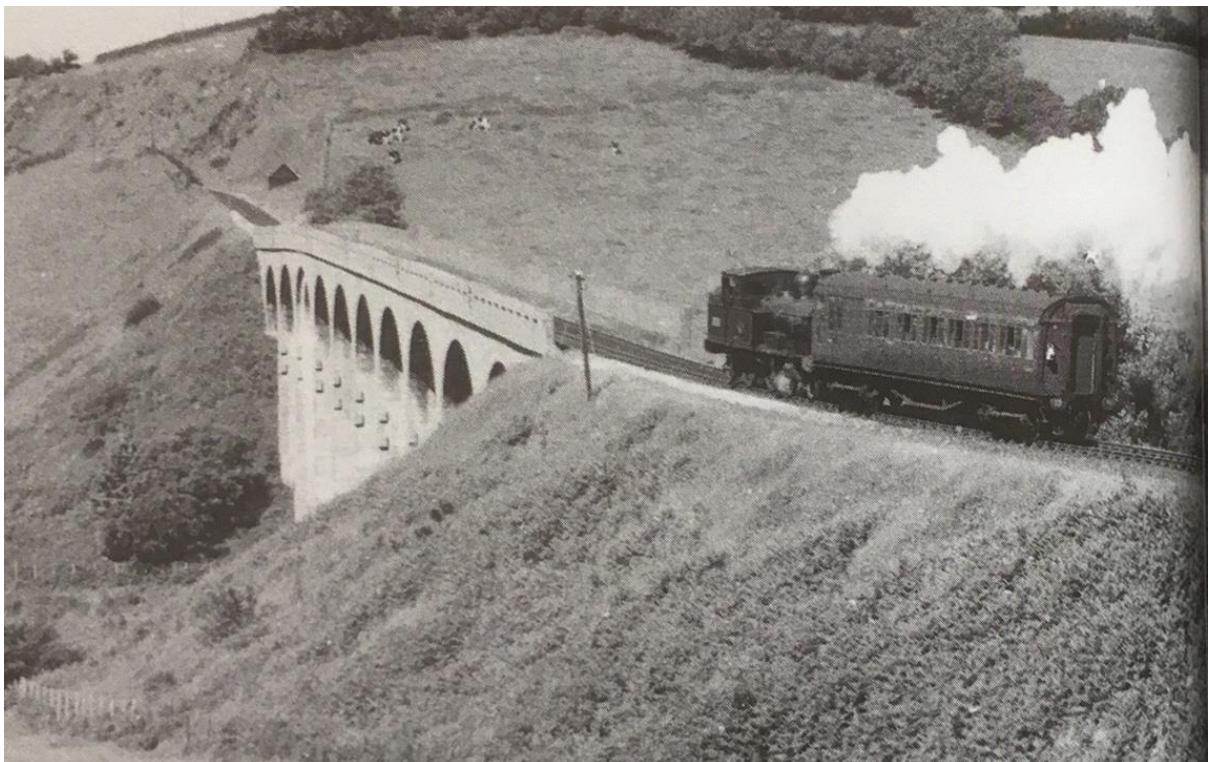
And just before I shut down, following the BoM 126 Cannington, a kind follower forwarded me this picture from a book he had bought. It shows the scale of the slip which is now completely hidden in tree growth.
