Bridge of the Month 130. Oct 2021 Staward Bridge, Allendale

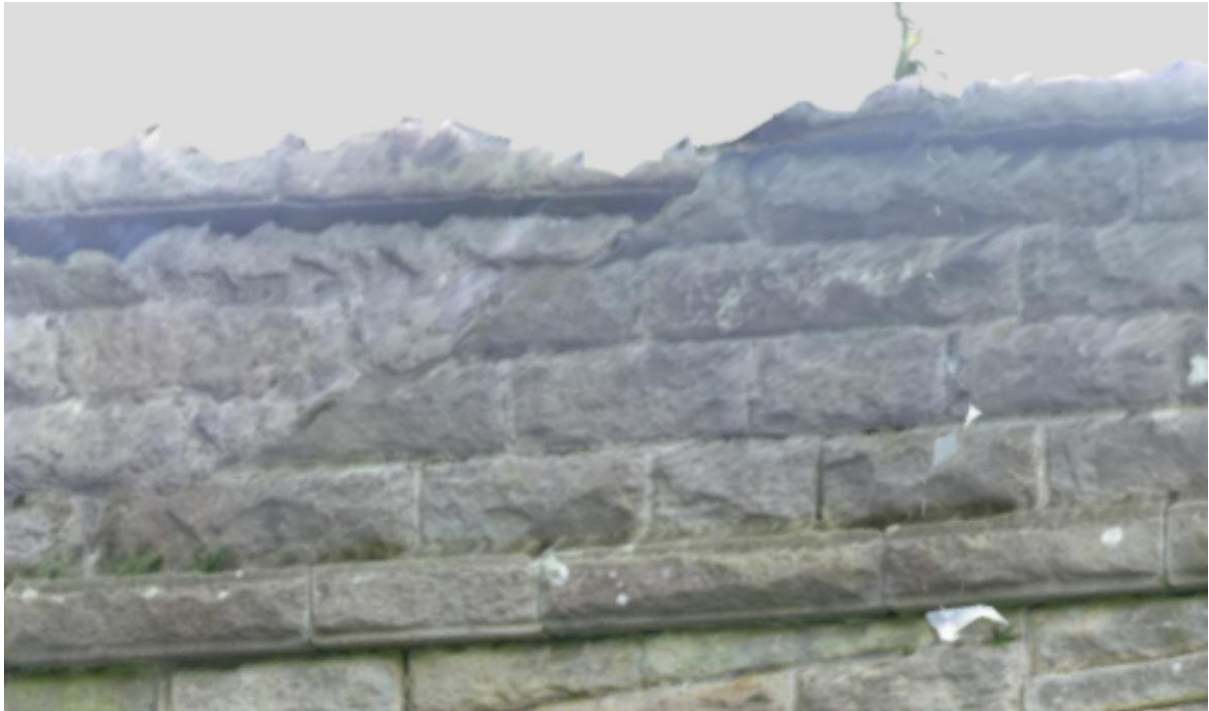
The white patches are where photographic cover is limited in some way. This results in large triangles in the model, which we filter out when we produce models, as it is better to have holes than the false appearance of completeness.

We can see that there is something strange going on in the parapet top left of the span and a closer look at that will inform us of the sort of errors that can develop in these models.

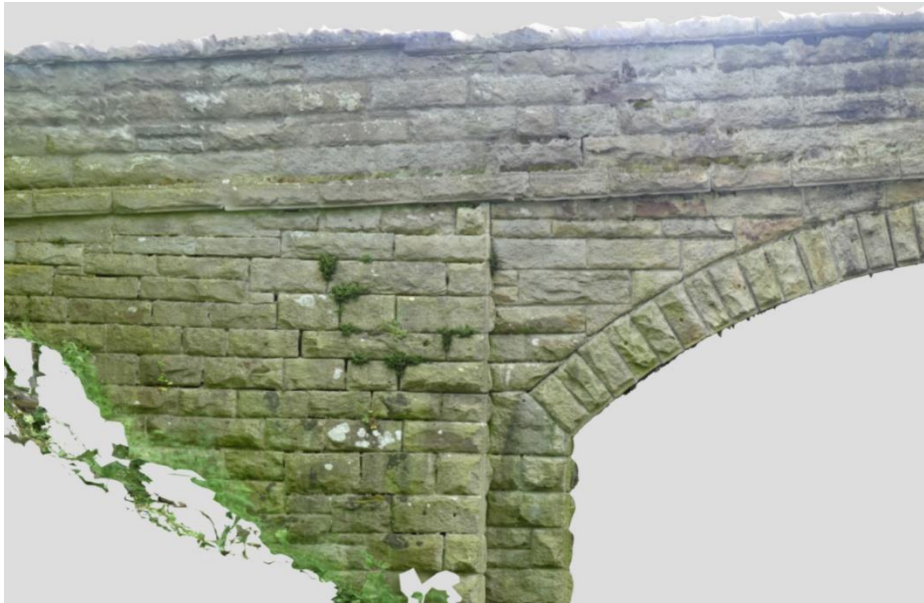
Here, the combination of moving and turning the camera resulted in limited overlap between photographs. The aim is generally for 2/3-3/4 overlap in both directions. This can be difficult to achieve at close range when working with a single camera, which is one reason that we use rigs carrying multiple cameras for our commercial modelling work.

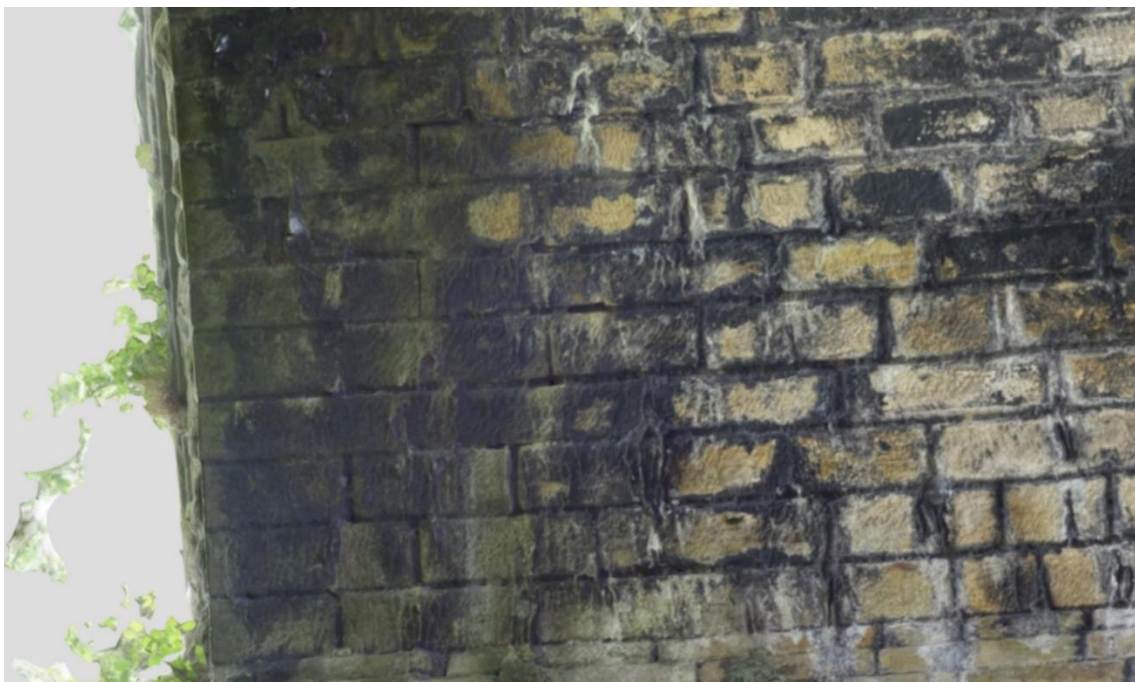
Looking closer at the soffit, the interesting features are in the corners. Here we have some completely empty perpendicular joints, though the bed joints are largely full.

While the bridge in Devizes, discussed last month, had damage that might cause trouble but for which an infill would be of no value, here we have a structure in good overall condition. A little judicious pointing of the soffit and perhaps some drilled drains to channel the water where we really want it, would give us a bridge with decades of life. It would also avoid damaging a wildlife route and a garden.

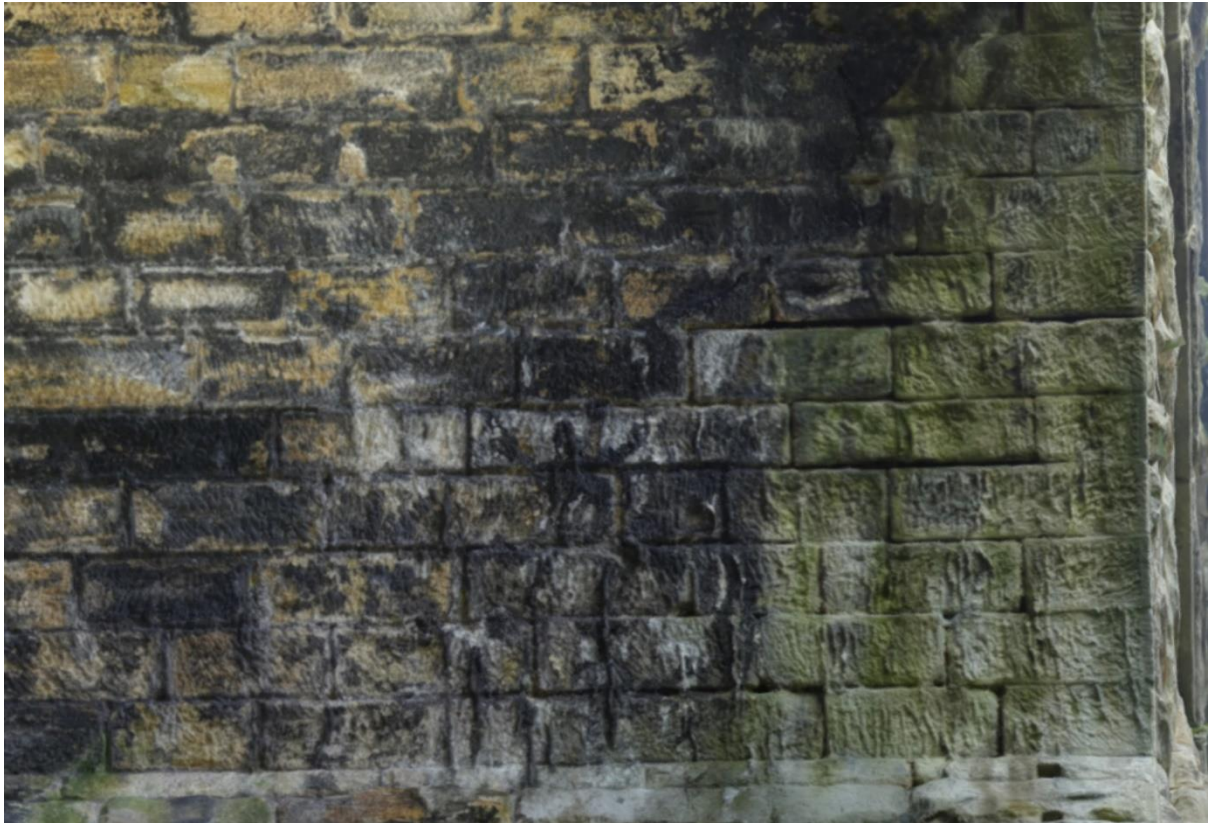
Move to the left and there is no apparent deterioration in the corner.

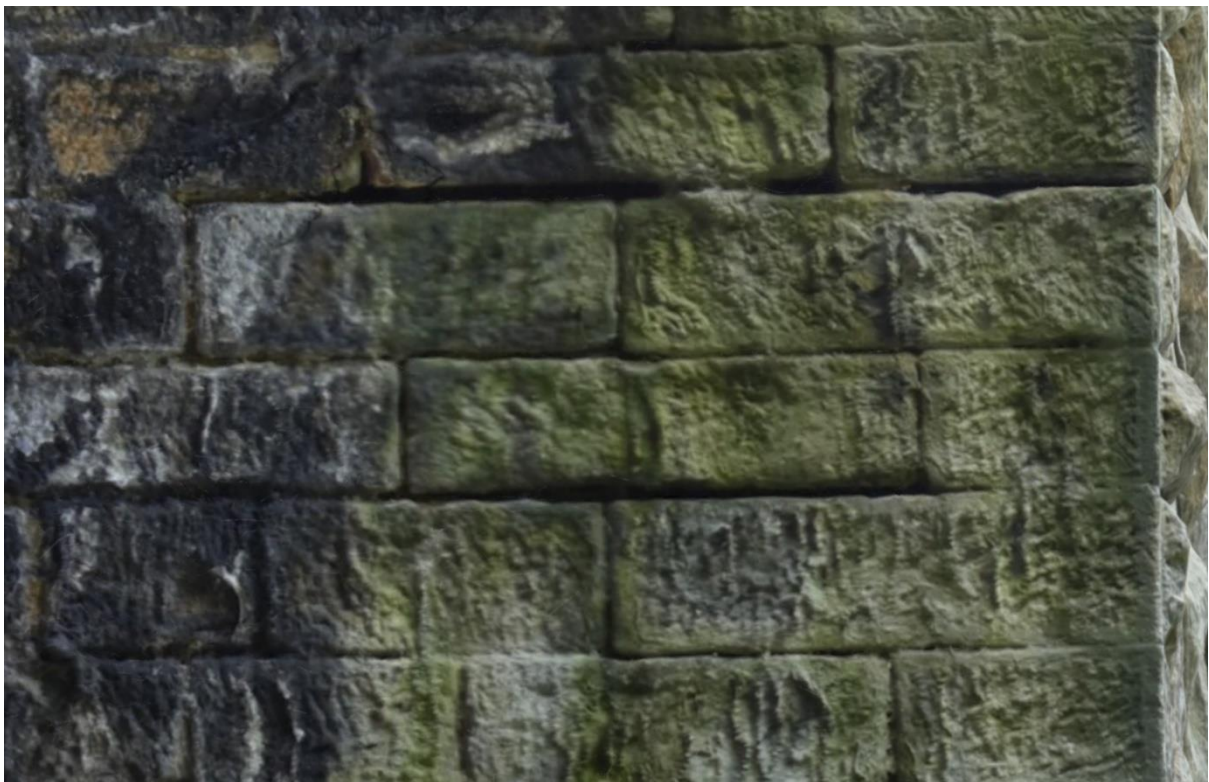
At the other end of the span there are some empty bed joints. A closer look shows stone that has been washed away from the edge of the joints. There has been a lot of water through here down the years.

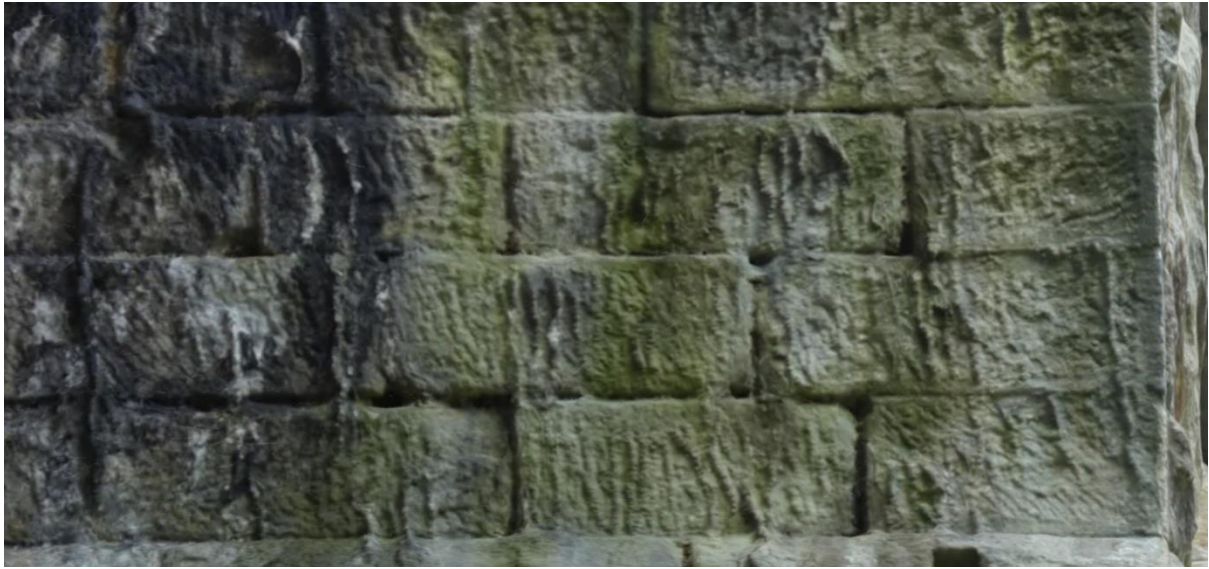
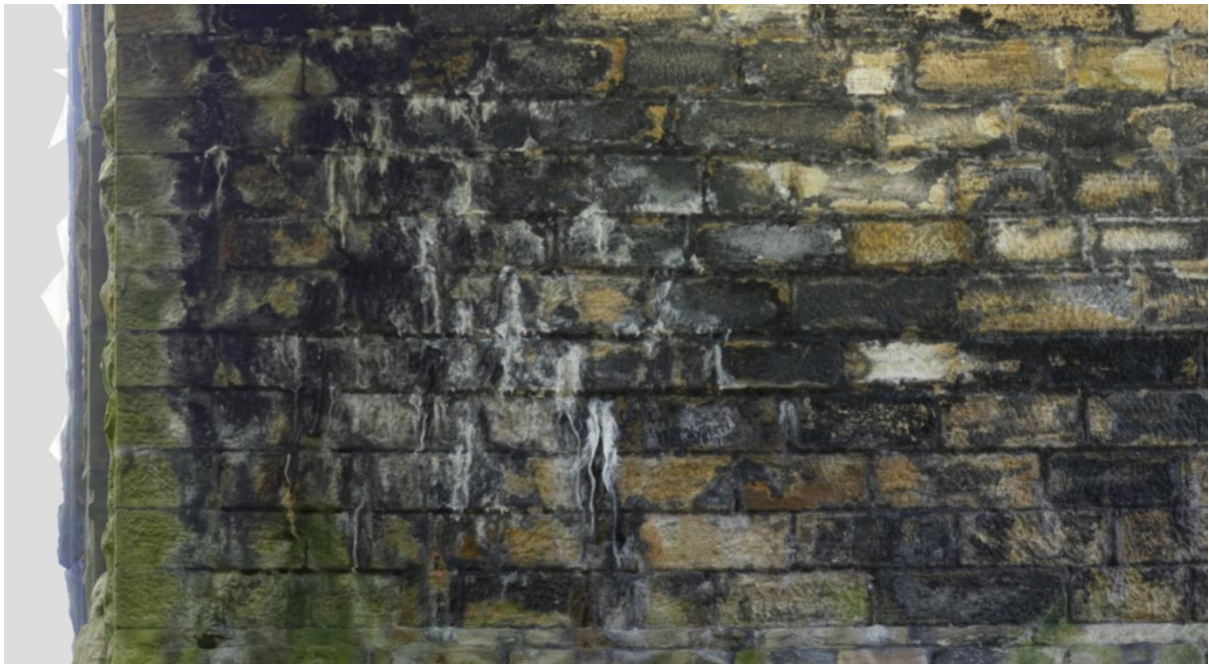
There is a further line of water run closer to the springing. I presume this is coming down the inside face of the spandrel wall to get to here.

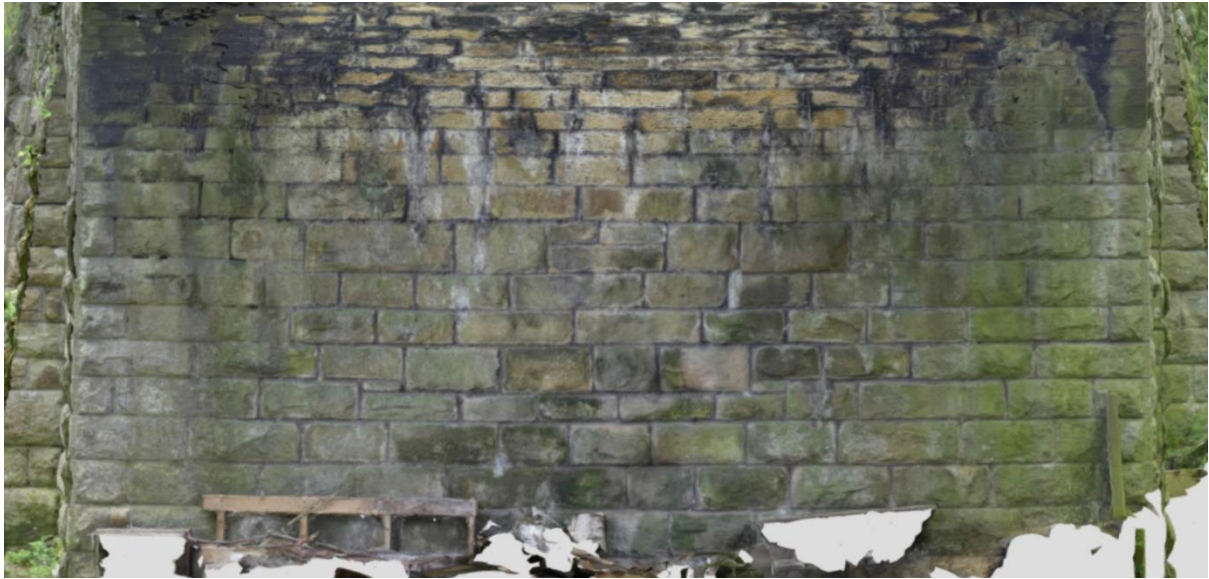
The fourth corner shows lime runs but little more.

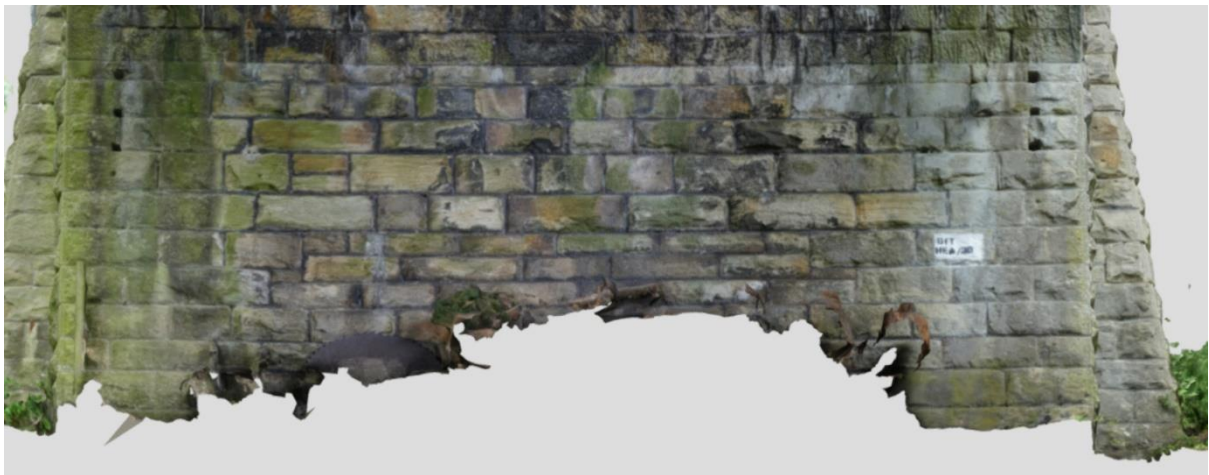
This abutment looks to have a substantial sag but it seems likely it is an aberration in the model. I would want to look more closely on site before drawing firm conclusions. In all other senses this looks to be in perfect condition.

The other abutment is partly obscured by vegetation and a stack of materials. Again, though, there is nothing to see that would encourage me to worry about it.
