## Bridge of the Month 131. Nov 2021 Clyst St Mary

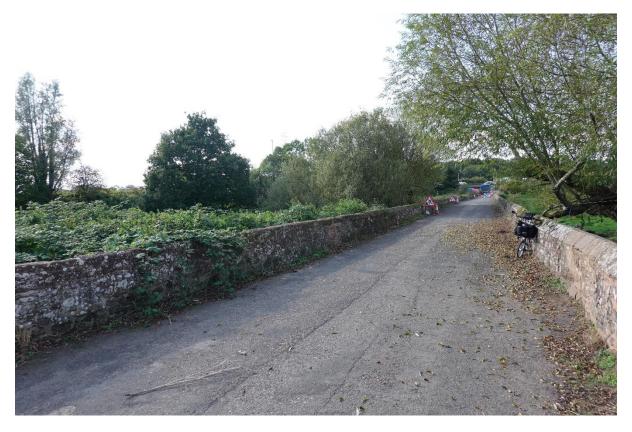
This <u>long causeway</u> across the Clyst flood plain looks sadly neglected in the photo. It is actually little used since the new road (visible in the distance) was built in the '60s, though it remains popular with cyclists avoiding the traffic. I have lived in Exeter for 26 years and only recently got down here with a camera. The bike in the picture is mine and my sunny October Sunday took me here and to Stoke Canon to the north, which will feature in December to complete year eleven of BoM.

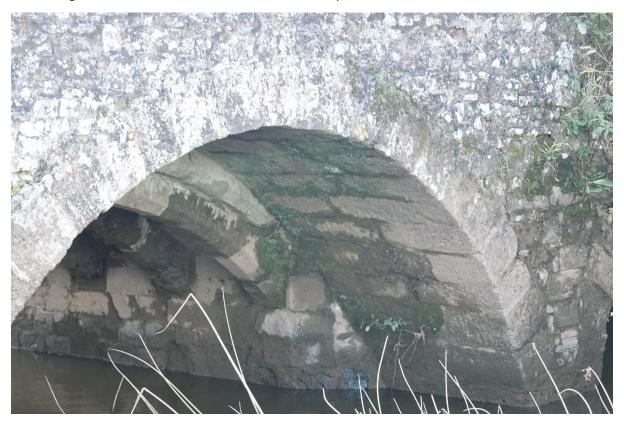
Interesting that there is no cutwater left even on the upstream side.

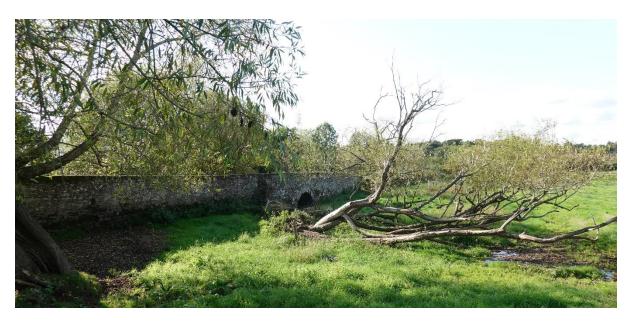
The widening this side is slightly greater. The new arch continues way beyond the springing of the old creating a much lower and narrower pier.

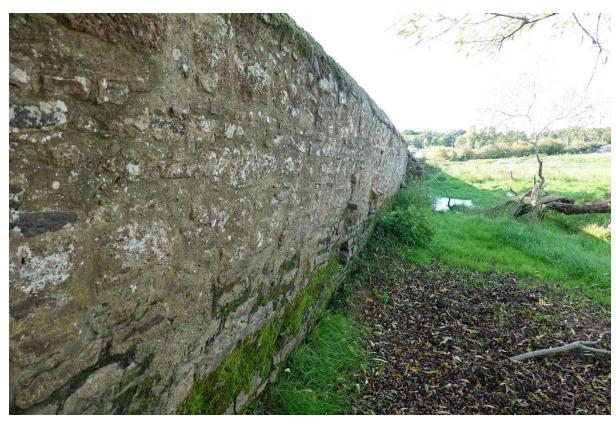
There is just one flood arch about mid length, so when the river floods this must present quite a barrier.

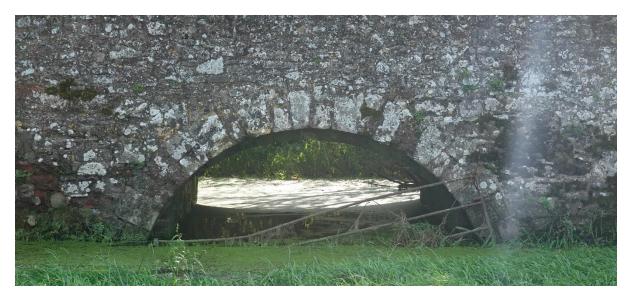
The wall of the causeway tilts at quite an angle but then, its foundations are probably both shallow and soft.

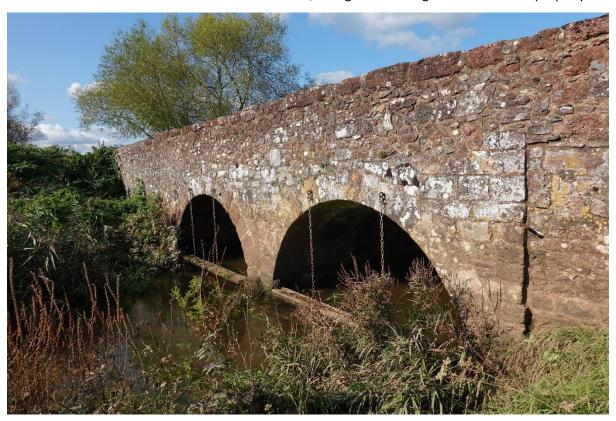
The flood arch also has a mediaeval middle section, though I couldn't get closer to see it properly.

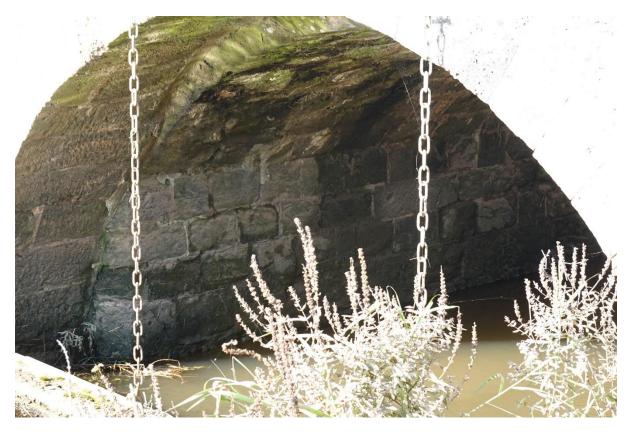
There is a much less active secondary channel with another two arches at the eastern end.

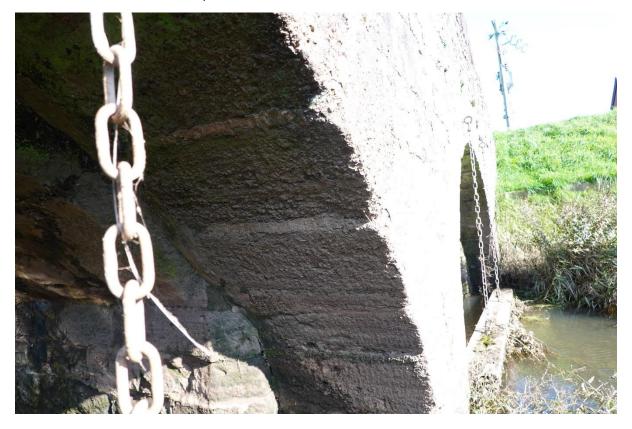
No ribs in these arches. Are they later?

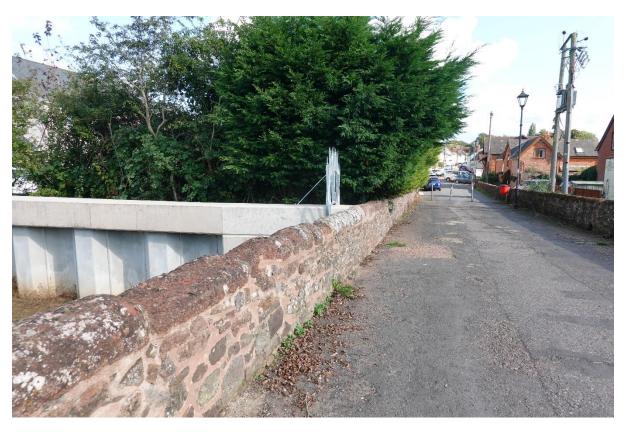
Once again, the widening arch continues beyond and below the originals.

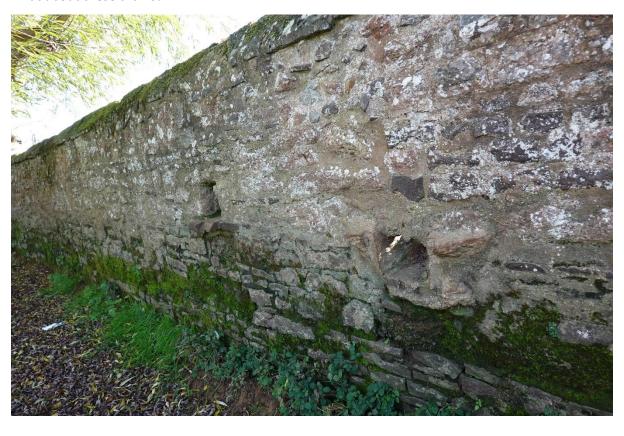
And to finish, here is the out-of-town end continuing into the village of Clyst St Mary. The environment agency have built a very substantial flood wall up to the top of the parapets. Have they just assumed that the parapets would take the load? I very much doubt that they would. In any case, what about these drains?
