## Bridge of the Month 133. Jan 2022 Preston upon the Weald Moors

BILL HARVEY ASSOCIATES LTD

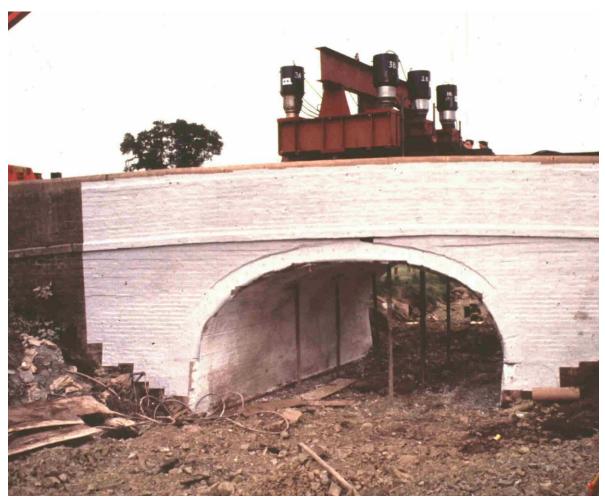
Here is a general view of the bridge ready for testing, as it was when Fraser and I arrived after a long drive from Dundee.

If you look back to the first photograph you will see a differentiating line on the spandrel wall and wing wall which marks the top of the backing. The backing is important because it is critical to the behaviour of the arch. The span is effectively reduced to just the central flat section.

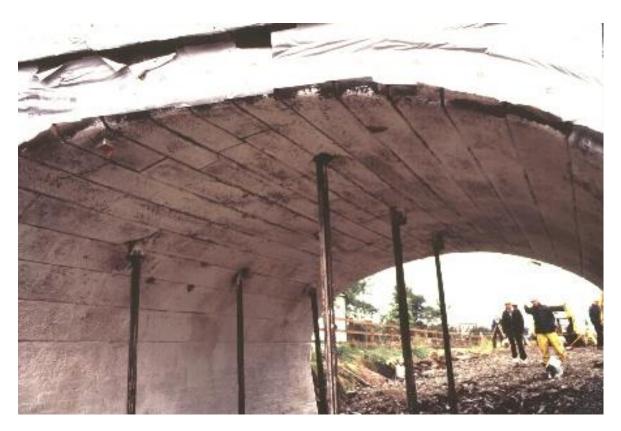
Those cables are very straight, so there is at least modest load applied and the bridge is beginning to respond. There are visible cracks through the voussoirs near this edge and slight spalling damage just outside each row of cables. The rippled and torn whitepaper is not actually white but covered in black squares of a size designed to exactly match the sensitivity of a film and lens combination. The surface was photographed repeatedly from a fixed location yielding (after considerable post-processing) contours of displacement on the surface. The spalling damage implies some rotation and that is confirmed by the slight opening of joints between the two rows of ties.

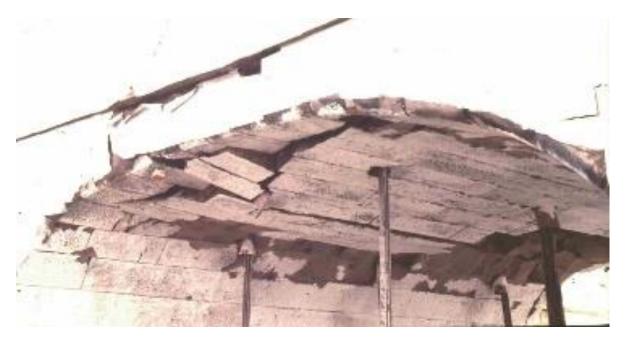
Here, the spalling is much more severe and the joint opening between the ties is considerable. Note how the damage is even more severe on the far side.

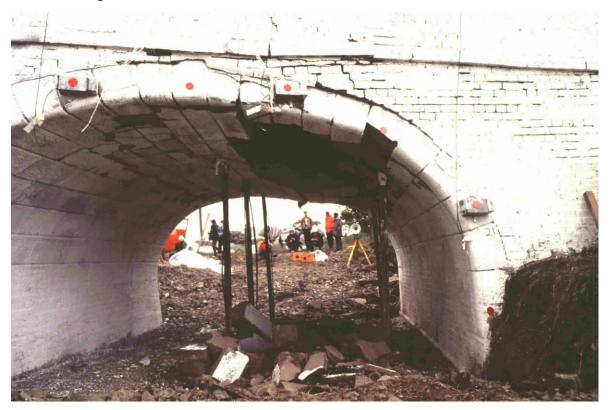
Actually, this picture is slightly earlier. The spalling is largely confined between the ties and near the camera. Pushing the photo a little reveals just a bit more.

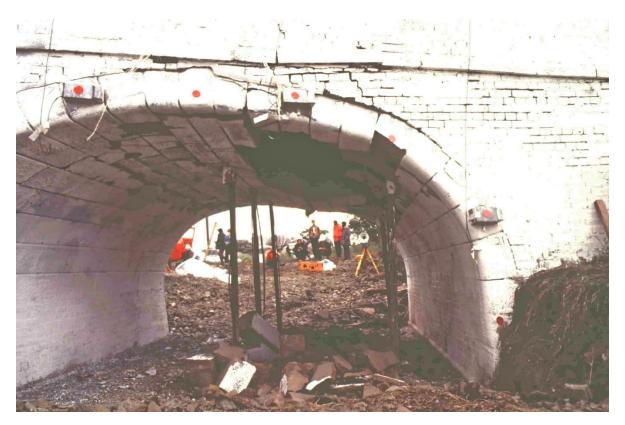
The stone on the floor is largely from between the tie bars. The piece on top of the pile is very thick. It seems to have fallen with little loss of material from above and may have split leaving a thin shell carrying the load.

Notice that, at both sides, the deflection between the walls is much greater than under them.

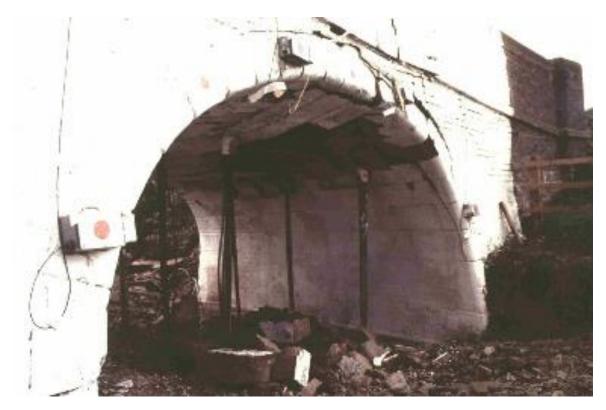
This picture shows the bridge very close to failure. Note how the ties close to the abutment are still tight while those nearer the camera are largely slack. The scale of loss of voussoirs is more obvious here. Note also the crack running down to the edge at the abutment following something close to the square line.

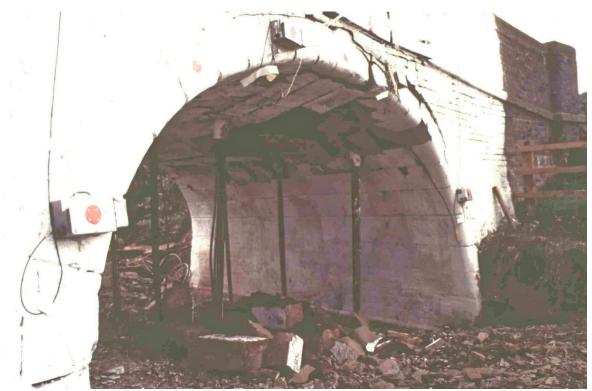
Once again, pushing the picture reveals a little more.

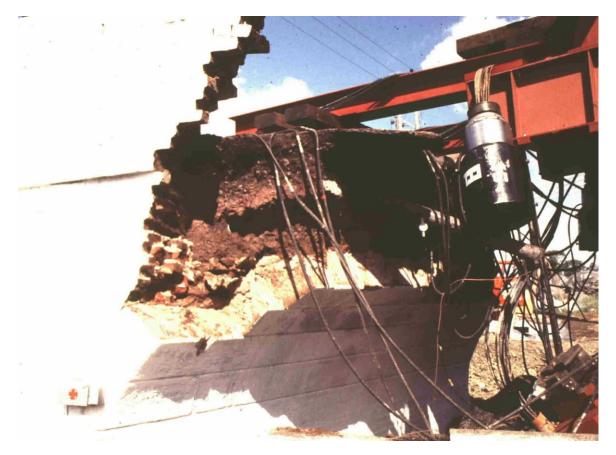
This picture shows the bridge after collapse and after a little modification by me and Fraser. Before we left the site we wanted to see what went on behind the arch. By pulling down a couple of voussoirs we exposed the brick back in inside the structure.

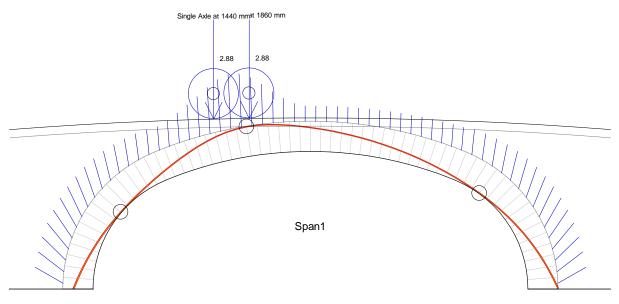
So that brings us on to look at analysis. Those of you familiar with BA16 will know that many of the programmes used produced low results for Preston. That's largely because we were denied the right to include backing in the calculation. And here you can see the effect of that.

According to Archie-M the capacity would be about 6 tonnes.

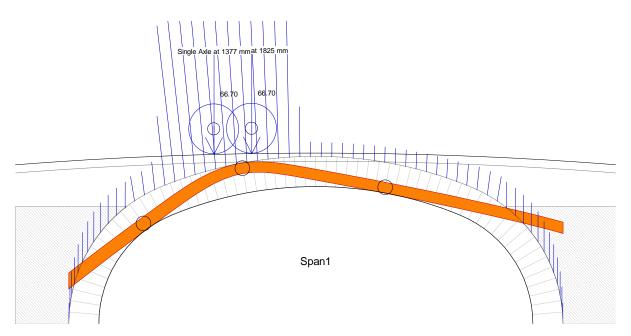
Put in some backing and the result changes dramatically. Now live load stress dominates completely. Large parts of the line of thrust are straight and directly under the load it runs very close to the extrados over some distance. This comes much closer to representing what happened in the test. Several cracks opened between voussoirs under the load and there was considerable crushing at the intrados at points were the thrust touches. Archie is indicating a capacity of around 200 tonnes, though that is based on a mechanism forming rather than the stone crushing.

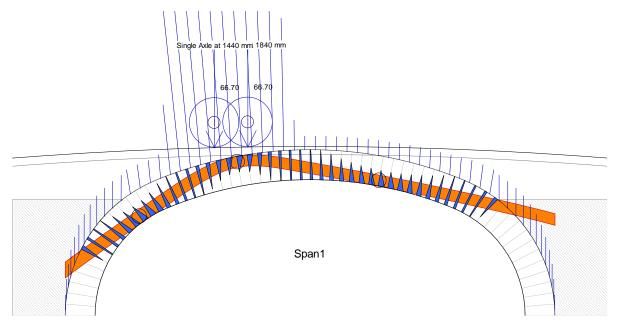
There is a version of Archie-M in development which shows stress blocks implied by the thrust line. Looking at that makes the situation a little clearer perhaps. Where the triangular blocks are short but wide the stress is concentrated close to the edge of the arch. There will then be significant rotation between the voussoirs.

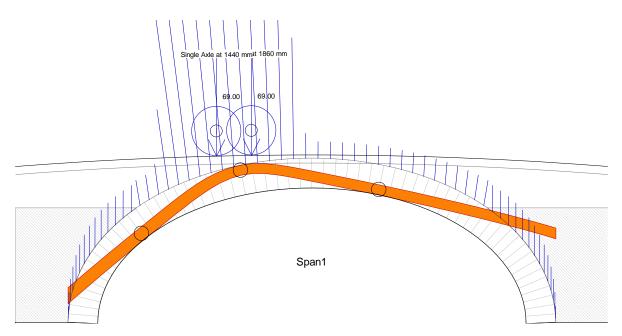
Finally, a look at the elliptical shape. Here the capacity is shown as very slightly larger.
