Bridge of the Month 13. April 2022 Annan Railway Viaducts

Let's start at Annan. I didn't notice at first that my photos covered two viaducts, one square and one skew. Further investigation shows these to be Annan Viaduct and Port Street Viaduct respectively. Apart from the skew, the construction is very similar.

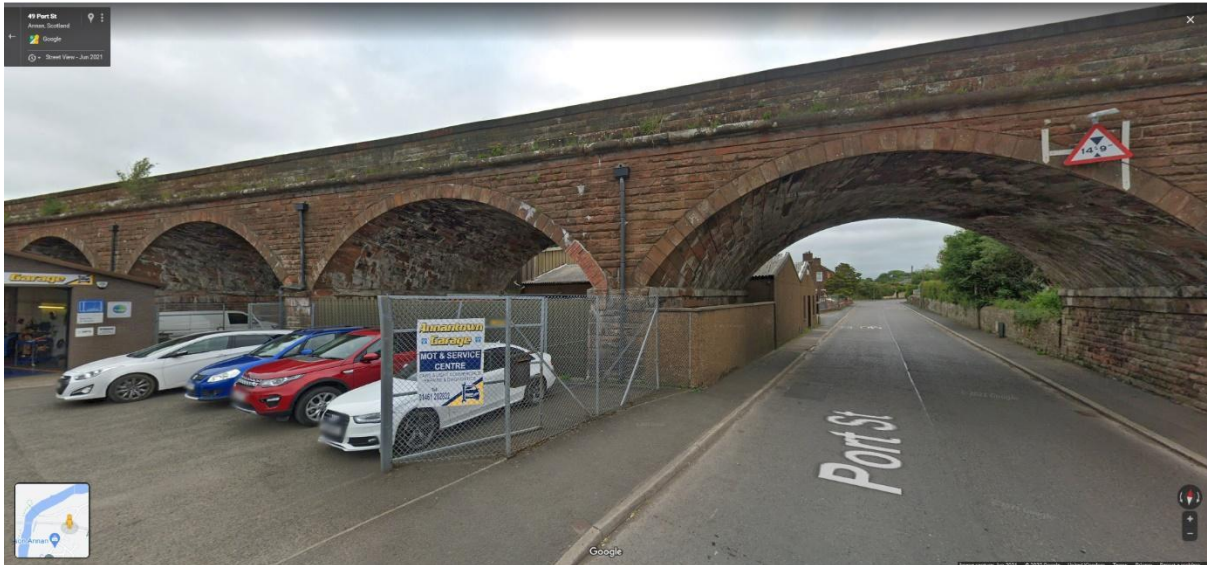
There are several things to note in this image. There are four modestly skew spans of 40ft (12.2m) span and 10ft rise. I would expect that span to be on the skew (parallel to the arch edges, not "square" to the pier faces), the same centres surely having been used for both viaducts. I hadn't thought that far when I was there 20 years ago.

What next? Look how high those drains are! We know enough about John Millar's bridges to say with some confidence there will be solid backing about halfway up the arch then internal spandrel walls (usually one under each rail) that pass right over the arch crown. Above that, the voids are capped with stone. Those stones probably correspond to the ashlar band below the nosings. There will be a sump to collect water behind the drains.

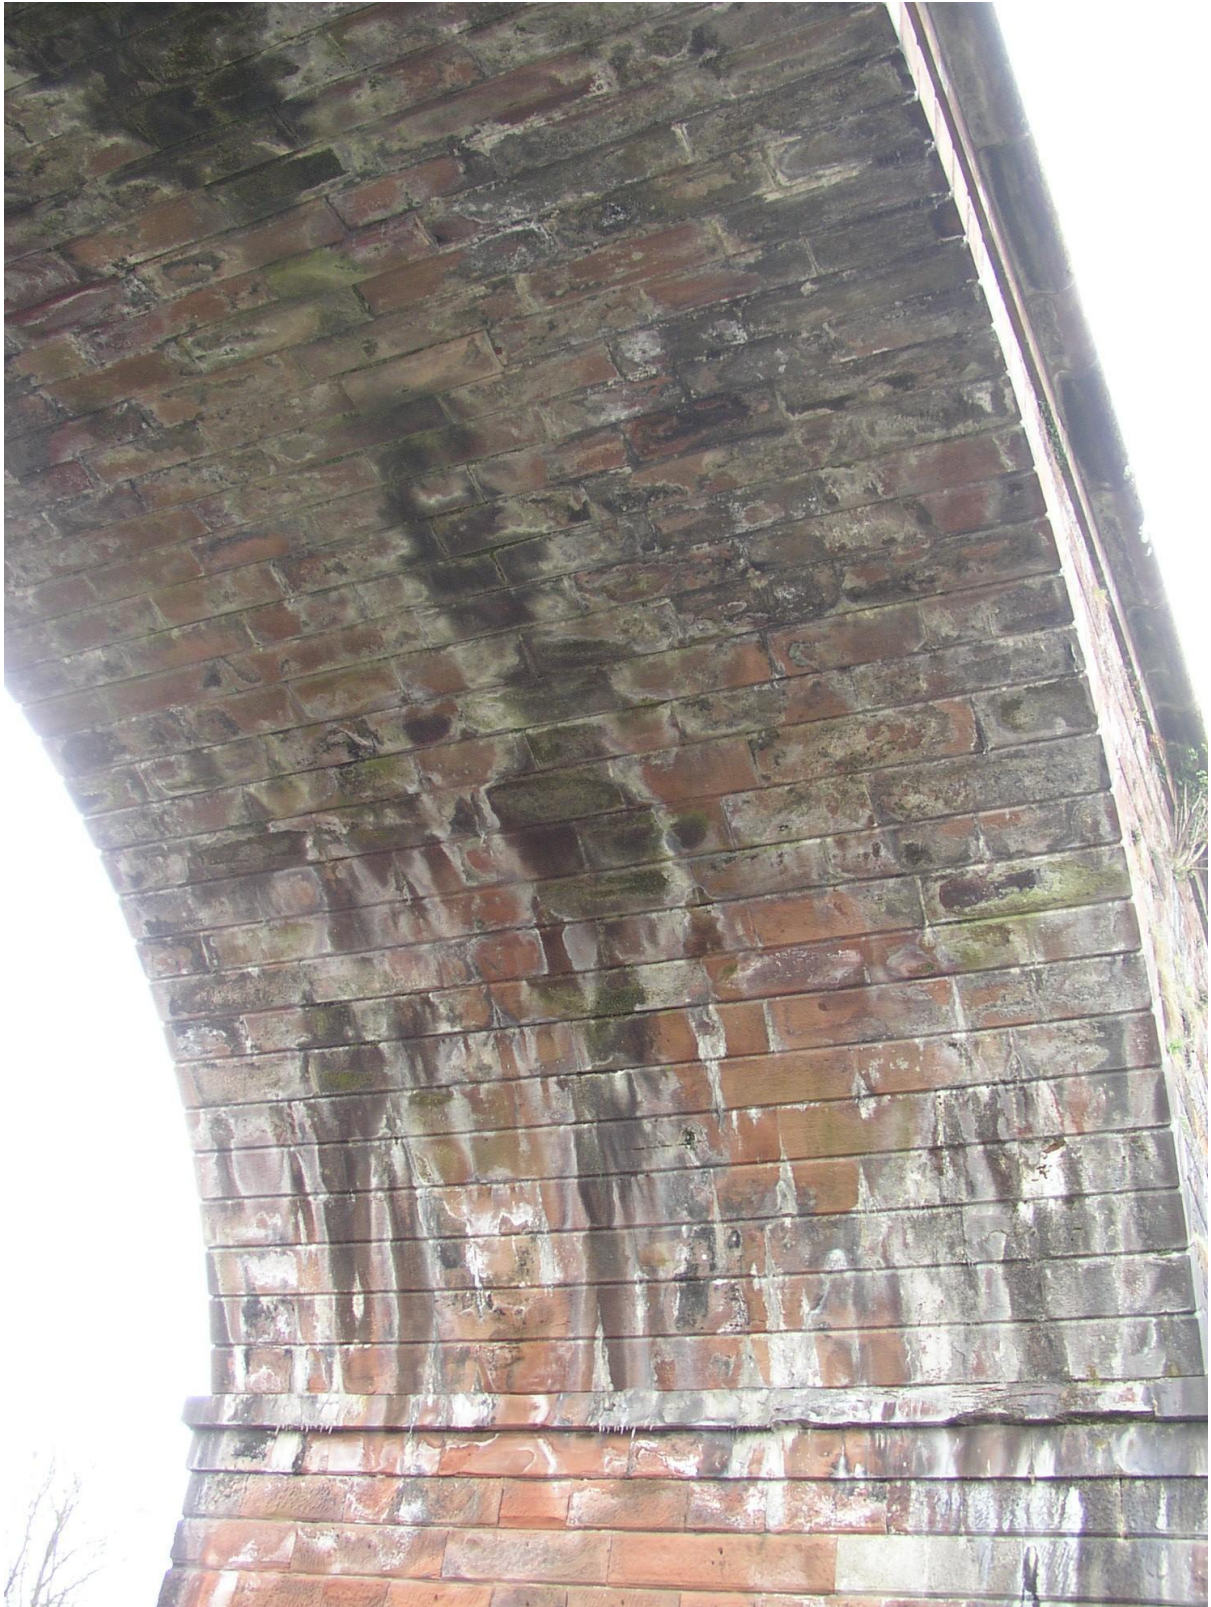
If we look up at the soffit, we see a run of water down the centre line from the crown towards the springing. So what is the drain doing? If the slab deck was built flat and the arch settled even slightly, the water would collect at mid span, not at the drain. Eventually, such water proofing as there is will break down and let that pond seep through. The upper face of the arch will not be dressed, so will be rough enough to allow water to collect above the joints and slowly seep through, de-naturing the mortar as it goes and helping with the articulation of the arch down the centre line between cracks.

Incidentally, this picture shows a square span and must be the river viaduct. Below, we return to the skew span and notice considerable damage to the spandrel wall and the edge of the arch below the drain. It is unlikely that water is penetrating from behind, at least below the top of the solid backing and the damage to the arch is restricted to the very edge, so we must assume that splash from the drain is the underlying cause. [Why not mechanical? Extends too far up to be the drain throughout surely]

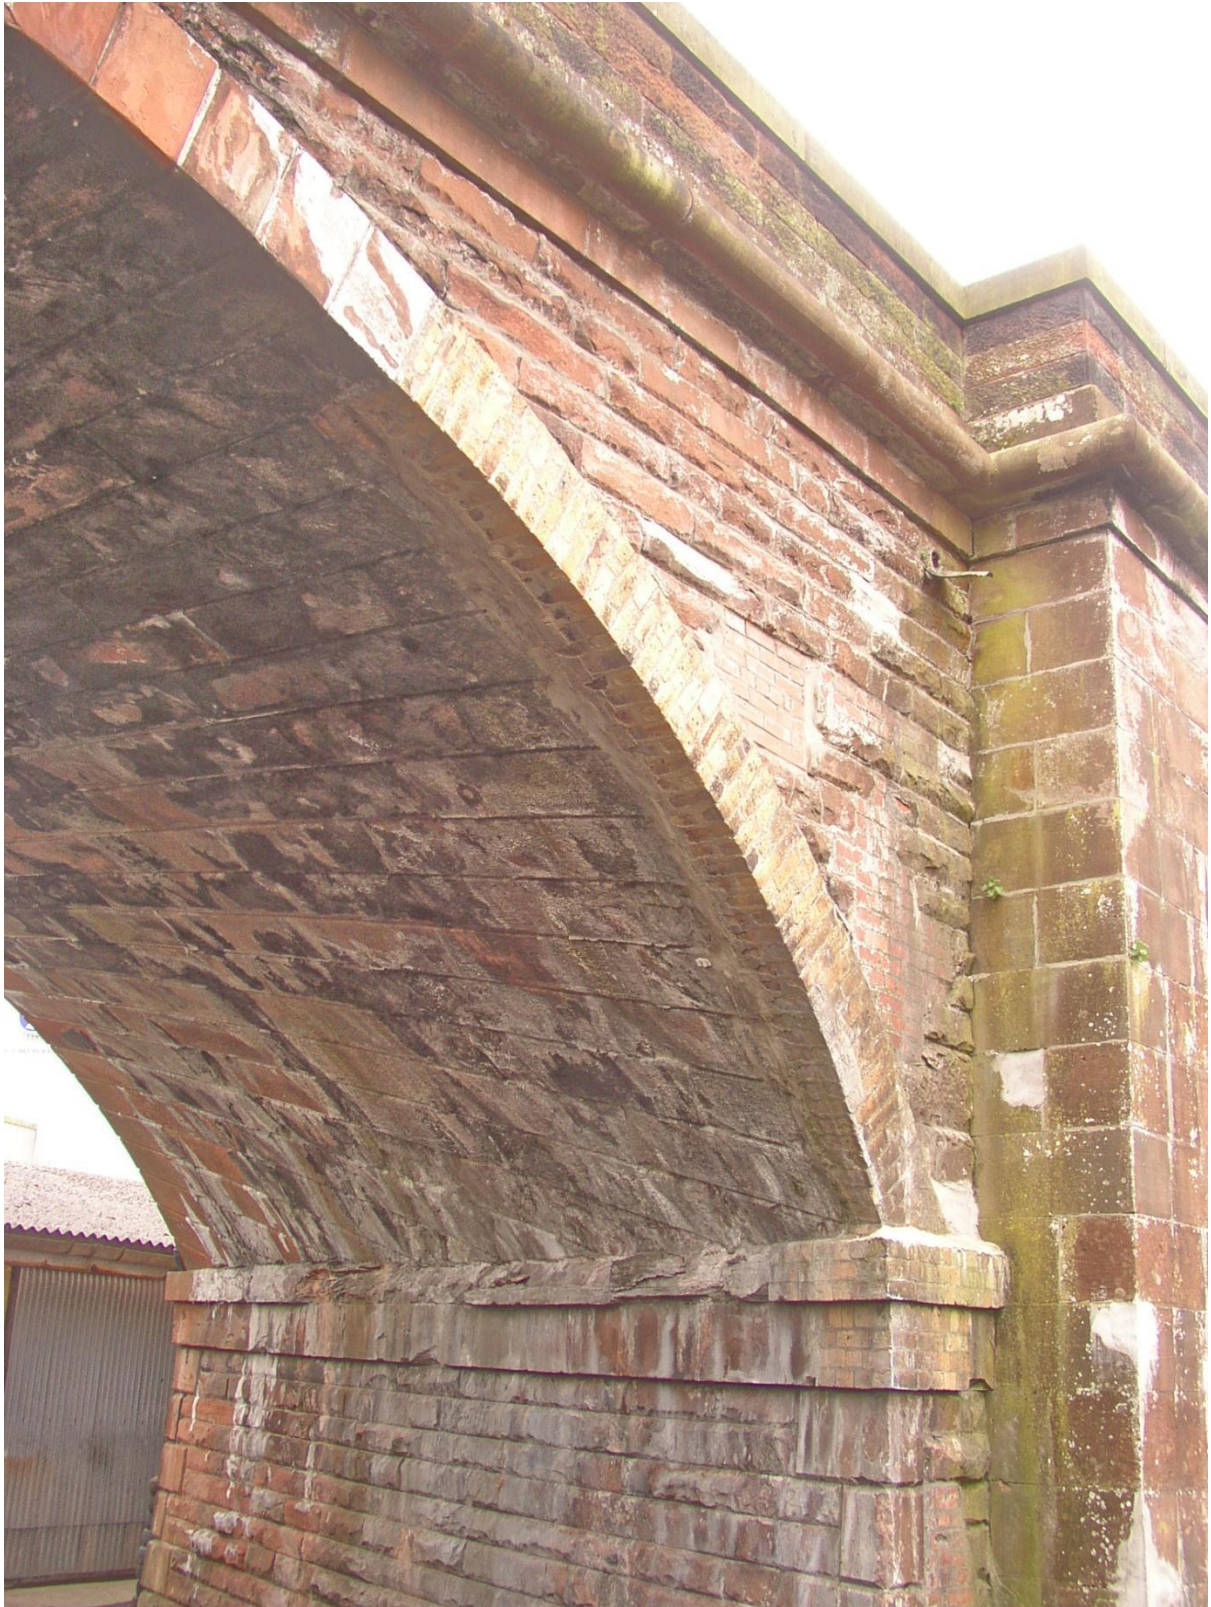
The string course below the springing is also a mess. Is that water or mechanical damage? It is at least possible that the voussoir stones are harder and I have seen damage in this area in smaller square bridges, but I don't think the cause here is the same. When you are cutting voussoirs the beds should be as close as possible to radial to the arch. In skewbacks, it is more normal to have the beds in the stone horizontal. When, as here, the skewbacks carry starter stones for the spirals, the

choice is less clear cut. I suspect we are looking at radial beds sitting on a horizontal face. The front edge of the spring course is going to be particularly vulnerable at the top.

It is also worth noting that the brick edge to the arch is bonded horizontally, not on the spiral. I wonder what work that narrow strip can do. It would be interesting to see what it looks like after a further twenty years.

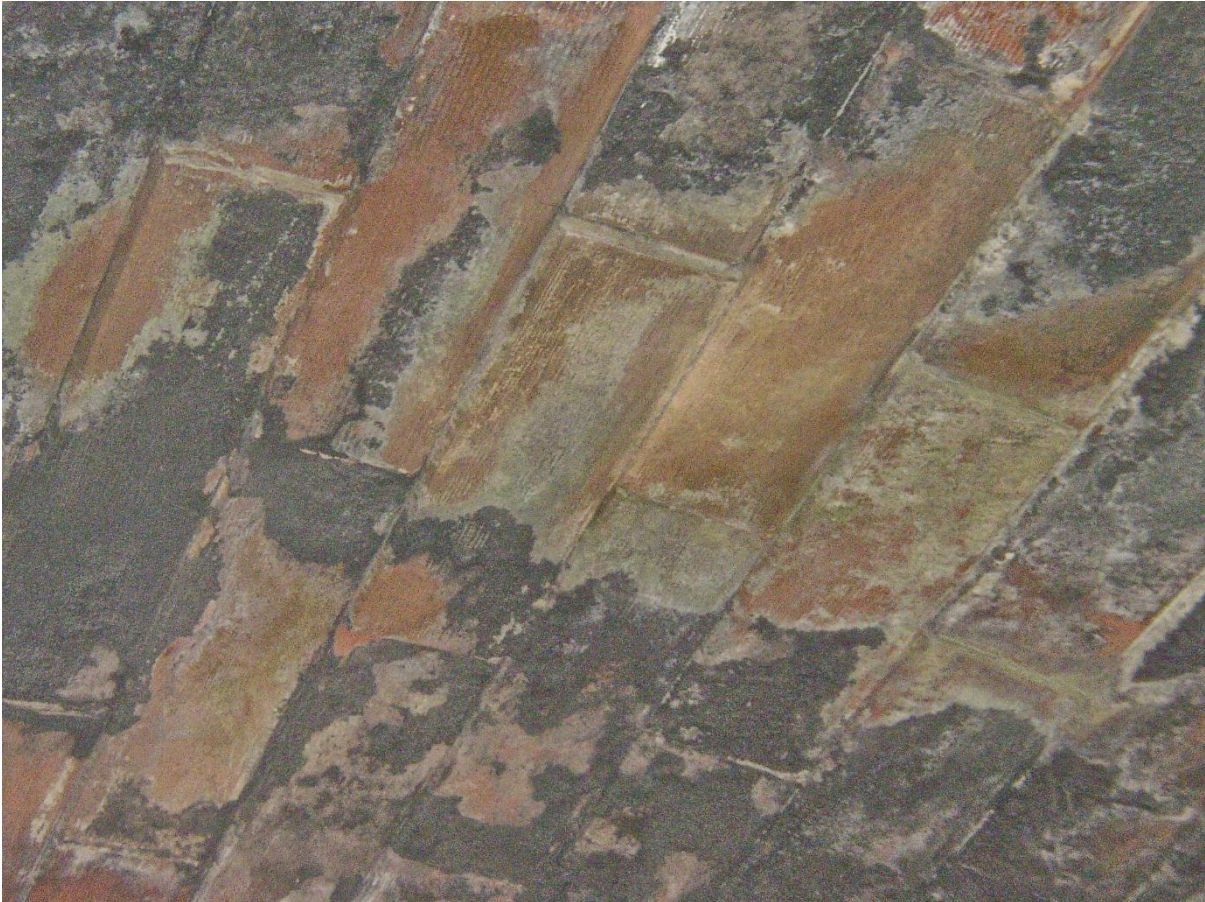
The behaviour on the centre line near the arch crown is interesting. Notice below that there is a vertical face of the voussoir exposed above the edge of the chamfer. The stone has rattled loose and dropped as the mortar washed out. [As these are dressed voussoirs, they are wedge shaped and can't drop far.]

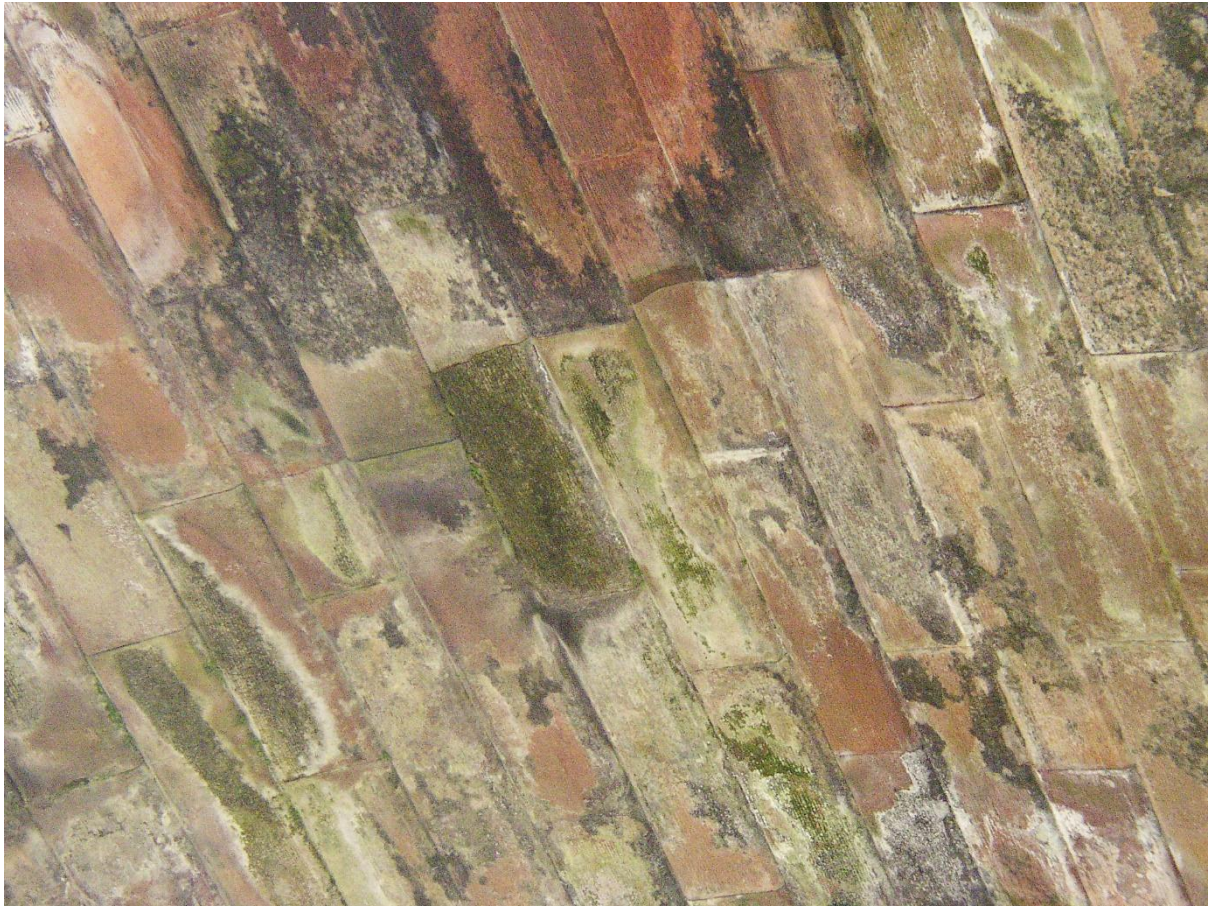
In other places, the stone has cracked through. It would be good to be able to work out the immediate cause of that different behaviour (photo below).
