Bridge of the Month 137, May 2022 Great Musgrave

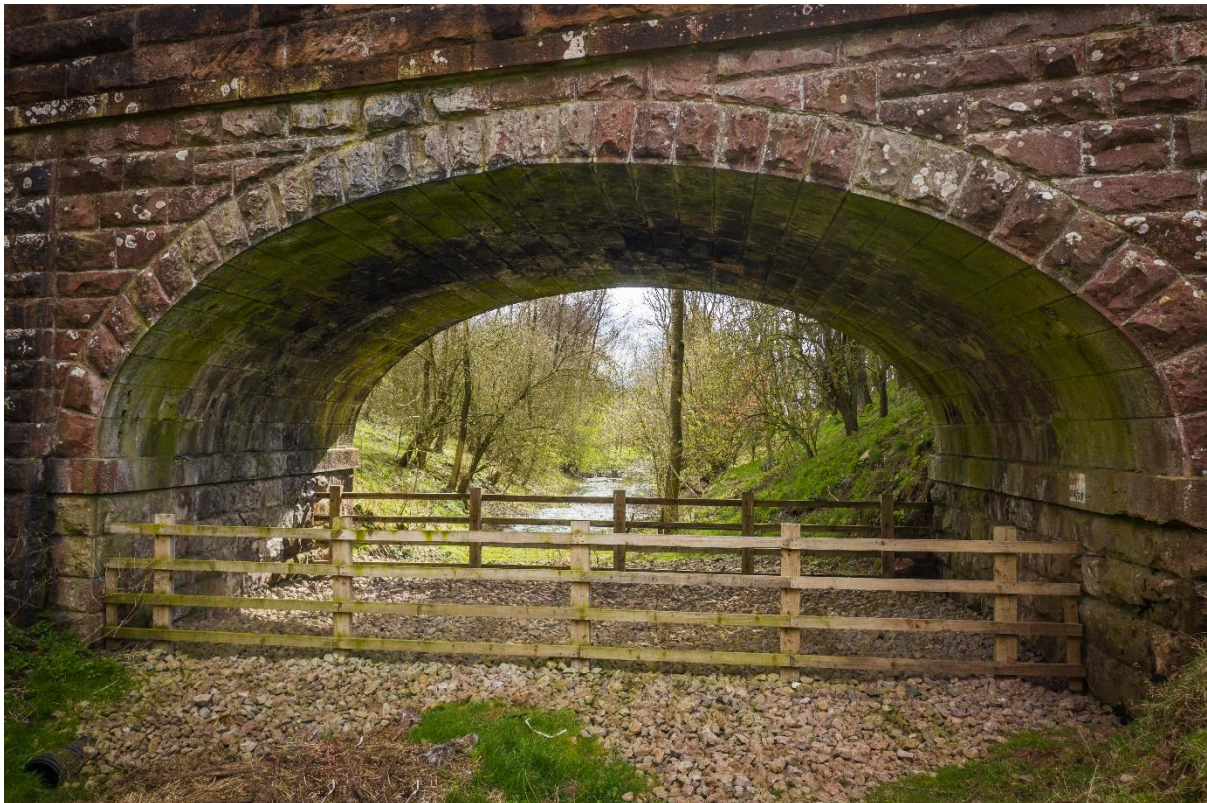
The bridge is skewed by about 13 degrees. You can see that in the first picture where the fences have been built square to the abutments.

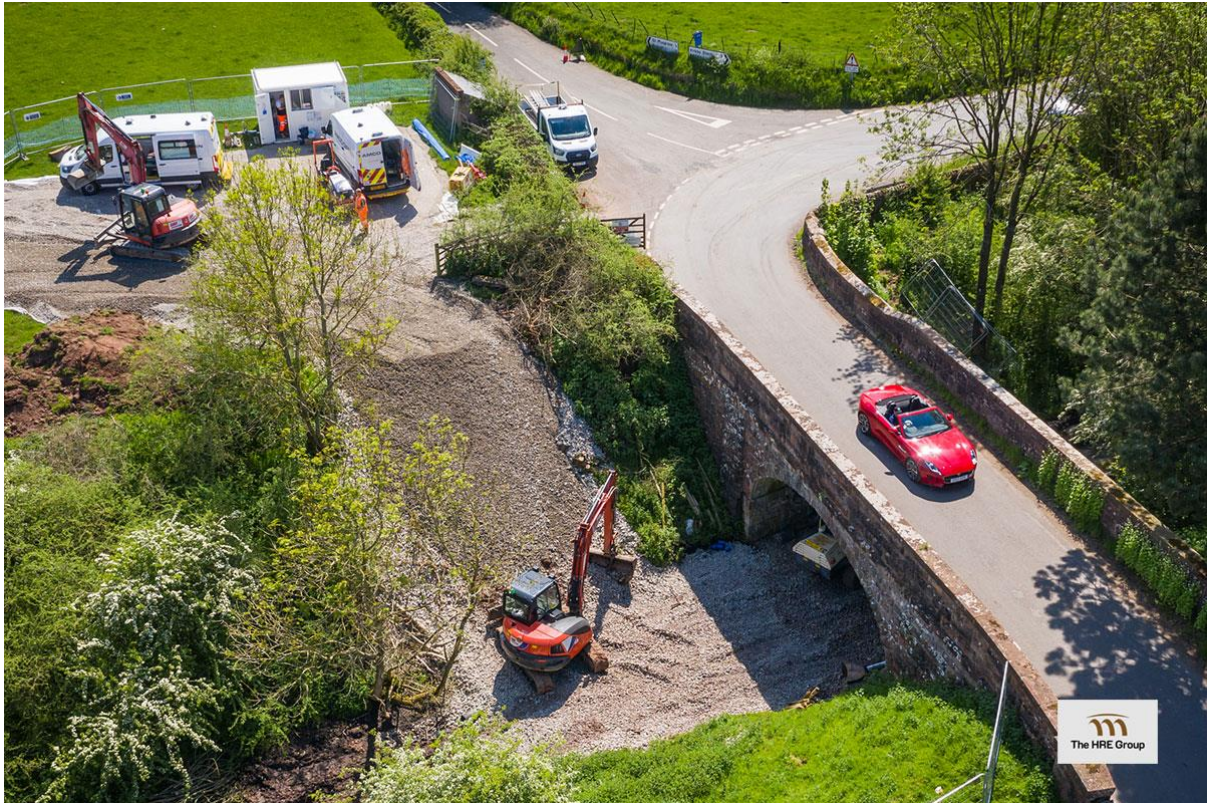
Below we see the infill work in progress. Notice that the car wishes to occupy the full width. It would be very difficult to get two trucks side by side into the 5.63m width between parapets.

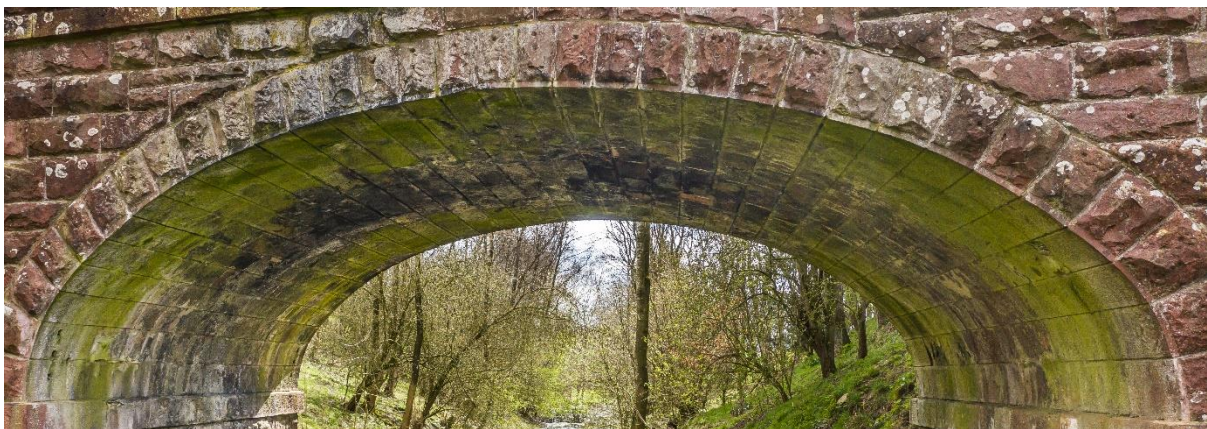
The joints all seem to be tight and straight. Loss of mortar could not amount to much and would certainly not impact on the bridge capacity. The water marks suggest backing at least to the sixth voussoir from the end but more likely the ninth, which would be more or less level with the arch

crown intrados. On that basis I would suggest the bridge would suffer no damage from any AWR vehicle. The worst case would be as shown below.

The bridge seems to have been condemned on the basis of measured loss of mortar with a figure of 170mm quoted. That particular measurement was in a perpend joint in the arch which was probably never properly filled anyway and has no consequence on capacity. In the bed joints, the loss is patchy with a maximum measured value of 40mm.

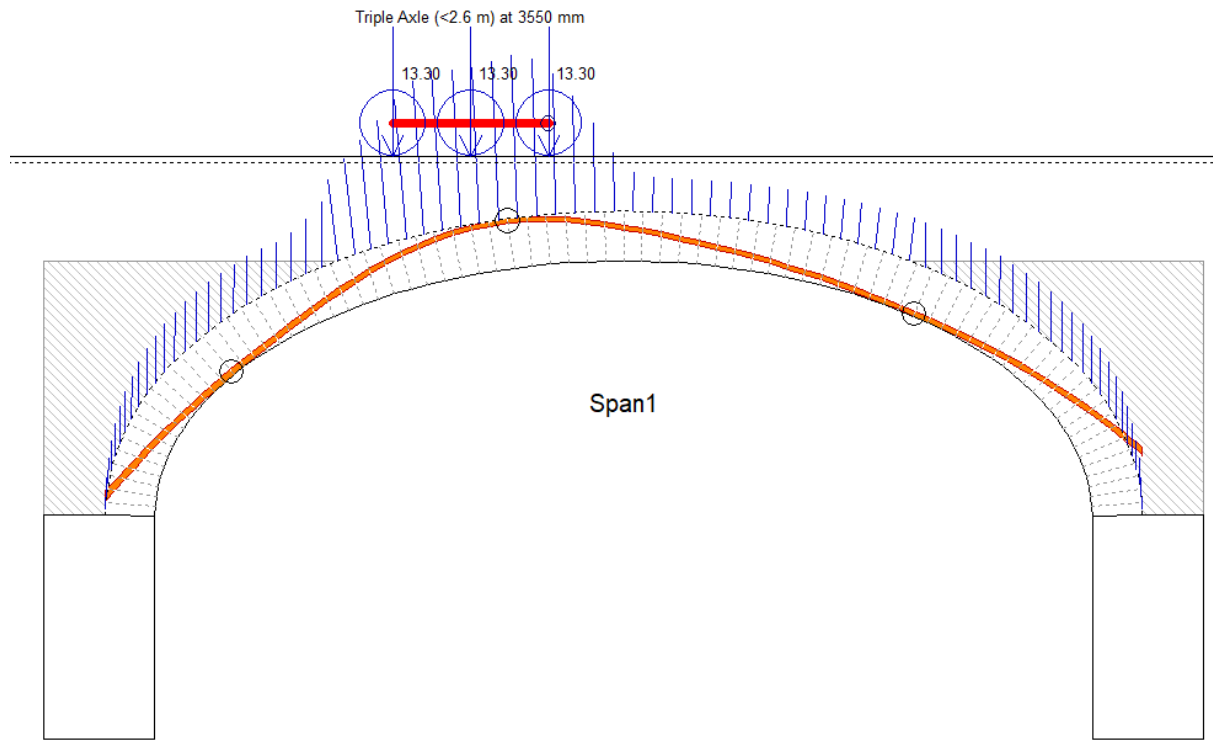
Nothing in the photographs I have seen suggest that there is any underlying reason for concern. The Archie-M pictures above would normally be accepted as evidence that the bridge has ample capacity. I haven't seen it in the flesh, of course.

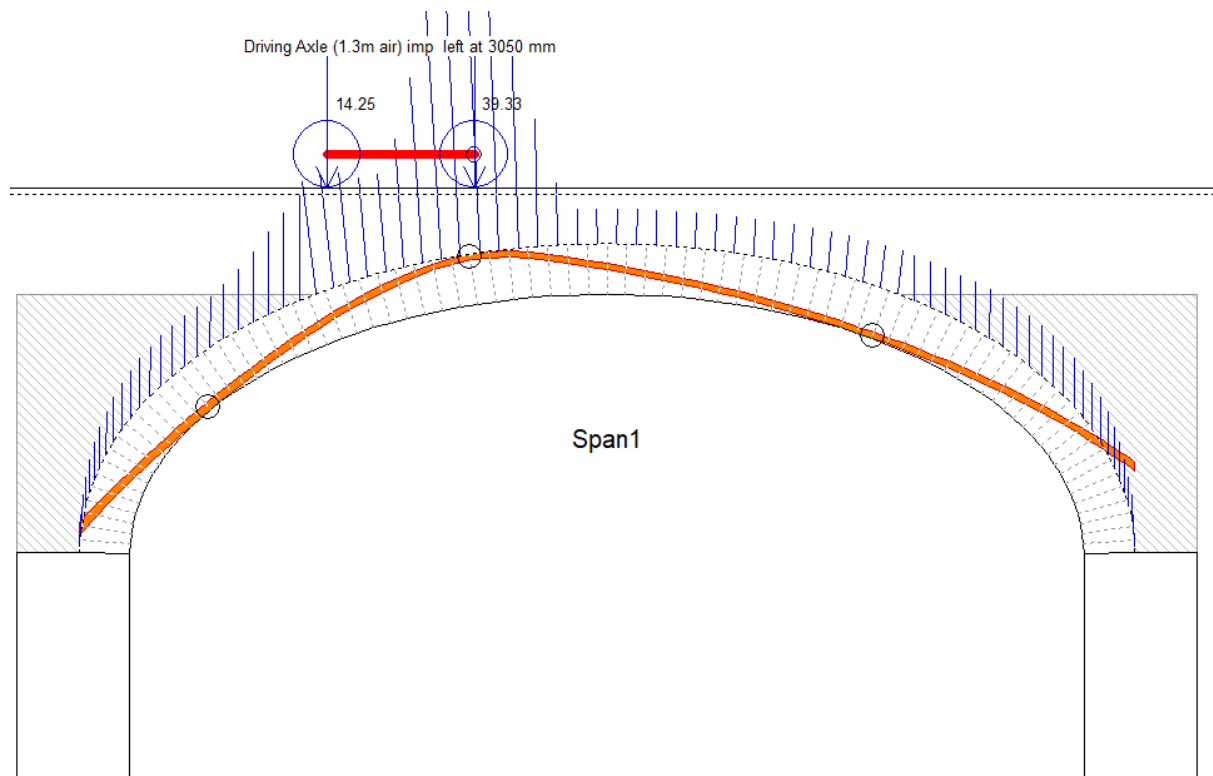
Or with impact
