## Bridge of the Month 138, June 2022 Melkington

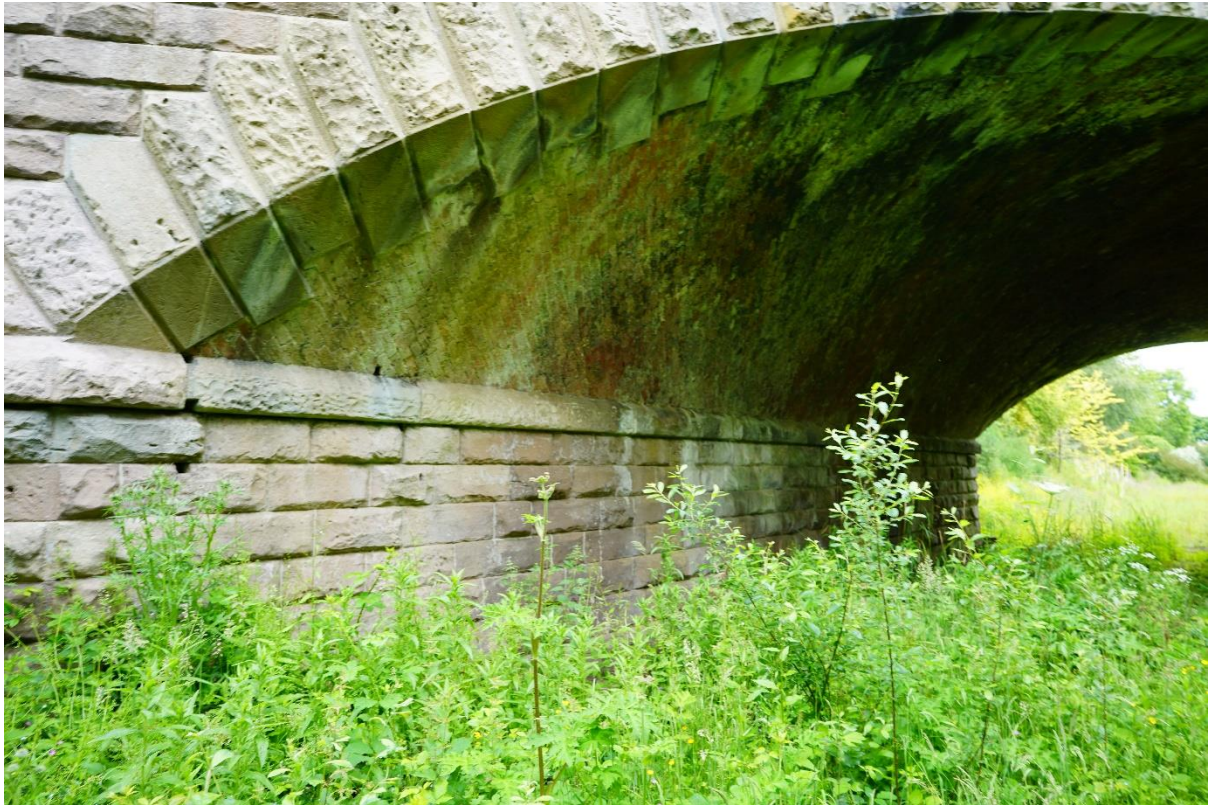
Turning to the acute edge shows how skew the bridge is. Previous measurements say just over 50 degrees.

Also in the corner picture we see mud runs down the line of steepest slope. I am not sure where they are coming from. Perhaps I will be able to see in the model so now might be a good time to introduce that. I spent 20 minutes at the bridge and took 230 photos from the ground using a Sony A7Riii with a 24mm G model lens. The bits that appear white in these images are where the camera couldn't see. Quite a modest pole would have overcome the problem on the elevations but the state of my hands after Chemo mean that I cannot manage a pole and trigger etc.

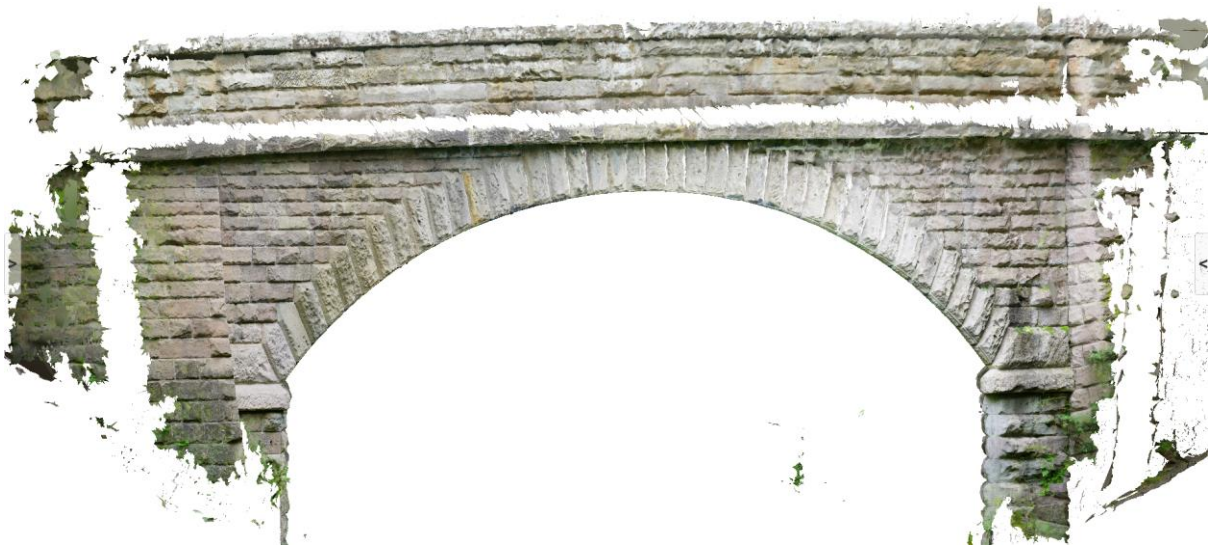
This orthographic elevation suggests that the arch is circular on the square, despite the very high skew. A square view of the spandrel wall looks rather flatter, with the curve increasing slightly towards the springing. Among other things, notice here how the voussoirs are lozenge shaped. This is what you get when you cut through a spiral on the skew.

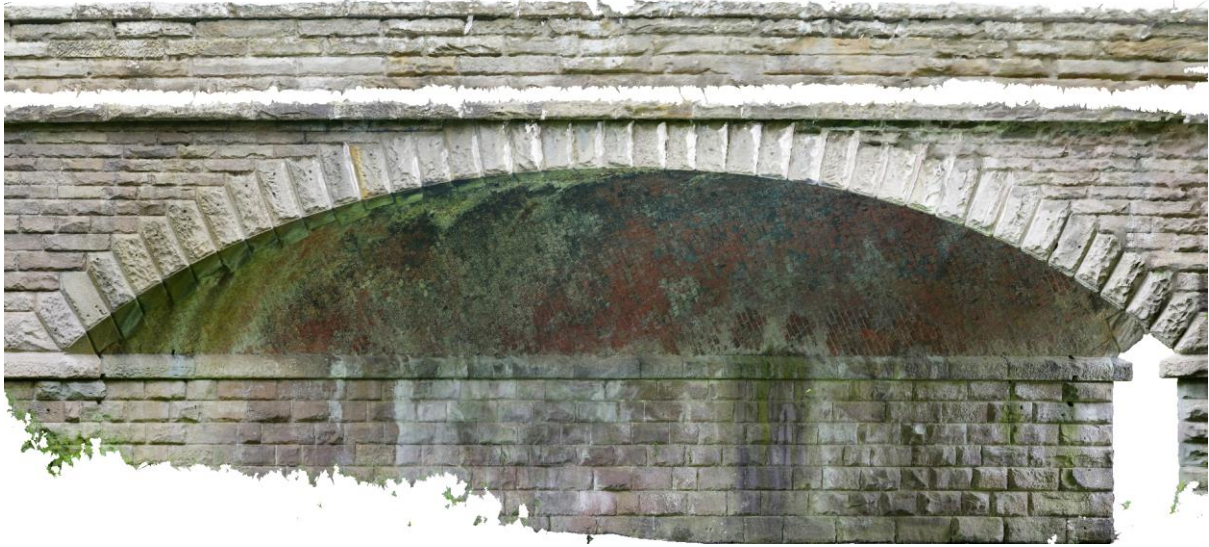
Notice how the voussoirs go lozenge shaped towards the springing.

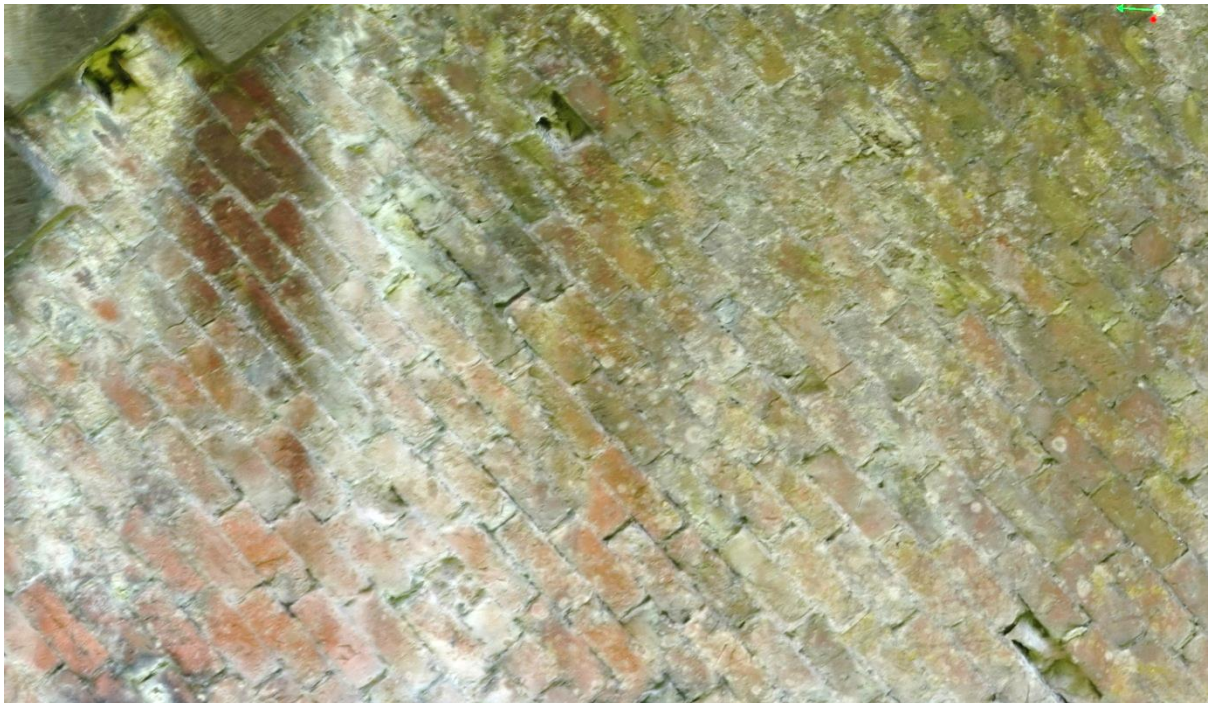
One thing I was looking for was mortar loss. The assessment that NH relied on to condemn the bridge said up to 100mm and reduced the whole ring by the full 100mm. I have examined the soffit closely and found negligible mortar loss. In the image below are 3 badly weathered bricks, one top left, one top centre and one bottom right. These were the only such bricks found. They are isolated, and certainly don't justify discounting a full ring.

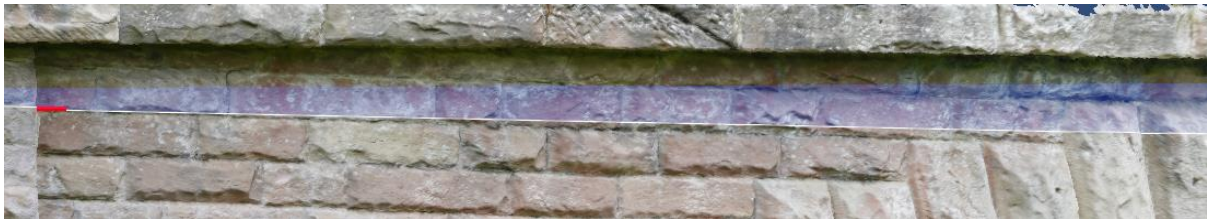
The rise is given as 2.39m or 7.84ft. The arch will surely have sagged a little on decentring. Striking a horizontal plane through the model certainly shows a dip to mid span.

The most likely original shape seems to be an 18ft radius, giving a rise of 8.05ft, 2.45m which would mean a sag off the centre of 64mm.

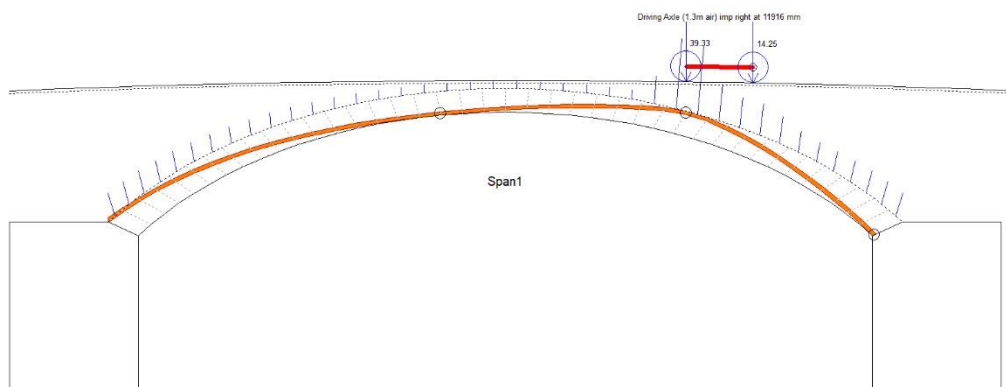
Putting those dimensions into Archie-M and auto-running loads from BD21 (because the assessment was done before CS454 was published) the worst case is a two-axle bogie with impact.

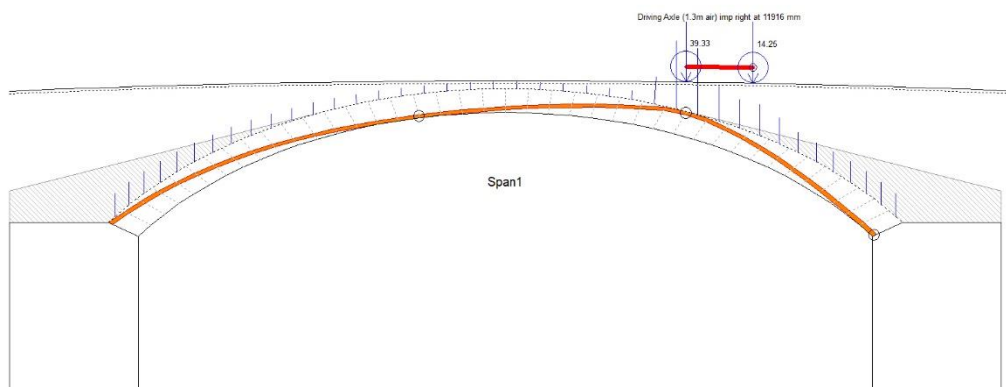
Adding a modest amount of backing makes the bridge more than adequately safe.

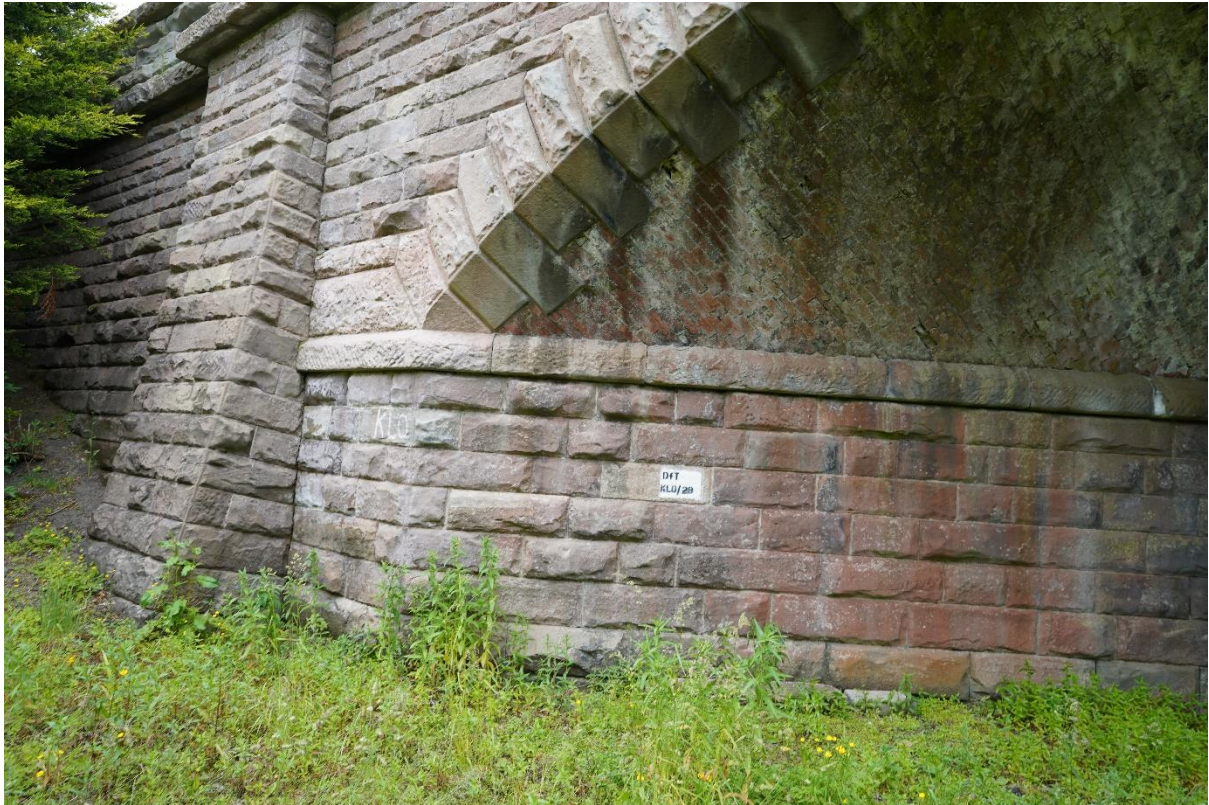
At the corner above, the skewback naturally forms a solid piece for the arch helix to sit on. At the opposite corner, construction is much more complex, with a double voussoir cut into the single stone.

This picture also shows how the voussoirs project about 25mm below the brick arch. That must have made for some interesting centring.

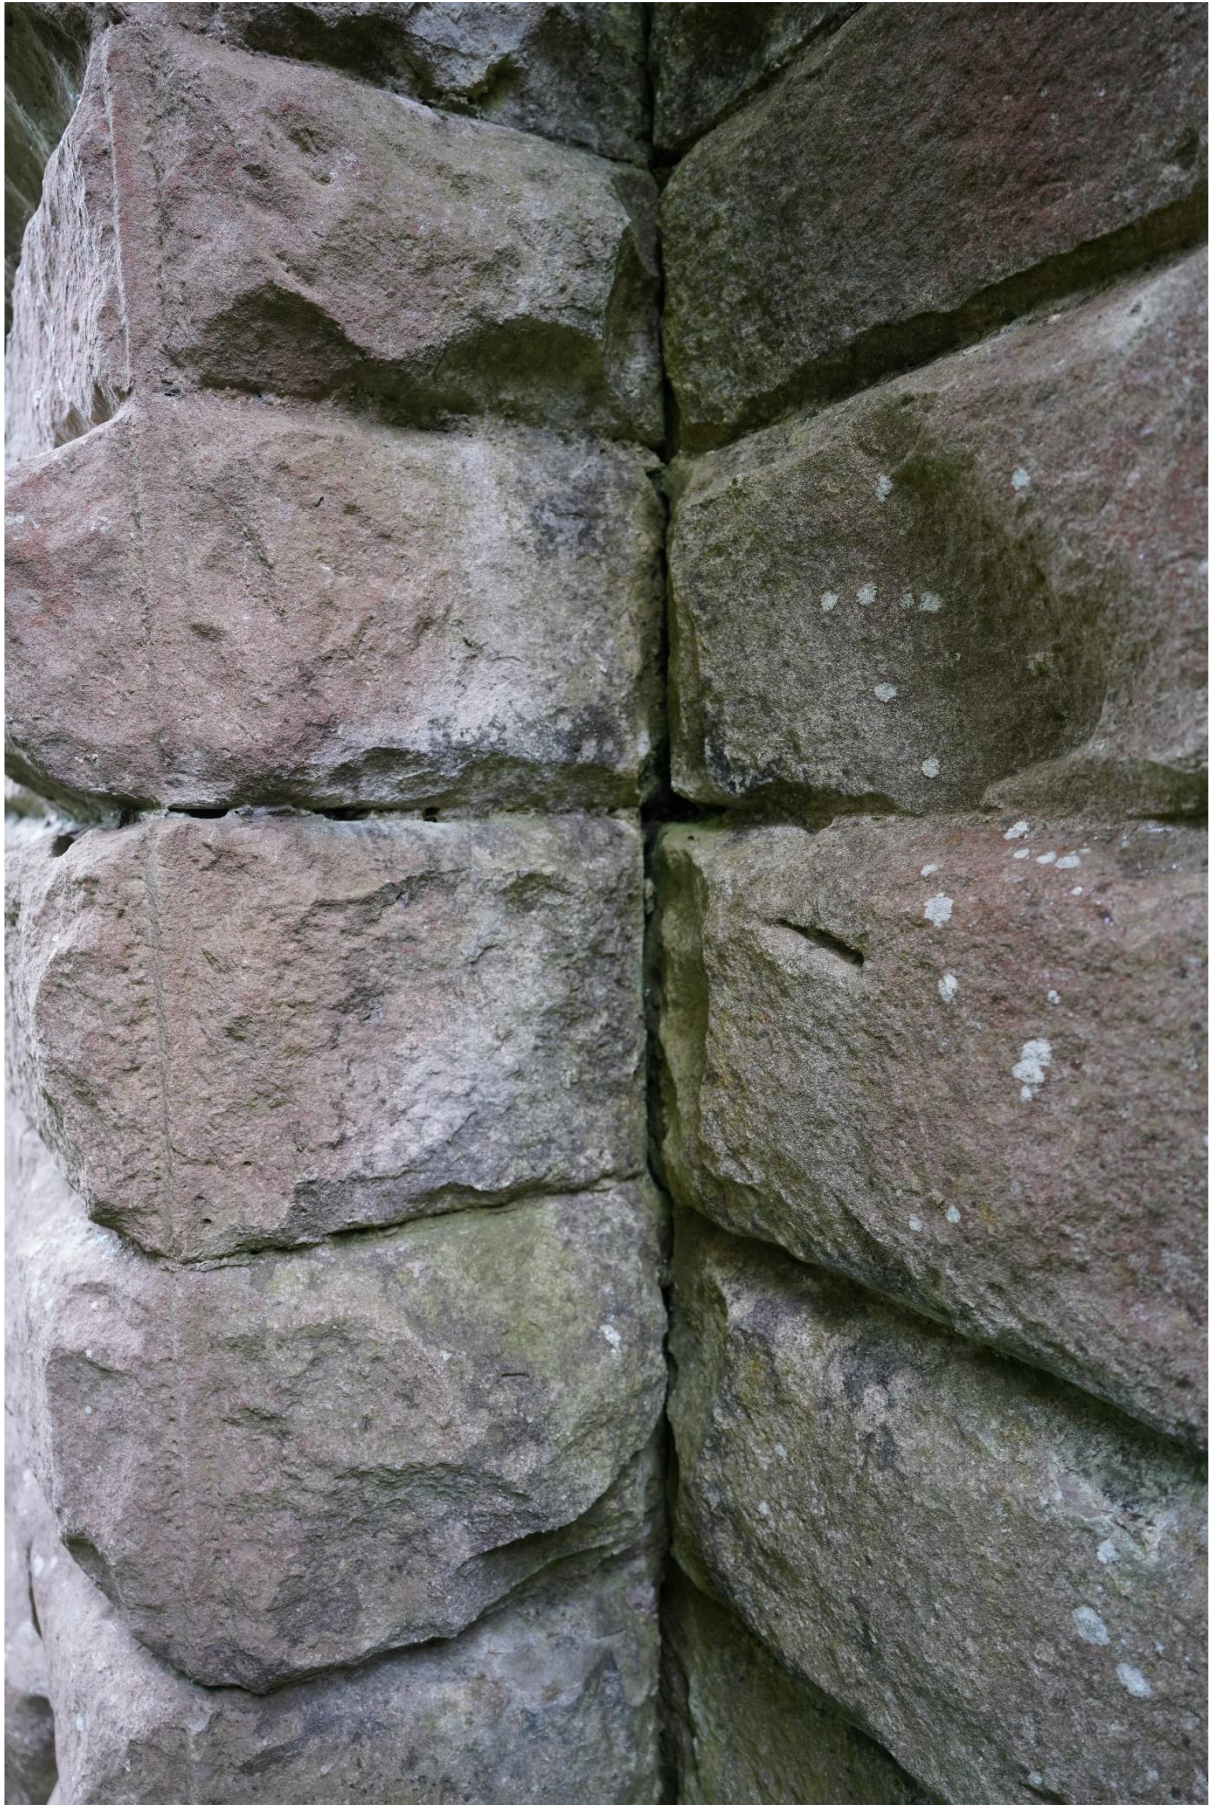
I was intrigued that the buttress seemed to be cut in rather than bonded.
