## Bridge of the Month 140, July 2022 Aberfeldy

The bridge, full title [Wade's Bridge Aberfeldy](#), was built in 1733, the crowning glory of the military road network built under General George Wade as part of a move to suppress the highlanders after the 1715 rising. There is rather more about the history and construction [here](#).

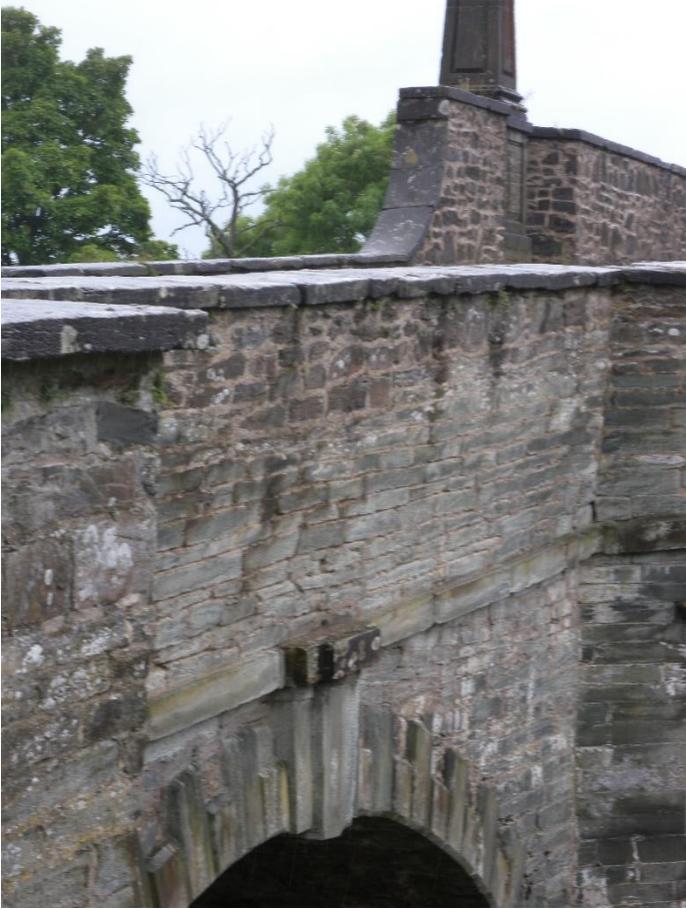
At some point, the pronounced hump was eased by building up the approaches to be tangent to a rather larger radius hump. As a result, the parapets over the side spans are quite low. The "flat" top parapets through the main span make for a great height over the piers, certainly more than 2m at the highest. The picture below gives some impression of the height.

The string course in the foreground original also formed a kerb on the inside and marks the original road level. The present level is roughly where the parapet changes colour. A look over the crown from mid span provides an alternative view.

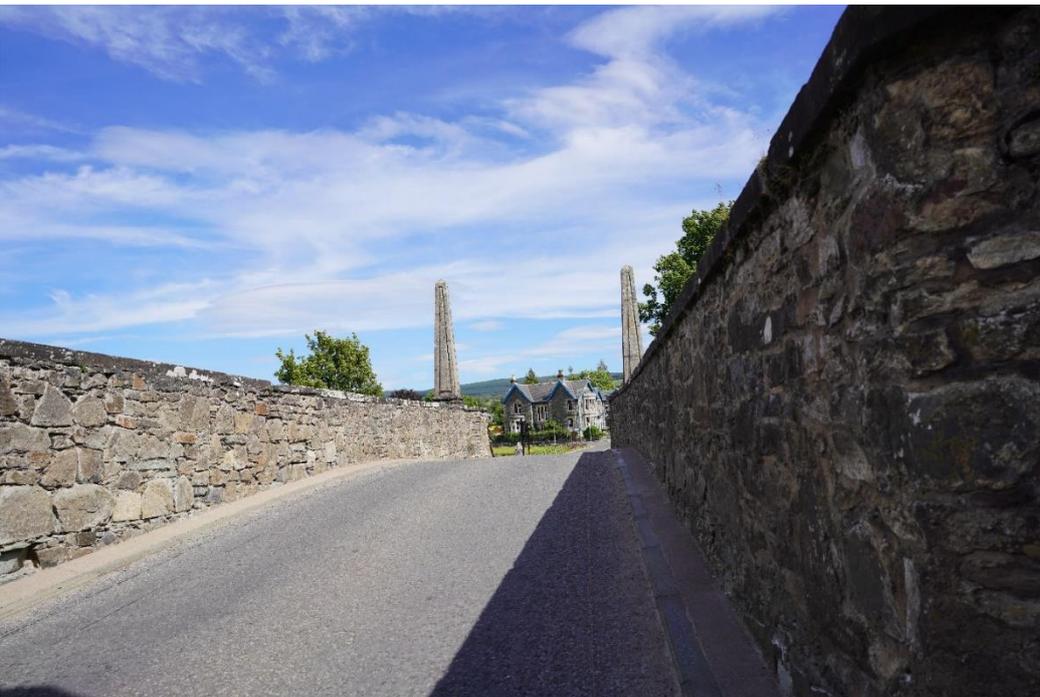
The dip in the string course is more pronounced than in the parapet top. The drop of the arch when the centres were removed was non-trivial. The parapets were not completed for nearly a year, so the sag there represents longer term movement.

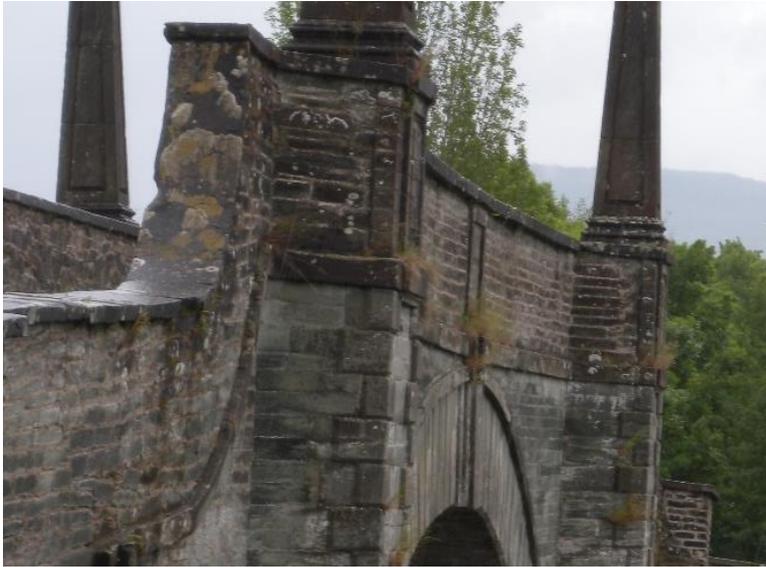
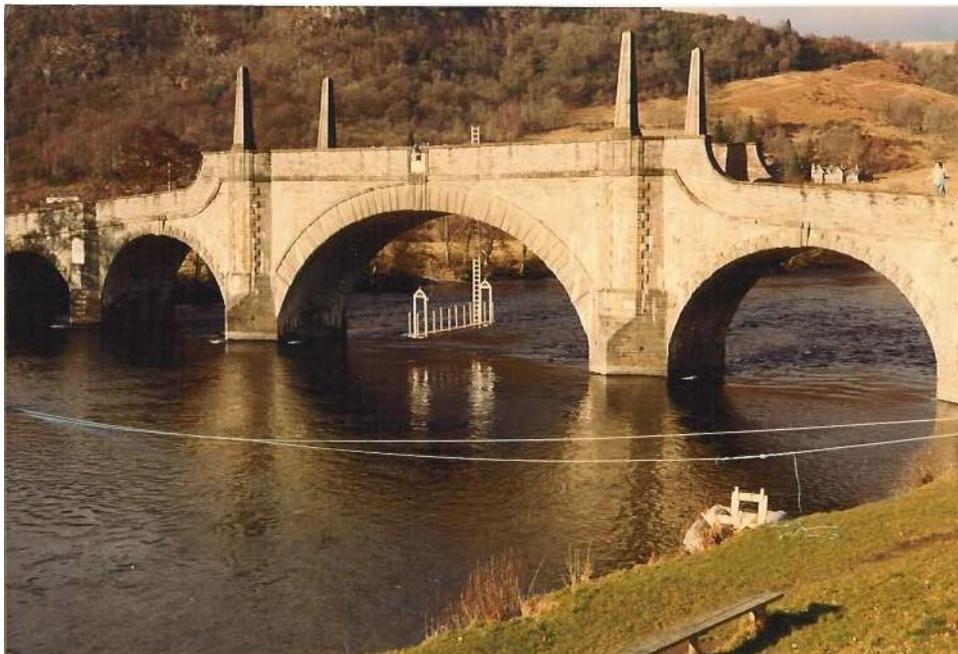
This picture from the 1980s shows the access scheme we devised for the early-stage monitoring. It had to represent a negligible restriction to traffic once in place but also the erection had to be accomplished during all the red time between traffic flowing in the two directions.

The monitoring was a response to the sudden imposition of a lot of heavy loads from a barytes mine. We estimated that some of the (notionally 40-tonne) trucks were loaded over 100 tonnes. The bridge was certainly shaken but no damage was evident and there was no measurable movement.

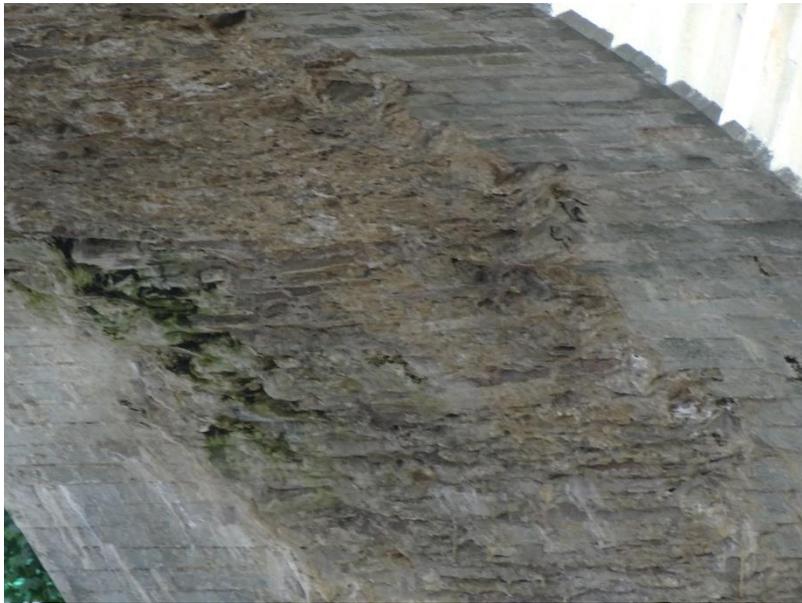
occasional larger stones. The closeups from the '80s are no longer accessible but modern long lenses can do well from the banks. Below is the main span where the dressed voussoirs extend some distance under the ring. Then rougher work has dropped markedly below the tight-fitting stones.

The wet patch is rather more trouble than it looks. An even longer lens from the opposite side shows that more clearly. That big stone looks to be on the point of falling out, though it may be anchored quite deep into the ring.

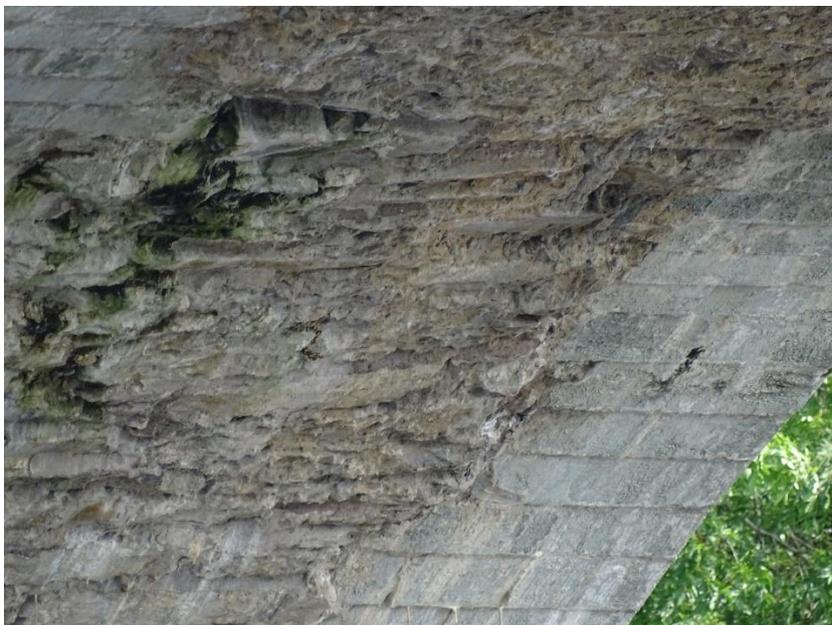
There is a similar patch diagonally opposite this one.

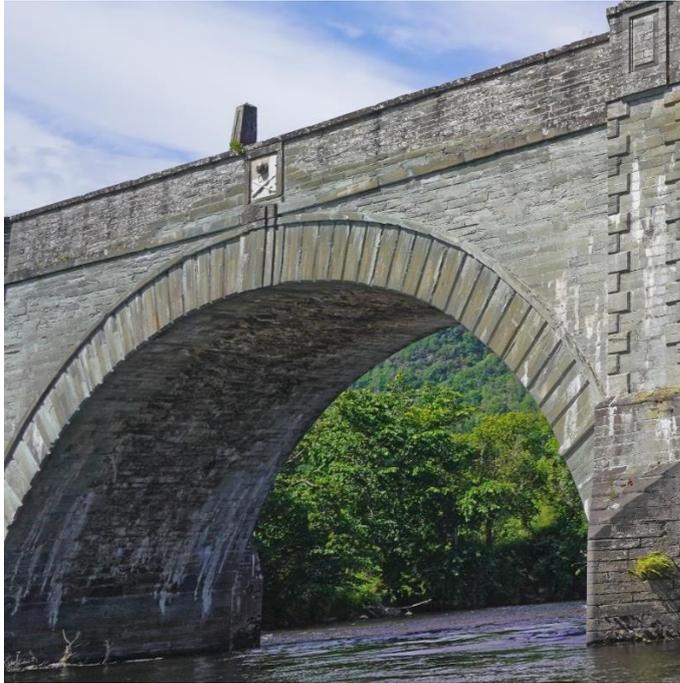
The wet patch is just about visible here at the  $\frac{1}{4}$  span point. In one recent flood, the water reached this level. That will have sought out any weak mortar and removed it. Perhaps it was weakened by those heavy vehicles nearly forty years ago and the damage is only just showing. I certainly cannot imagine why the damage should be at diagonally opposite points in the span.

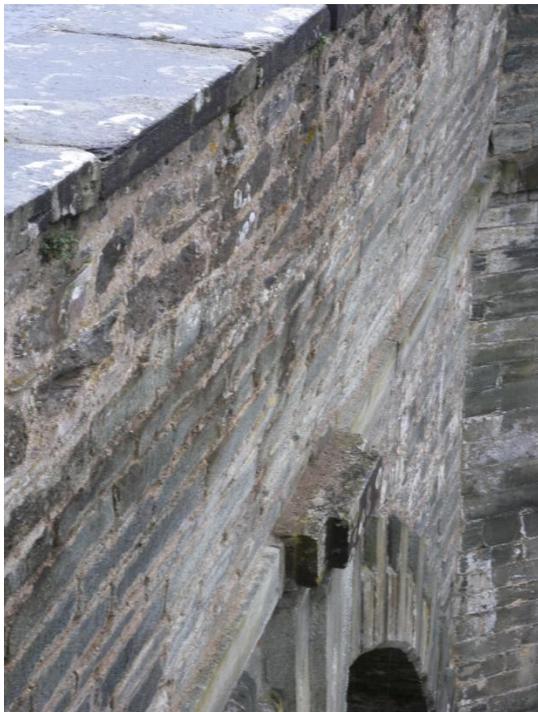
Perhaps you can see here how the parapet slopes out steeply through the bottom half of its height. The traffic lights require a cable over the bridge. The pitch intended to seal the slot for the cable broke down and water got in. Cycles of freeze thaw pushed the parapets out inexorably.
