Pontsarn Viaduct, [on the edge of Merthyr Tydfil](#), was built in the 1860s to carry the Brecon and Merthyr Railway over the Afon Taf Fechan, which flows here in a fairly steep sided valley. It is a spectacular structure, in need of some TLC.

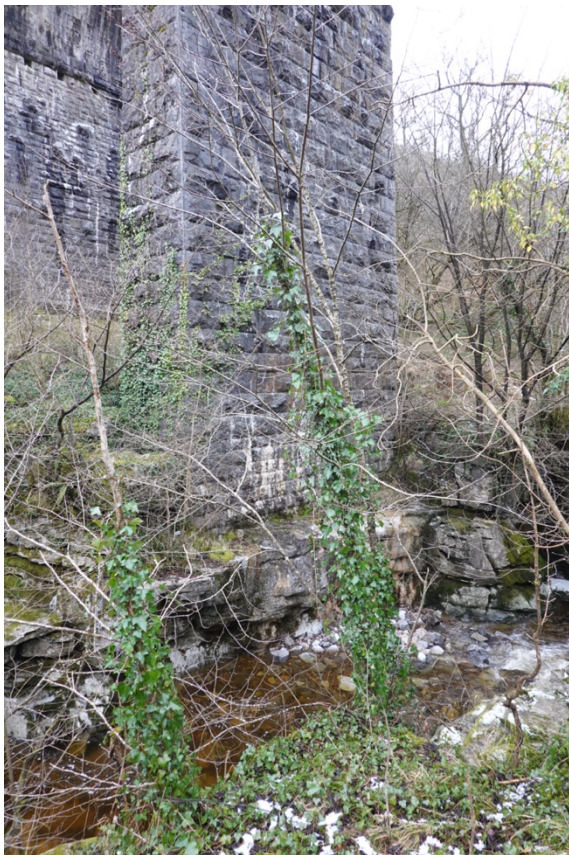
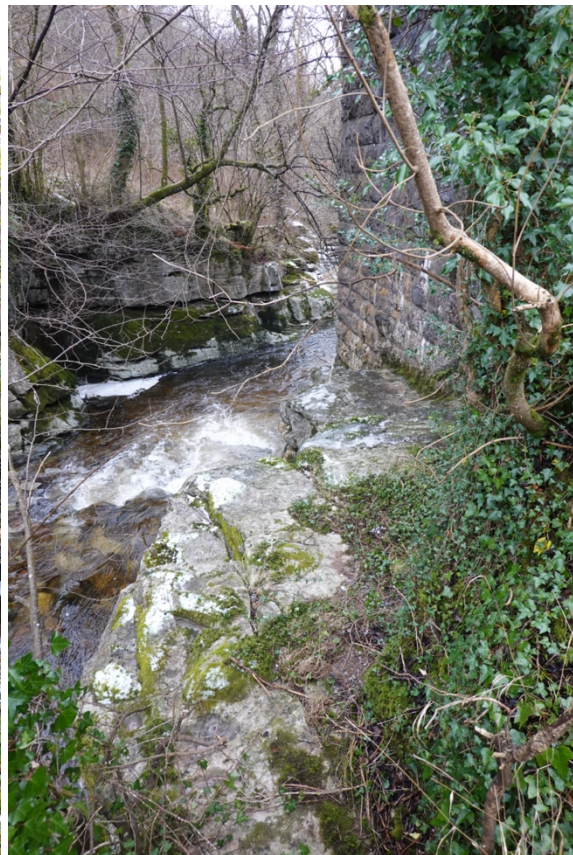
The piers of the river span are founded directly on exposed rock. The west bank pier (right photo) straddles the edge of the shallow gorge where the river does a dog leg. I didn't get a view from downriver. I wonder how much of the undercut on the east bank (left) has developed since the viaduct was built. Presumably the other piers are also founded on rock.

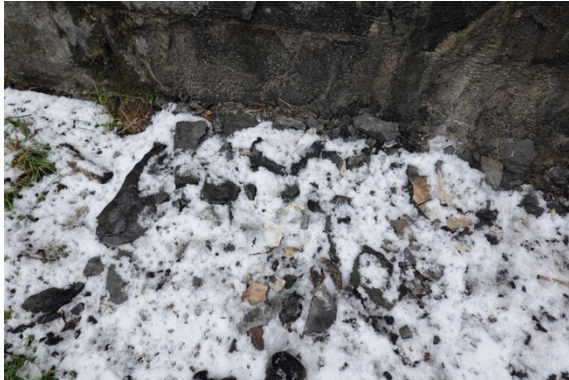
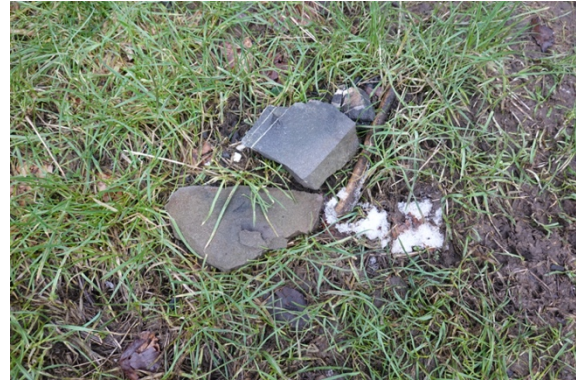
The bridge is built of local stone, reportedly direct from adjacent cutting, perhaps to the east, where the track bed runs along a ledge cut into the hillside. That stone is not the most robust; a scattering of small shards is found on the ground around the piers.

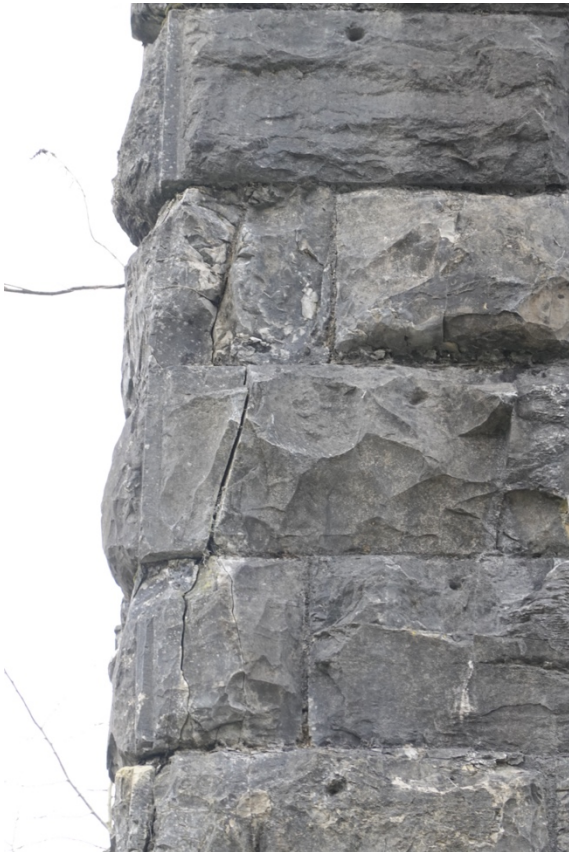
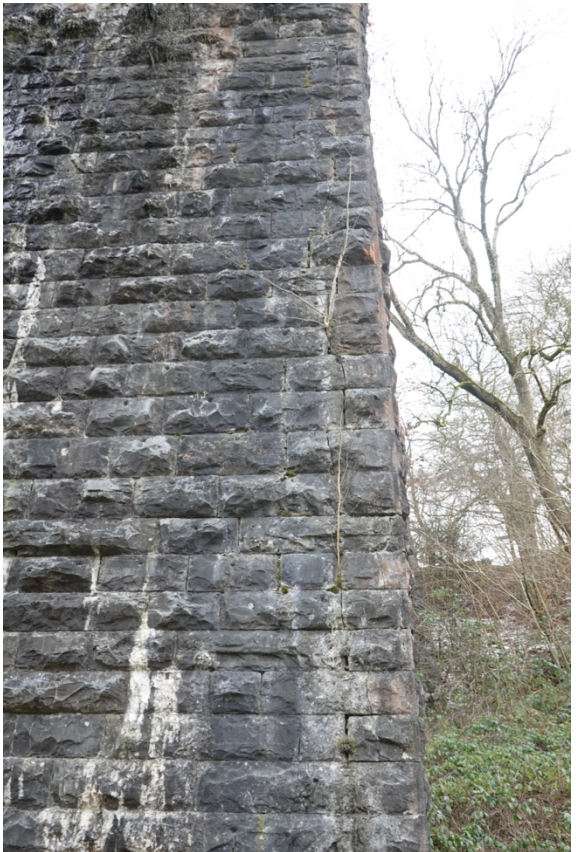
The small shards are only part of the story. It doesn't take long to find cracks that will sooner or later lead to larger chunks dropping. From the crown, cracks at the pier corners are most visible. Trees are established in some of these, prizing them open at several levels.

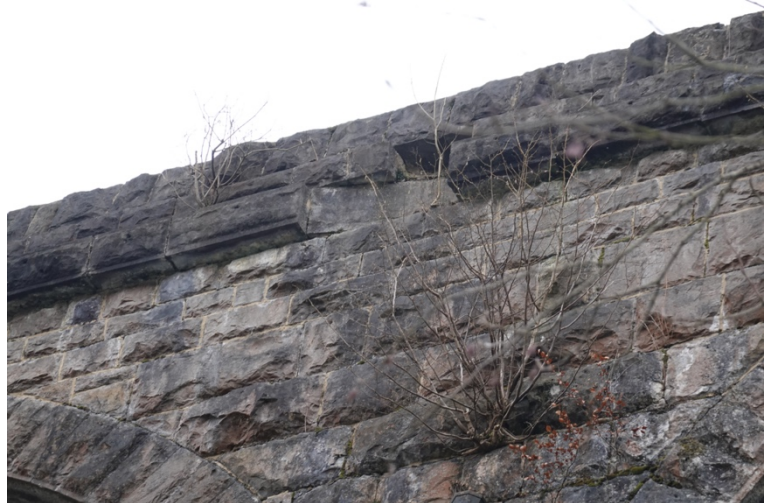
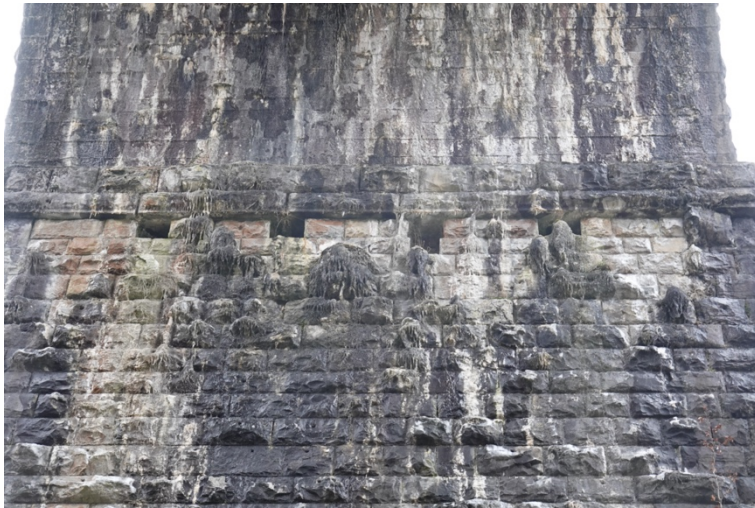
Some larger pieces have fallen here and there, including these sizable chunks from the string course and parapet.

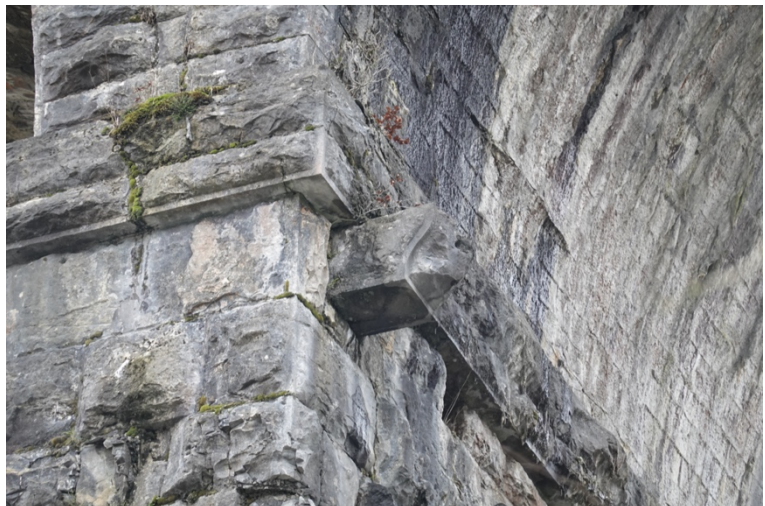
There are remarkable lime growths on the upper part of the pier in some spans. I thought these might be nests until I was able to inspect the photographs. The pier faces are battered, and the stone rusticated. The drips must have landed where the stone protruded furthest to begin with, and the lime built from there.

There is a row of four putlog holes below the impost stones. In the photo above, a stone has been lost below one of these. Given the unfortunate alignment of the perpendicular joints, was it simply pulled out when the centring was removed? The end holes seem to be blocked. But wait ... elsewhere there are beautifully dressed corbels. It just happens that in the photo above they have snapped off.

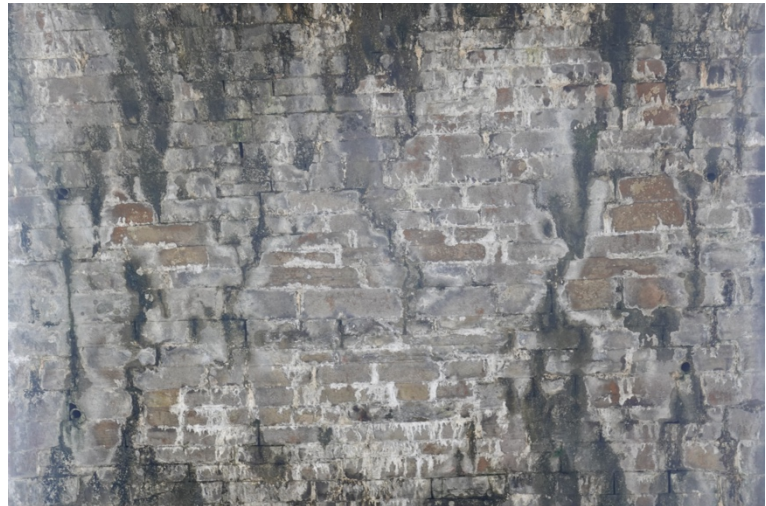
The arch rings are in less than perfect condition. Not terrible, but lots of water flow and clear lines of weakness stepping along perpend joints.

The presence of four drains in that shot is interesting; they weren't visible to me from the ground. The variability of placement confirms the visual impression that these are retrofitted. We're looking at the crown here. There is a definite

increase in flow through the joints to the upper and lower edges of the frame. The drains seem to have been placed rather high relative to where the main flow starts.

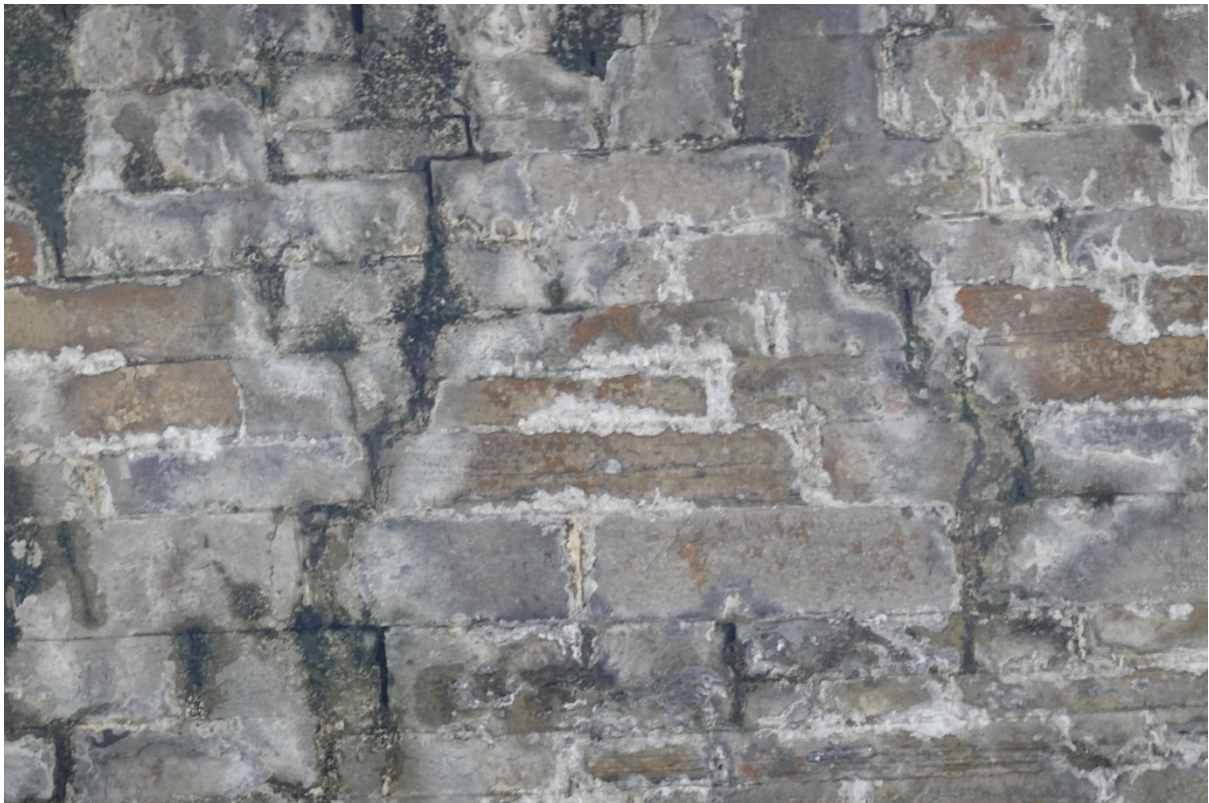
Making sense of the damage would really require getting a camera much closer and building a model. Bill's sony RX100 has a remarkable zoom range though for a carry everywhere camera. The photo below was hand held from 25m range. Interesting that this soffit is not built of neat courses. The masons here worked just as they would build a wall, making the most of the stone that was available. Notice at the top, left of centre, a stone notched to accommodate a step in the course below.

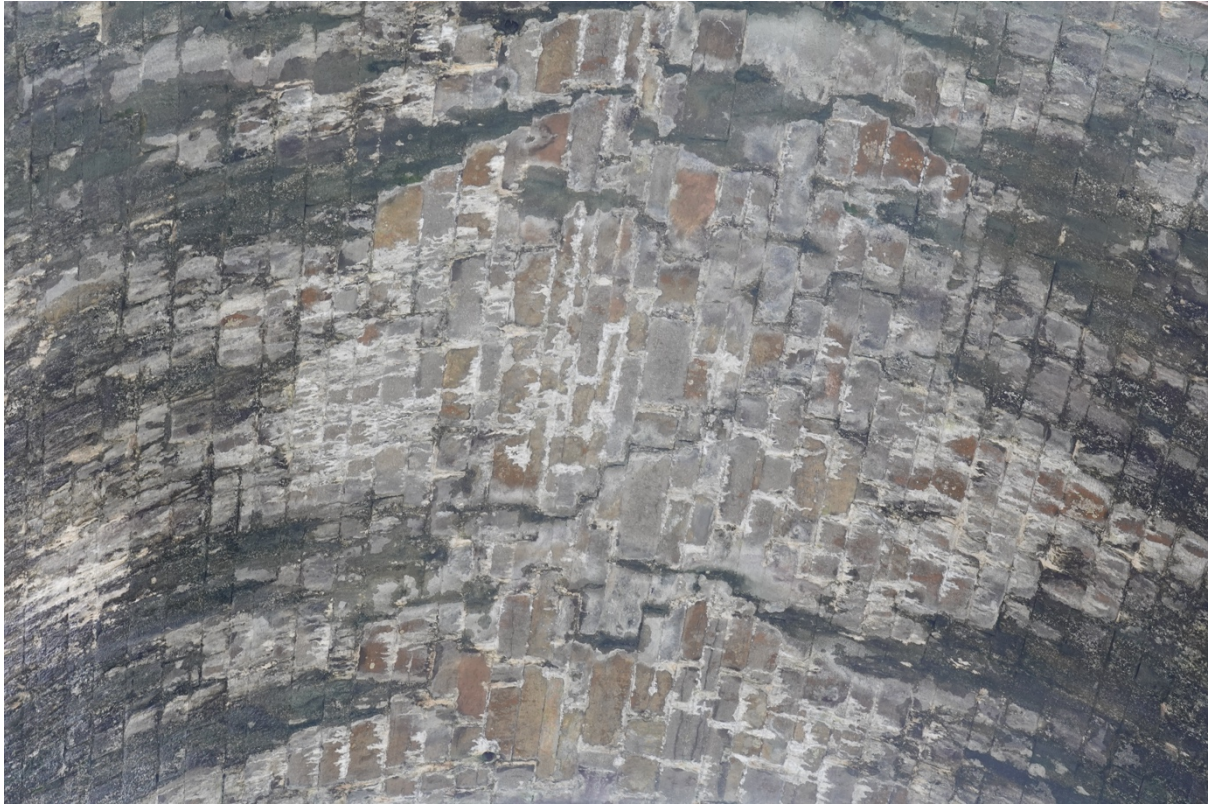
Other spans are similar. Are the striking runs of joints just highlighted by water flow, or is there some movement involved? The viaduct was built for twin track but only the north side track was installed. I would have to visit again to see if there is any indication of a link to loading. The line was built for mineral traffic, but was out of use long before the long wheelbase wagons were introduced that have caused so much damage to viaducts. The suboptimal position of the drain is clearer here.

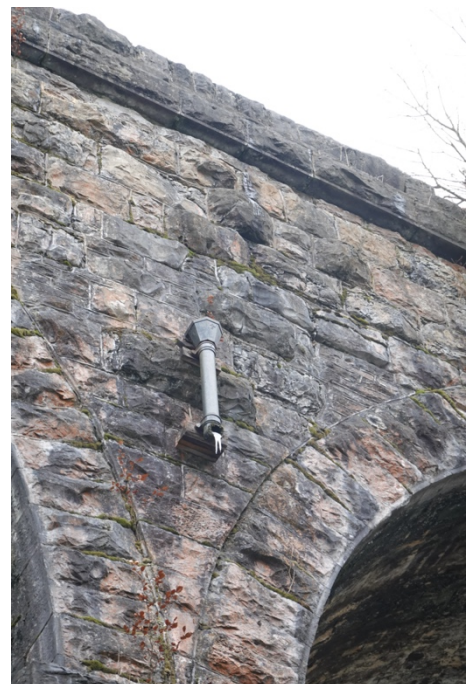
How was the drainage supposed to work? This is an interesting feature. The drainage comes from the pier centres, as is common, suggesting backing sloping down a low point. The position of the drain is very low, so either draining the bottom of a deep internal sump, or there may be internal walls, with drainage from the base of these rather than the top. Whatever happens internally, the flow is caught directed by hoppers into short stubs of drainpipe, then discharged with a half hearted attempt to get it clear of the masonry.

I didn't realise until looking at the photos that these rainwater goods are mounted on timber packers, accommodating the rough surface. There appears to be a stray piece of timber stuck behind the hopper above, and the base is on four packers. I fancy these aren't original; I wonder what preceded them if that's right. How long have the timbers been there? And if the pipes aren't original, is the drain? I haven't seen remains of any other drainage.

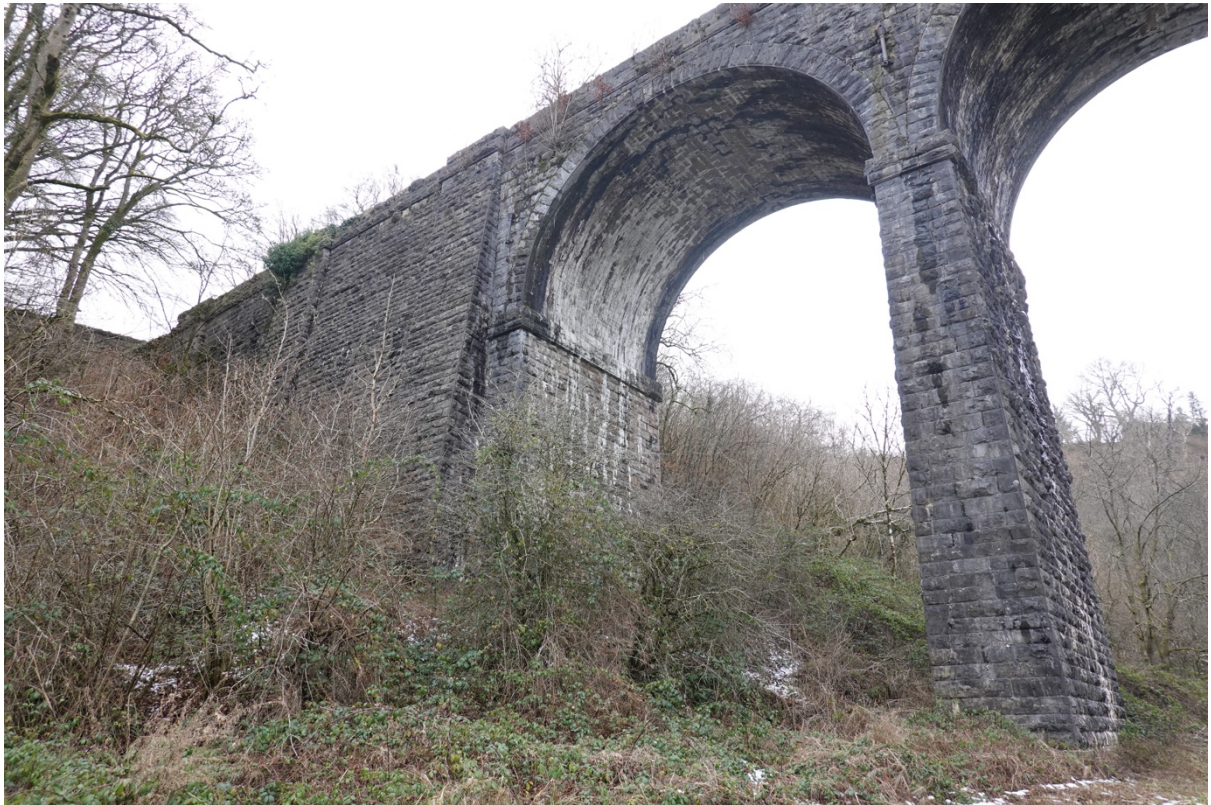
Drainage is provided over the abutment, not universal, but probably wise given the scale of the abutment here. Another curiosity in this view: there are no putlog holes at the abutment.

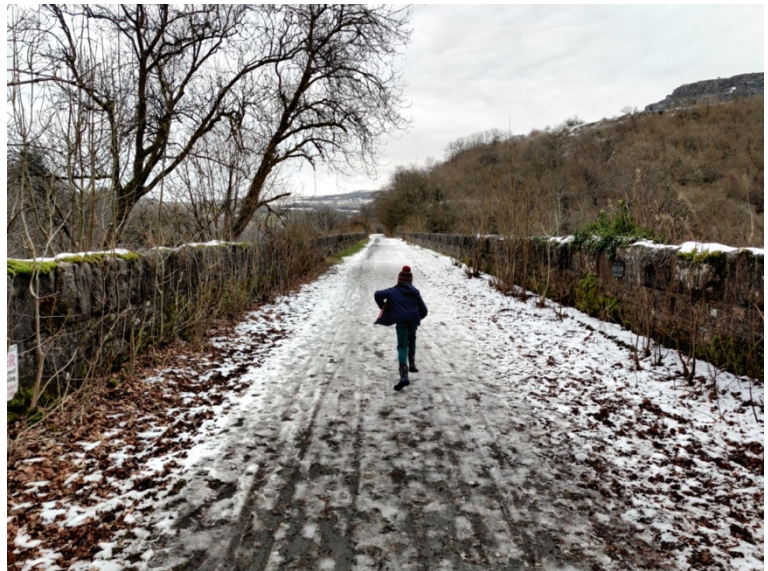
Moving up to the top, after a short break in the pleasant and popular Aberglais Inn, we can see the width, good for two tracks. The scale of the tree growth down the insides of the parapet is quite shocking, given the accessibility.

A stitch in time saves nine, the saying goes, and nowhere is this more true than in managing vegetation on structures. There is real, difficult work to be done here, and it is becoming increasingly urgent.

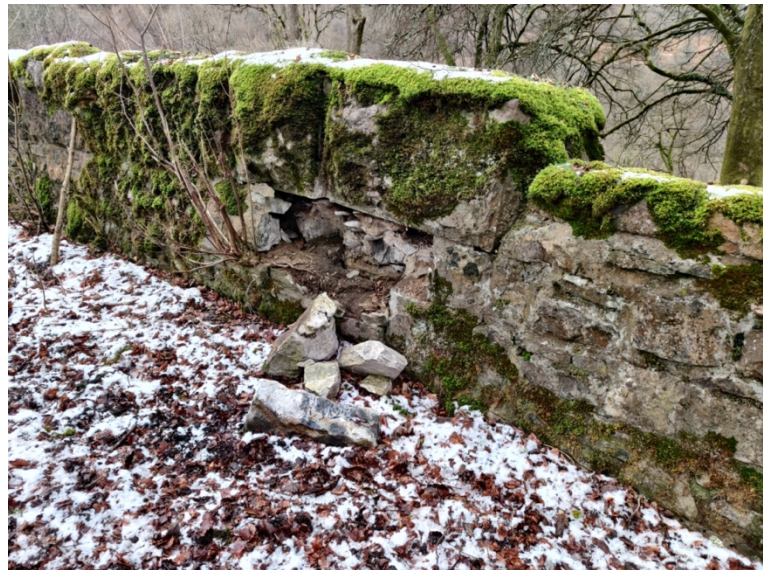
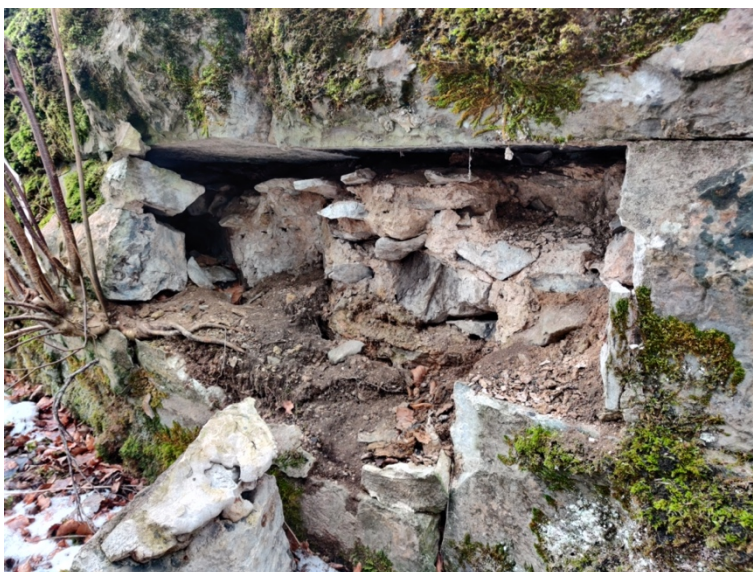
Less positive, the feeling of decline felt from below is borne out with evidence of real damage resulting from neglect.

A close look gives a nice view of typical wall construction, with two faces and a core of shards, mortar, and considerable empty space. No match for the relentless power of unchecked tree root growth.

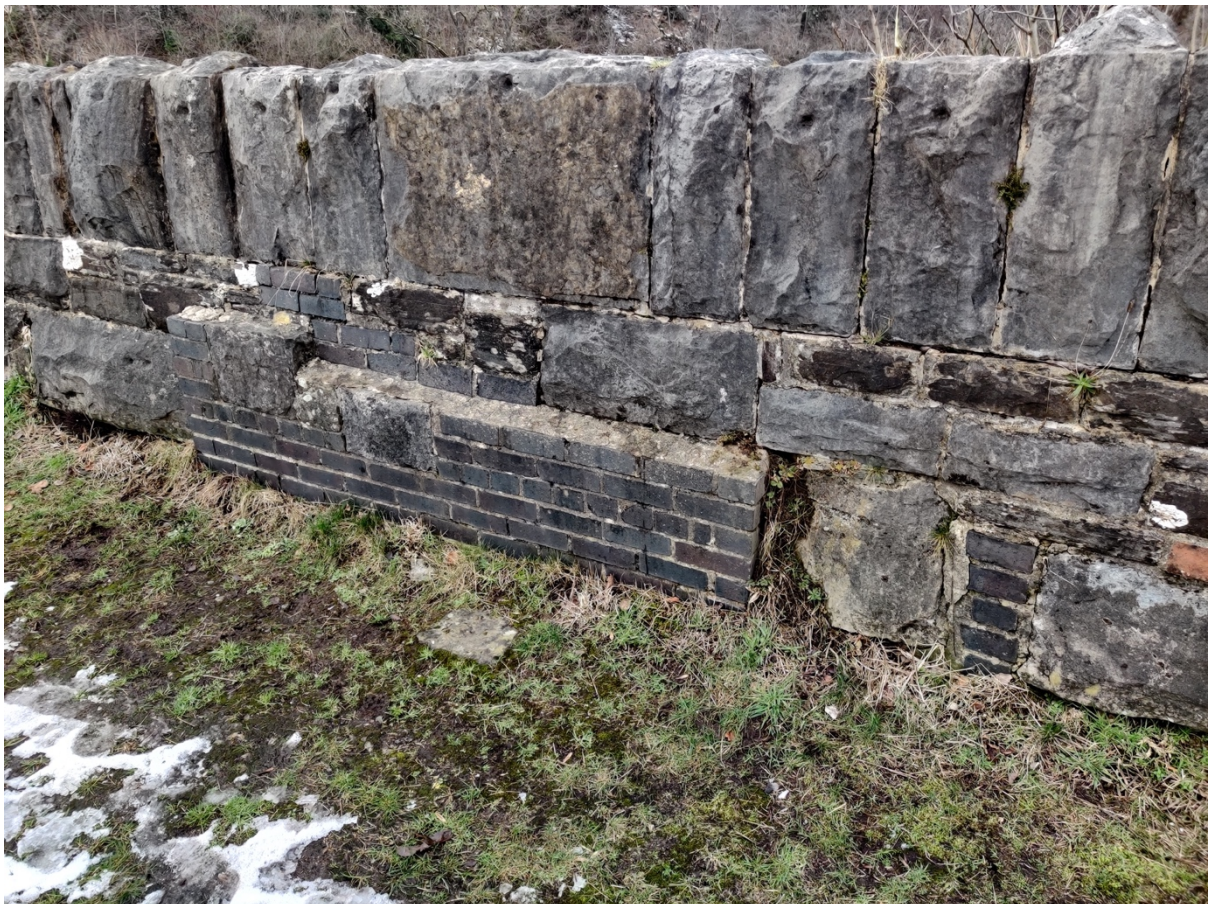
Earlier, rather functional repairs suggest that the parapets were never the most robust, or the best maintained. There are many patches, some in stone, most in blue brick, several proud of the original surface.

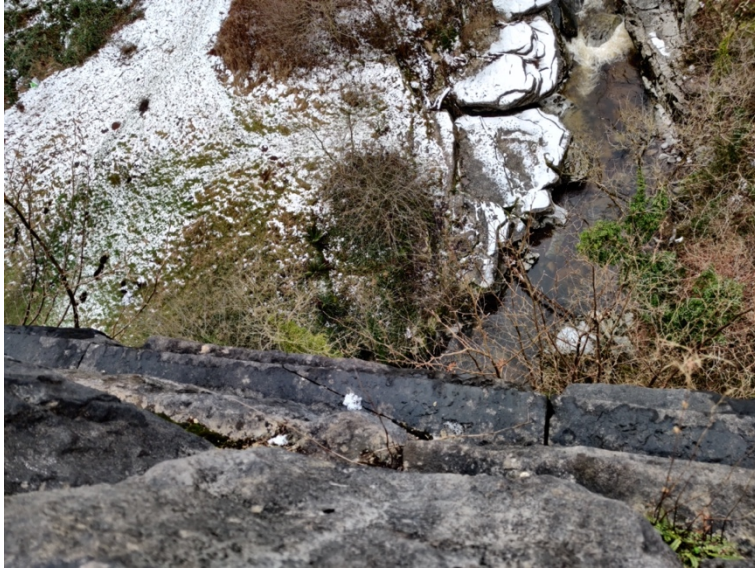
A camera held over the side captures some of the drama of the location, but also happens upon a fractured stone in the string course, waiting to go the same way as that featured earlier.

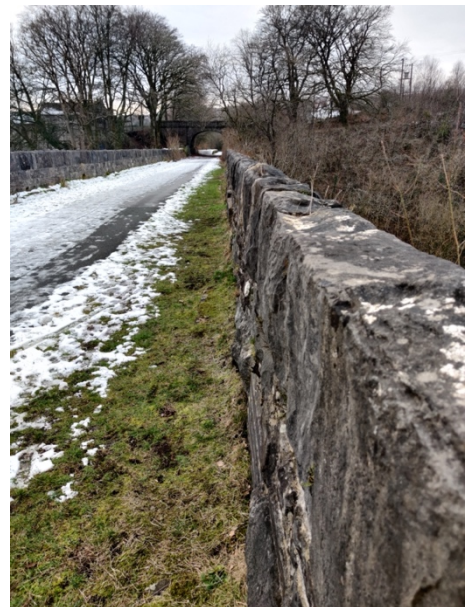
A pronounced outward tilt in the north parapet increases to a point. I confess I didn't check how this aligned with pier or span below. L'esprit de l'escalier.

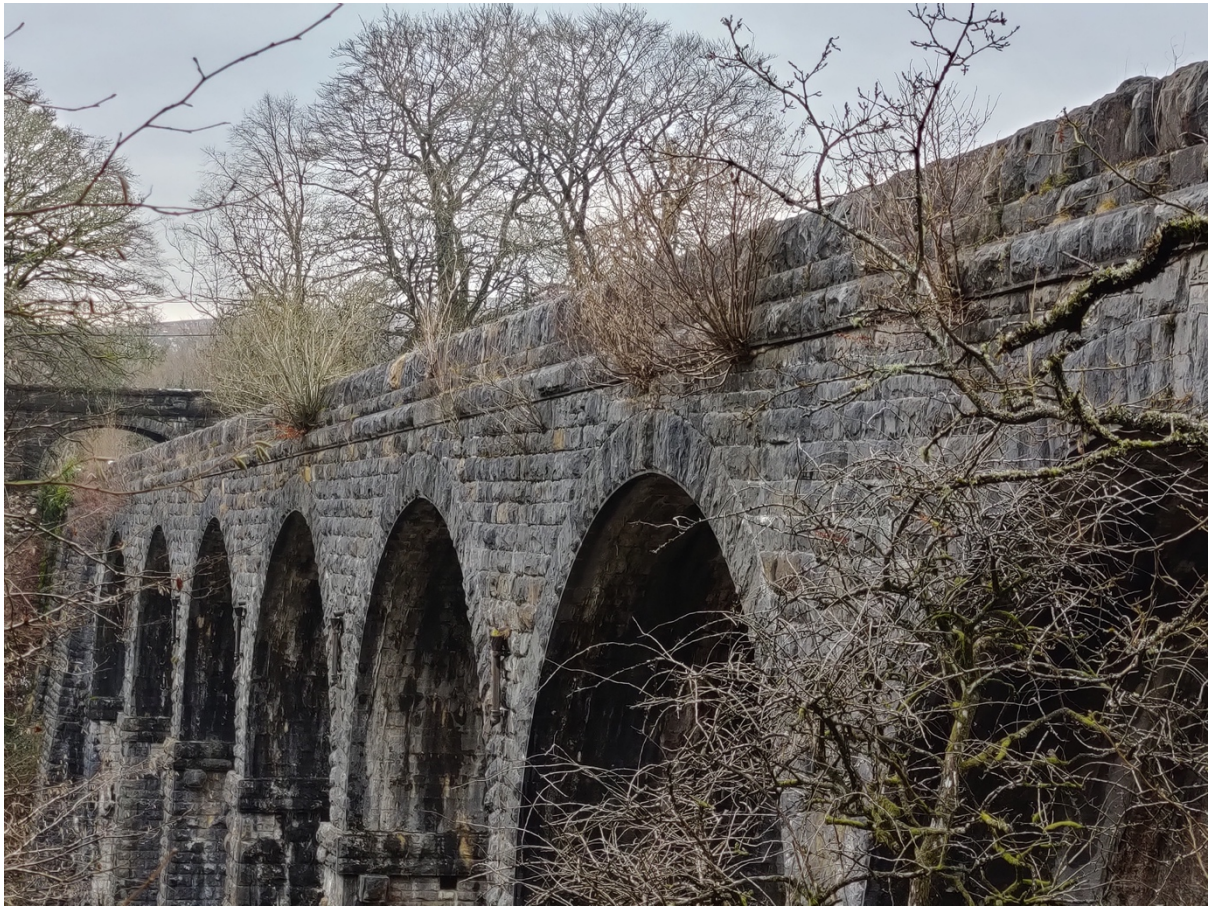
A slightly zoomed view nicely captures the over line bridge to the west, and shows the slope, not previously so obvious. The stone courses are independent over each pier, and meet in a jumble over the crowns. Note again how low over the pier the drain hoppers sit.
