## Bridge of the Month 149, May 2023

### A702/Westwater, West Linton

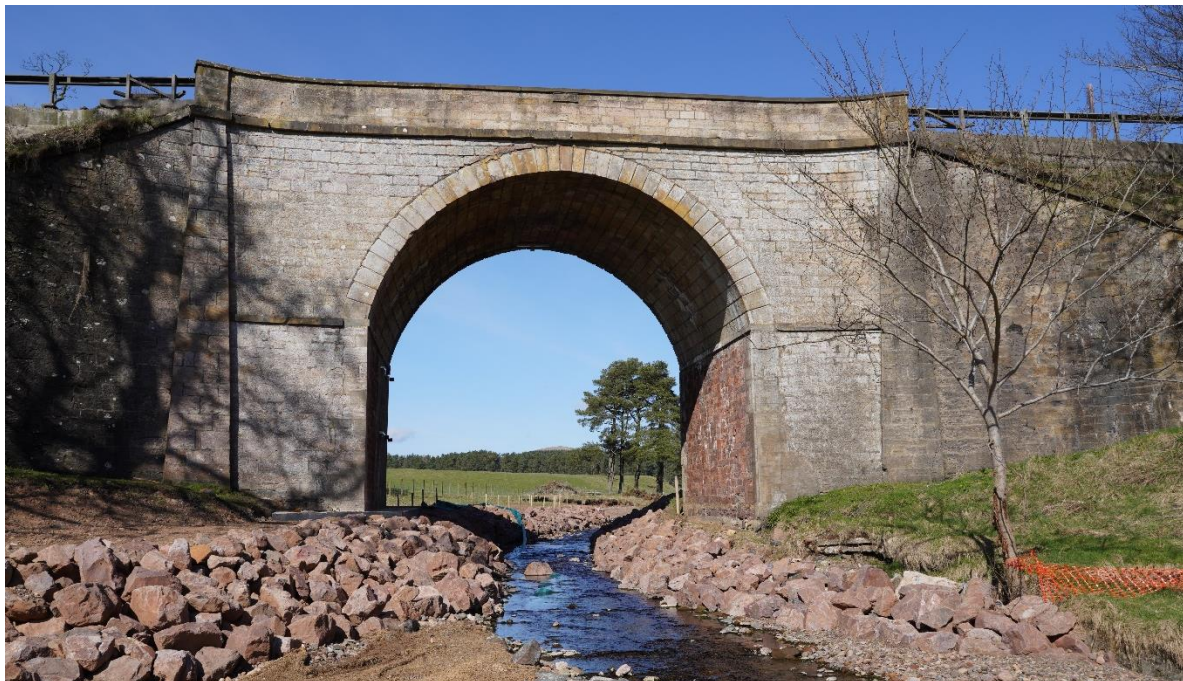
It is a fine bridge in its own right, but of special interest because it was closed by severe flood damage in January 2023. The repair work so far to the river is obvious here. I understand it isn't finished yet.

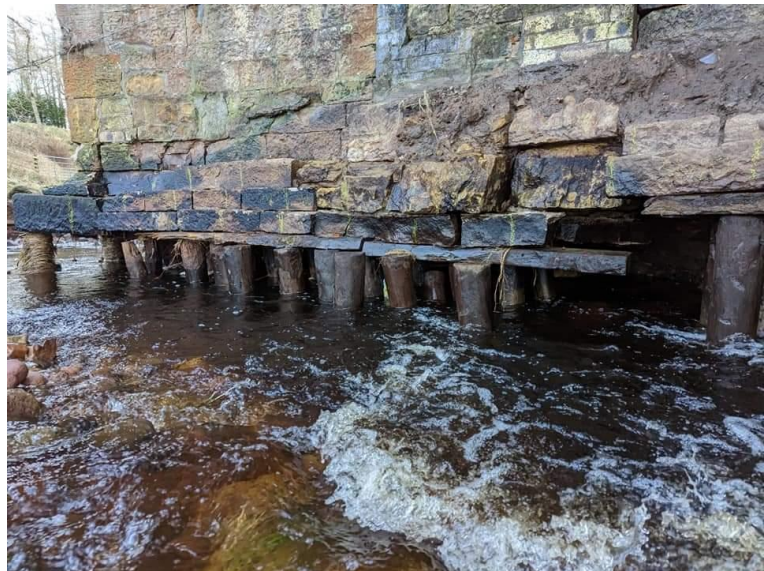
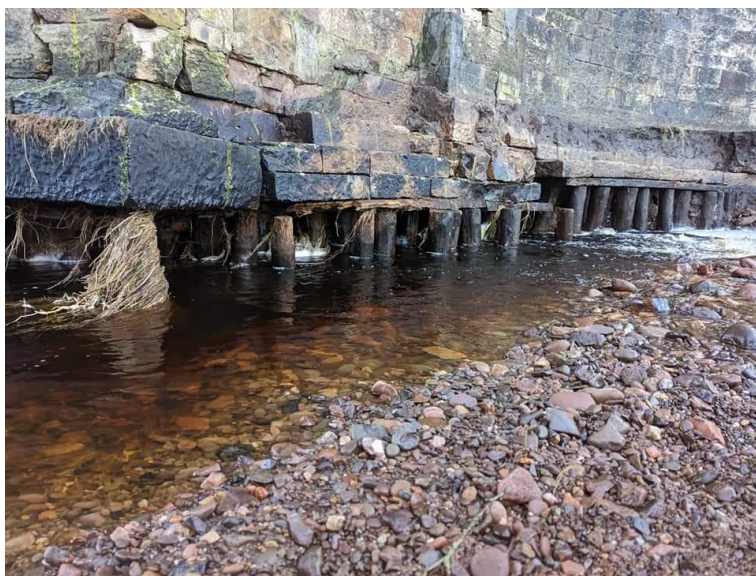
The first view is of the south side of the east abutment. The flood has cut deep, but not quite undercut the abutment here. The remains to the right are presumably of scour protection.

The real interest is to the west, where the water got right underneath the abutment, completely cleaning out the soil and leaving the bridge standing on the timber piles. Not a happy situation, but the piles held up!

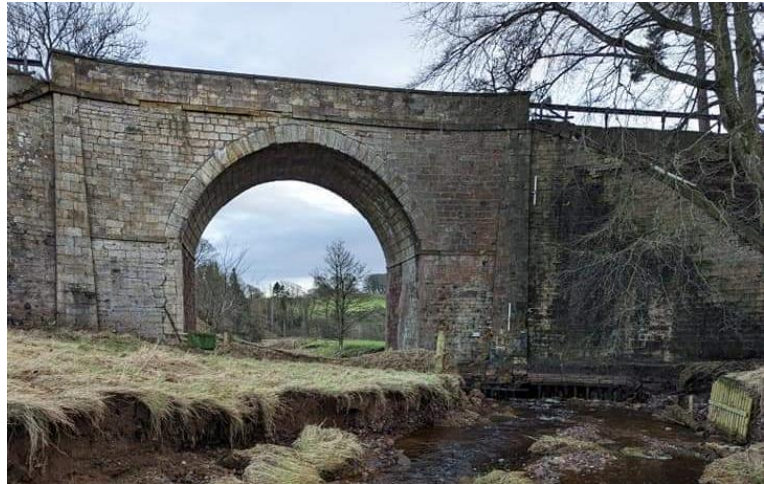
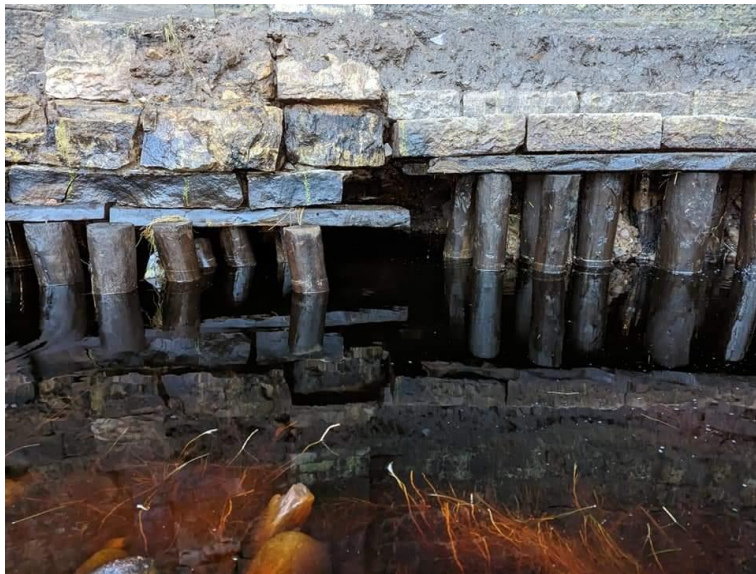
The damage spread a very long way back. The change in top of pile level is the back of the abutment, the rest is wing wall.

Stepping back, we can see that the scour extended most of the way to the back of the upriver wingwall. I don't have a photo of the downriver side.

And lastly from this set of photos, a detail of the interface between the abutment and the wingwall. The perfectly cleanliness of the piles is striking.

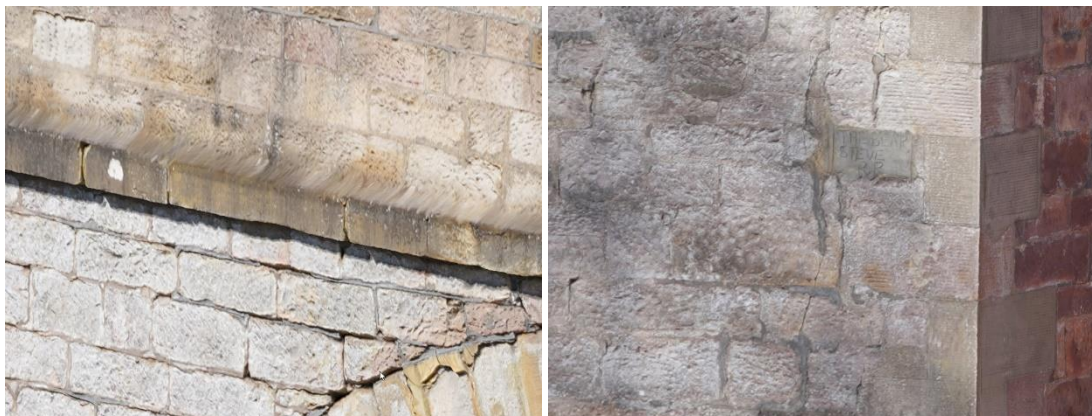
Fast forward to April, and major work had been undertaken. If anyone can fill in detail here it would be great. From external appearances, the void under the west abutment has been flooded with concrete/grout, and the river channel defined by rock armoured banks.

I had no pole, so all modelling photographs were handheld from ground level. As a result, detail drops off with height, and upward facing surfaces are not captured. Details from high and low illustrate this.

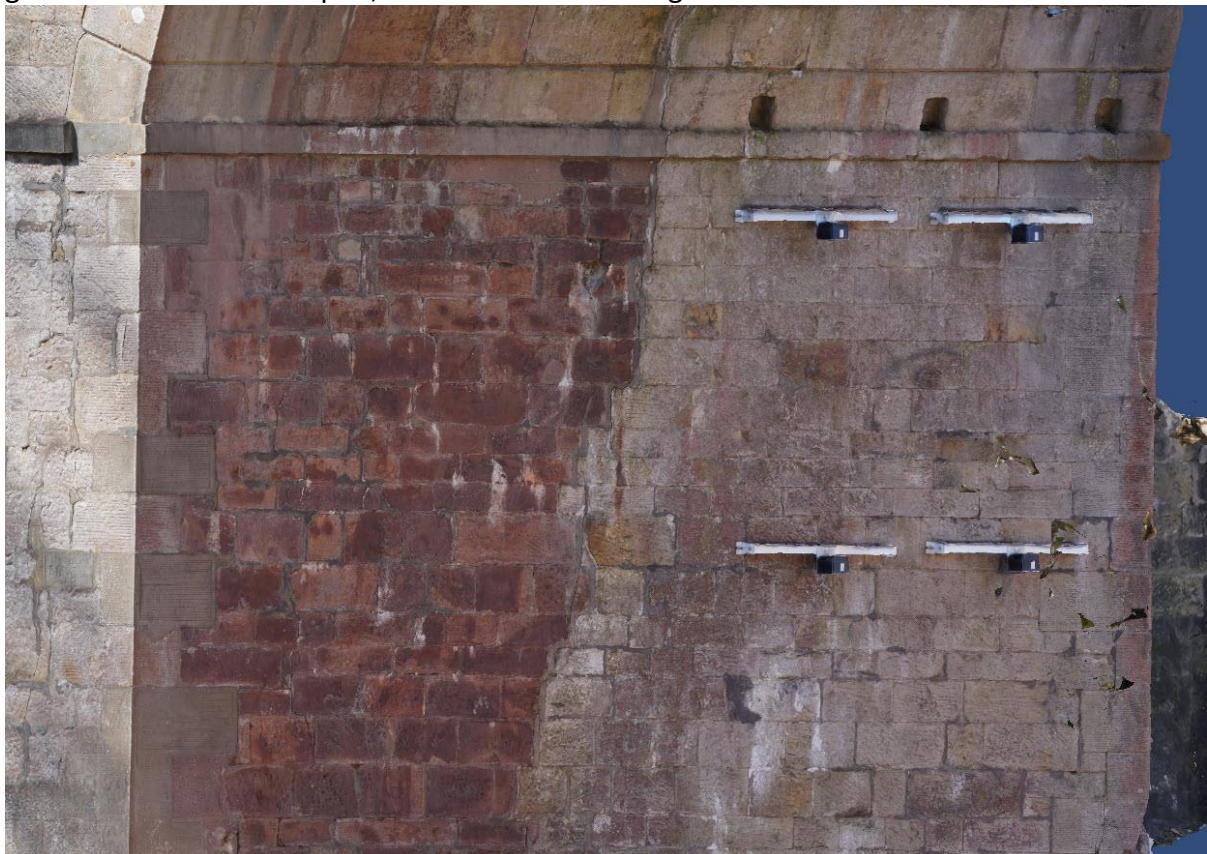
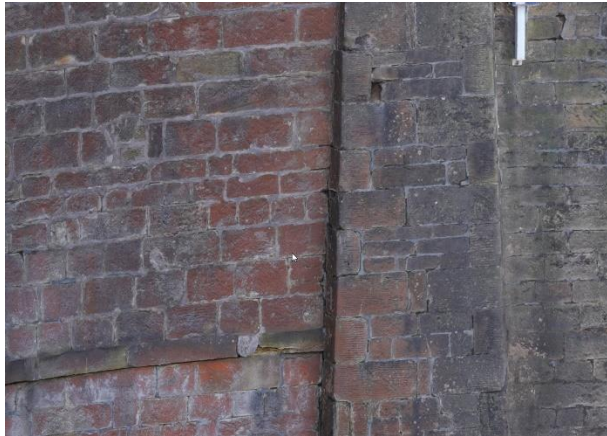
The west pier appear to have been built in two parts. The north side has putlog holes at the springing, while the south side does not, and the colour changes around mid width. This change is not at a defined vertical line, but tapers out towards the southeast elevation at ground level. Was it a repair, rather than a widening?

It is perhaps too easy to think that the colour change is a change of stone. On the northwest elevation, there are marked changes in colour that appear to be a result of growth of different algae.

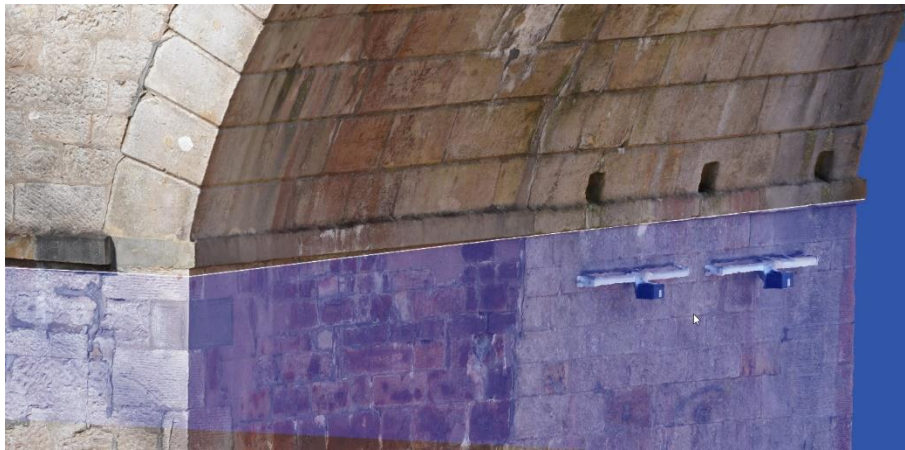
The string course at the springing shows a clear difference in slope. Absolute slope is uncertain, see earlier discussion, but change like this can be trusted.

The crack extends past the springing into the arch. It can be traced to the crown, continuing to trend slightly in the same direction.

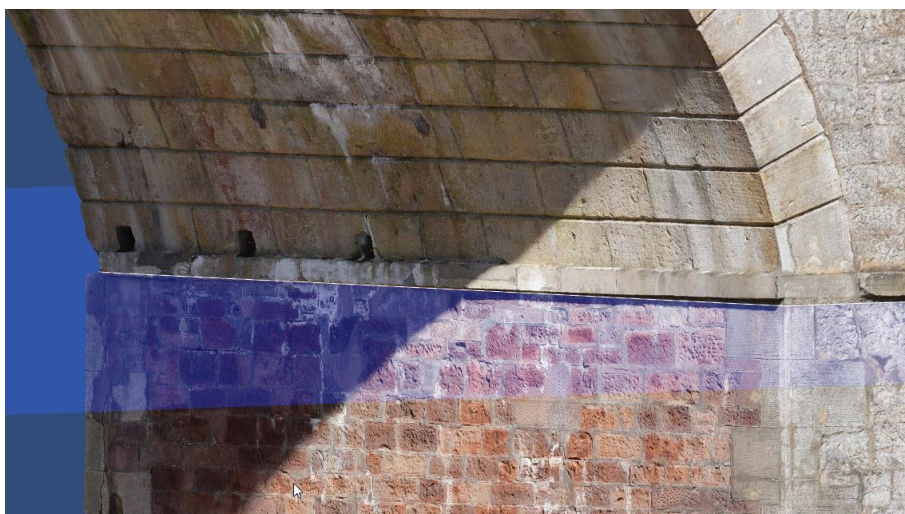
The same pattern is found at the northeast springing.

This abutment face shows no obvious signs of reconstruction. Perhaps none of it was – or all of it. Sliding the plane down shows that the change in slope is present through the height at the southwest, but isn't visible in beds at the northeast.

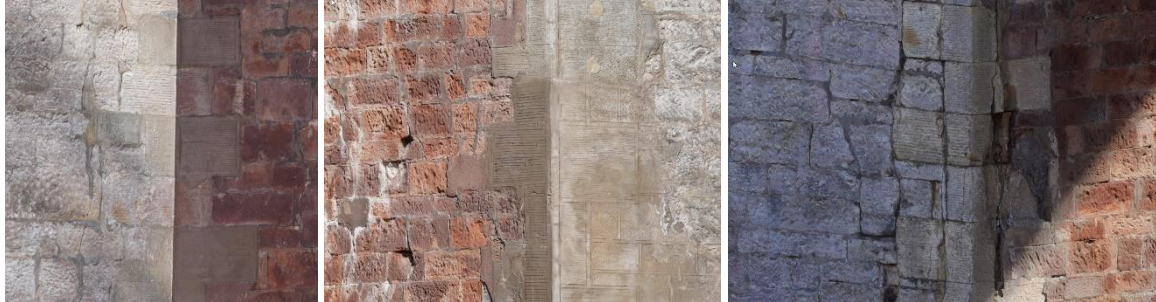
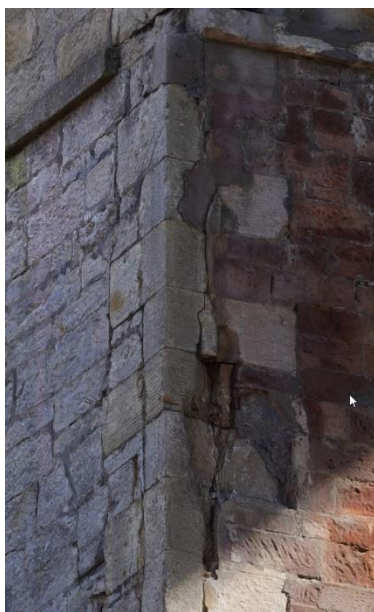
Three abutment corners show vertical cracking, or repairs in the form of stones replaced with mortar, or both. Interestingly the one with no similar damage is where the worst of the scour took place.

The northwest corner of the northeast abutment (far right above, repeated left) is least patched, but most damaged as it stands. Whatever the movement is here, it is causing significant damage in the cracks, with spalling of the crack corners and beyond, some areas filled in with mortar. The image to the right is the same view in false colour, highlighting changes in surface angle and thus local damage.

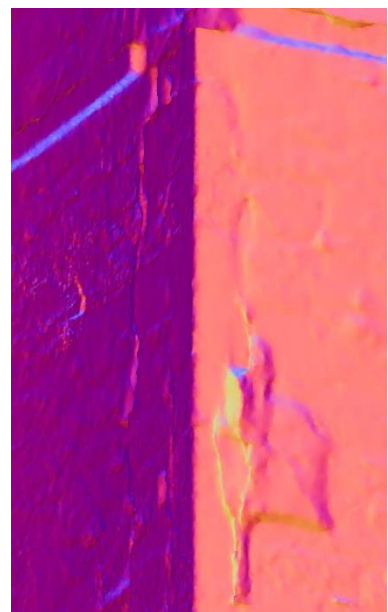
Cracks to the soffit inside each spandrel wall, and damage and old pointing above the ring over the crown, suggest some load related damage. This is common damage, of course. It is not a strength issue, but a result of differential movement between the flexible arch and stiff spandrel. Thus “strengthening” won’t do anything to help.

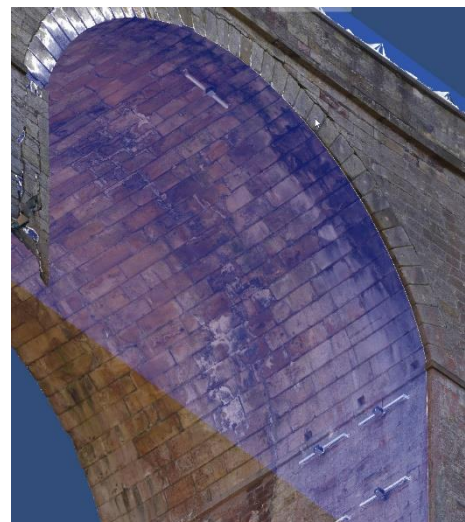
If we set a vertical plane on one elevation, then move it to the other, it is clear that the faces are not parallel. Note, right, how the plane (set on the other elevation) grazes the elevation at the near springing, but cuts well back at the far side. The divergence starts at the crown and develops to the far abutment.

The crack in the southwest abutment is fairly wide. It is filled with mortar, and has opened again since last pointing. We can’t tell whether the reopening took place as a result of the flood, or whether it was simply ongoing. The latter seems likely. It will be interesting to see whether it continues after recent works. Interesting enough, I think, that it deserves a few [Moiré Tell-Tales](#).

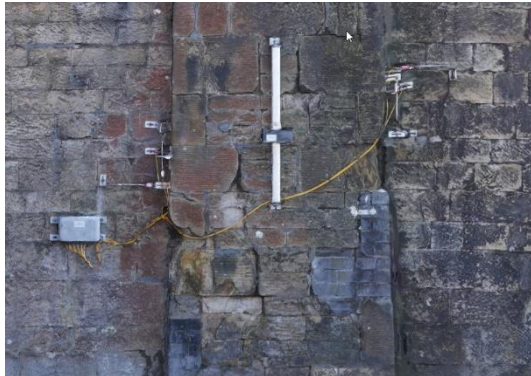
There is some wireless monitoring equipment installed, which will be sending readings off site on a regular basis. Monitoring equipment is expensive (though probably not as expensive as its installation), and decisions and compromises must be made about what to measure. What is measured often gives an indication of concerns.

The most intensive monitoring is of the rear pilaster/buttress at the west wingwall, and the wall behind. The pilaster has 3-dimensional displacement measurement in front and behind, and a vertically oriented tilt beam at the same height. The wing wall just behind the pilaster has a vertically oriented tilt beams near the top.

The obvious concern here is that the pilaster has separated from the wall behind and moved out, and it can't continue doing that indefinitely

without collapsing. The damage below this instrumentation doesn't look entirely fresh, so this isn't all a result of the recent flooding.

The vertical tilt beam is measuring tilt very locally. It would be quite possible for this section to move outwards without changing tilt much, and certainly without showing any consistent change. Data from the tilt beam alone would not indicate what is happening here; the deflection measurement is needed.

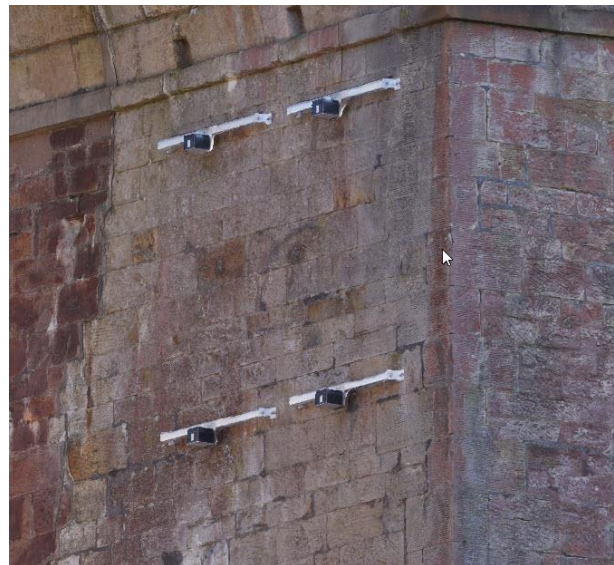
The other area of intensive monitoring is on the right half of the southwest abutment face. There are 3 no. tilt beams here. All are placed on the same face, all horizontal. That means all 4 are configured to measure tilt across the bridge width. The tilt meters may be 3-axis, but the beam is designed to give an accurate tilt over a reasonable gauge length (1m is still quite short for many purposes). If I wanted to know what was happening to this piece of abutment, my inclination (see what I did there?) would be distribute tilt beams round the corner, and to have some vertically oriented, to get the best possible measurements in all 3 axes.

Unless there is a particular concern about differential tilt between these pairs of beams, I would prefer longer beams.

Given the history of differential movement between the two halves of the abutment, I would really want measurement of the other side too, and across the crack.

Tilts are always only part of a story. I would also want to be able to track relative vertical movement of the four corners. That is a very difficult thing to do – more or less impossible using online monitoring. Robert Thorniley-Walker's "movement gauges" are the only tool I've come across that might help. They allow measurement of differential movement to about 0.1mm using a standard level. The web site is down at the moment.
