Bridge of the Month 151, July 2023

Another bridge near West Linton

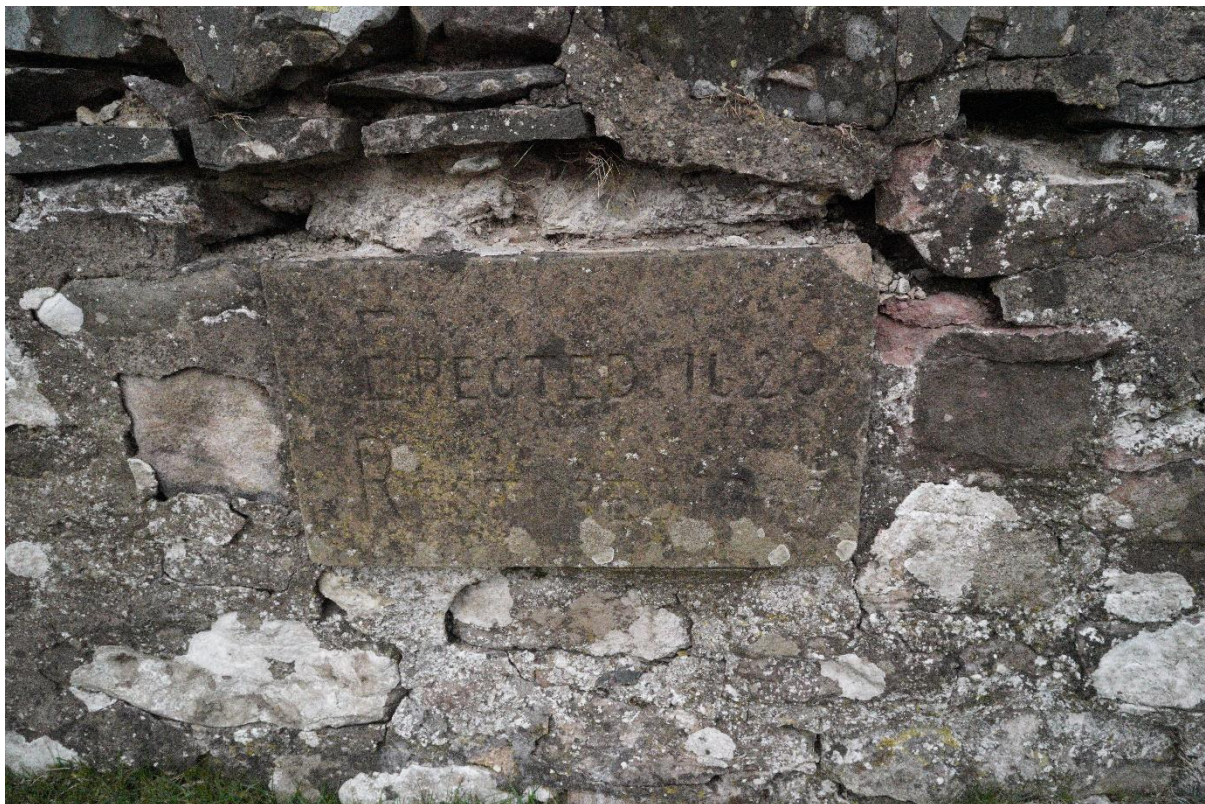
A plaque in one parapet claims the bridge was originally built in 1620. This was presumably added at the second date of 1892. There is no way of knowing what, if anything, is original.

It will be clear from the voids above that plaque that all is not well. I seem to have concentrated on photos for modelling and not acquired any sensible overview photos here. The best I have are partial and at jaunty angles. The downriver elevation looks fairly sound.

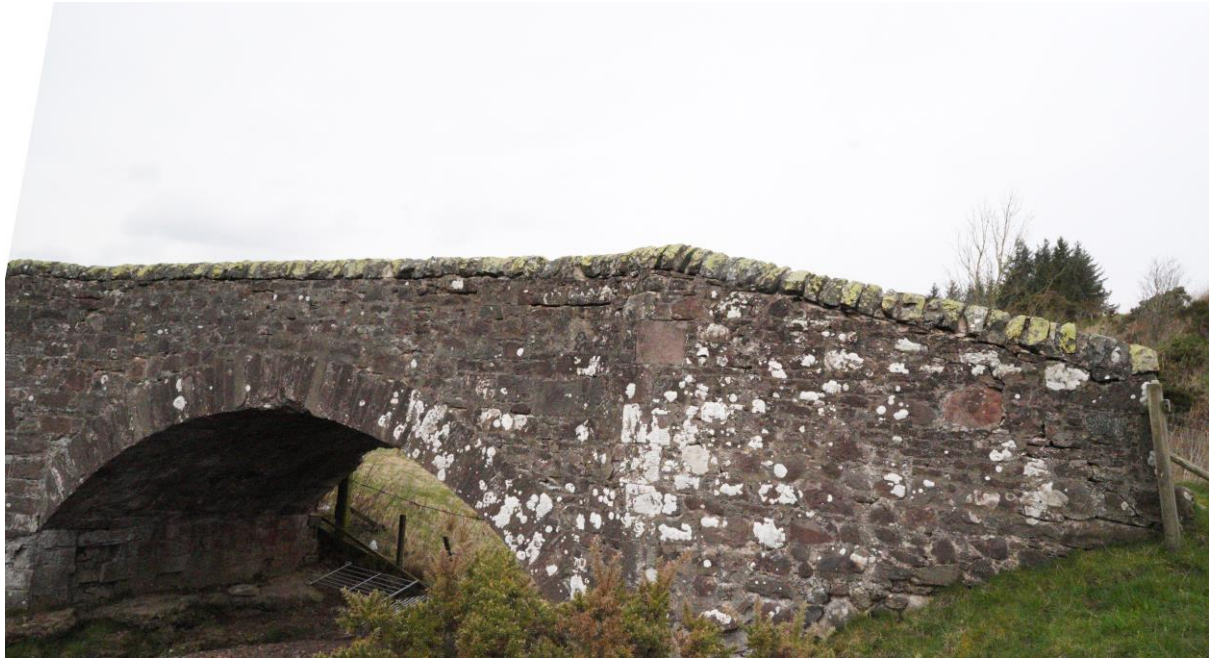
The upriver elevation not so much.

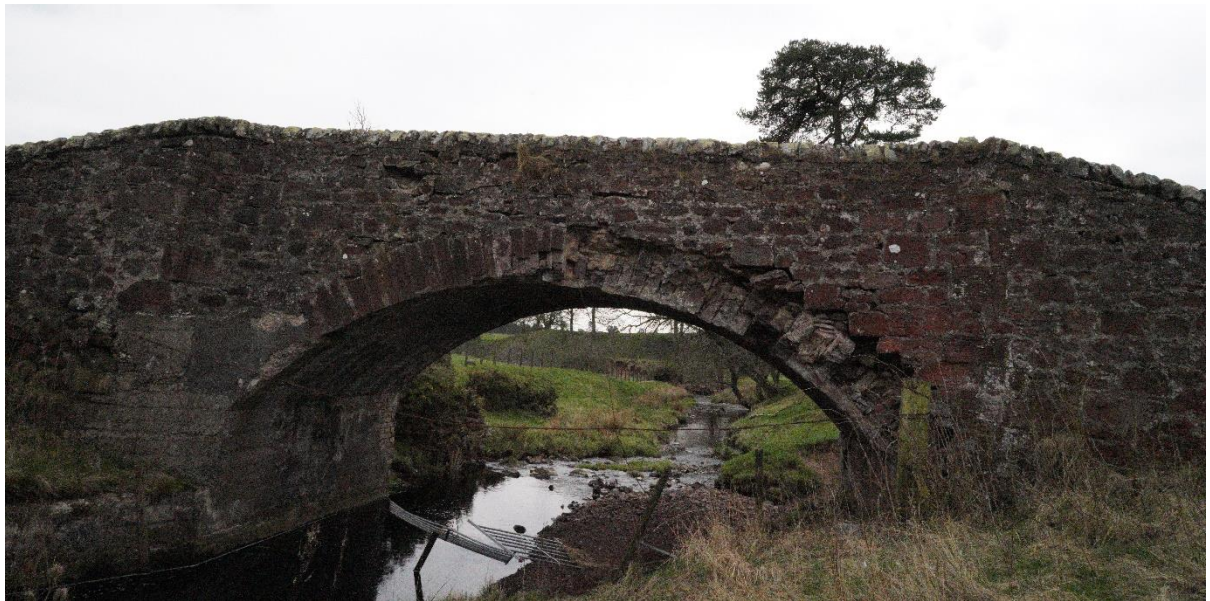
Notice also that the left abutment and lower wing wall is concrete. The flow is still hard on that side, so presumably there was severe scour damage here in the past.

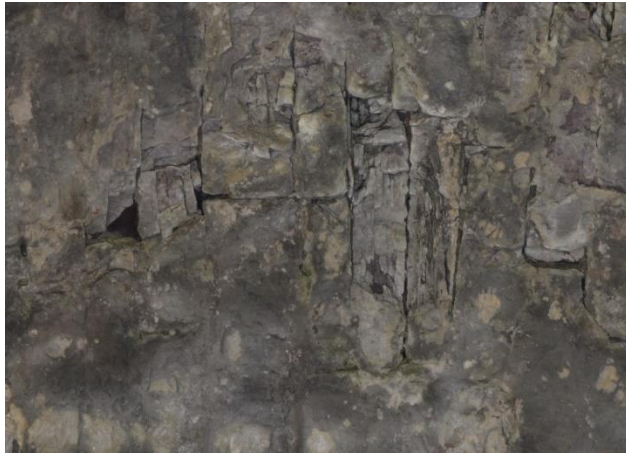
The stone probably wasn't "all that". There are many stones trying to break apart.

It looks as if earlier loss of surface material has been covered over by mortar, which probably won't have helped in the long run.

As well as the concrete abutment, both ends of the ring have been re-skinned with brick. It's not absolutely clear, but I suspect different brick, so different dates. Here at the left bank, the brick repair to the abutment corner presumably predates the concrete.

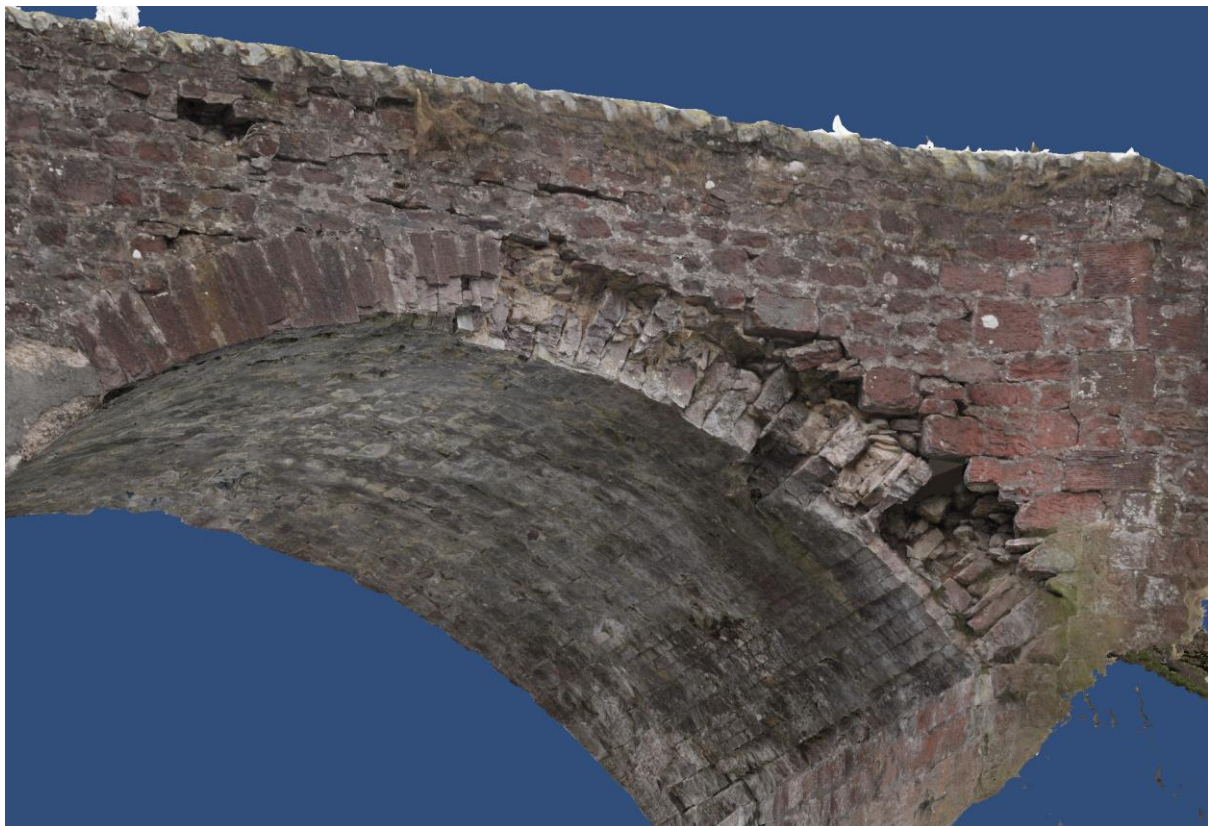
Above the right quarter point in the photo above, where the edge of the ring has gone, part of the inside face of the parapet has fallen off too. Possibly related, possibly not. Notice the rubble inside.

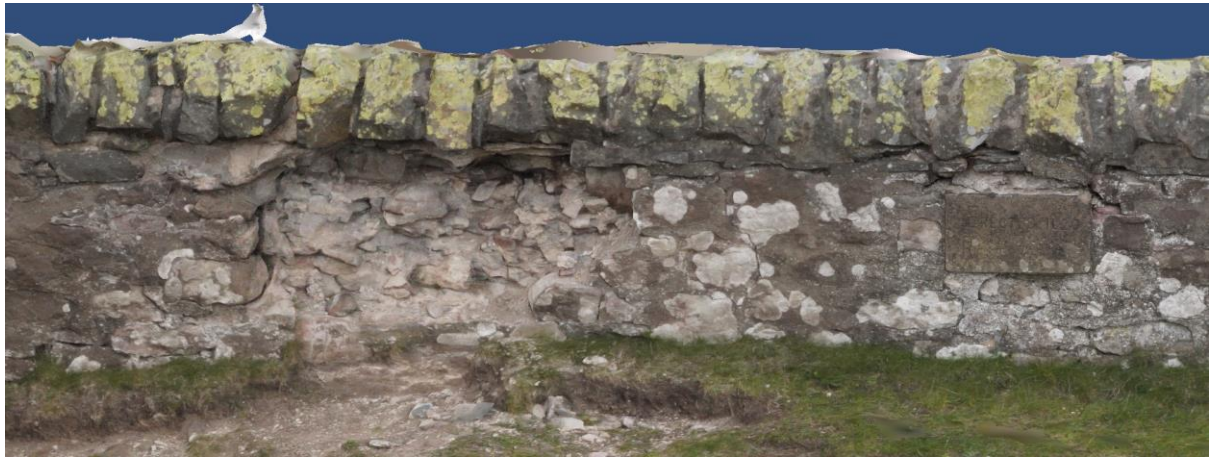
And speaking of rubble, the ring damage gives us a glimpse of the backing. The stones of the ring are broken up, and it isn't clear that they were all originally through stones. But in the nook above the ring and behind the spandrel/wingwall the unshaped rubble backing is visible.

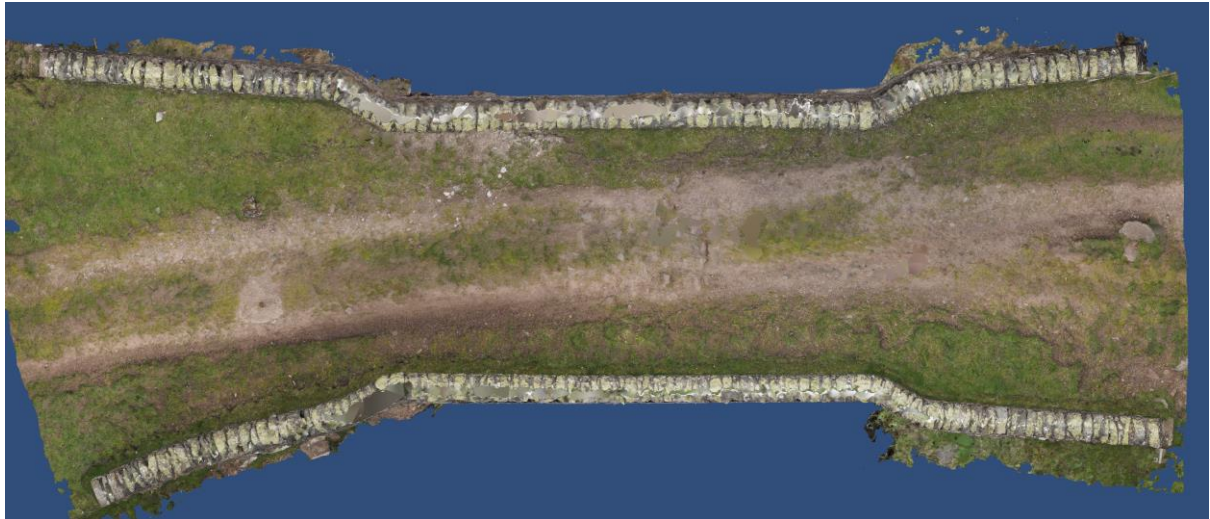
I nearly forgot to include a plan view (above). Notice the unusual plan shape of the wingwalls, with a sharp initial flare than a more gradual widening. To encourage recalcitrant cattle into the gap?

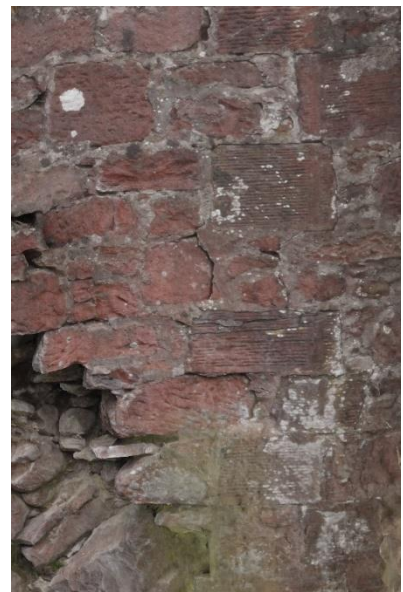
The flare closest to the bad ring damage is cracking (right).

There is no sign of it at other corners, so this is probably just a consequence of the nearby movement and loss of support, but plan shapes like this are prone to damage that doesn't normally affect masonry bridges too badly. Recently I've seen damage in a step in parapet – sharper than this one – and outward leaning wing walls that I suspect are driven by cyclic movement causing ratcheting effects.
