Bill Harvey Bill Harvey Associates Ltd and OBVIS Ltd

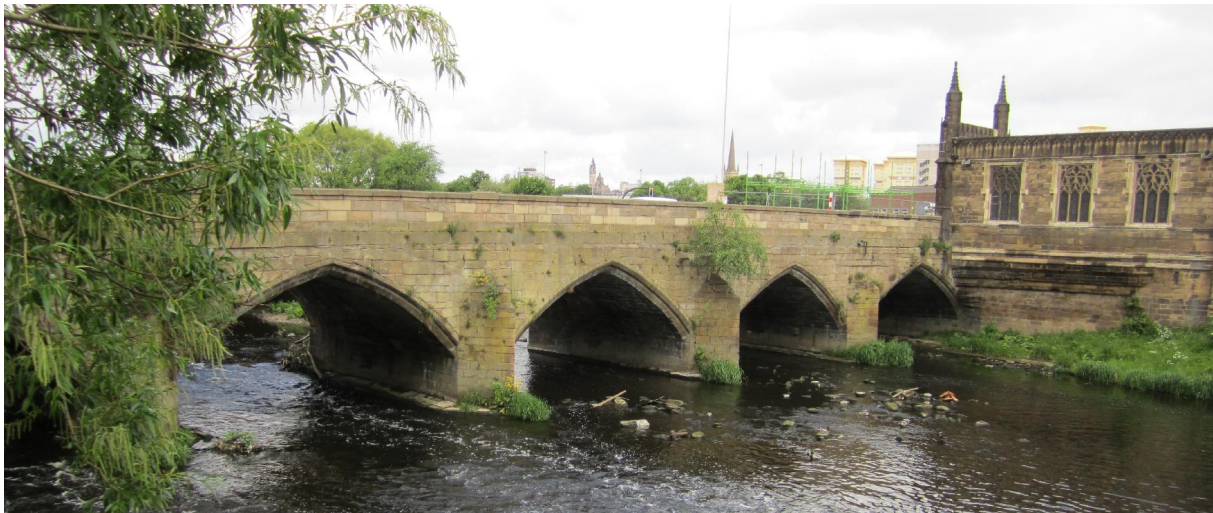
Here are 4 spans of the 9 spans. There is another hidden behind the tree and four north of the chantry chapel which actually partly blocks one span. These five arches have flat soffits whereas the four northern ones have ribs (see below). This surely indicates an element of reconstruction of even the earliest parts.

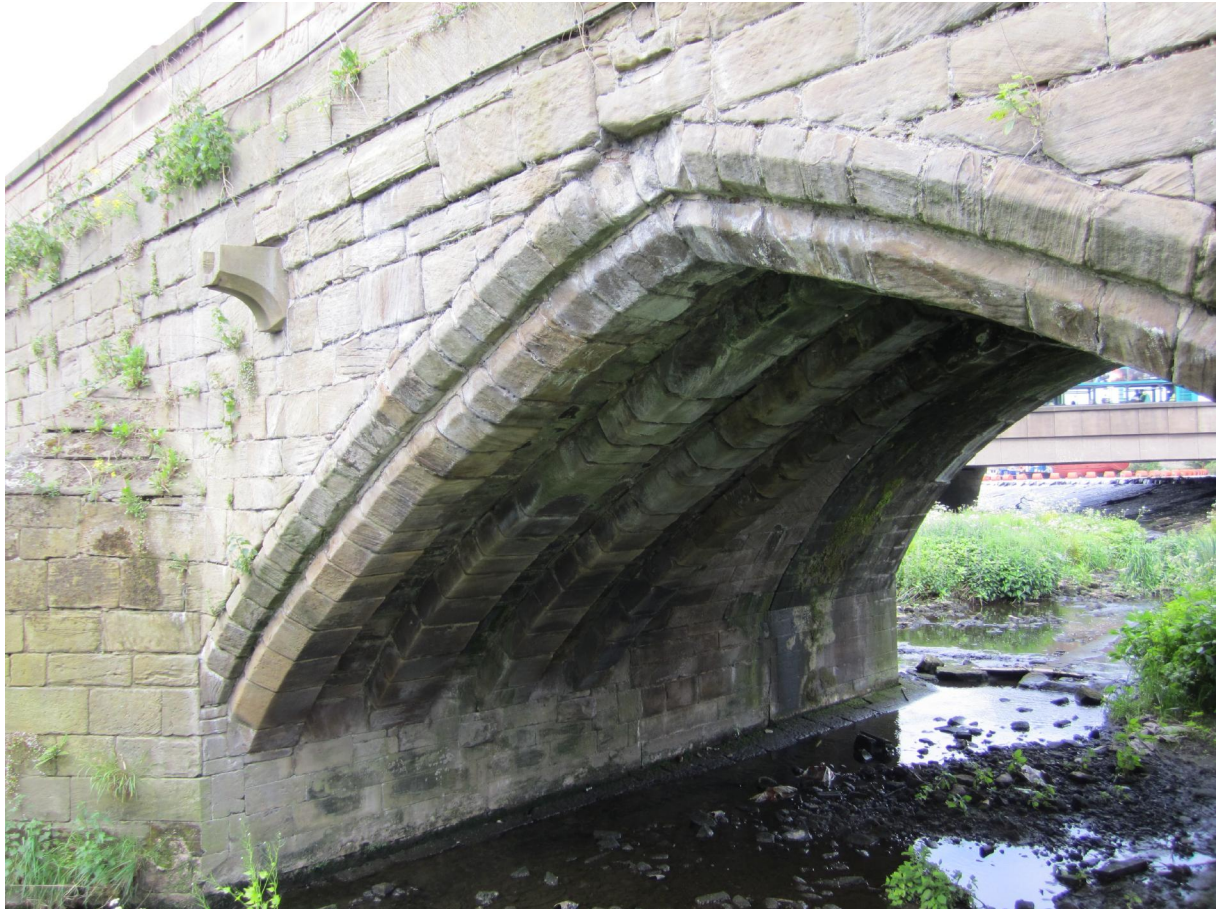
This shot shows the ribbed arch which is likely to be original. It is also quite badly distorted and seems to me to be suffering from neglect of the structural elements.

The ribs seen here are chamfered on the outer edge but square in the middle. If the ribs and gaps are equal (as they appear) the width of each will be 18in (450mm) with a 9in edge (225mm) corbel chamfered by 6in(150mm). The other dimensions then suggest that both the ribs and the arch are 9in thick.

It seems likely that the arches were originally two circular curves, meeting at a point. The picture above shows that there has been considerable movement in some arches. This one is very flat at the quarter point and the erosion has concentrated mortar loss where the curve is minimum. Some repointing is needed to avoid loss of stone in the next flood.

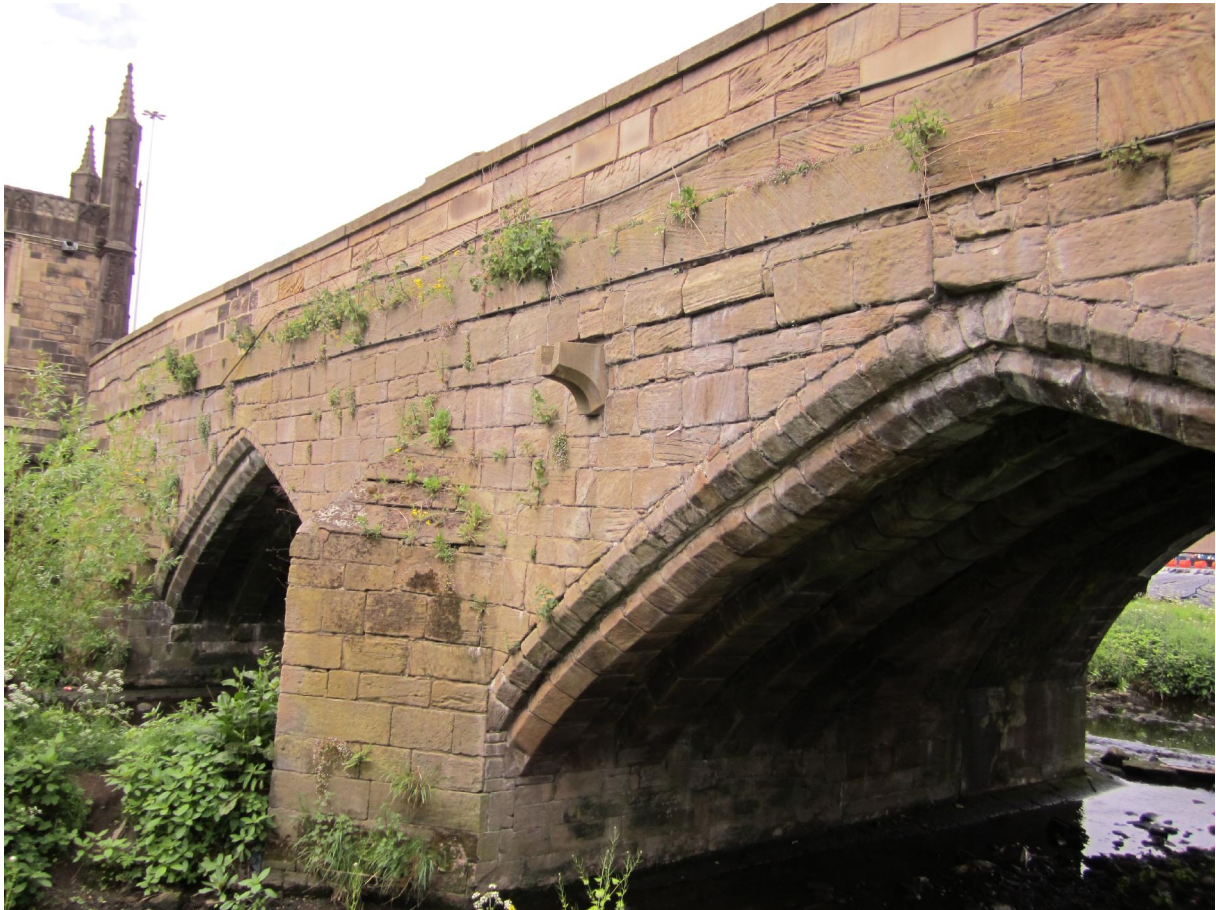
Here, there are obvious signs of earlier distress, and also of previous basic configurations. The original stonework is coursed making use of different bed thicknesses in the quarry and carrying each bed through the whole bridge. This was typical of the imported cathedral kits that were brought over from Caen. Tracing the courses through this picture we can see:

Below the parapet, a hard edged string course that almost certainly dates from the 18th century widening.

Below that is a string of deep stones with a chamfered top edge. This might be the original string course or possibly the top of the original low parapet.

Next comes a stepped course, broken at the water spout but with a make up layer on the near side.

From there down, the courses seem to continue through the pier but break up and stagger to this side of the spout.

It looks very much as though this pier has partly failed and tilted a little. Whether that was caused by loss of the span or whether the span simply distorted to accommodate it, the outcome is a distorted arch and a patched spandrel. The fact that the pier does not seem to have settled suggests that the span might have been lost and the pier tilted before it was restored. However, the shape of the arch itself and the mortar loss in the ribs around the quarter point might point to the arch remaining in place but distorting substantially.

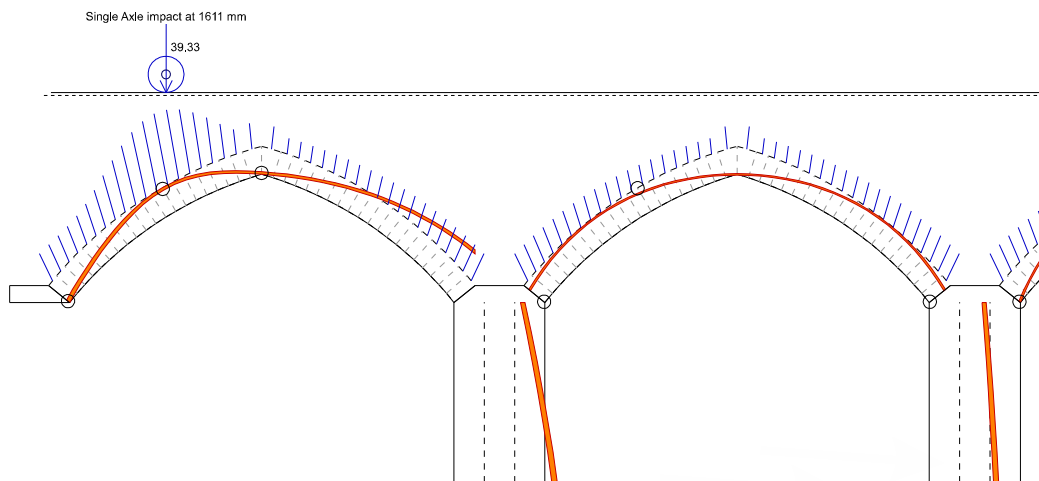
Loading with a single modern axle and balancing the thrusts as best I can shows the bridge rather weak without any backing. In this form, the left hand span would probably collapse as a result of tilting rather than collapse of the pier.

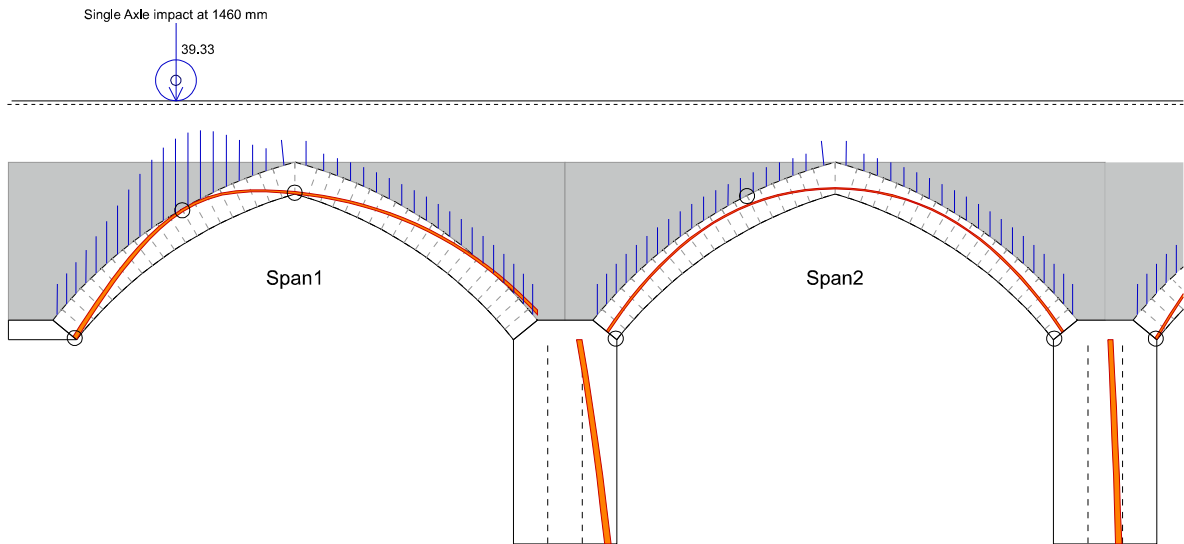
With backing, stability is much easier to achieve.

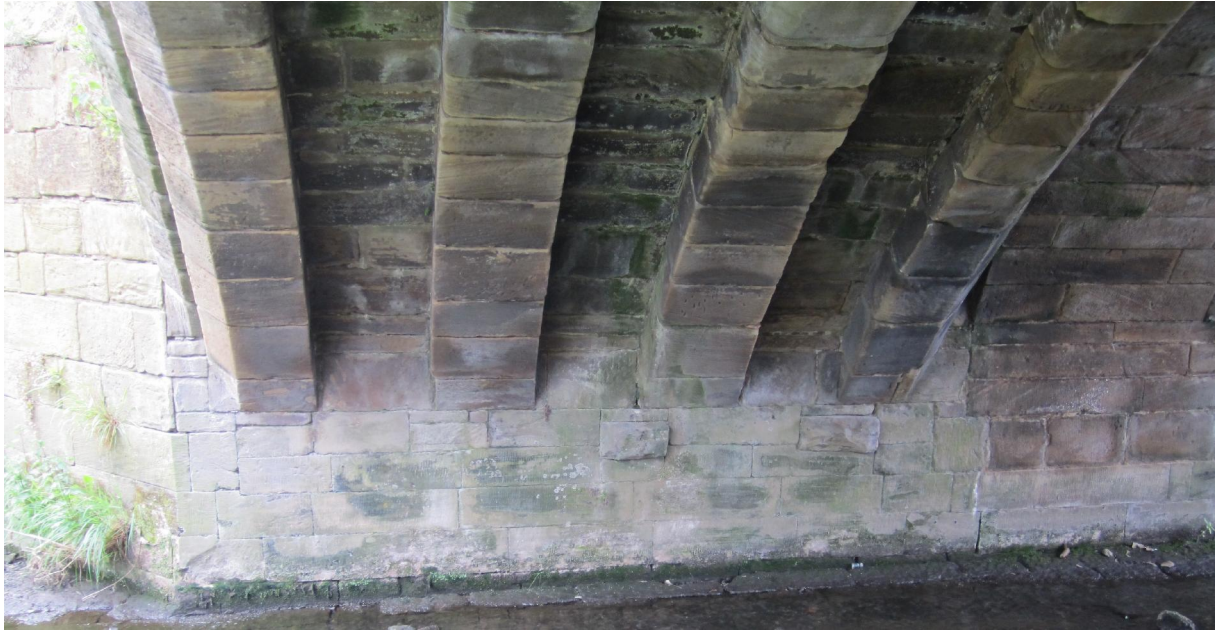
The picture above shows corbels (some broken off) for support of the centring, though it is hard to see why they would be necessary on such low piers. The fact that they do not line up with the ribs raises further questions! Below, it is easy to see how the widening was accomplished. On a closer look, both above and below, the river bed seems to have been paved. No doubt this would provide a good deal of protection against scour, but it would have been expensive and quite difficult. It is probably 18th Century work.

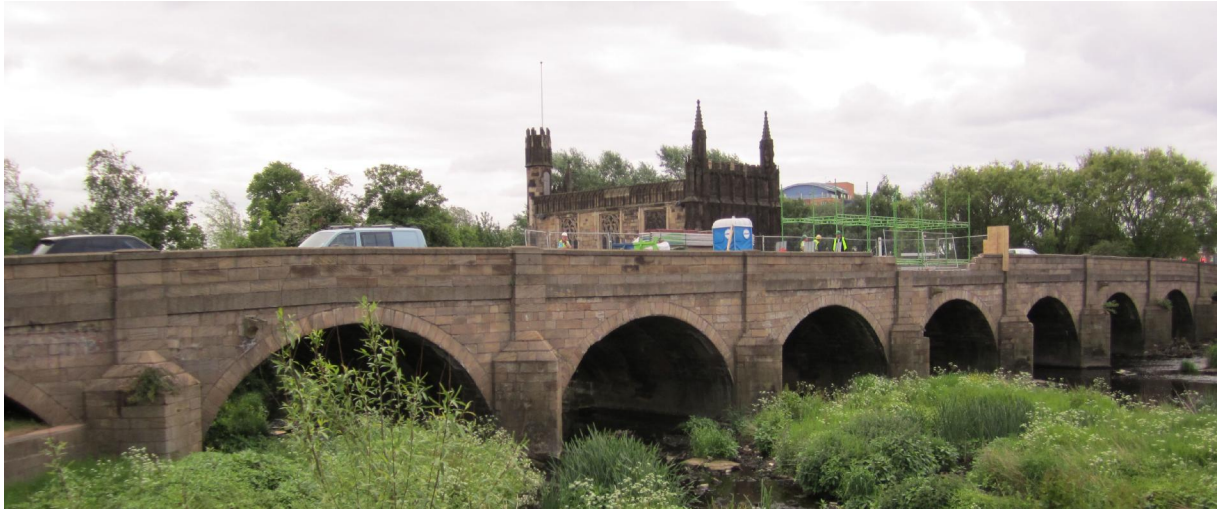
There is little to say about the rest of the bridge. This view from the North West shows almost the full length of the latest reconstruction with work going on to the parapet.

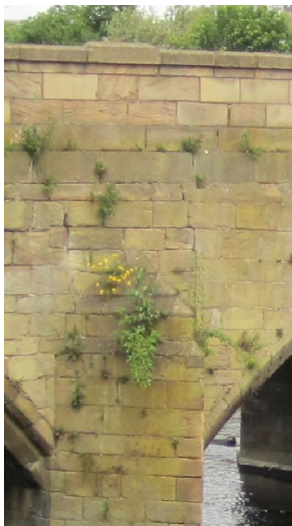
A closer look at the South West shows other aspects of 18th Century modifications. For example, in the enlarged view to the left there is clear evidence that the cutwaters used to rise to road level to form refuges. The area between the top of the cutwater and the string course is obviously a patch.
