Bridge of the Month No26 February 2013
Polsloe Station

Polsloe Junction Bridge

This bridge, over Pinhoe Road in Exeter carries the branch line from Exeter to Exmouth at <http://goo.gl/maps/Ktcl9>. This screen grab shows that the single track is slightly more skewed than the bridge itself. It also illustrates the ability to measure such things as skew from publicly available data.

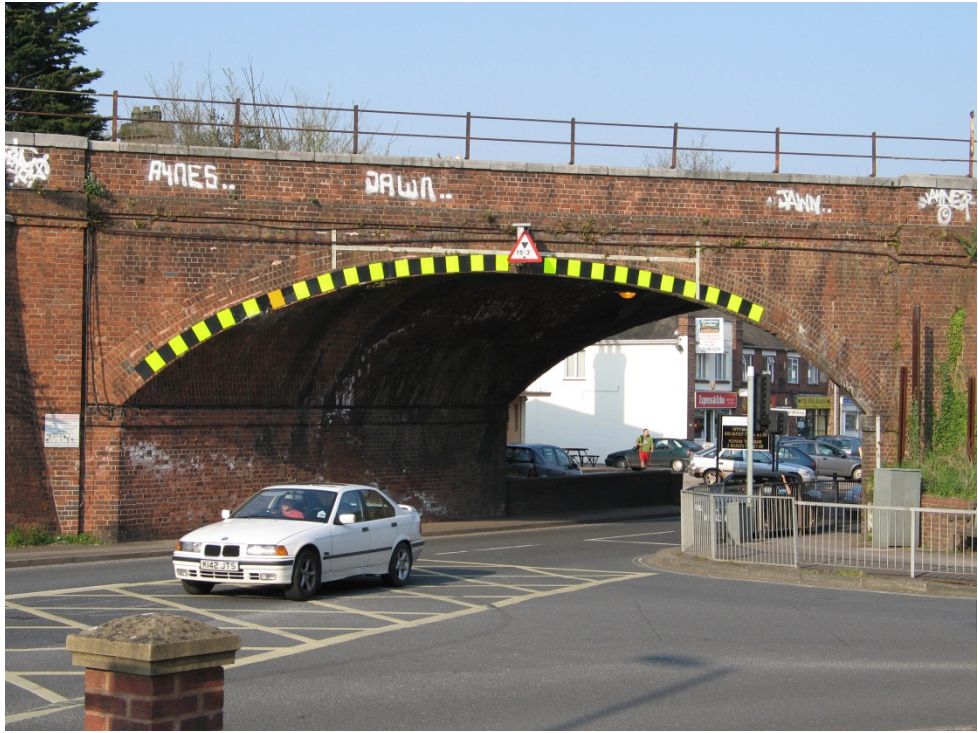
The bridge shows a number of the classic issues of skew bridges and one or two features I only noticed recently.

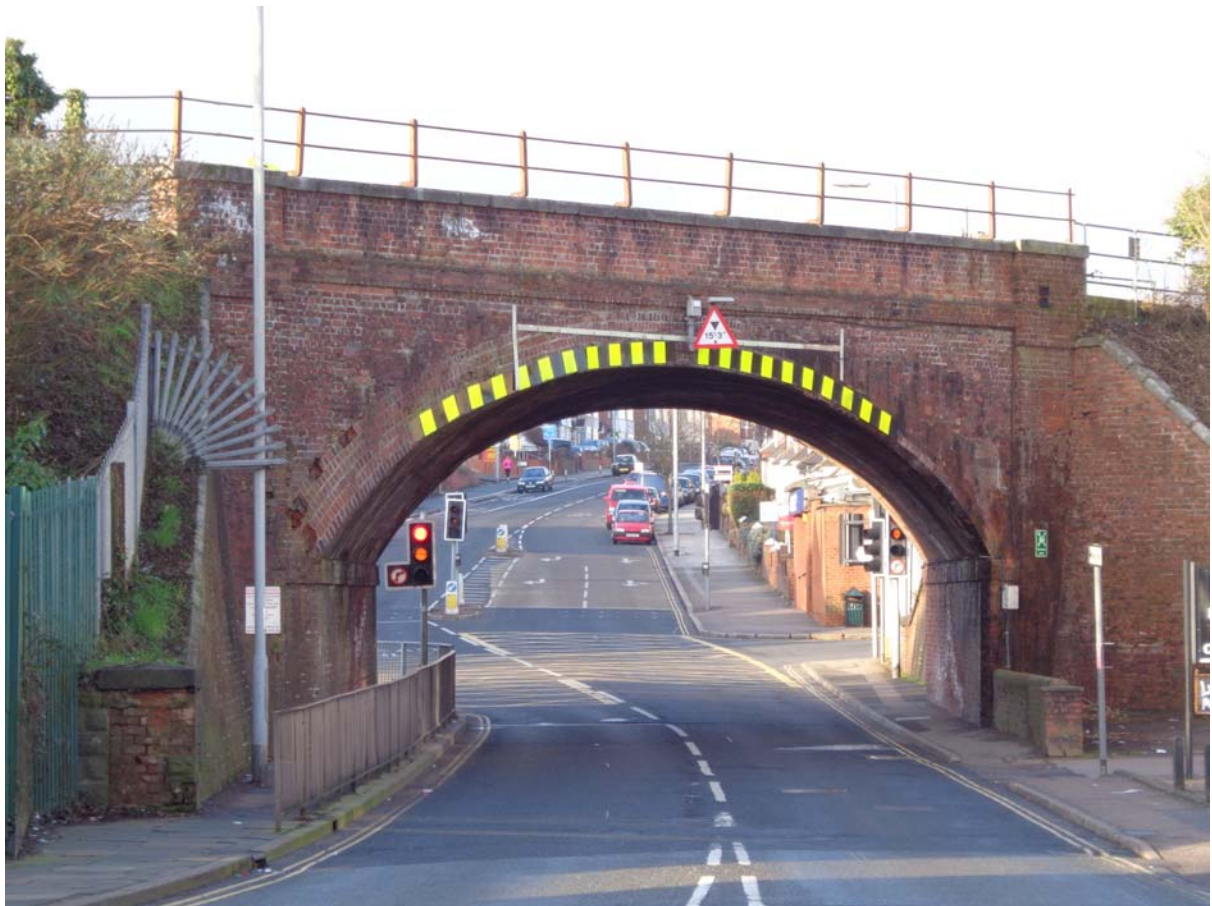
This is, as close as I can get, a view normal to the spandrel walls. The shape looks a little distorted, particularly at the right hand side where the curve seems to sharpen towards the springing. Part of the problem with such simple observation is the chequer board “please don’t hit this bridge” warning.

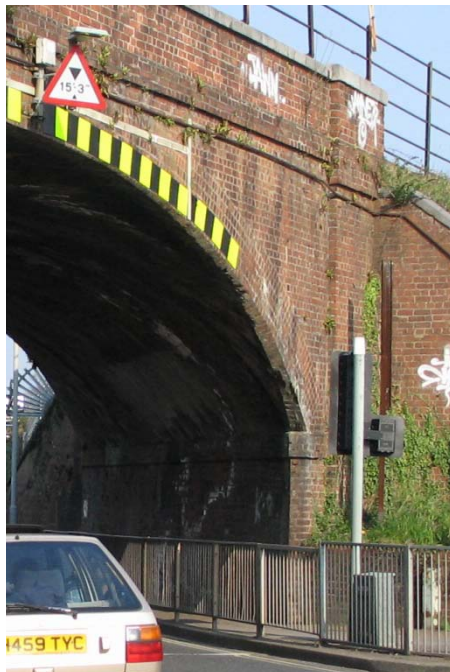
The road is too busy to stand in the middle and get a square shot and the skew is so great that perspective will distort the profile anyway. This picture was taken from a traffic island some distance away but the foreshortening caused by the telephoto lens helps. This shows clearly, I think, that the arch is circular on the square span. That means that the spandrel view (top) should show an elliptical curve with the major axis horizontal. This is quite hard to spot on such a modest segment but the square view is diagnostic.

These two profiles are mirrored below, where it is also easier to see the 120degree angle of the basic arch form. Like most arch bridges, this has probably sagged somewhat, creating an even flatter central portion.

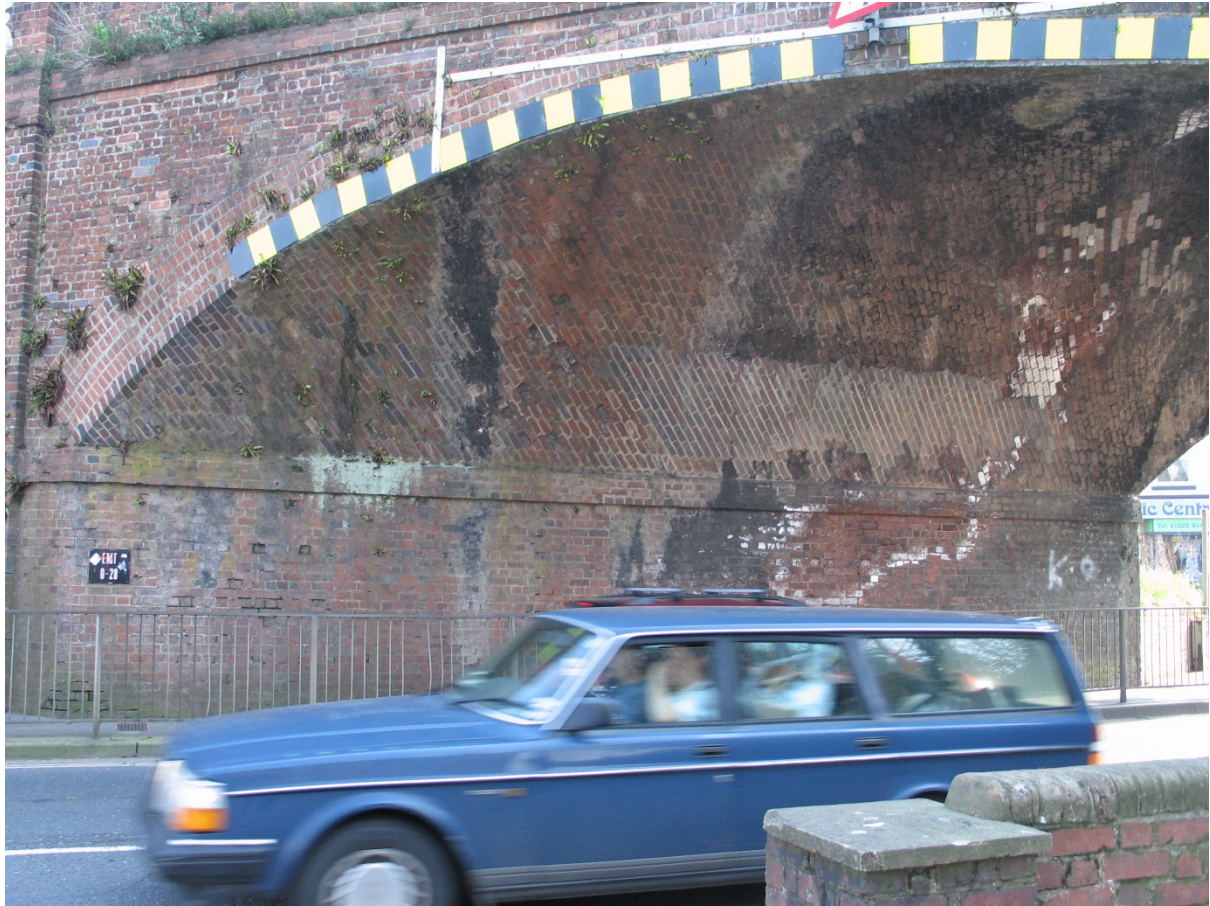
Look closer, though, at the right hand corner.

Here, you can see that there is a chamfer on the corner tapering from nothing near the crown to about 9in or a brick wide at the springing and down the abutment. This taper is clearly intended to remove the razor edge of the arch and is pretty much essential in highly skewed bridges built entirely from brick.

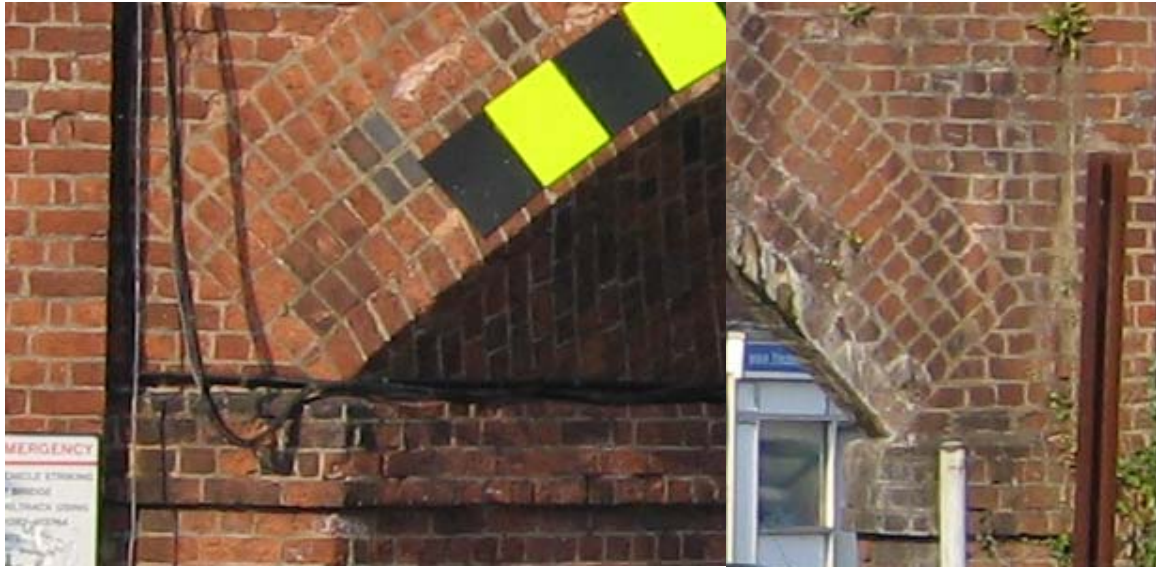
A better view of the soffit shows the severity of the angle of skew and the concomitant angle of the helical courses of brick.

Notice here that the helix meets the edge more or less at right angles at the crown but at a progressively more acute angle as it progresses towards the springings. This inclination is particularly disadvantageous at the obtuse corner (of the bridge, but where the edge of the arch inclines towards a razor edge). That is part of the reason for the chamfer. This fixed helix also results in very poor bond of the brickwork in the corner shown above. The repairs emphasise that the bricks here are essentially stack bonded.

Notice also, though, that the end of the bricks in the bottom course are lozenged whereas those in the higher courses are still essentially square (see the detailed picture below). I have looked at this bridge many times since I moved to Exeter in 1995 but I only noticed this detail when pulling out photographs for the note. What this shows is that only the inner course is laid in a spiral. The outer 5 rings are laid horizontally.

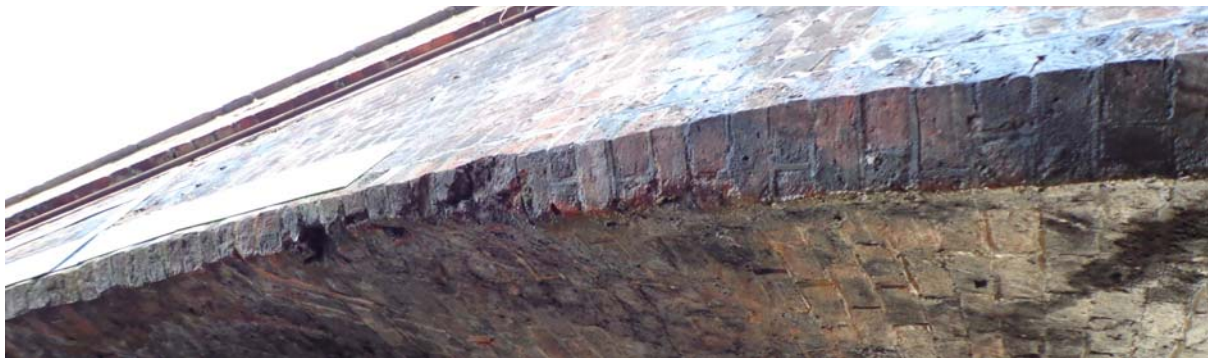
But at the obtuse corner (to the right here) there are six full courses of square bricks above the chamfer compared with six total at the left. So the ring has gained thickness round the ring.

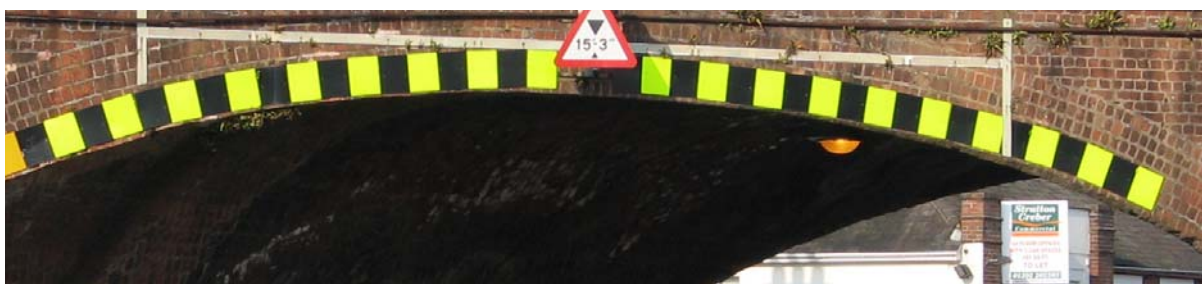
This picture of the edge shows how it is constructed. Alternate courses have a brick right through on the diagonal and a trimmed soldier up the spandrel face.

It seems unlikely that this taper is across the full ring, and without proper measurement it is impossible to know whether the true circle is the intrados or the line of the courses. Construction convenience, though, makes a basically circular centre almost certain.

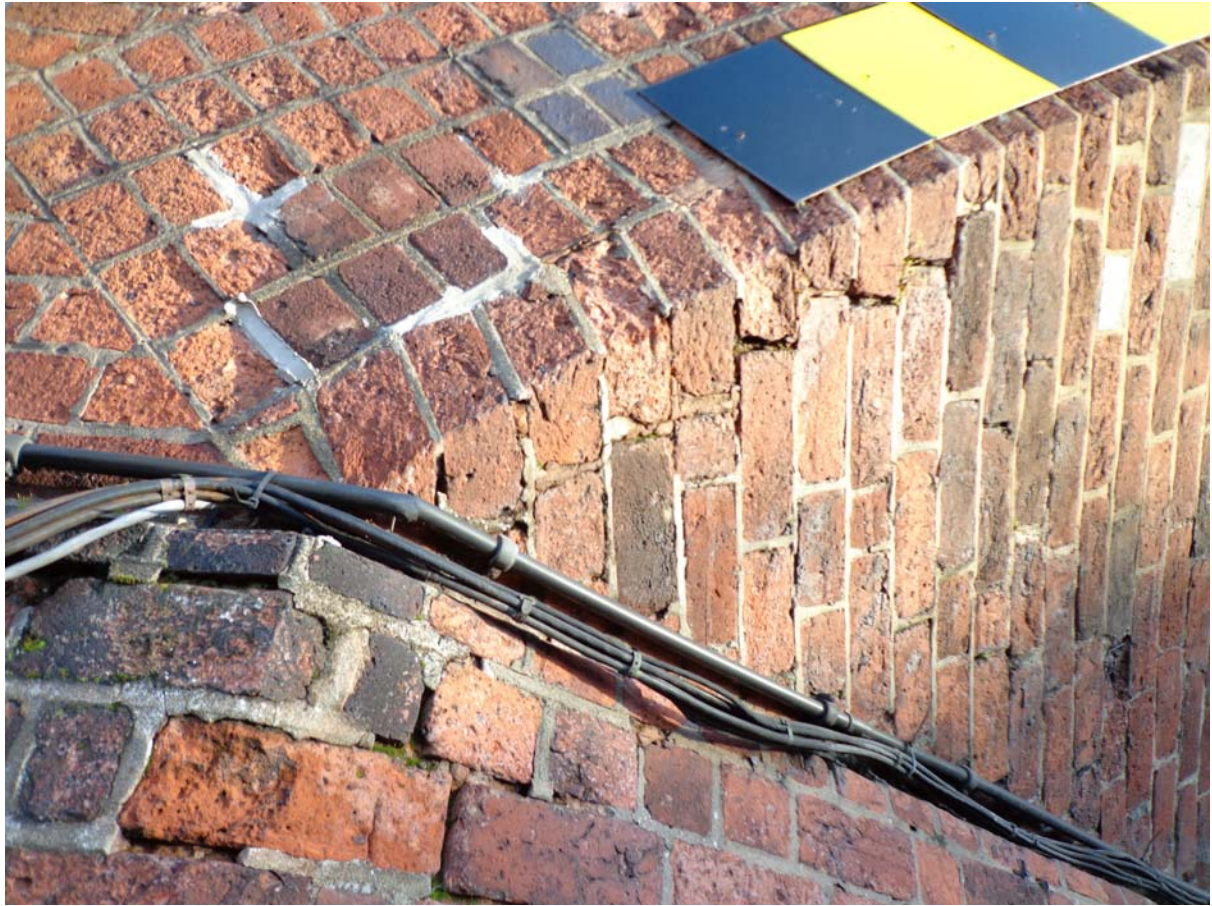
At the south facing obtuse corner, the bricks are clean and original. The reason for the lozenge shape is clear. Note also how the bonding has failed again and the edge bricks are coming free. This is the sort of thing that is prevented by the complex coursing at Cowley Bridge Junction (BoM11 August 2011), but at what cost.
