Bridge of the Month, November 2013 Bargower Test

Bargower test bridge

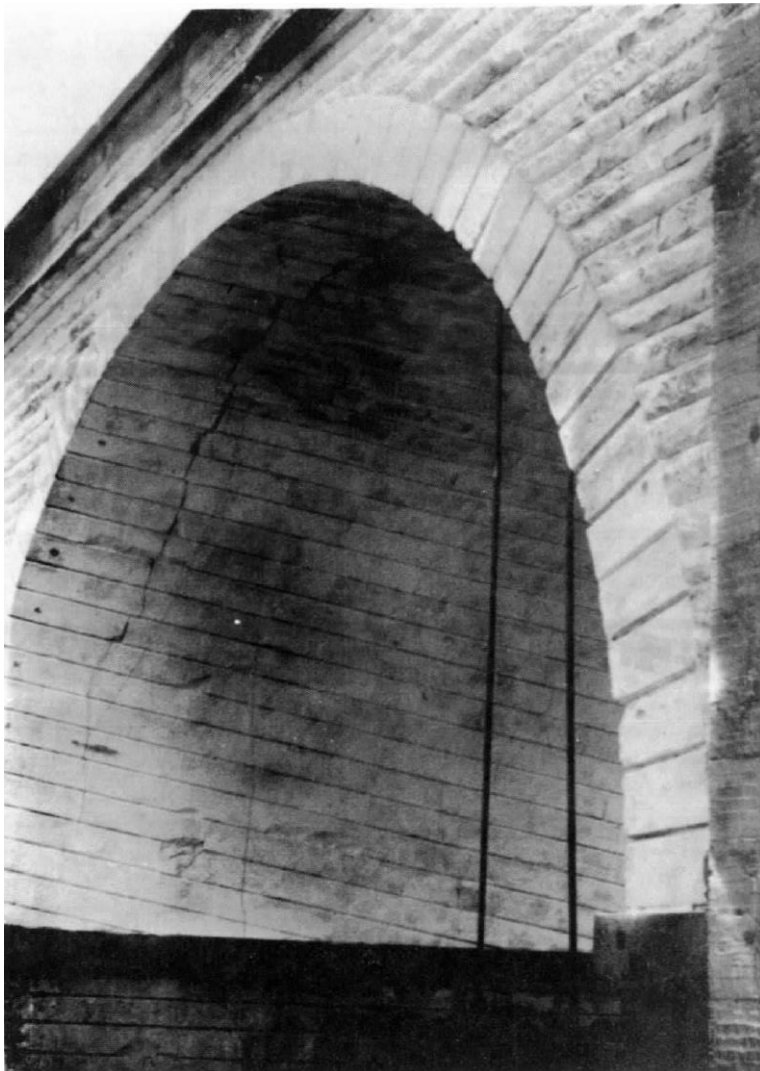
At Bargower, there were clues even before the test was set up. There were substantial cracks, parallel to the parapets and 1m or so in from the edge of the arch.

This photograph from the TRL Contractor's report shows the bridge whitewashed for testing but before any load was applied. Note the substantial crack about 1m in from the edge. Note also the tilt of the Voussoirs indicating a 16° skew angle.

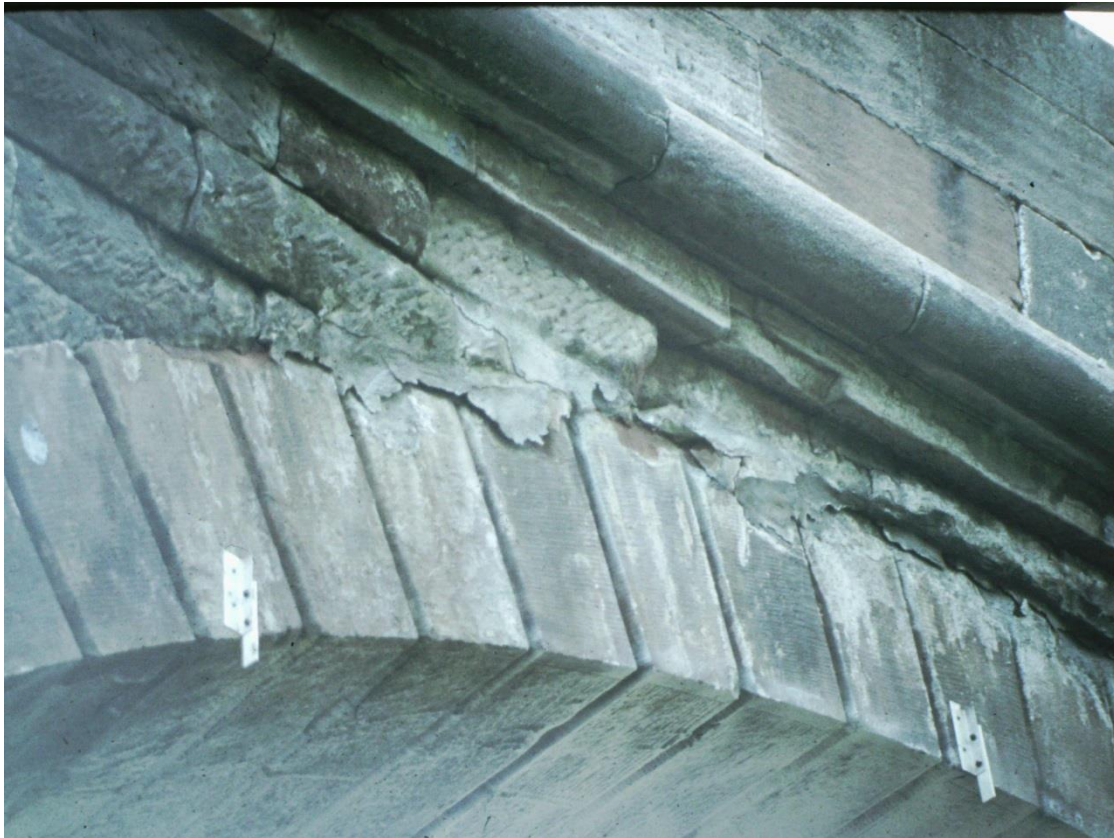
There were also some interesting issues with performance, such as the pushing out of the parapets.

This is caused by freeze thaw action between the parapet walls and the road surface. Water gets in and freezes, expanding and pushing out the wall. When the ice melts, the wall stays where it is so there is a bigger gap for water and more ice to expand next time.

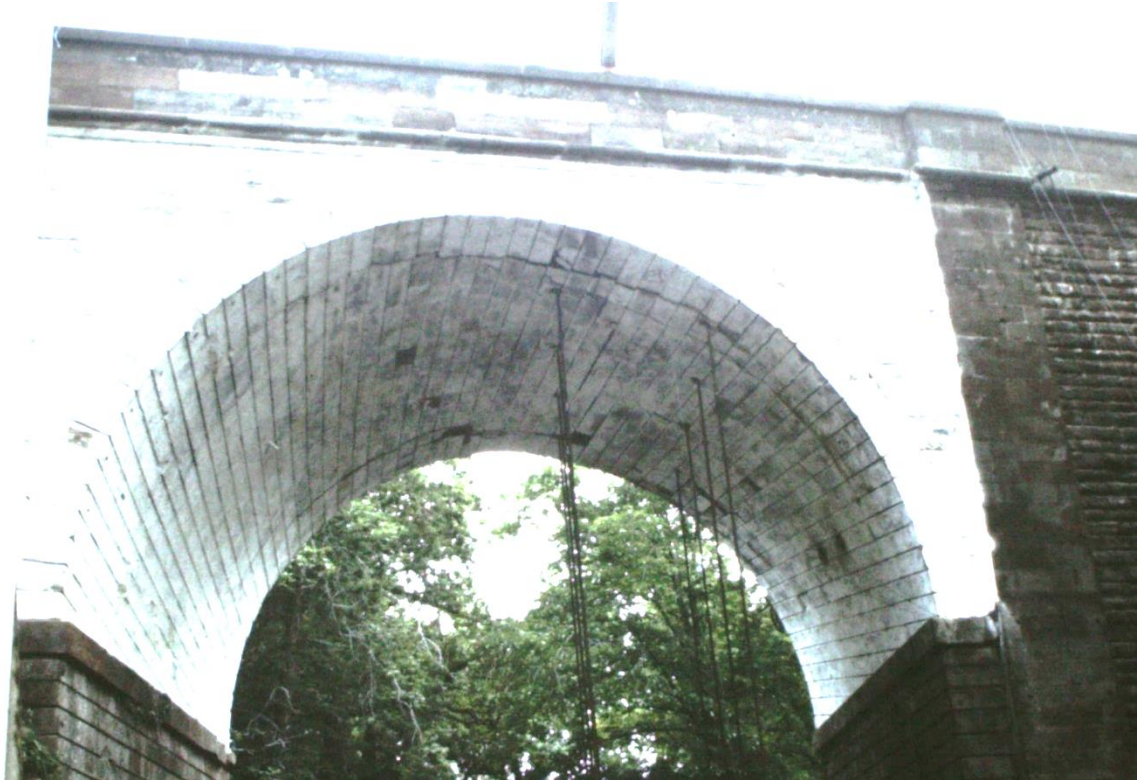
The picture below shows the bridge damaged beyond repair but before failure. At this distance, it remains uncertain what the load was at this point. However, it is clear that the arch proper is carrying a considerable amount of load. There is a visible crack stepping between the inclined voussoirs, somewhat towards the crown from the load. There is also some crushing to the left of the crown and near the right hand quarter point.

The report suggests that the crack under the inside edge of the spandrel at the far side was not present, or at least was not large, before the test. It is worth noting that the crack moves inwards to the inner rock anchor under the load.

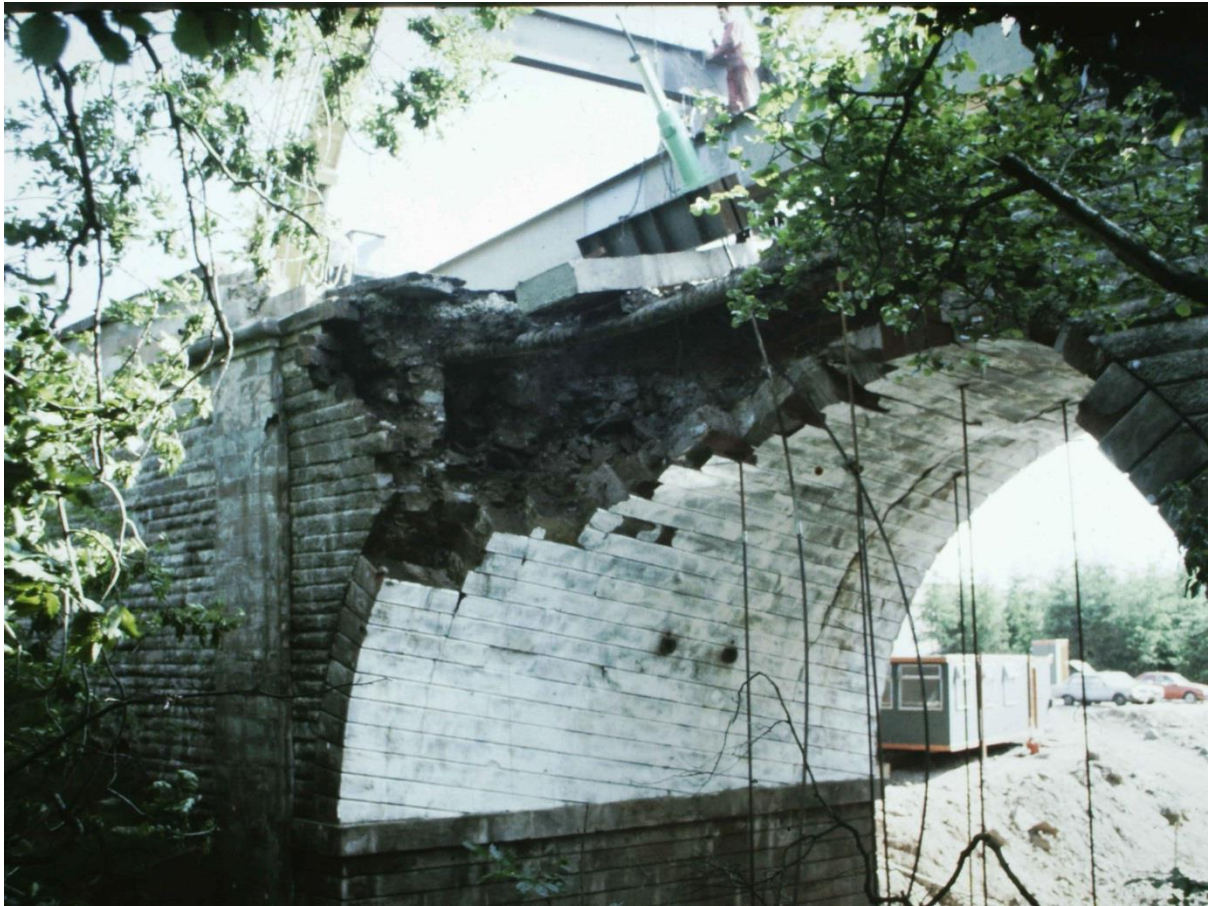
Now is an appropriate time to jump straight to the so called “ultimate” load. The failed bridge is shown below and there are some interesting things to observe. First, note that the near end of the lad beam bends down severely and the rock anchor cables to the nearest jack are completely slack. Then, though, note that the remaining 6 ties are still essentially straight. The nearest two are apparently free of the arch so the load is being supported by the beam and any corbelling in the fill. The arch seems to have failed along the line of the crack that is visible in the photo above.

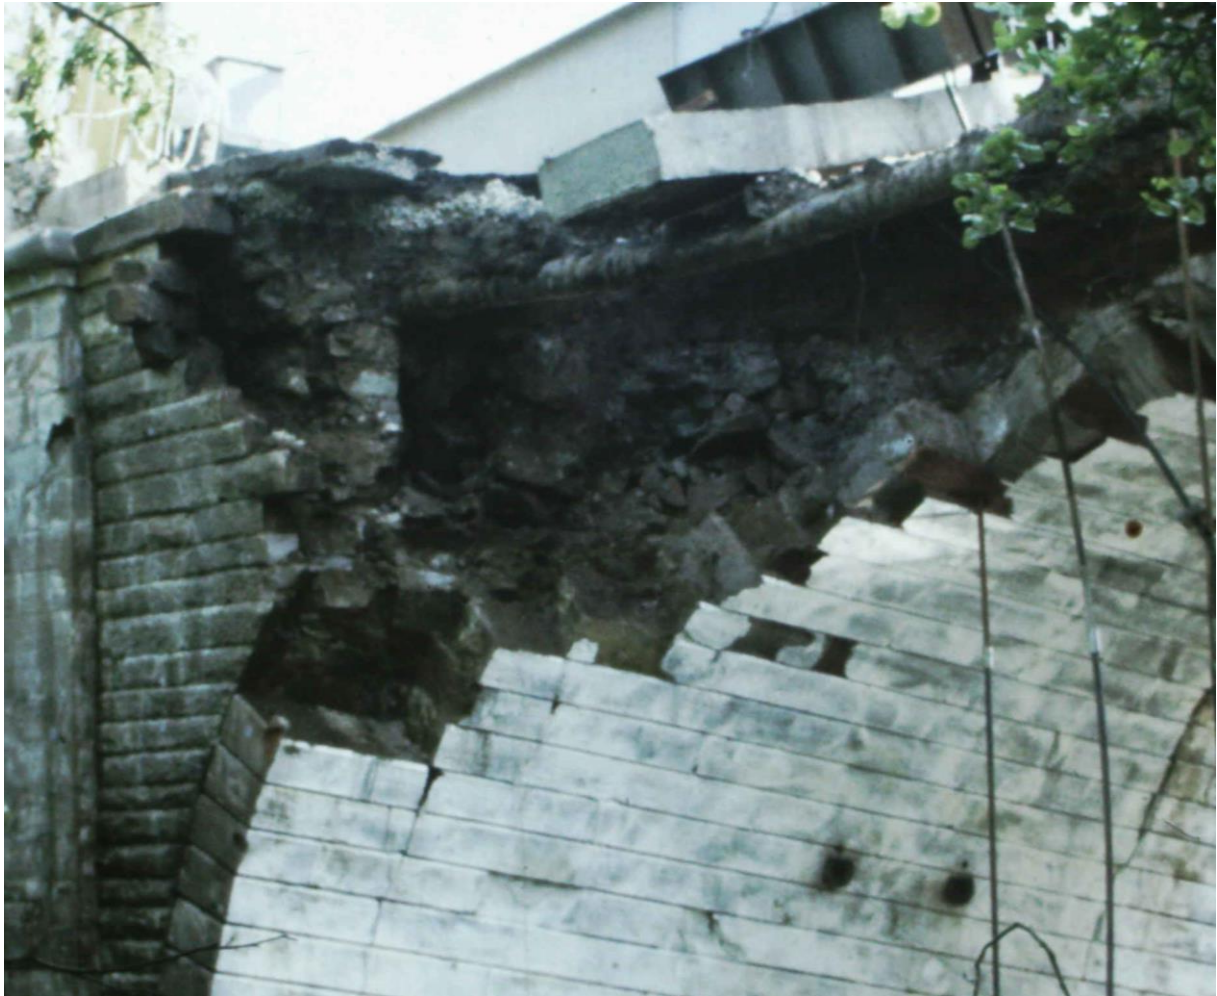
Then, examine the structure and note that the rubble masonry spandrel wall is more or less constant thickness right up to the under-side of the surfacing. The alignment of the duct against this wall and well under the loading beam, emphasises the fact that much of the load was carried direct on to the spandrel.

So there is some doubt about the value of the failure load so baldly and confidently stated in BA16.

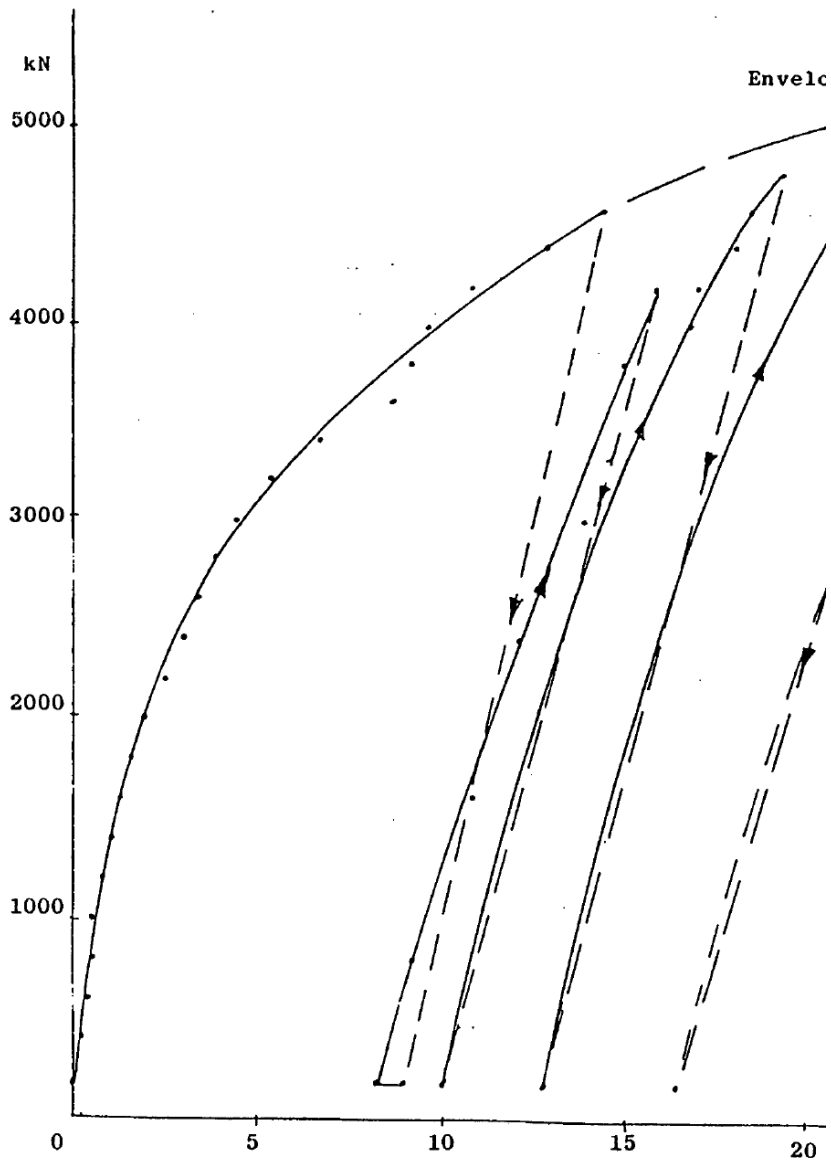
This curve represents deflections in the spandrels. The report says that there was visibly greater deflection in the section of the arch between the spandrel walls. We can only guess at the distribution of load between spandrels and arch.

This load deflection curve is a mean between two values. The smooth curve plotted in the first phase does not flow well with the plotted points and there is no obvious way to see how the different components of the structure responded.

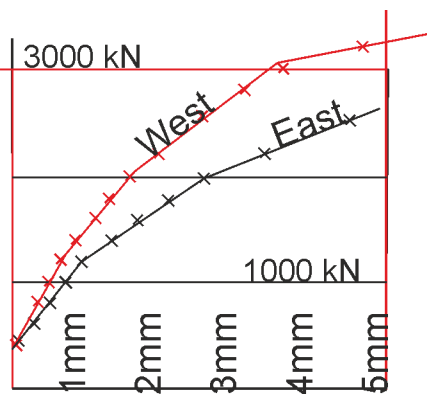
Initial load deflection curve

To me, the slope changes markedly at several points and the changes map from side to side. Given that the spandrel walls themselves are both stiff and strong, the first kink at around 1200kN may

well be caused by the initial crack in the arch barrel itself, or possibly by the development of the second (Eastern) longitudinal crack.

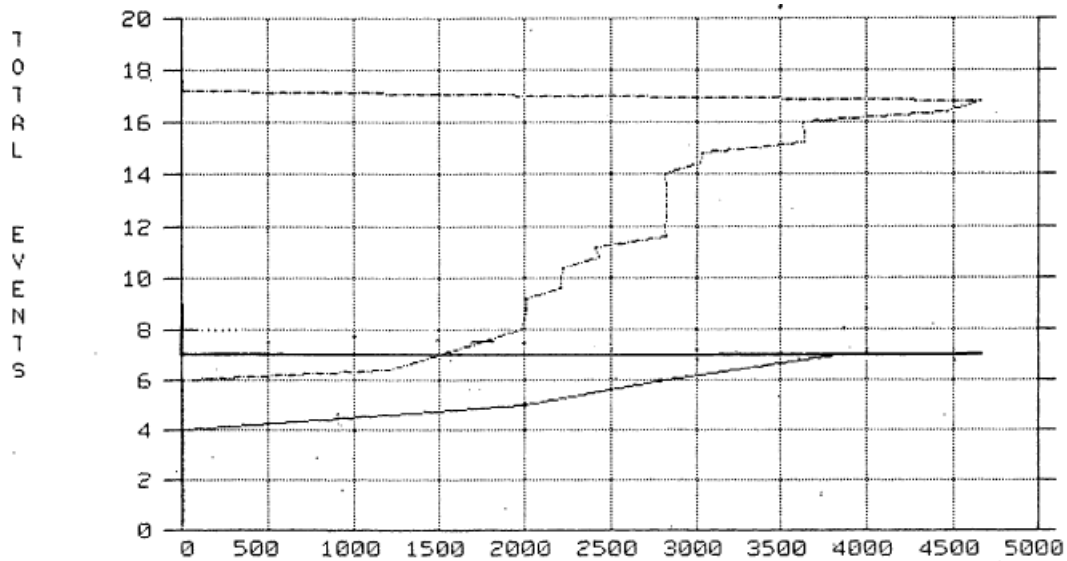
The dashed line above shows the acoustic emission response near the load point. Once again, there is a distinct change in the rate at which damage accumulates at around 1200kN. An acoustic emission “event” is basically a sound above a certain threshold.

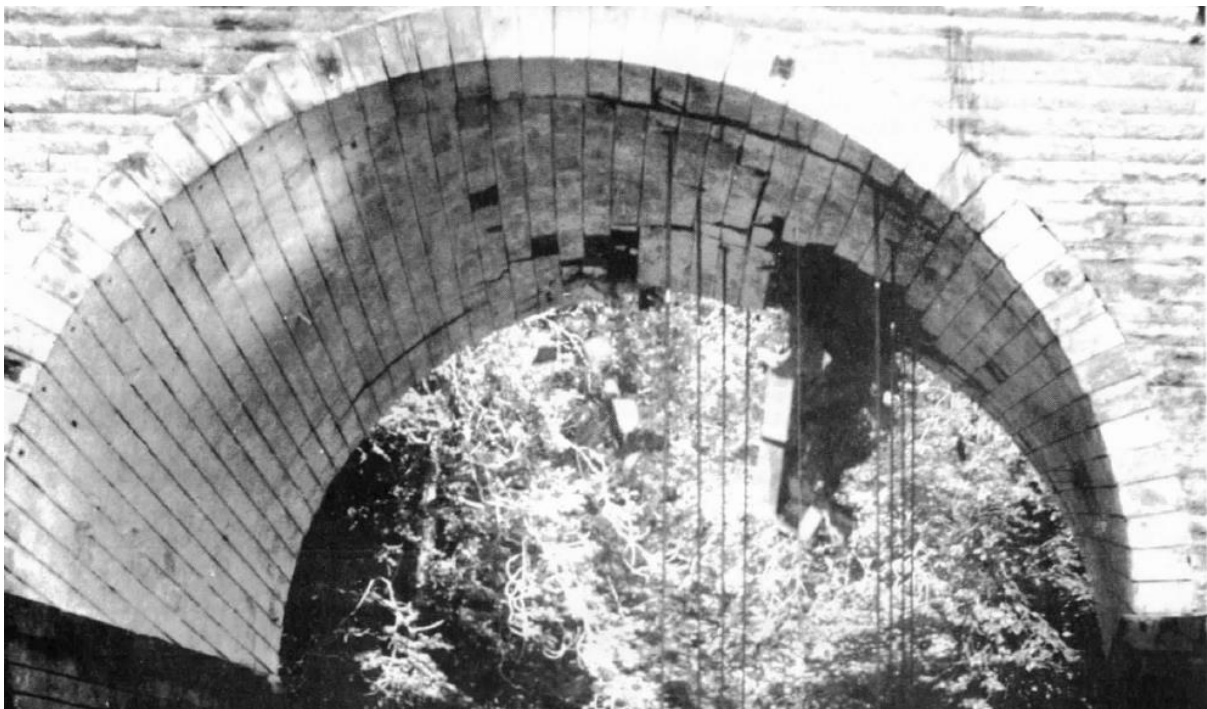
Note here how the falling section is on the abutment side of the load hinge. I think that means the arch has split and crushed where the force is biggest. At this stage, the rock anchors are still tight.

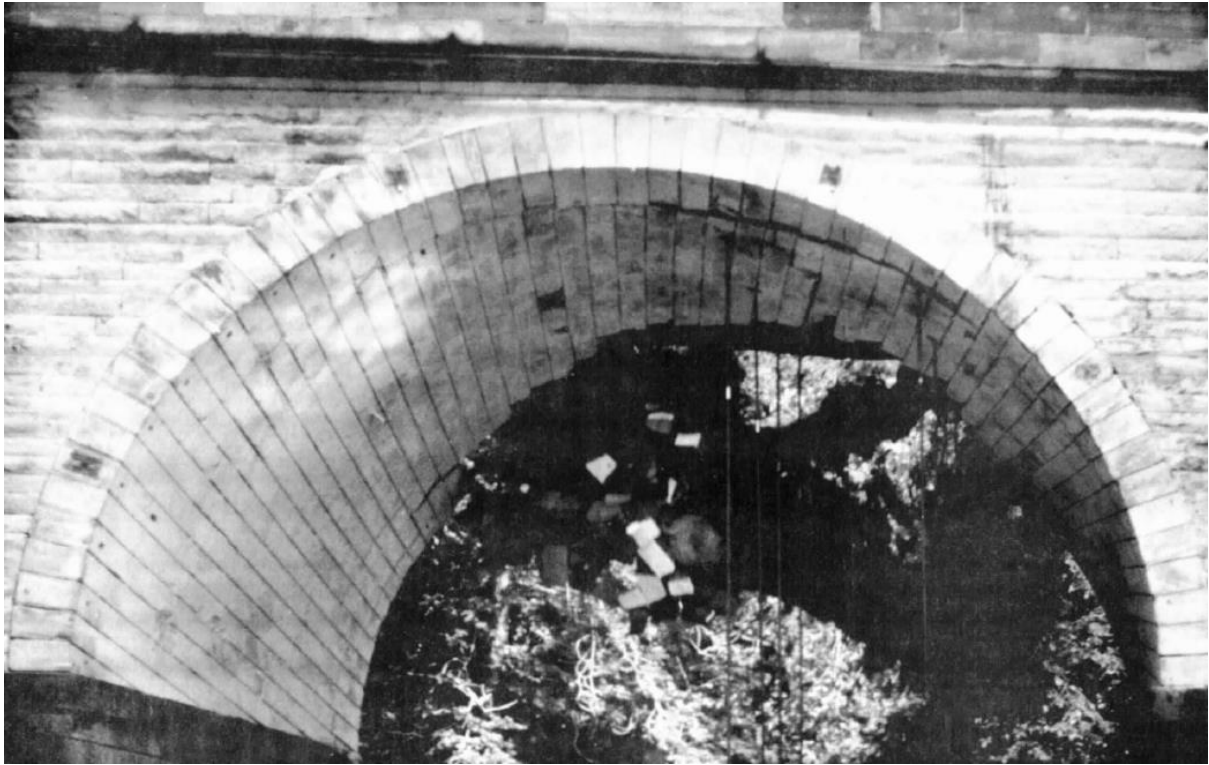
Here, the spandrel wall has gone and the parapet is following it down as a separate item.

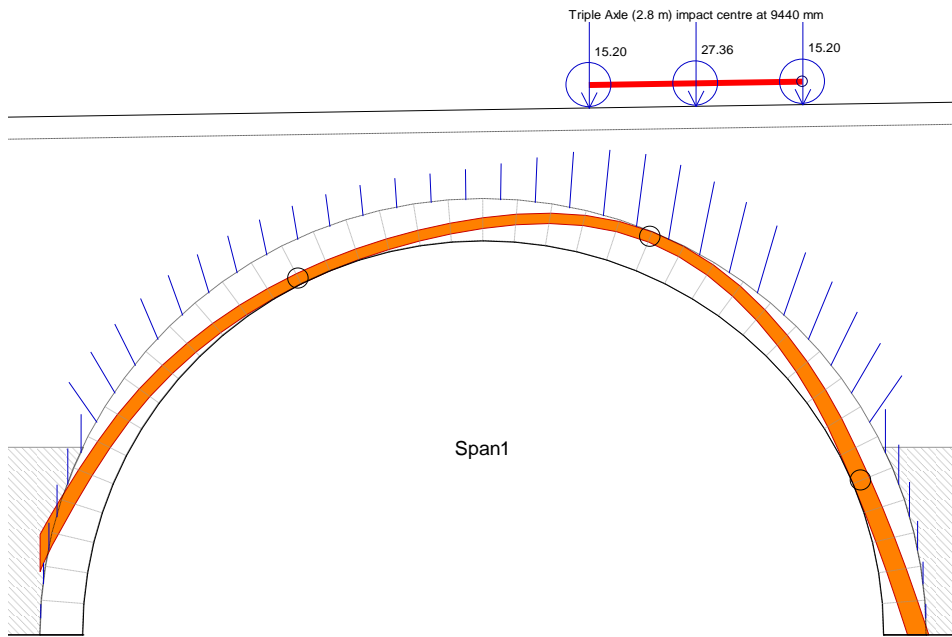
If the arch were modelled with backing to half the crown height (which roughly corresponds to the line where the face of the abutment projected upwards intersects the arch extrados) and the ring strength were reduced to 2MPa Archie would show the bridge to have a modest reserve of strength for all standard vehicles.

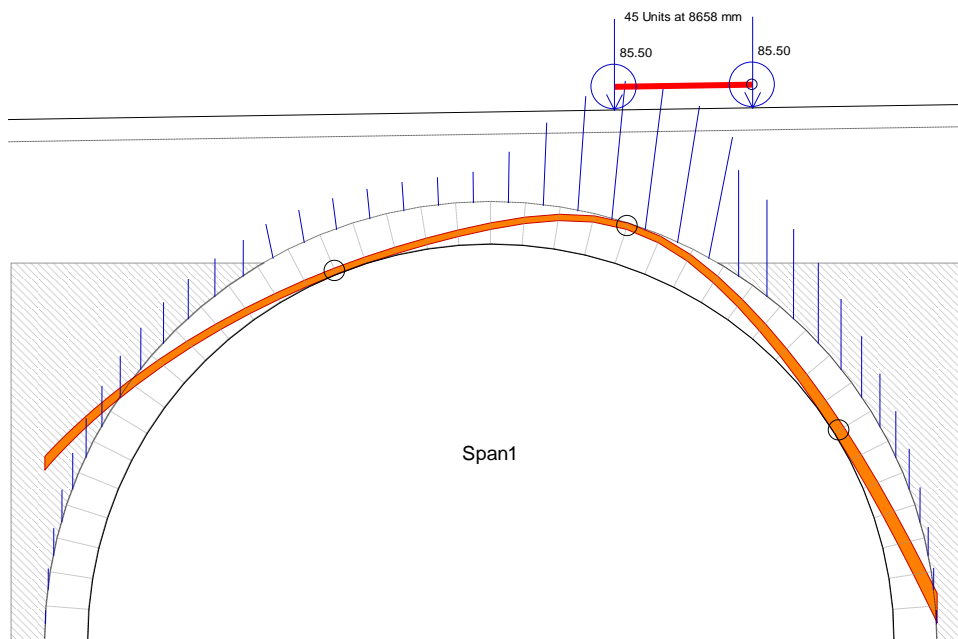
Putting the backing level with the crown and allowing a strength of 5MPa, which would be more normal for such a bridge, the structure would be amply able to carry 45unit HB vehicles.

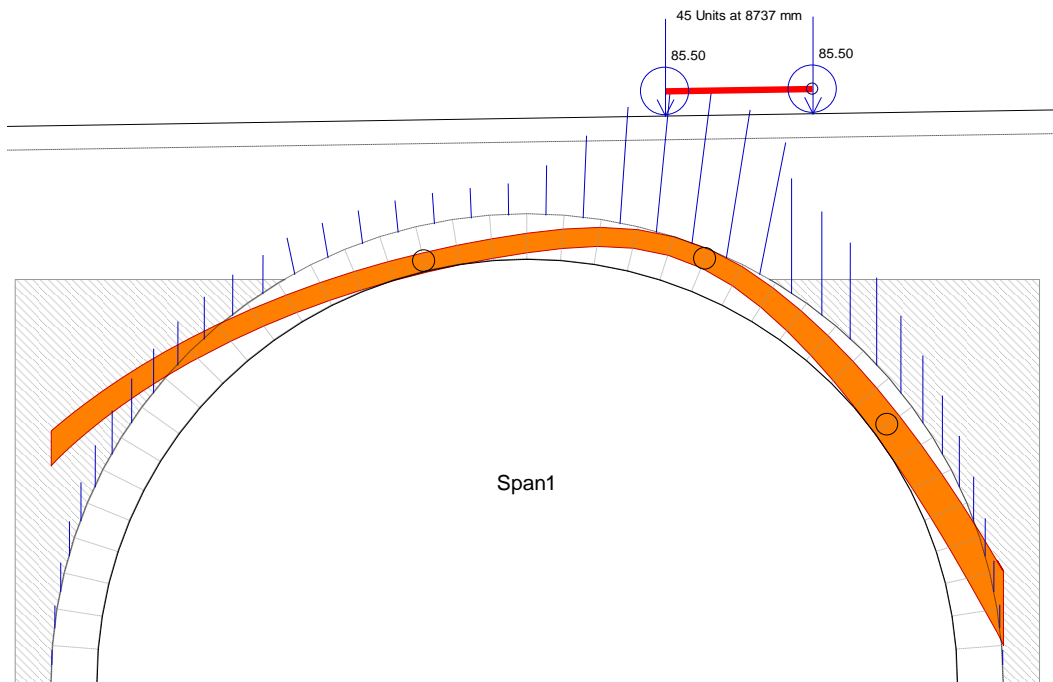
Reducing the strength to 2MPa again consumes much of that capacity.
