## Bridge of the Month No46, October 2014 Clopton Bridge, Stratford-on-Avon

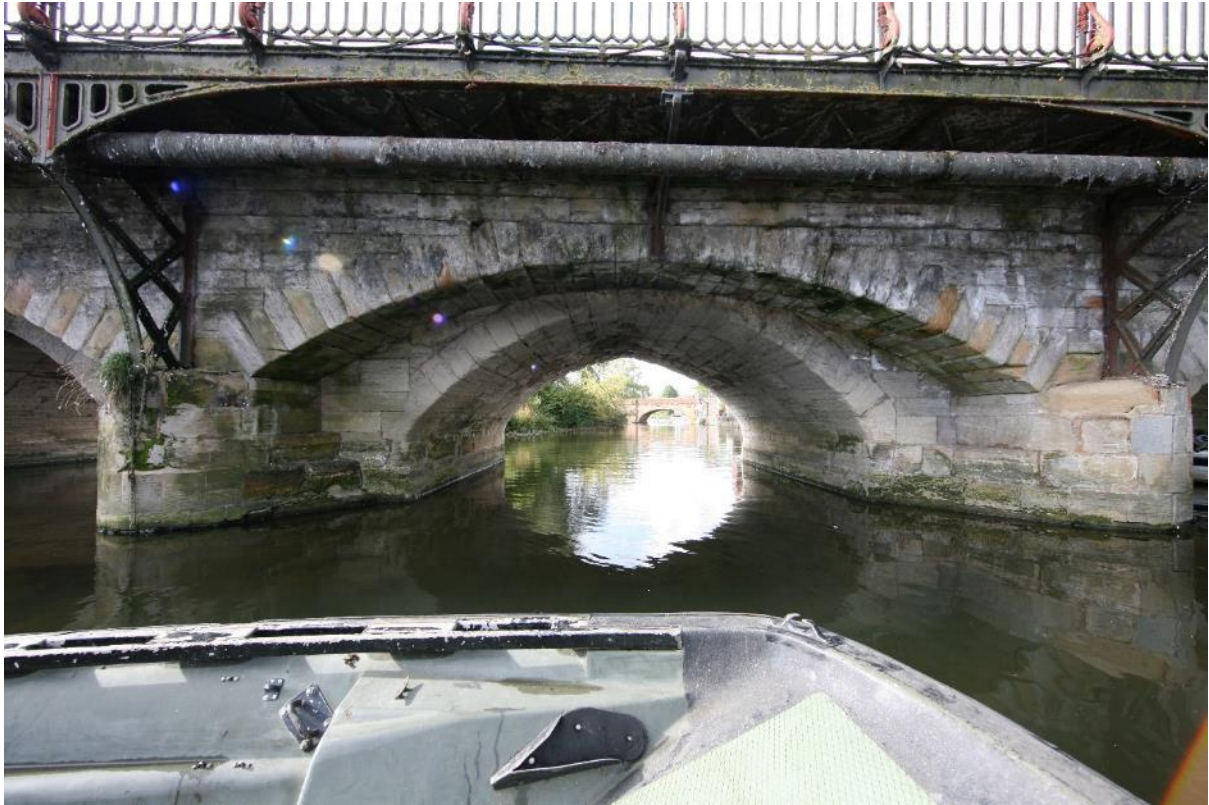
A closer look from the river shows the progressive widening of the bridge.

The arch was added in 1814, with the pedestrian refuges removed to make room for them. Then in 1827 a separate pedestrian space was made by adding a cast iron cantilever. The cantilever brackets are tied right through the stone bridge with pattress plates and nuts on the downstream face.

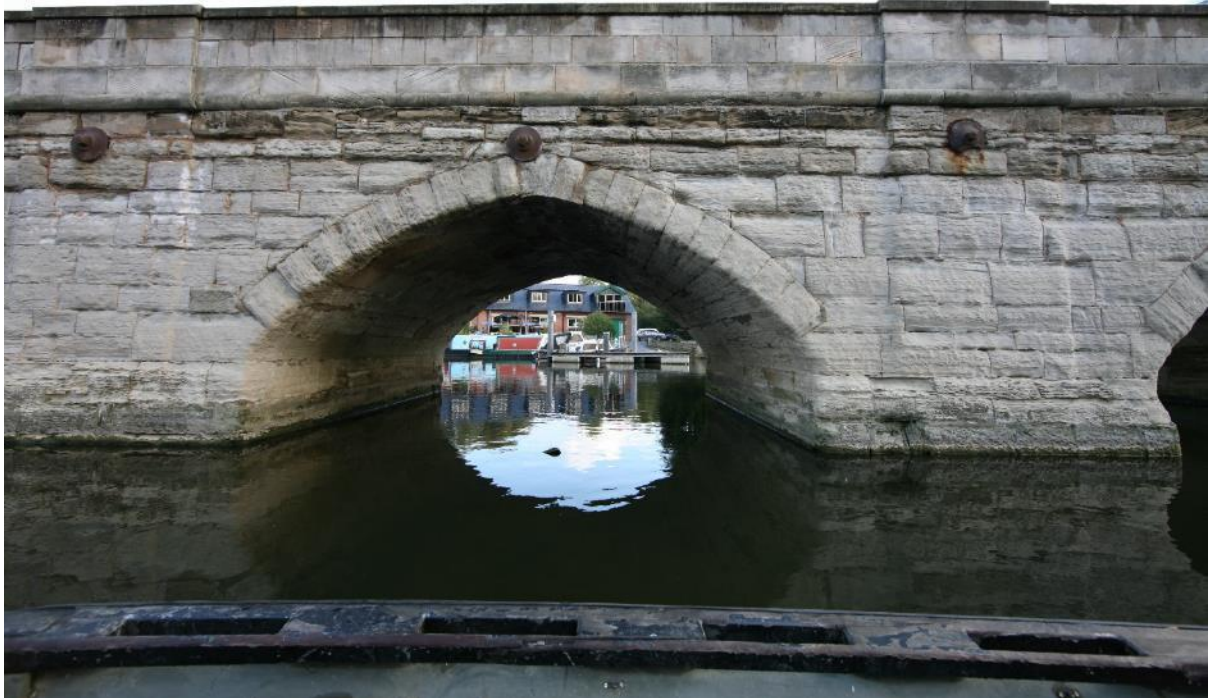
This is the same span viewed from downstream showing the anchors for the cantilever footbridge. Notice also the dramatic change in weathering at crown level. This suggests that the piers are full, not of soil but of something in the range from concrete to masonry.

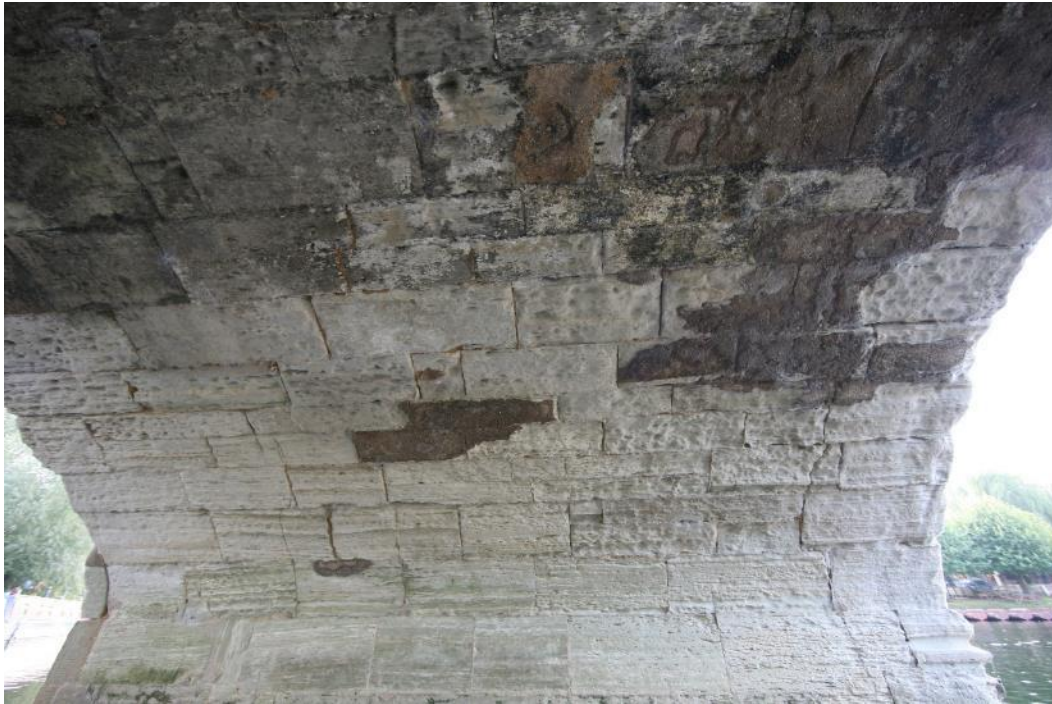
Even when running full, the water does not reach the crown of the arch except possibly at the upstream edge. As a result the lower reaches of the stonework are scoured clean while the crown gathers dirt.

I wonder whether the deep grooves in the bottom right stone are a result of normal erosion of a softer layer of stone or of ropes pulled round the edge.

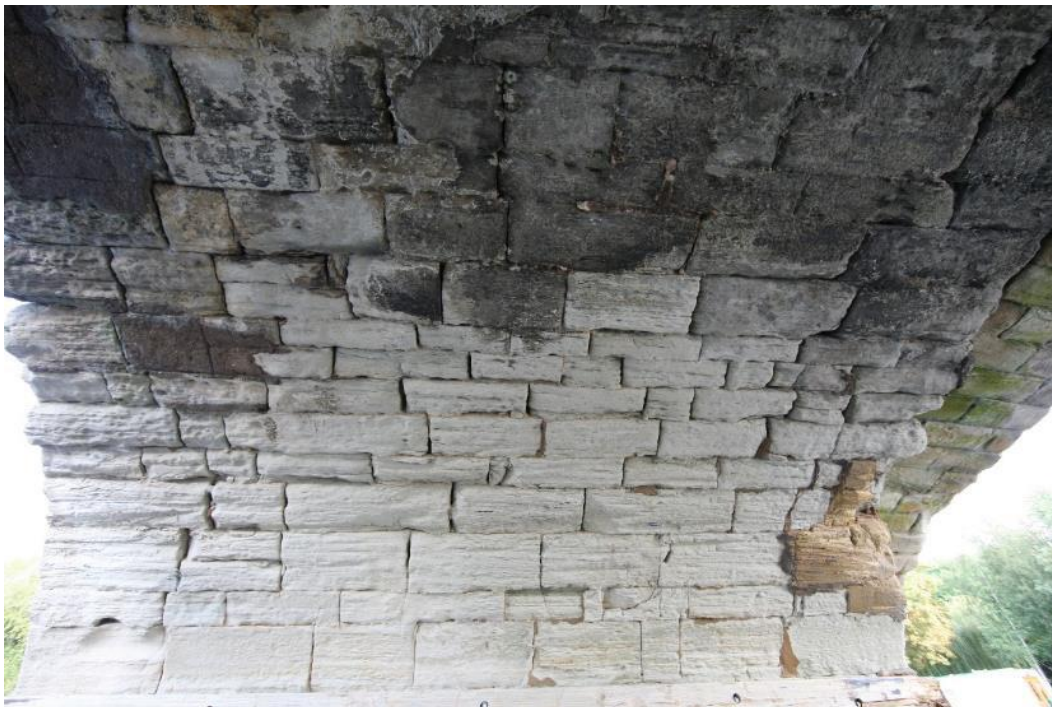
This image is typical of the 12 non-navigation spans. All the joints remain tight and the stone is only slightly eroded. Compare that with a navigation span.

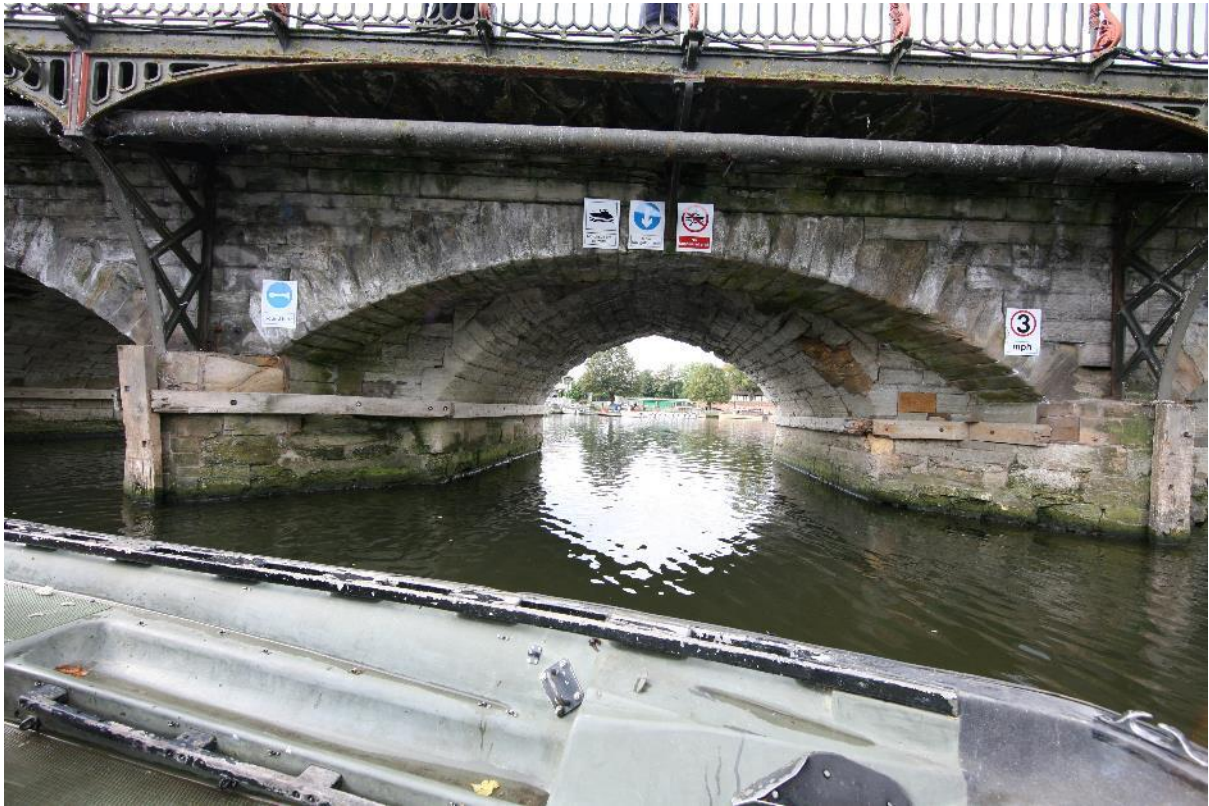
Here the boats are travelling predominantly downstream. The spans are signed. The boats that do the damage are the holiday narrow boats which strike and gouge the arch at the corner of the steel roof about 1.5m above the water. These blows have shattered some stone at the edge and it has been replaced in a different material. That, in turn, is now badly damaged.

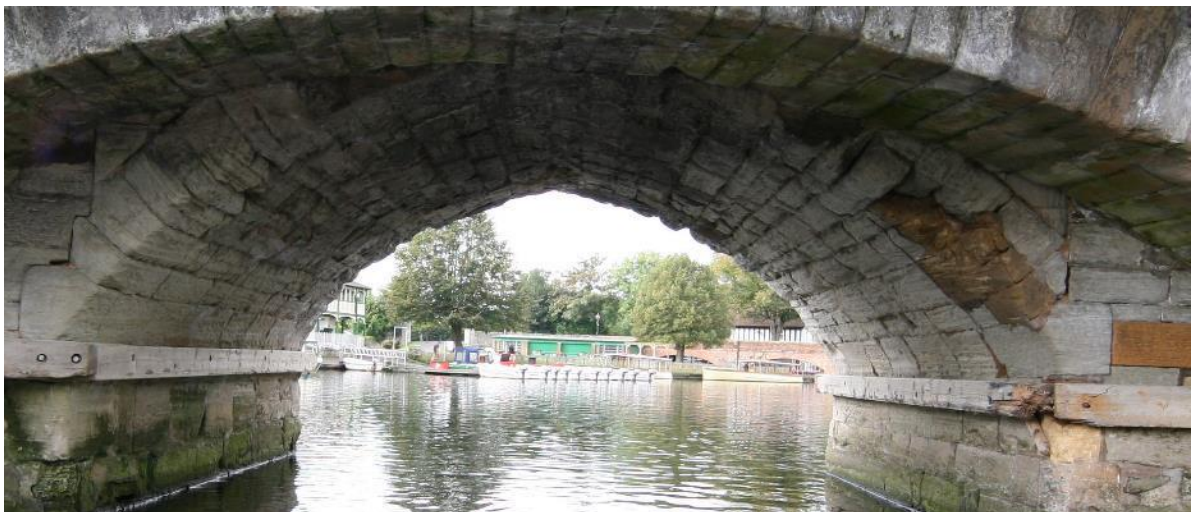
This square shot of the span shows the position of the damage with respect to the rubbing strakes, which are clearly not up to the job.

What I found most interesting though is the extent of mortar loss. The joints are obviously all but empty right up into the dirty patch at the crown. The flooded river has then severely eroded the corners of the stones so that any repointing will be rather exposed and will probably be washed out in the first flood unless a very special material can be found.

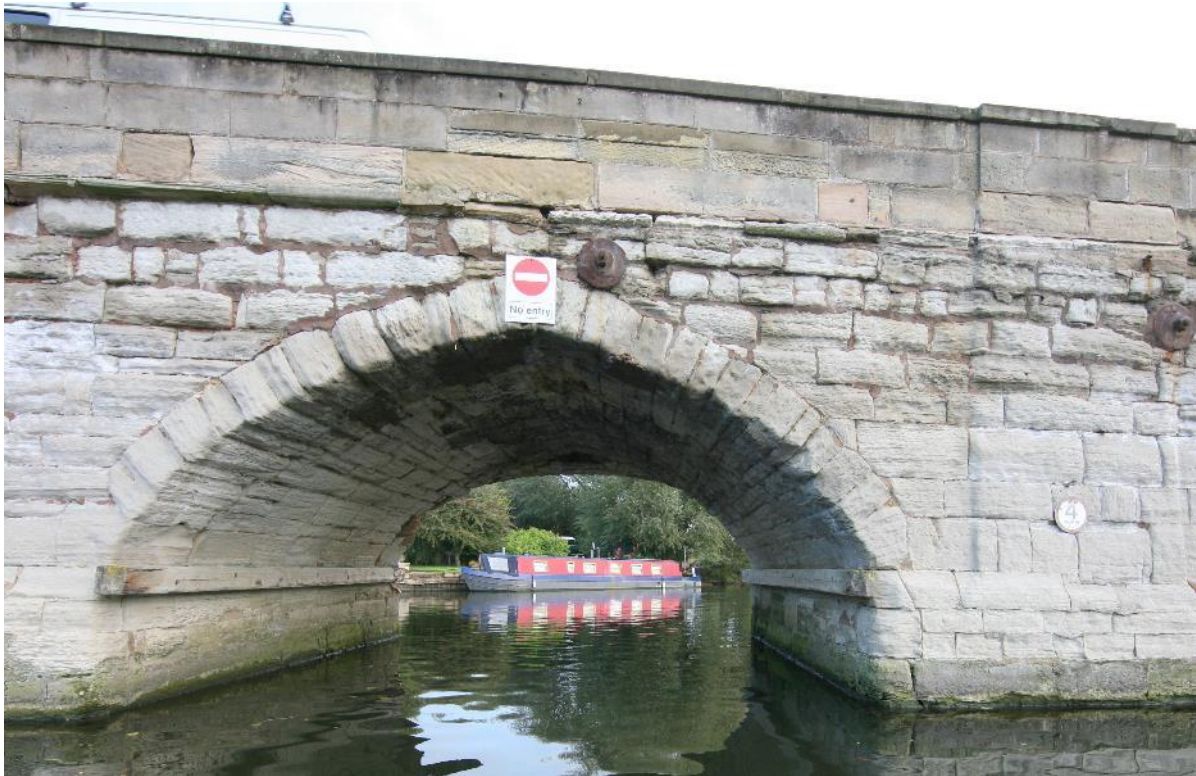
A closer look shows how deep the notches are at the downstream edge.

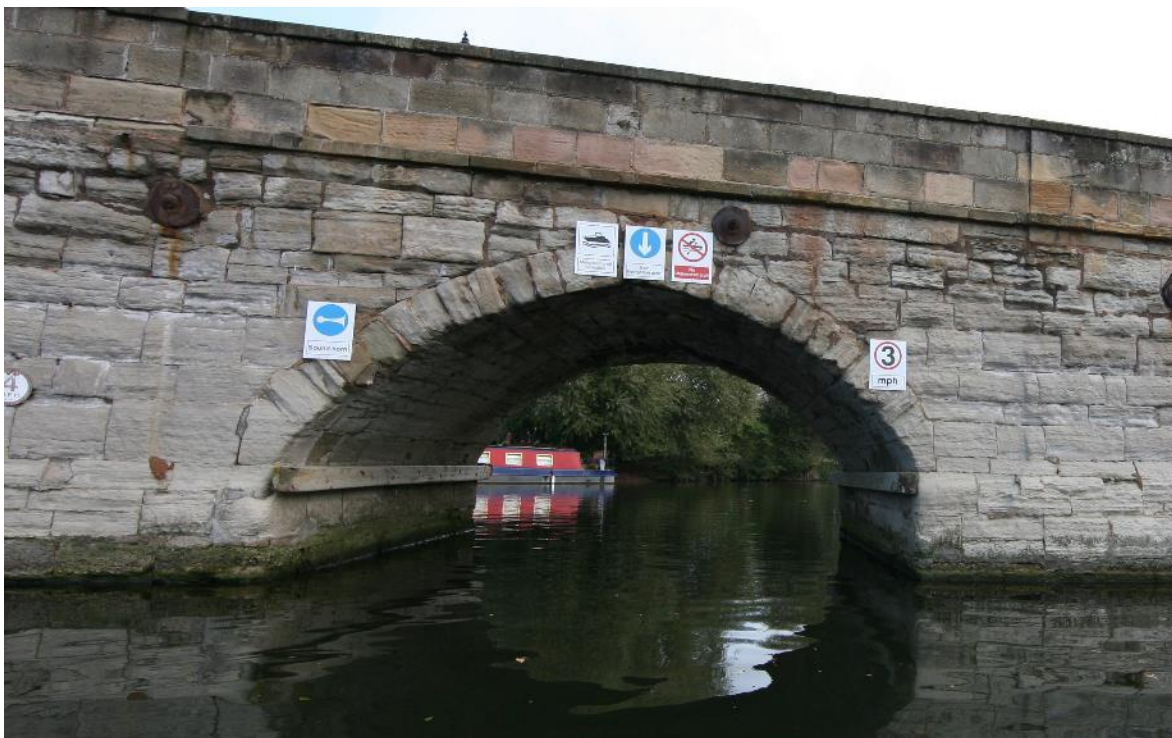
The view from downstream shows that the widening arch actually drops below the original at the crown. This is the only span in which this is true.

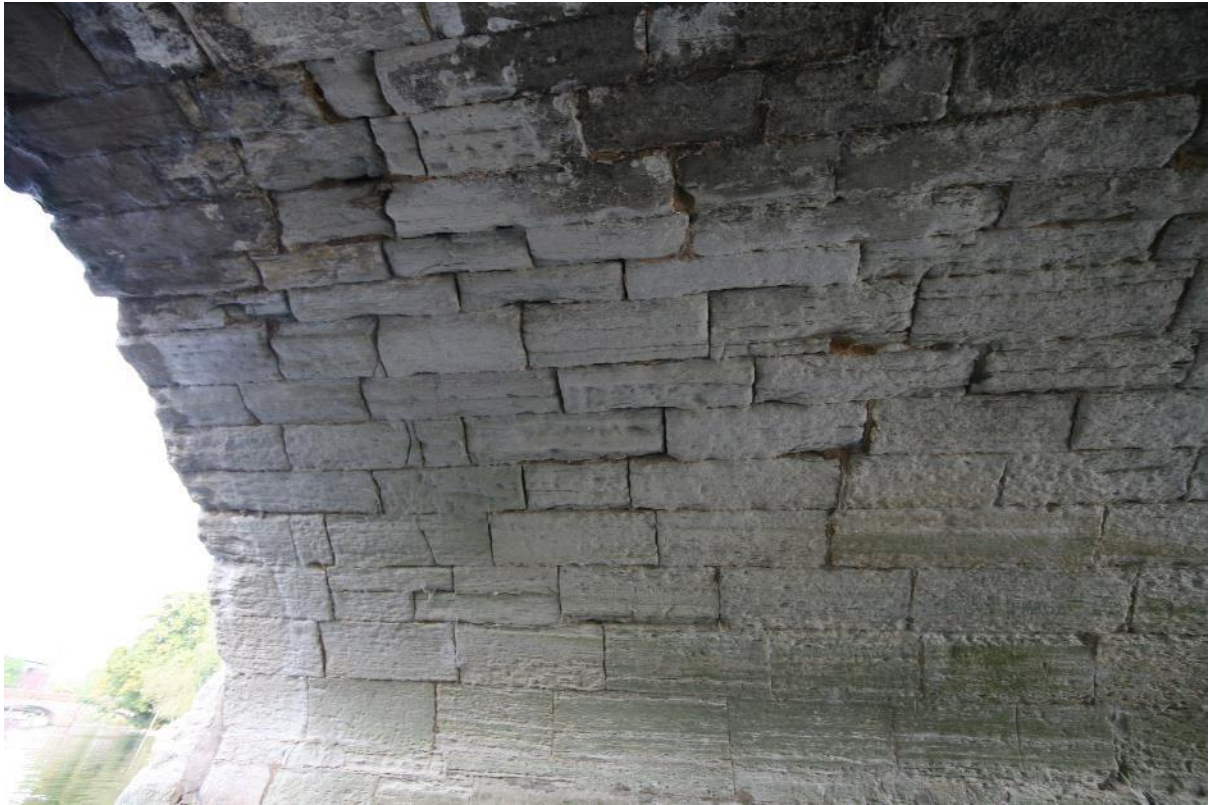
He boaters obviously find the upstream passage much easier. No impact damage on the edges here, though the span itself is similarly eroded.
