Sorry it has taken so long to get to this one, I was in New Zealand for November, and December just vanished. Life is still a bit hectic made more difficult by Sue declining somewhat. However, let's try to get back up to date. I was taken to this bridge in [Hodges Park](#) while working on a concrete arch with Duracrete of which more later.

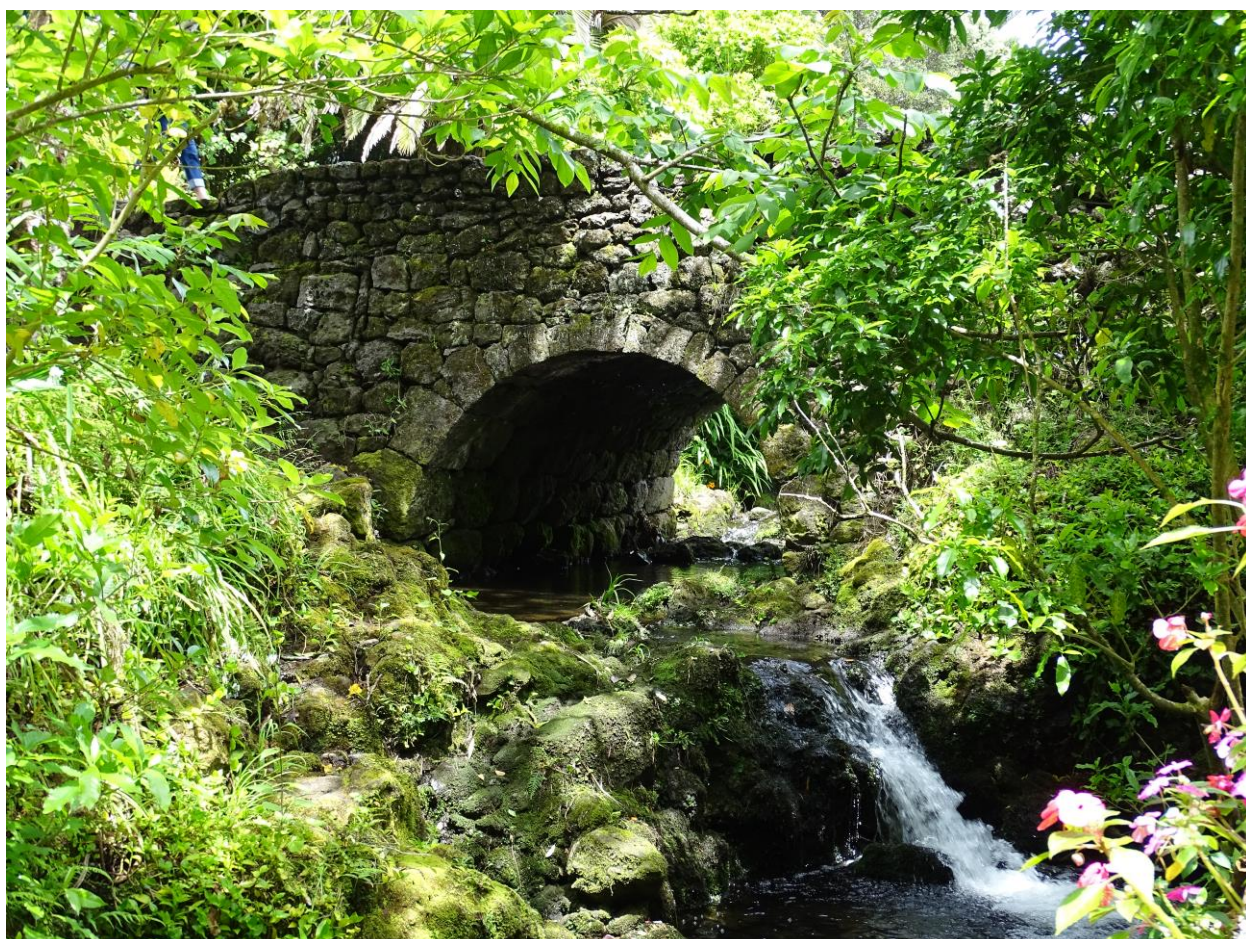
The bridge itself is obviously quite small, but rather lovely.

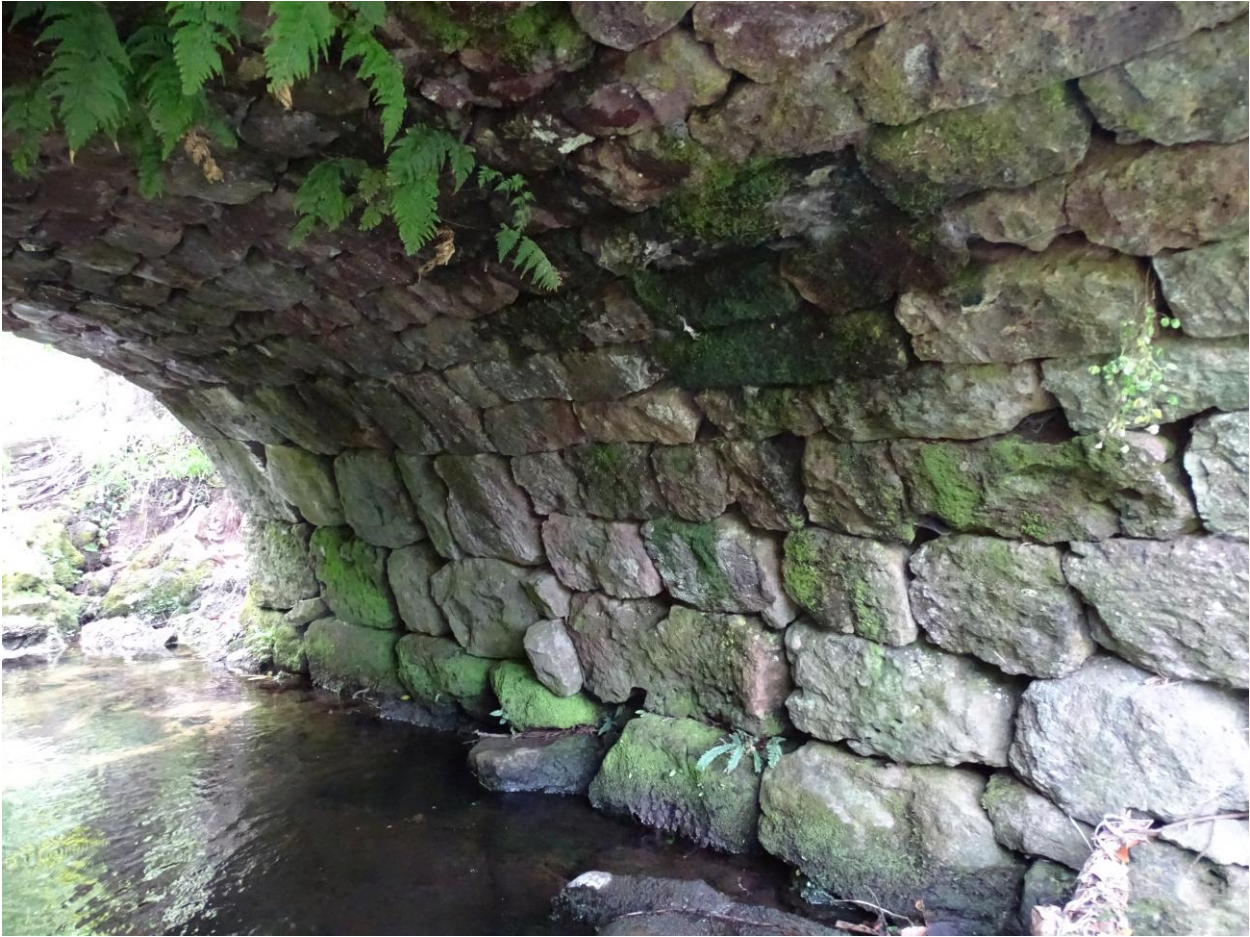
The whole thing seems to be dry stone.

The nature of New Zealand weather means that this suffers regular and severe flooding but is still looking on good sound condition.

Not much more to say except that just as I type this I notice that it has been widened. At the point where the bottom three courses merge into two there is a butt joint that continues right up over the ring. My only defence in not noticing this before is that I had very little time and very poor light. Modern cameras can see much better than we can. Such things need to be noticed.
