Bridge of the Month No 55, July 2015 Manton, Nr Rutland

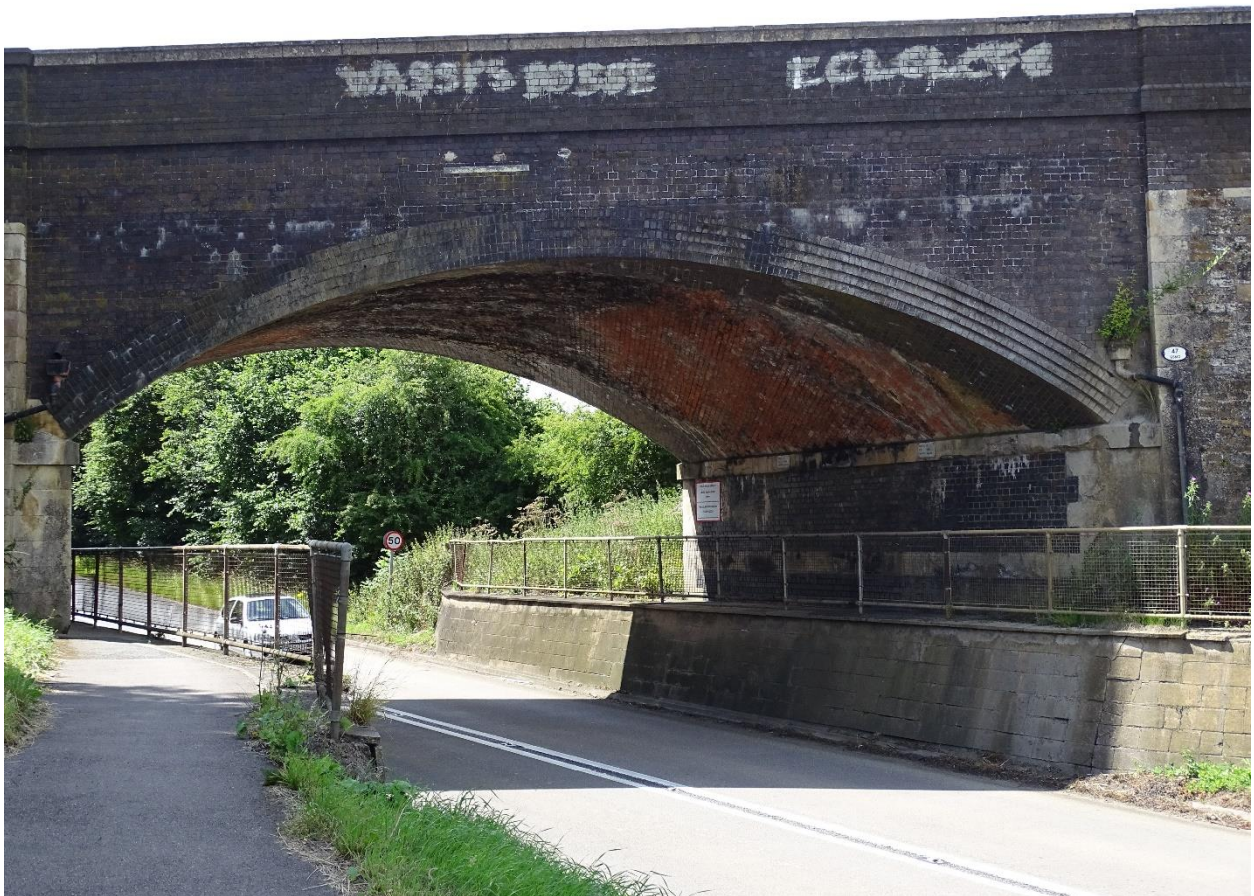
The first thing to note in this GA shot is the raised walkways beside the road. In fact, I think what we are looking at is the opposite, the road has been dug out to provide sensible headroom and the walls support the original foundations.

The bridge is skew by about 30 degrees, and has a relatively shallow arch. I didn't have time to measure but about 6ft rise on a square span of around 30ft.

The original face of the buttresses and the ends of the abutments are stone, but it is clear that most of the rest has always been brick. Much of the arch soffit is of poor grade (though apparently perfectly adequate) bricks, but a lot of the visible surface has been replaced with high quality blue bricks.

Notice that the stonework finishes just about at the level of the arch extrados crown and there is an obvious joint at that level. I think that everything above there has been rebuilt. I suspect that there might have been a simple stone cope on top but an opportunity was taken later to add higher spandrels and brick parapets.

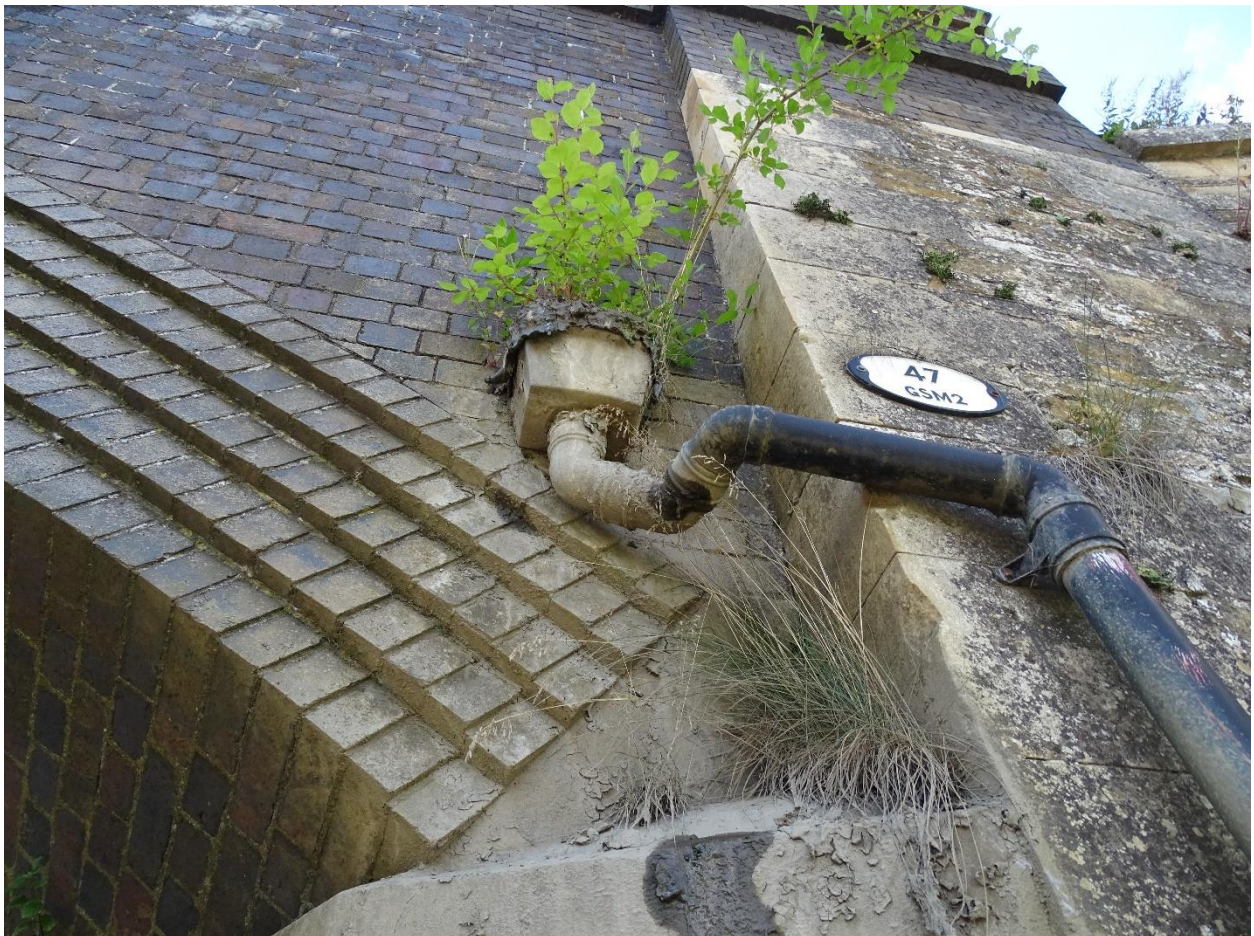
As ever, neglect is taking its toll. There is a drain at each corner carrying water out through the spandrel.

They are positioned fairly low, so almost certainly the drain slopes uphill into the structure. Here we see a considerable flow of mud which has blocked the drain. There is now a tree growing.

I think we can assume that this damage is caused by the water/mud rather than anything substantial structurally wrong.

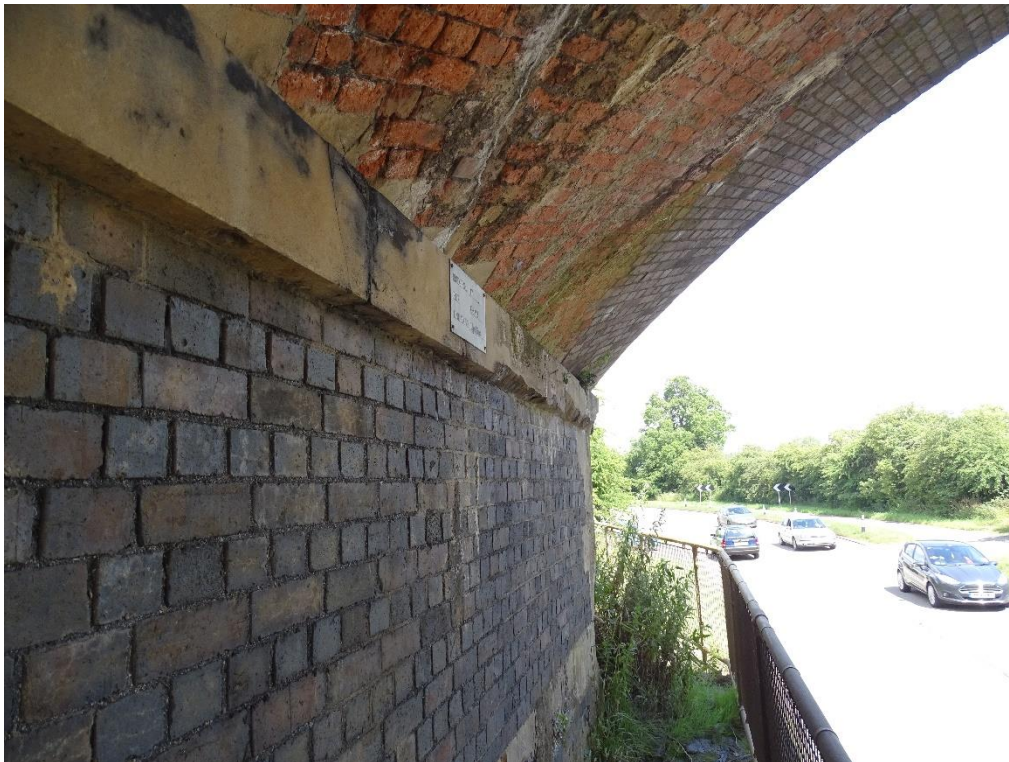
While that below, though clearly close to the water supply must also be influenced by stress.

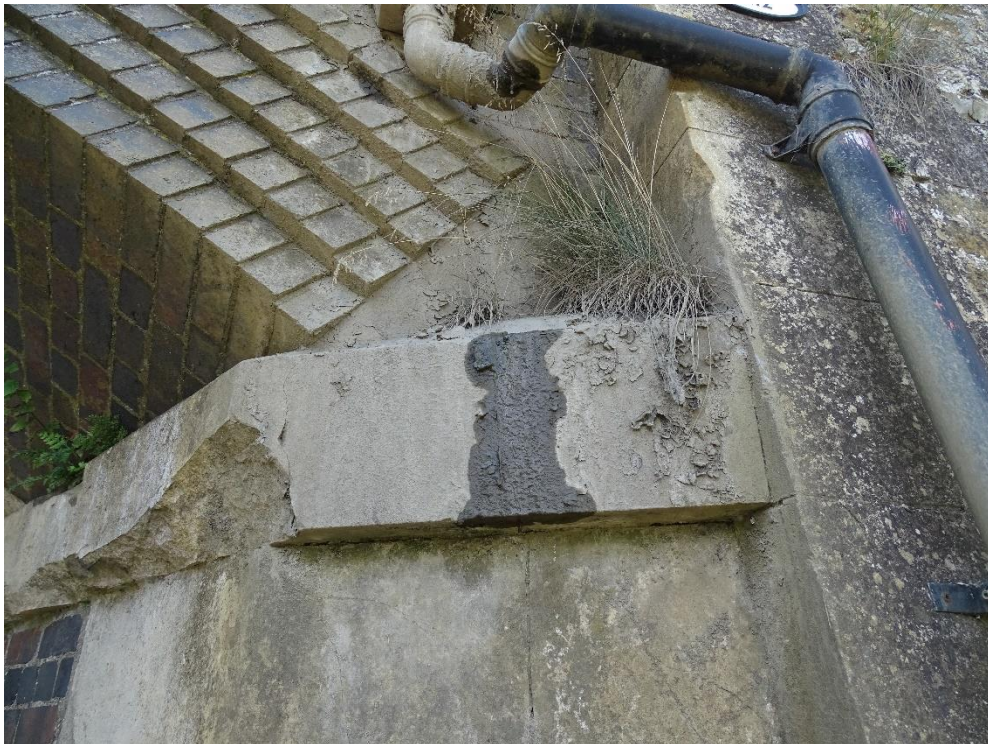
That becomes clearer looking from the other side where there is a fracture running from the edge of the abutment to the springing intrados.

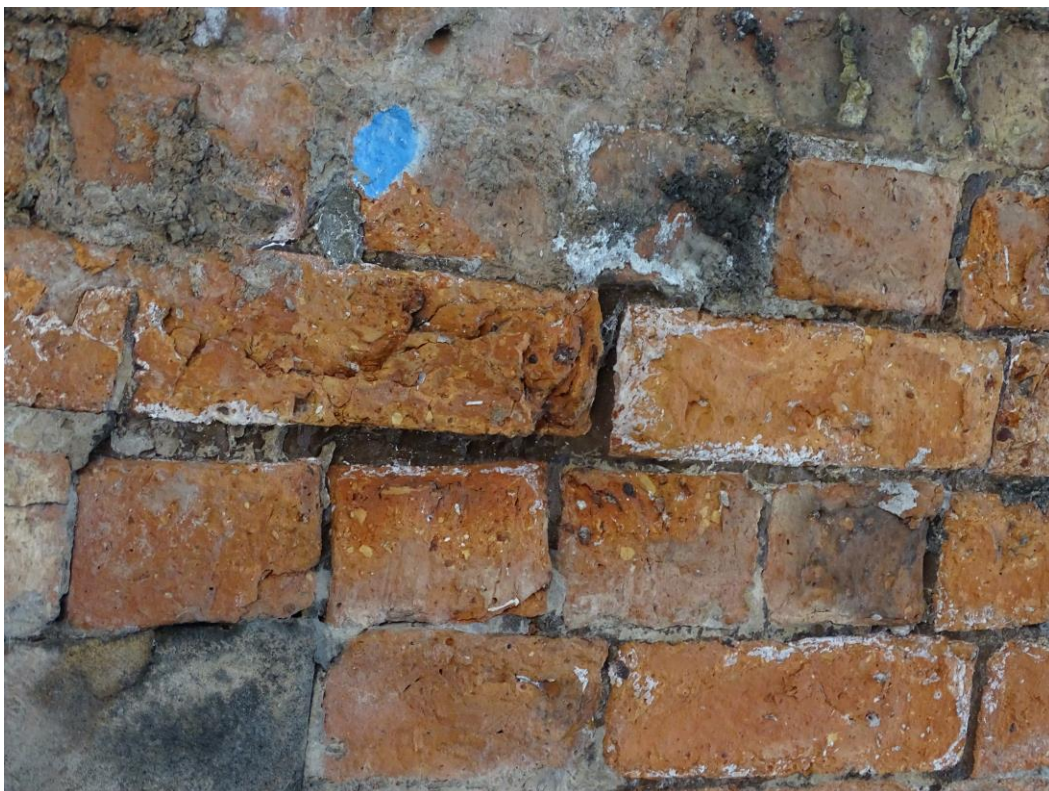
A close up view shows the poor quality of the original bricks. Anything behind the skin is likely to be less sound than this.

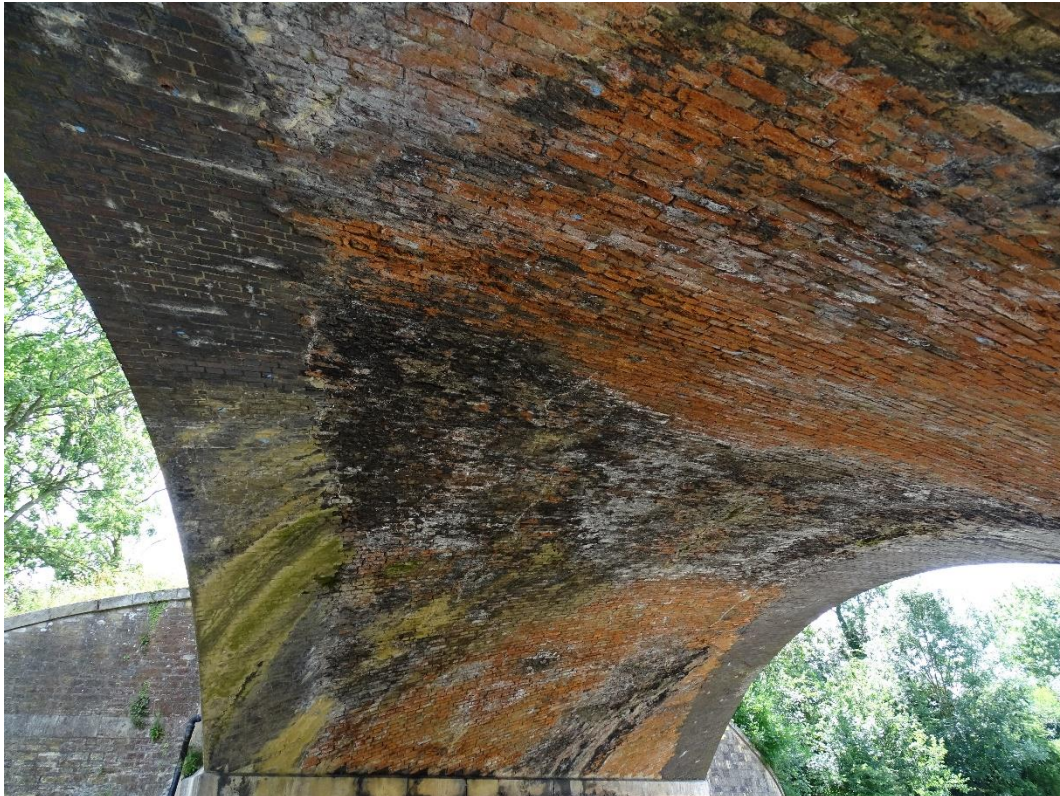
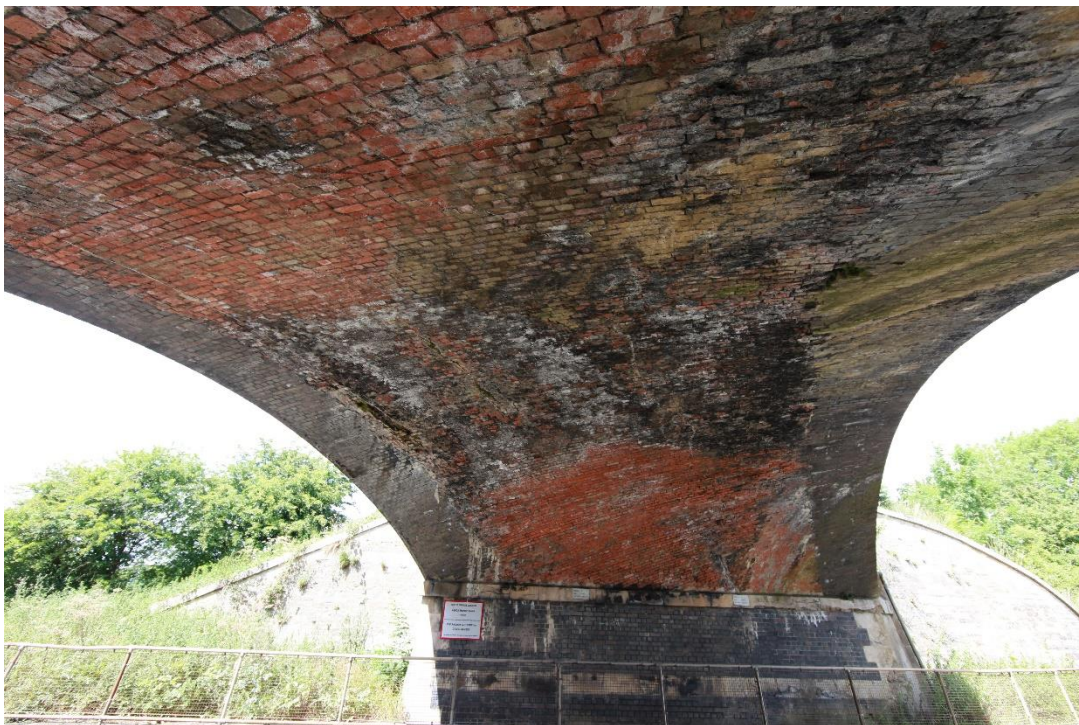
A look at the soffit shows that one edge has been completely rebuilt. Note that these photos are taken with a moderately wide angle lens, 24mm (equivalent, actually rather shorter in reality) on a Sony HX400V, so they distort the image slightly but show almost the whole soffit in enough detail for a close examination. Putting alongside that what can be achieved with a 14mm lens on a Canon EOS5DMk2 is perhaps worthwhile.

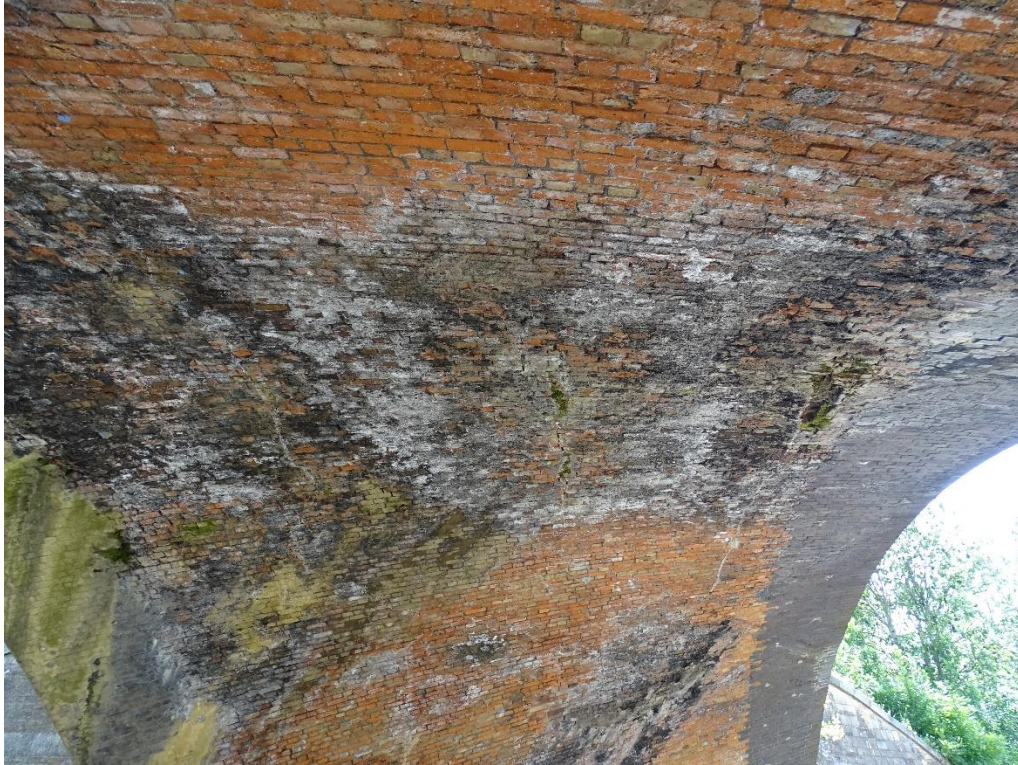
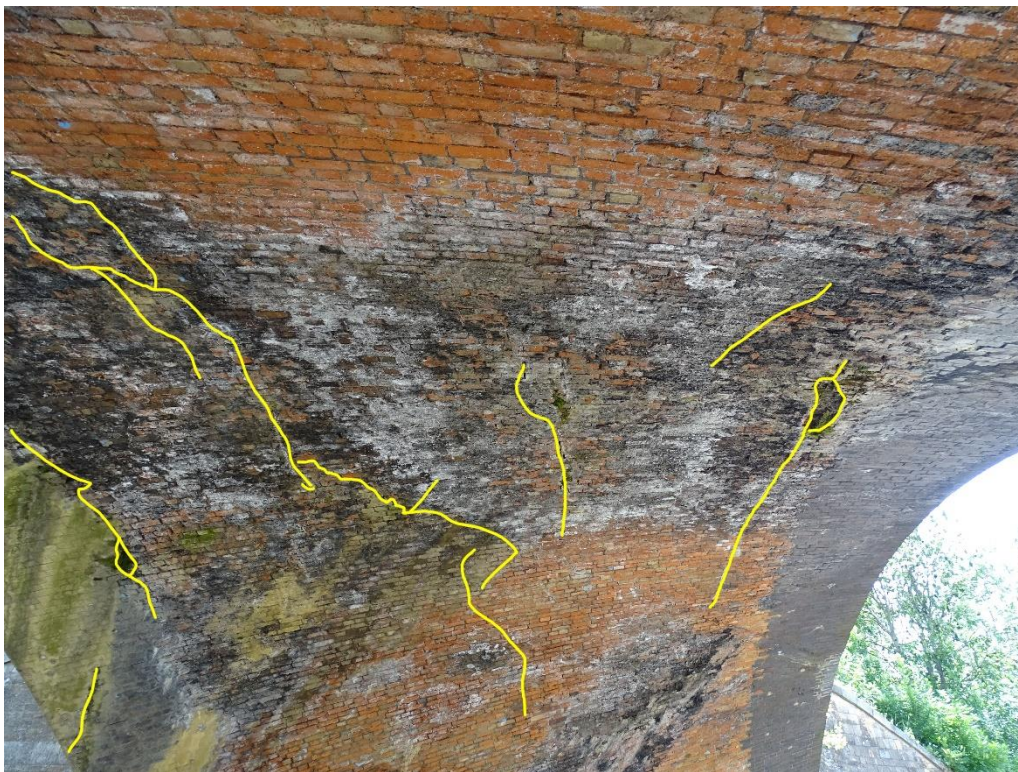
This shot is taken from close to the bridge centre line and shows almost the full width. Cracks are visible (some actually marked with chalk) that look as though they run parallel to the tracks and possibly directly under the rails above. It is also from the Sony, zoomed in a little, perhaps to about 35mm equivalent.

One last comment, though, these parallel cracks in skew bridges are something I first came across in the past year. I haven't worked out yet how they are caused or why they seem to be (at least so far) peculiar to skew bridges. Serious thinking time but any ideas to bill@obvis.com, please.

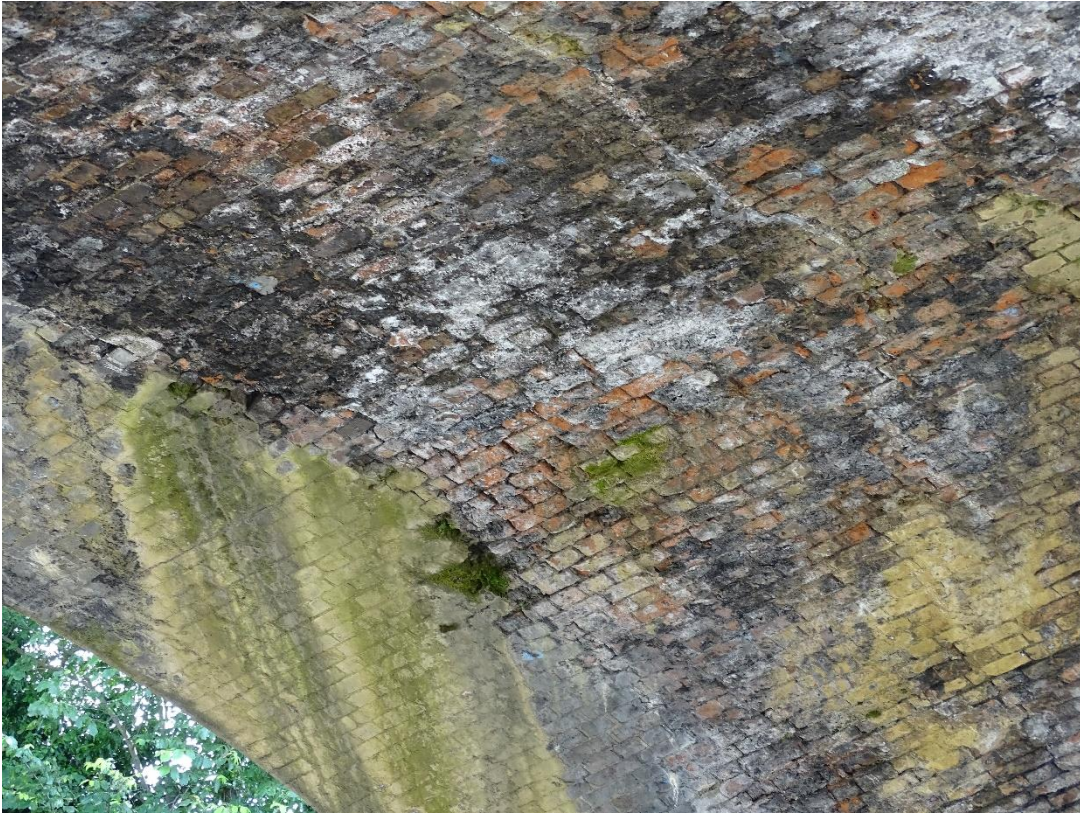
And finally, A closer look at one of those cracks, showing how busy it is. Mud flowing out, damage to the bricks. What can be done to upgrade this, I wonder. A matter for some thought. Perhaps we will return to it.
