The railway in Bath is interestingly routed. Obviously Brunel wanted his station in the city itself but there was no way in or out so he carried it along the opposite bank and crossed the river Avon with two skew bridges to plant it just on the very corner <https://goo.gl/maps/z0PzV>. The viaducts approaching the river on the two sides are remarkably different. I recently had a day holiday in Bath and wandered down here. There is a lot going on. My descriptions may seem uncritical to some readers but it is important to note that:

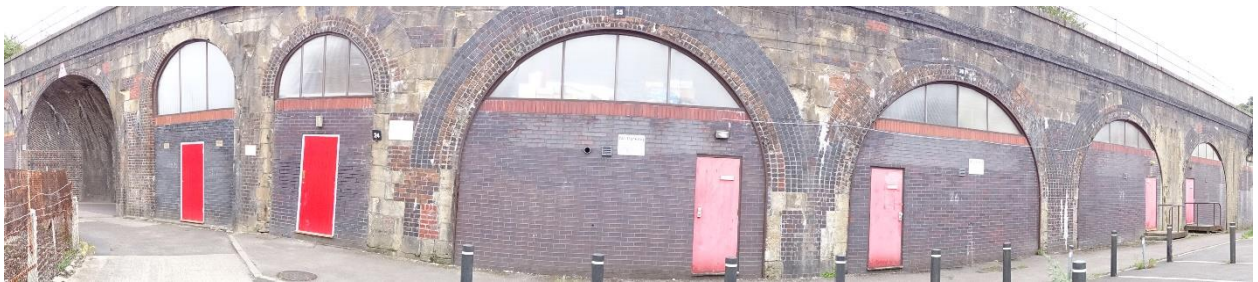
This sweep panorama (modern cameras are wonderful) distorts things somewhat, indeed the viaduct actually curves around the photographer, but it does provide a general picture.

The river is to the right here. The span just visible to the left is skew and the next two short spans are closed at the inside because they are making space in an otherwise massive abutment.

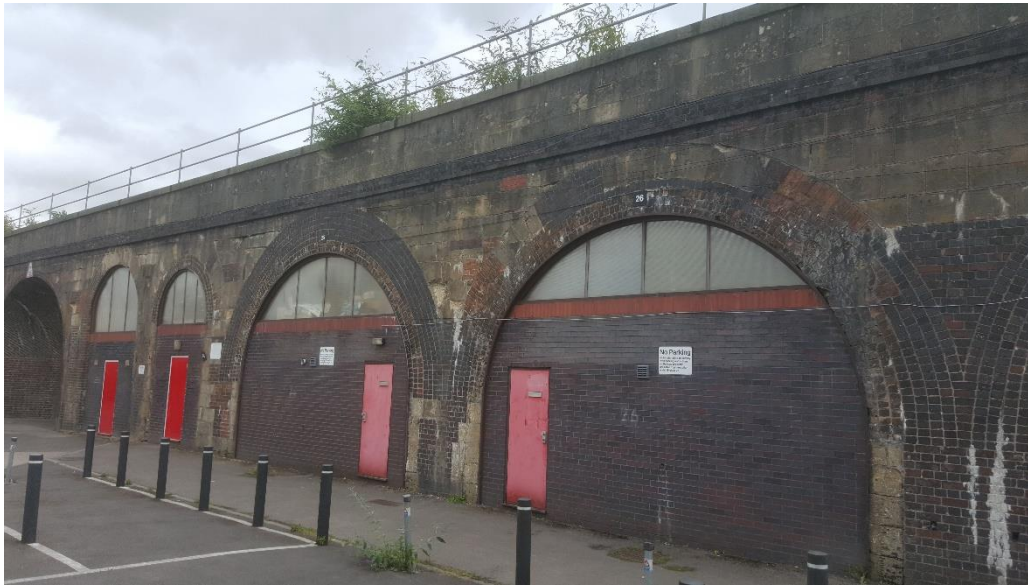
The stone is a bit grubby but I think it is clear that the whole thing was originally Bath Stone. As I was just returning from a week working on Archie in Hungary, I had no measuring equipment with me but I think the original spans were about 20ft (6.1m). The most prominent arch here looks very thick but as we will see it has been reskinned and under ringed.

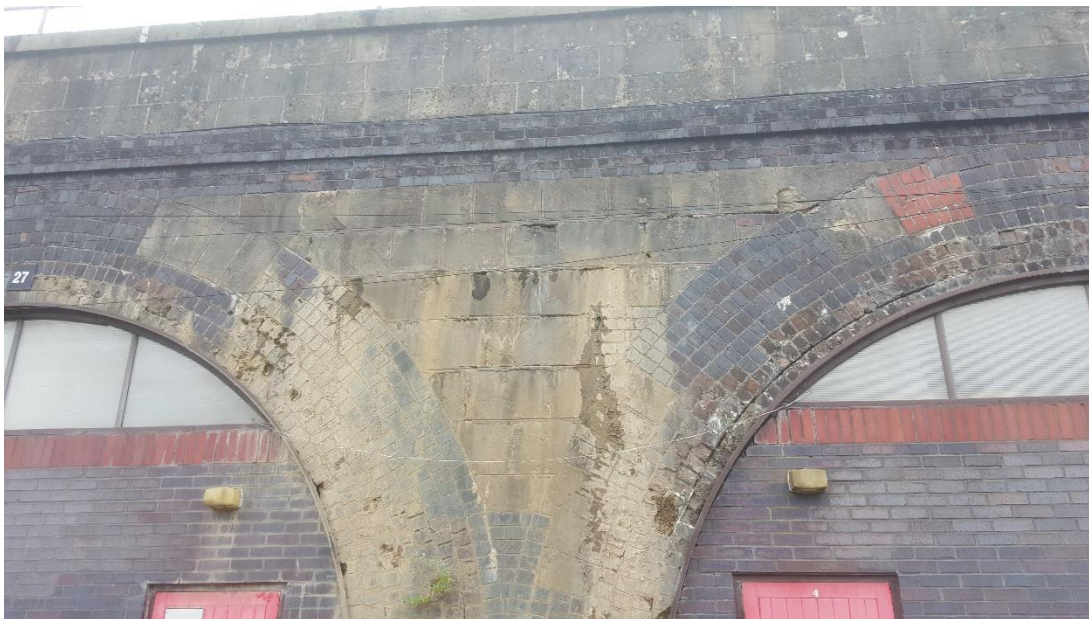
This, less distorted shot allows some of the history to be extracted. The stone voussoirs at the crown and quarter point of span 26 are apparently 18in (457mm) thick. Where it has been patched it is just 4 bricks. At the springing the pier face seems to align with the bottom of the fifth ring with an additional 3 added later. I suspect this shows two phases. A single under-ring and re-skin followed by 3 more when that didn't stop the movement, for movement there certainly was.

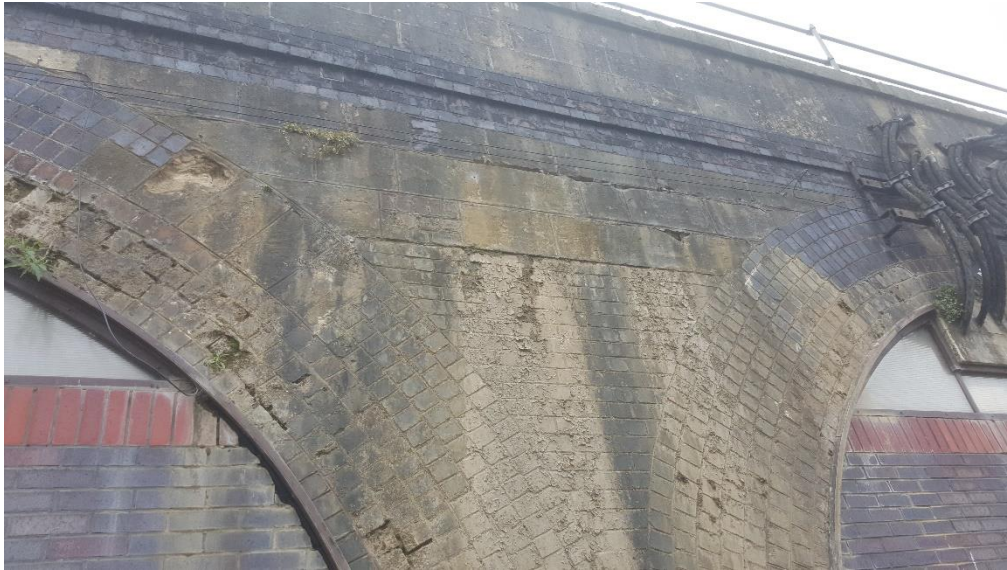
A closer look shows all sorts of things. Perhaps the most obvious is the stream of mud apparently coming from the full width, including through the ring at the stone voussoir on the left. At the next course up the stone is spalled over some length and at the right, the damage progresses into the ring. Also at the right, the inner ring seems to be separating. In span 27, the separation at the crown above ring 2 has created a path for the muddy water again.

The stone parapet seems to be both original and sound. The band of brickwork below it, though, suggests that there has been damage at this level.

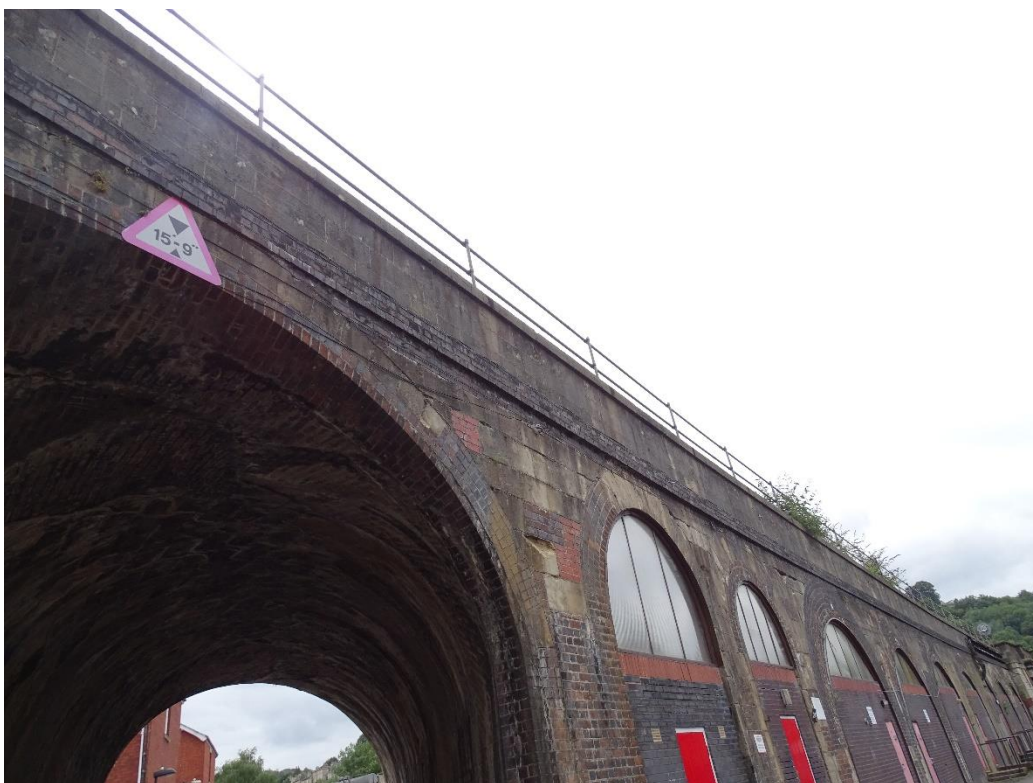
Looking to the right, the damage continues and is perhaps worse. The stains on the ring in span 29 (to the right) show that it is articulating enough to allow mud through 5 rings.

The process driving this behaviour is described in detail in a paper recently submitted to ICE. This is not the place to do more than note the damage and ask readers to look out for similar things and let me know please.

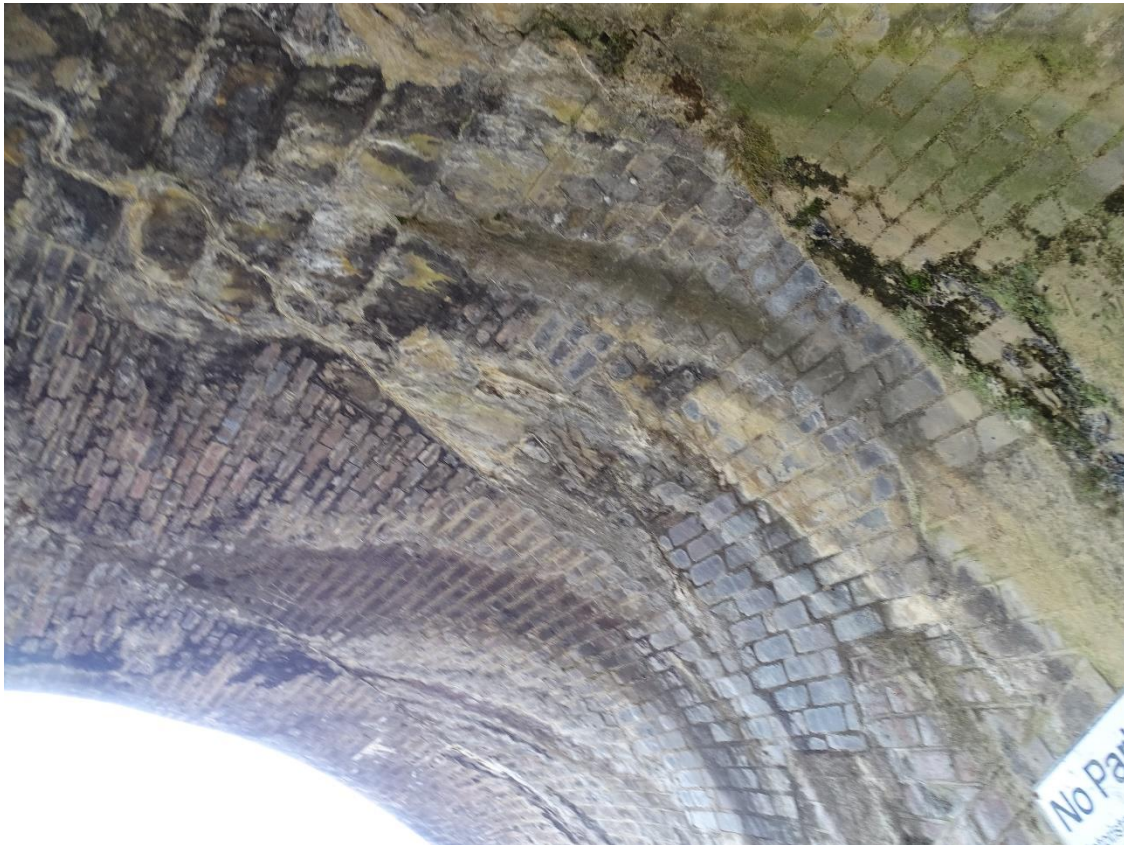
Looking along this run from the East we can see why this span has not been lined. To do so would be to severely restrict the access for traffic through this skew span. At the far end we can also see the main river spans.

The skew span also exhibits damage that I first came across recently.

These cracks run more or less along the skew and there are many more of them than one might expect. I am still struggling for ideas about how this happens.
