The role of serendipity in finding strange bridges is really quite outstanding. Last week I had to attend a meeting in Telford but arranged to meet various people on the way. I changed trains in Cheltenham and had an hour to spare so wandered across the road for a coffee. I was reminded of the fact that there is a [cycleway on a disused branch](#) and noticed a bridge over it so let's have a look. What I found was this!

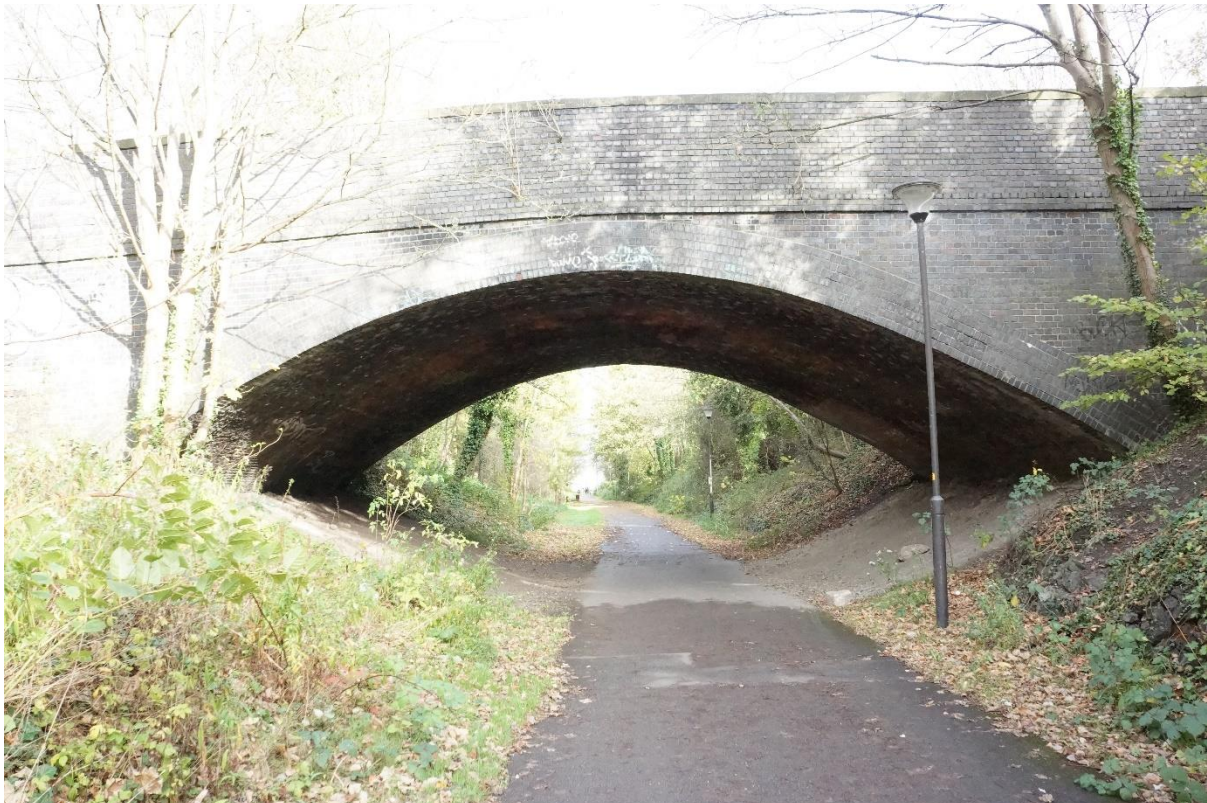
What a strange shape. If you find time to look yourself, follow this [link](#).

To move like this, some degree of spread of the foundations is necessary, but one would expect that to lead to an overall drop at the crown, not preferential rotation of the outer sections of the arch. The nature of the deformation here is quite marked. With the arch flattened almost completely at the quarter points. Of course, I didn't get to measure it, indeed it would have been difficult anyway. Counting bricks suggests about 40ft span and 8 ft rise which would give a 29ft radius. That sounds unlikely. Are there similar but undamaged spans on the "line"? I will go and look when I can, but if anyone local can get me a picture it would be great. My own collection, even of this one, is limited because I had a dodgy memory card.

I think that the concentrated rotation at the third points indicates the end of the backing. A closer look actually shows a flattening of the arch over a considerable distance, and separation of bricks and rings in the process.

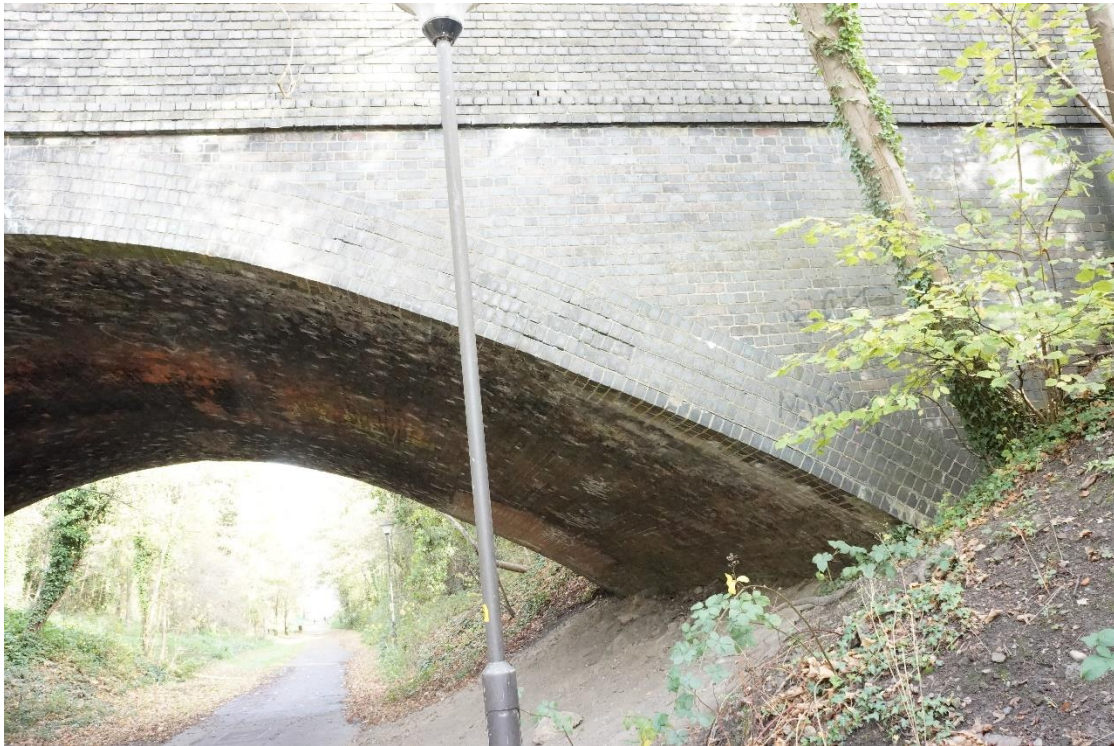
Look again, though, that bottom layer to the right of the lamp post is new and has sagged partly because it wasn't stressed into place.

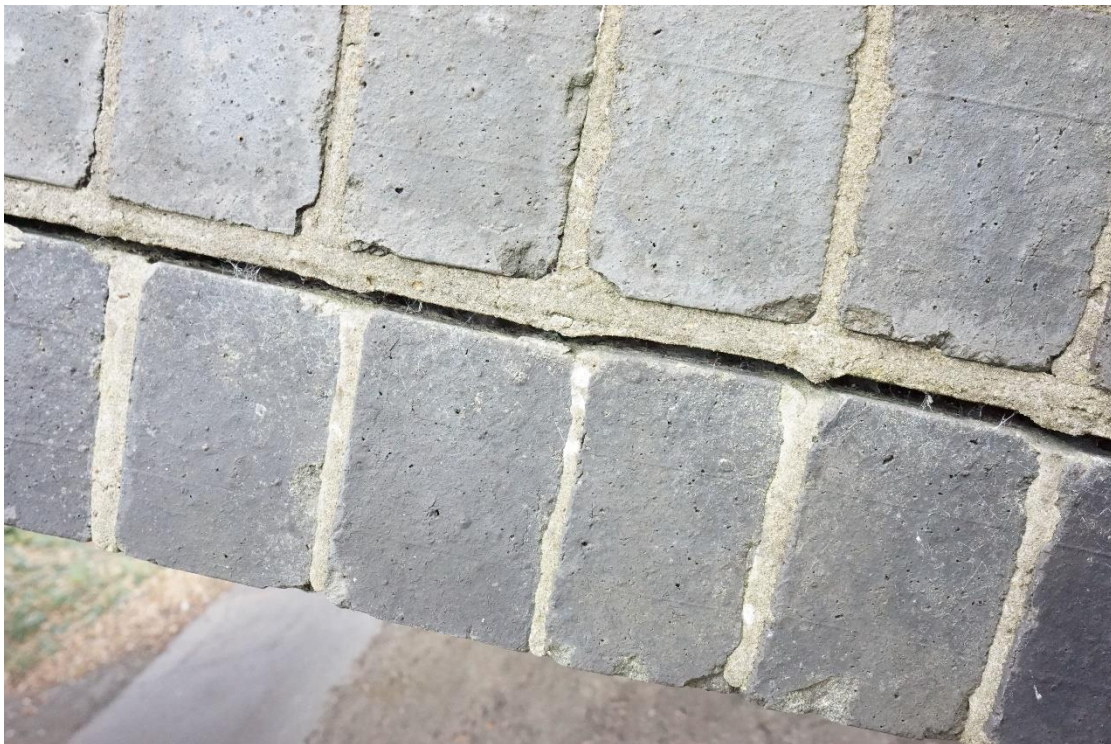
Look closer again and it becomes clear that there is substantial separation of the inner rings. But you can also see that those are metric bricks below the crack, noticeably smaller.

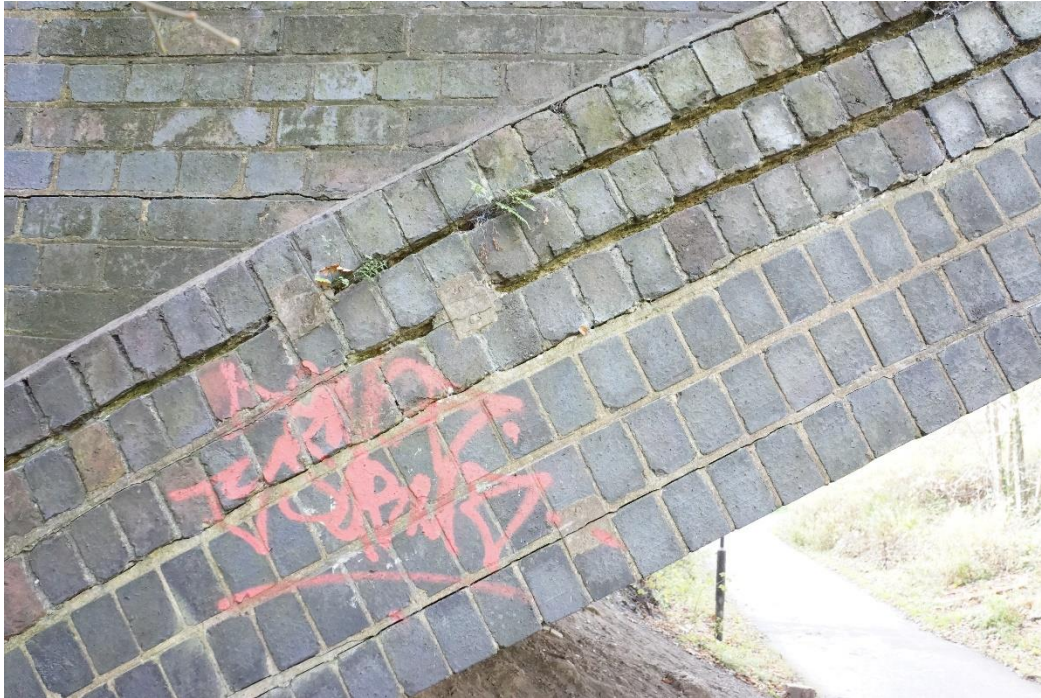
It is clearer on this side that there has been substantial repointing, but how long ago? And why was it confined to the lower three rings. Ahhh, as Hamish points out, three rings of new brick. Notice also the horizontal crack in the spandrel here. It must be related to backing level. Incidentally, that is a header in the ring just below the end of the crack.

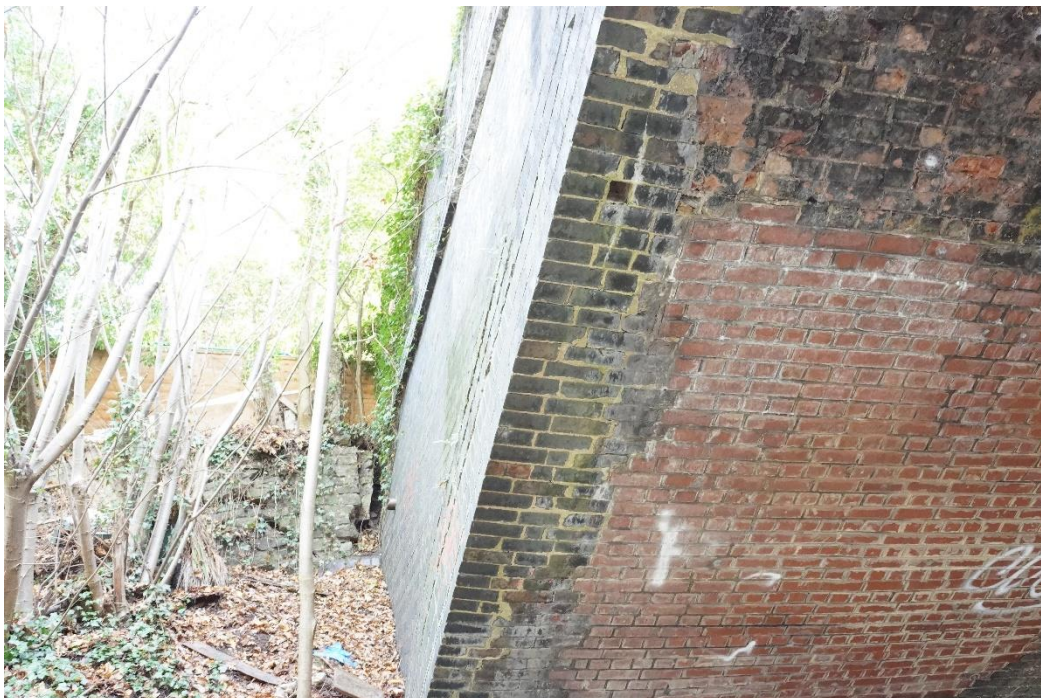
Look from below and you can see just how much patching there has been.

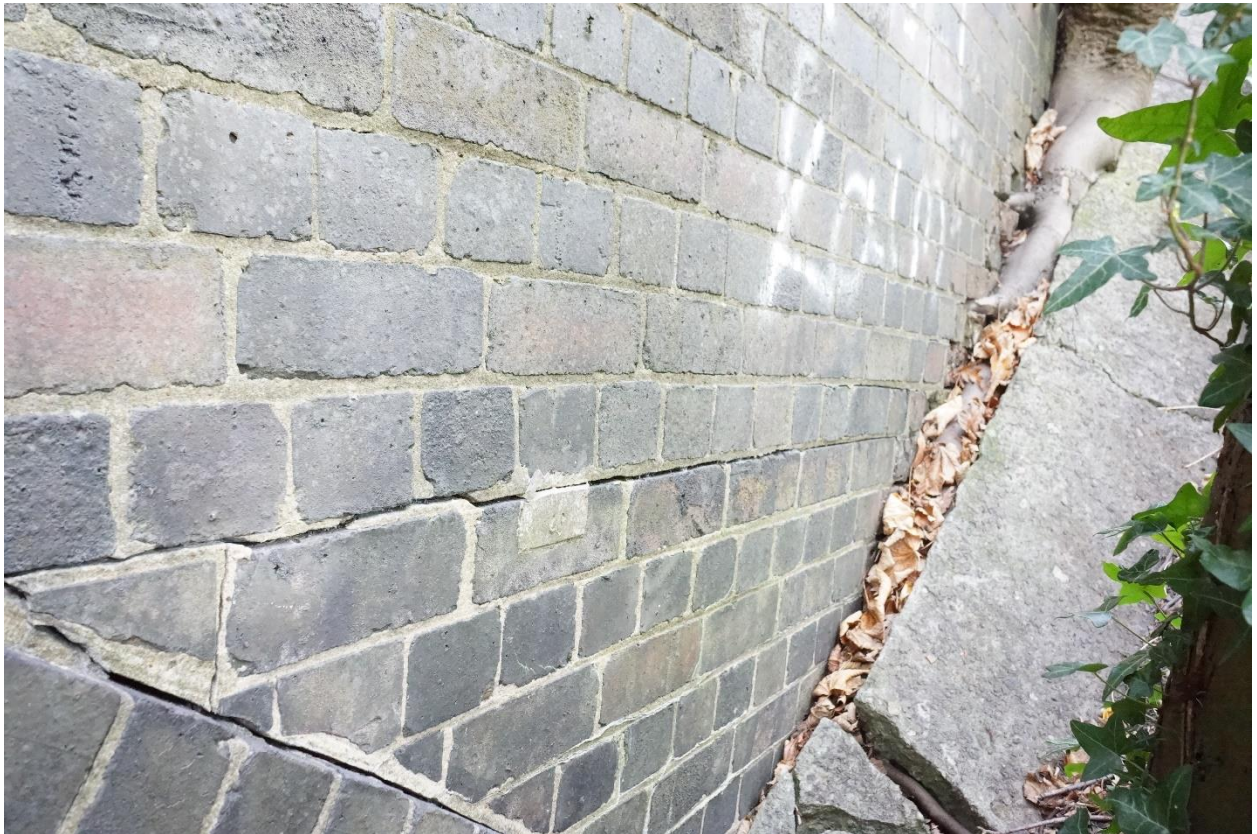
The horizontal spandrel crack is matched on the other side.

Just look at that tree getting a grip into the brickwork!
