## Bridge of the Month No61, January 20165 Natland (again)

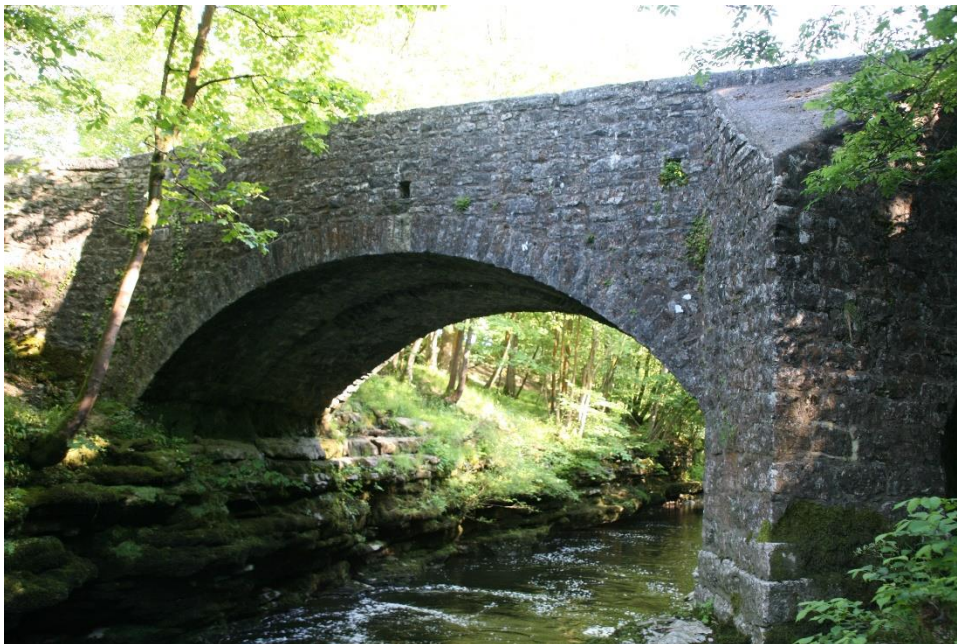
20 months gone and back to [Natland](#). Here to embark on a major review of Cumbrian damaged bridges following the flood in late in December. The scale of that issue is visible from the [map we built](#) based on the data made public by Cumbria CC. Anyway, we visited Meg again in Natland so I walked down to have a look at the little bridge there. Not high on the list of priorities but it tells us a lot about the flooding. To begin with, here is a May photograph from the last visit in 2014. There is a dry span to the right but the river overtopped the bridge this time round.

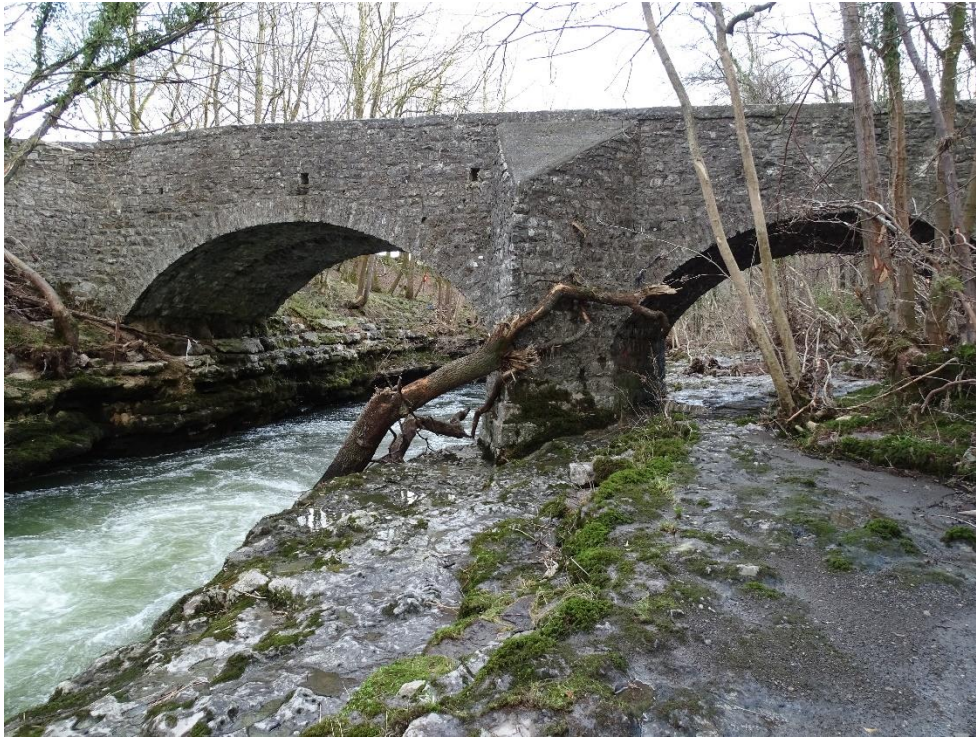
A similar view from 30<sup>th</sup> Jan 2016 is shown below. I suspect that the trees to the right helped to impede the flow and so raise the level upstream.

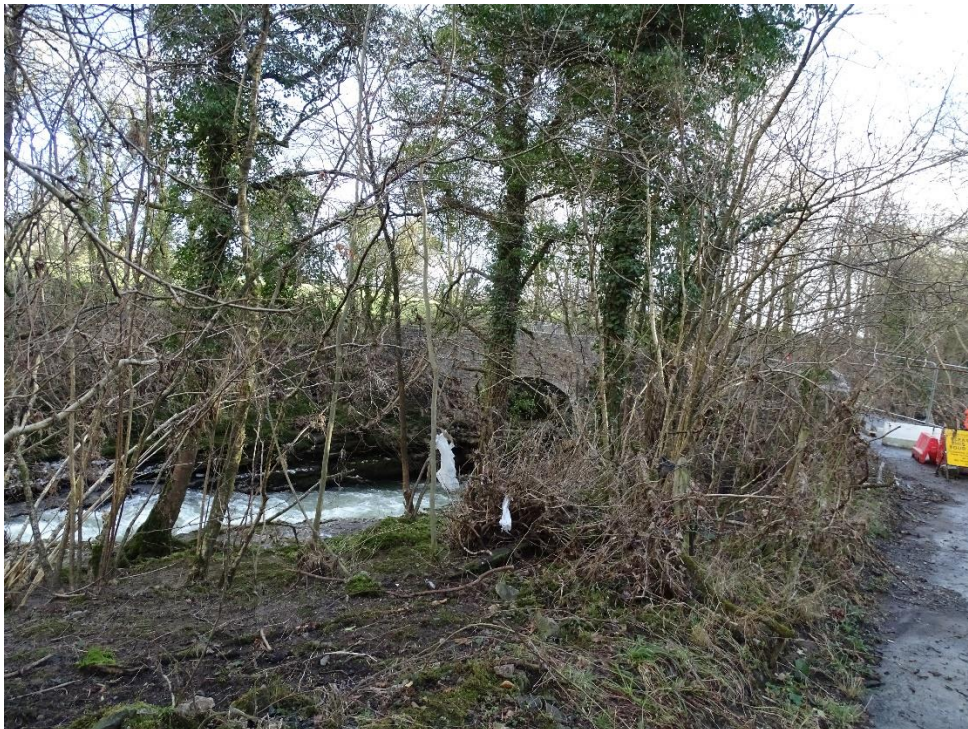
The picture below shows the approach and gives a clearer picture of the scale of the flood. There is debris in the bushes above carriageway level at the front. Part of the river flow diverted o to the road and hit the inside curve of the parapet wall taking down the wall right to foundation and arch level.

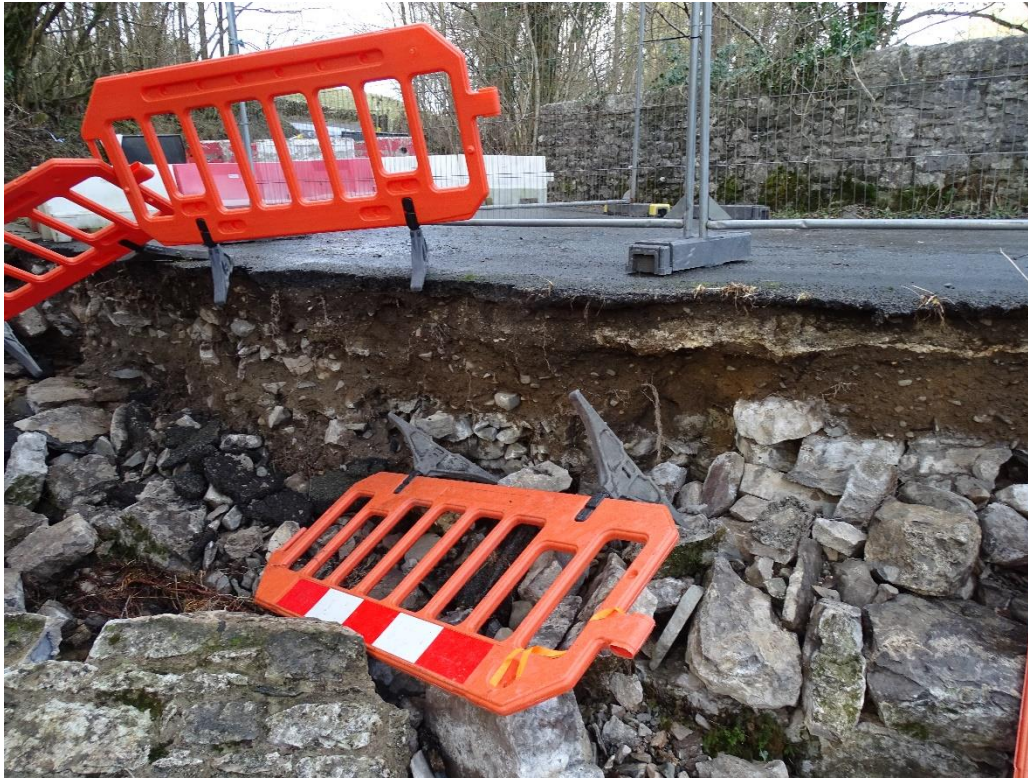
Below is a view back up the road from the fallen masonry. The river came over just above the furthest barriers.

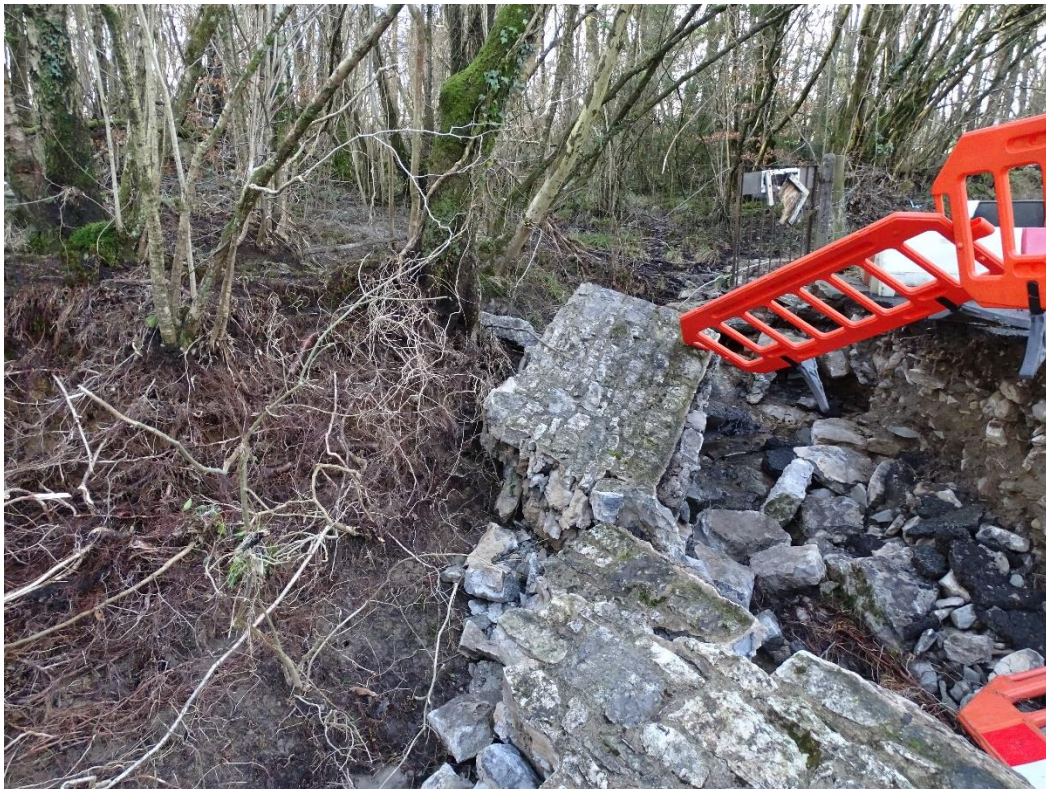
And below is the damaged wall.

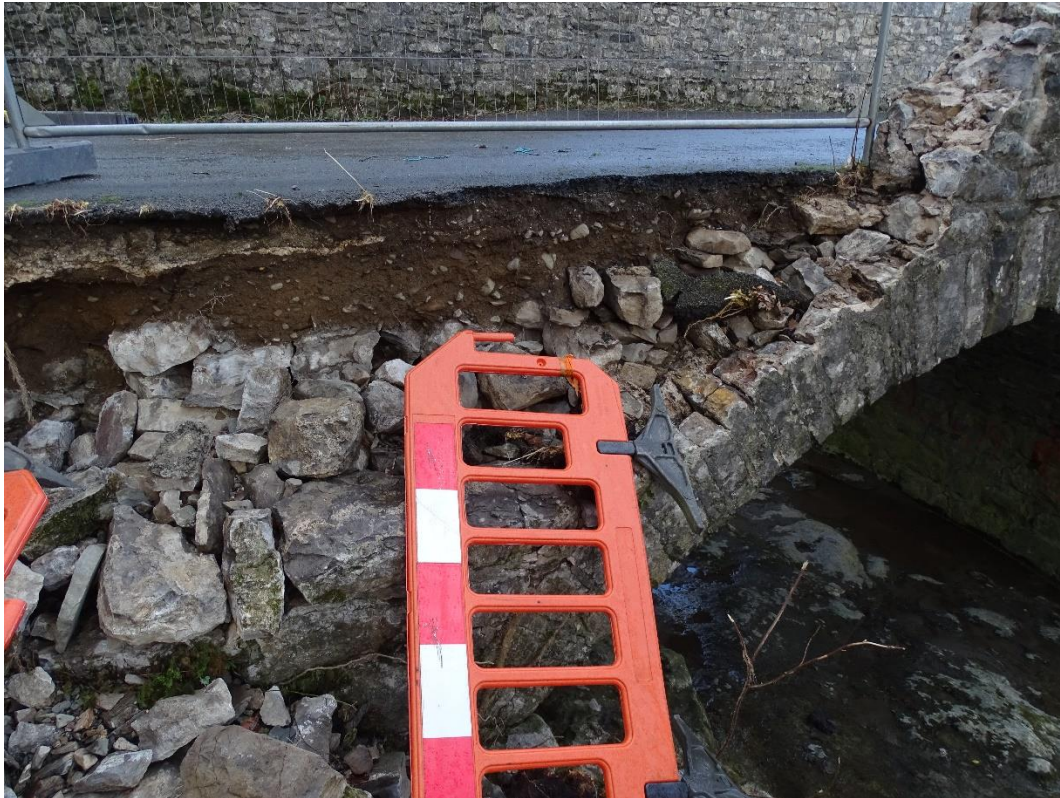
A view from the other direction shows the scale of destruction. Notice the spit voussoir stone just to the right of the plastic barrier base.

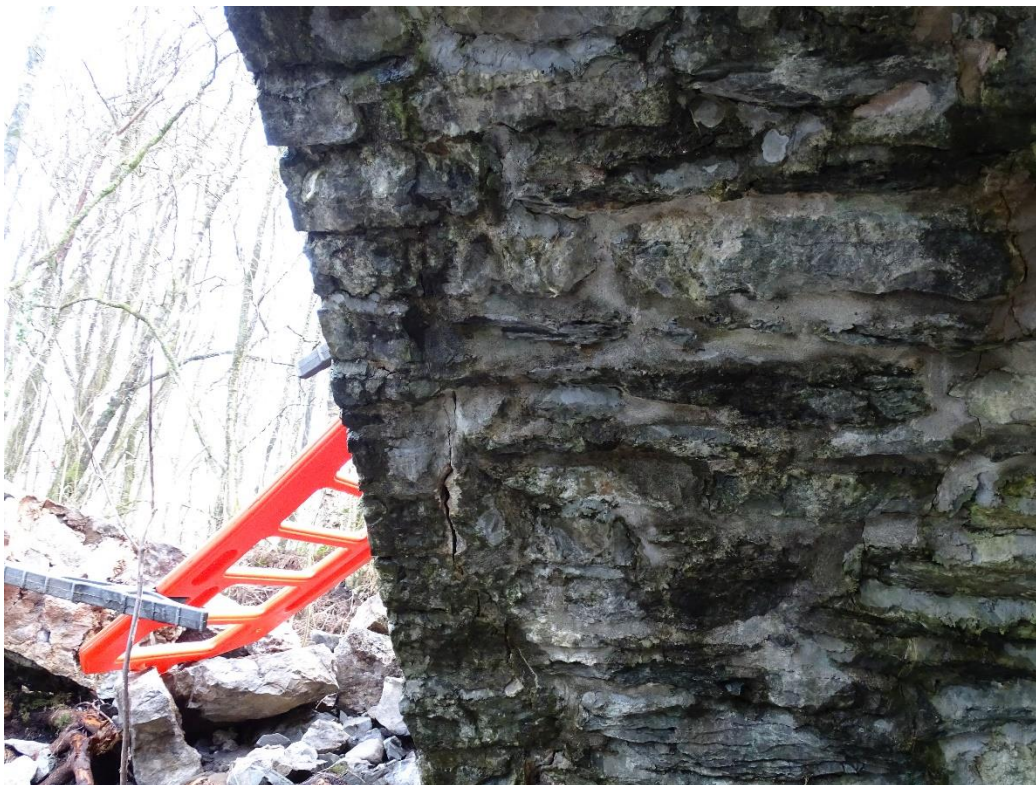
Below that crack is the most obvious place. Since I took this photo, I have been wondering about the attrition round the crack. I think that the wall must have rocked considerably before collapsing, first generating this crack and then pushing the outer stone up and down abrading the corners.

In the scale of things, this is modest damage and a sound rebuild job on the spandrel and parapet should improve matters.

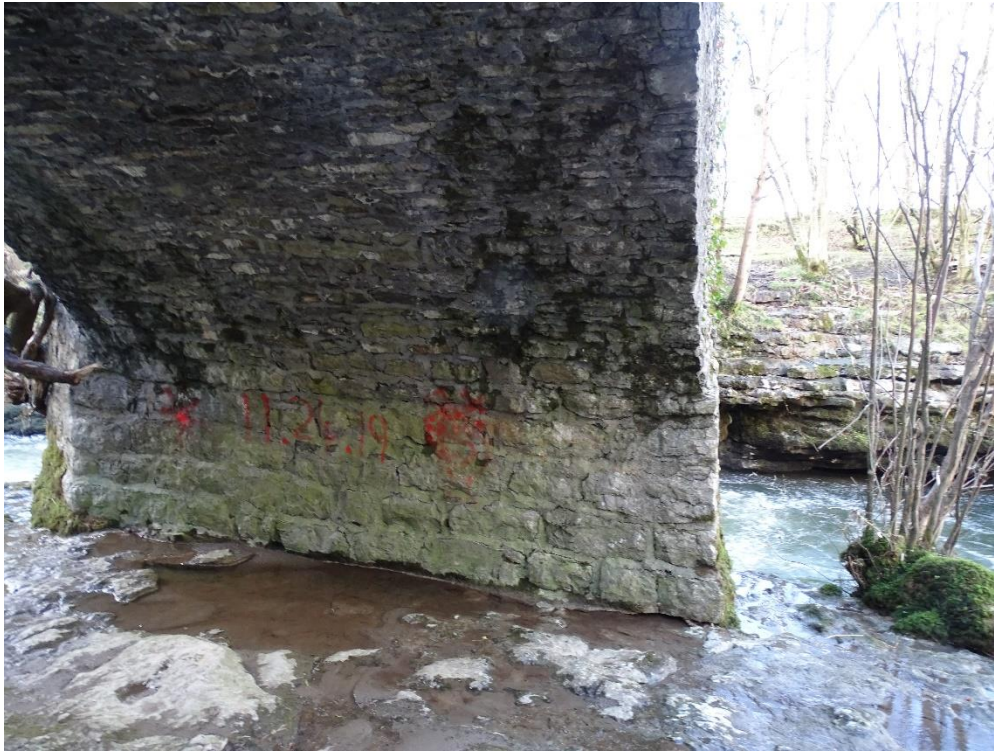
At the opposite springing of this side arch there is wash out of the mortar at the foundation and that really needs replacing quickly before it creates further damage. There are already 2 cracks visible around it. There is a crack right round the first stone, then another 3 stones in rising diagonally up the joints. Another big flood might well remove these if they are not repaired.

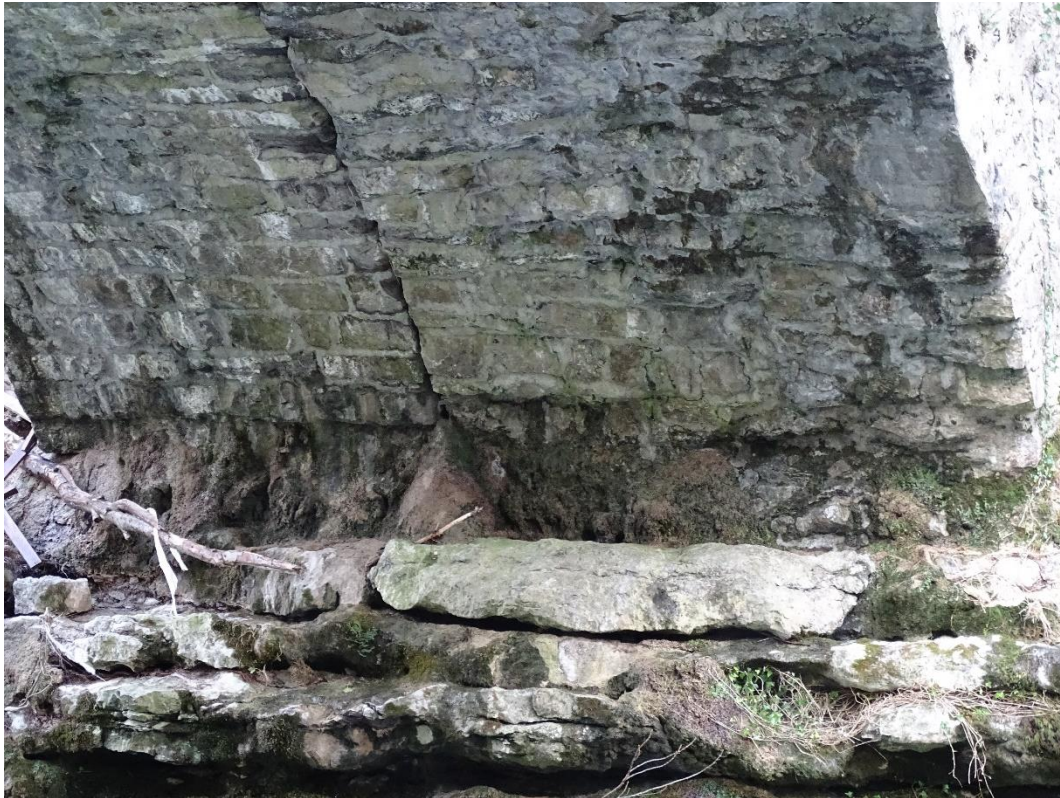
The thing that alarmed me most was the eastern springing of the main arch.

The first impression is of clay as though the stone facing has been lost. Luckily, I was able to go back to my previous set. Though I don't have a shot from this angle, the first image above can be pushed a little to reveal the condition from 2014.

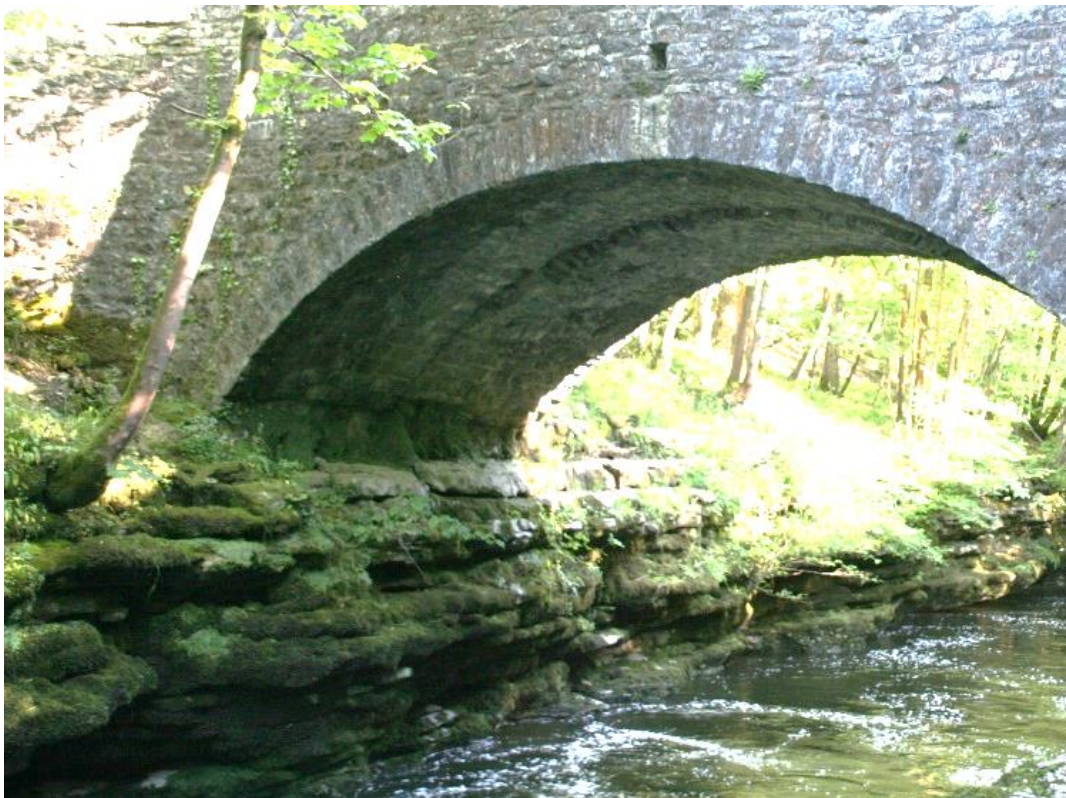
And here we see that the springing actually looks the same.

This is my biggest excuse for making a revisit this month. I am forever banging on about two open eyes and one open mind. I was here myself 2 years ago and though "surely I would have noted that"? But it seems not. On the previous visit I had seen it as exposed rock, which it surely is or it would have been washed away.
