Bridge of the Month No72, December 2016 Moco Farm accommodation bridge 3

Bridge details

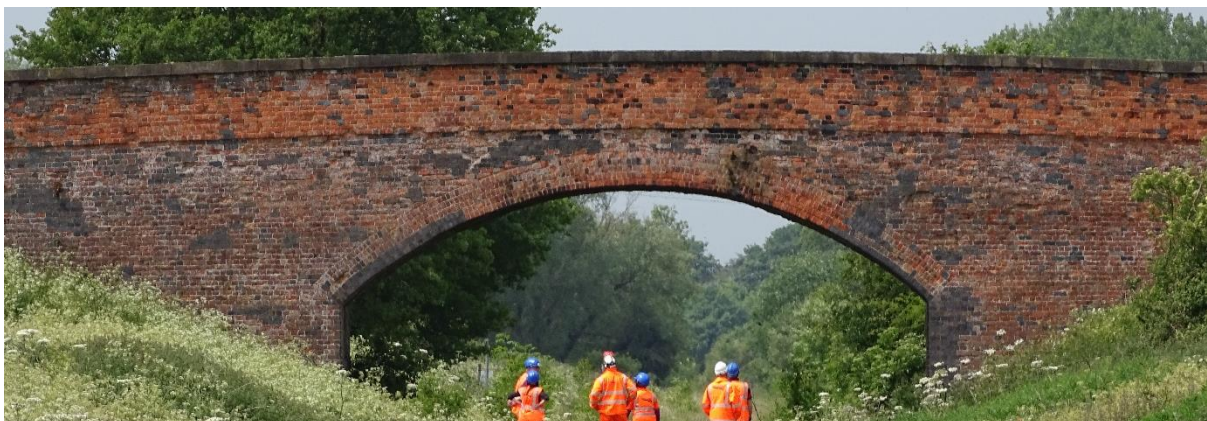
Lets begin with a general picture from our initial inspection. There are a lot of blue bricks scattered through there and it is reasonable to assume they represent the position of the worst deterioration to develop before the railway was closed. There are noticeably more in the paler band below that shadow line at the bottom of the parapet. It is unlikely that the bricks there are of generally worse

quality so it seems likely we are seeing the effect of water penetration, meaning that the wall must be thicker above that line, or at least following that line and slightly higher, since we can assume that water will run downhill as it penetrates from inside.

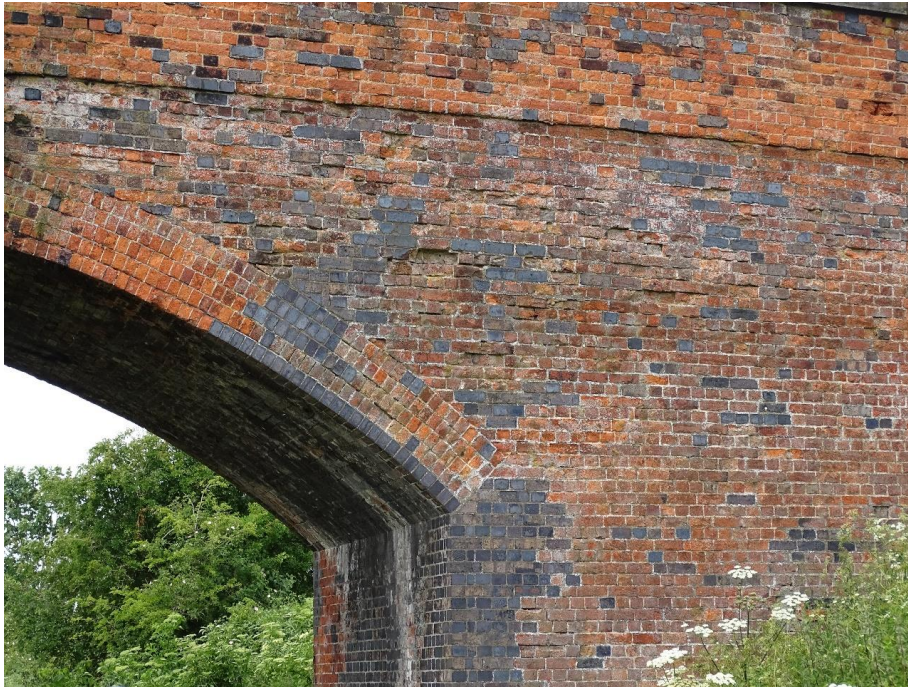
A closer look confirms that general impression. There is that stripe of paler appearance then a band that is generally darker but still severely damaged and finally the wall face looks essentially sound.

We know from the drawings that the thicker (i.e. structural) part of the wall was intended to top out at a line parallel to the base of the parapet. What isn't shown on the drawings was how that might be done.

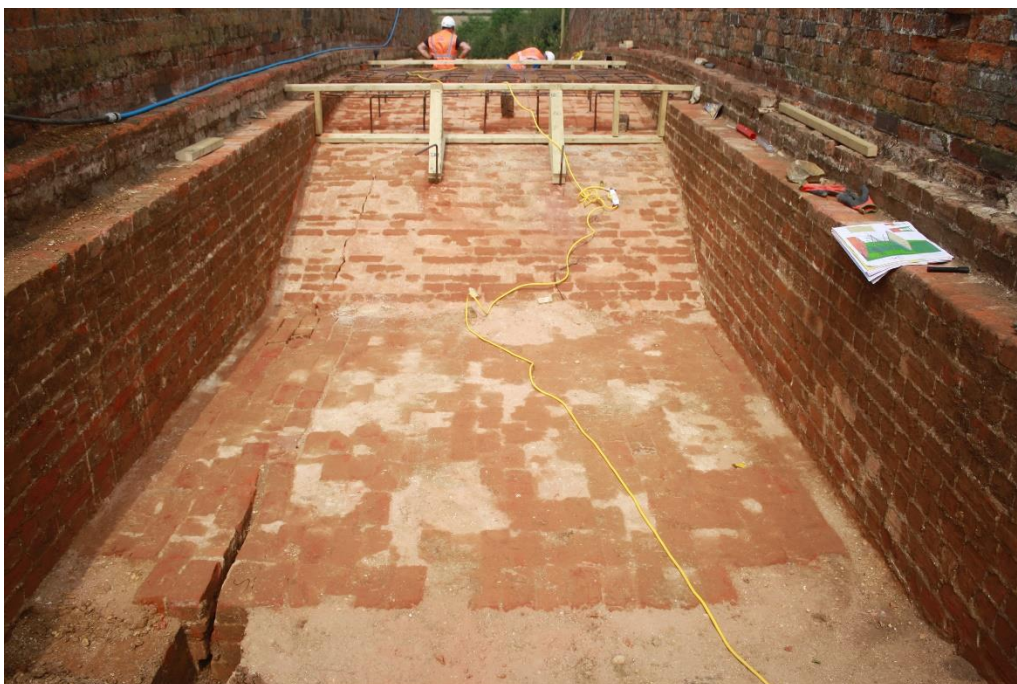
After the excavation behind the abutments (Note to self, we need to find a way to avoid doing that in future) we could see much of the detail of construction. Of course, it didn't match the drawings.

The stuff we can see here is almost worth a BoM in itself:

- The parapets sit on a slightly thicker plinth
- The spandrel walls then step out to a greater thickness with a top face and the coursing still parallel
- The backing is level topped and laid in such a way that there is no bond in the main direction of force flow. Actually they are pretty much stack bonded too so no bond in any direction.
- The wing walls step out in thickness again at backing level.
- The sloping beds of the wing wall meets the level beds of the backing at a clean but joint that suggests no bond.
- There is a much bigger crack at the backing/wing wall interface reflecting that in the arch

The wing walls are about 1.2m thick at this point. The higher level reduces to about 600mm.

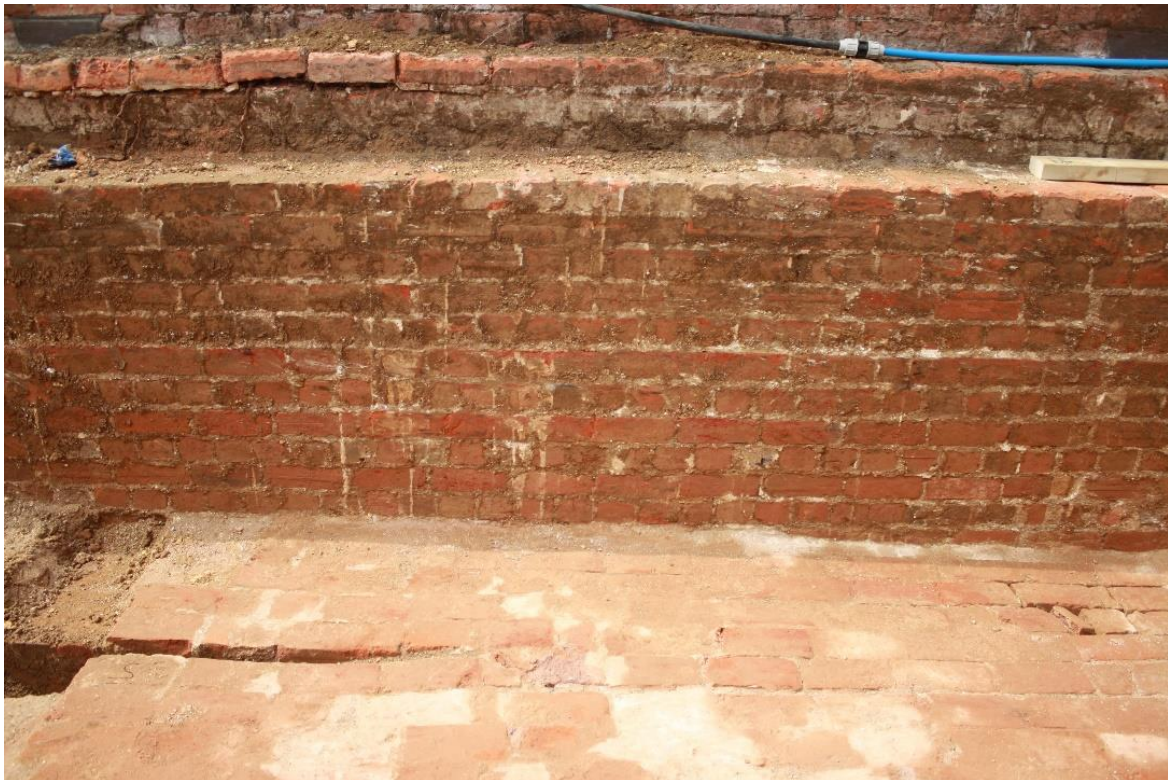
Looking to the side we can see that the courses in the upper wing wall are inclined (which means they match through thickness) whereas those of the backing are horizontal. This raises obvious questions about the bond between these two parts. Is it hit and miss, with a through brick wherever the courses lined up or is it just a butt joint?

Further back, the pattern seems to continue so that the thickening part of the wing wall is bedded on the slope while the inner part is horizontal.

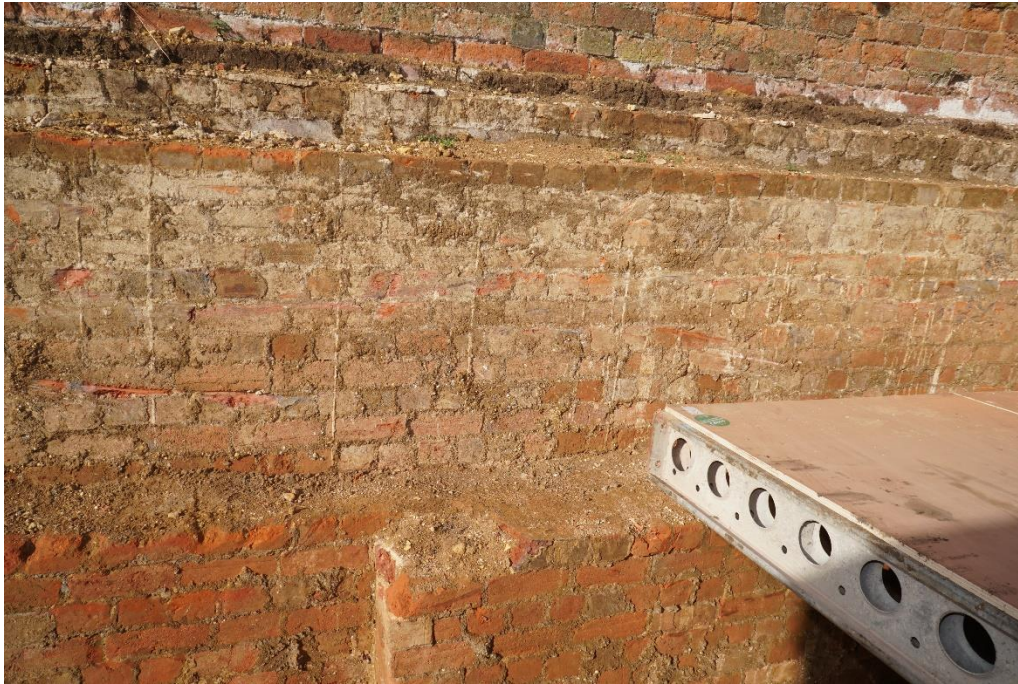
Looking in from the back end, note that the wing wall thickness steps in as shown on the original drawings.

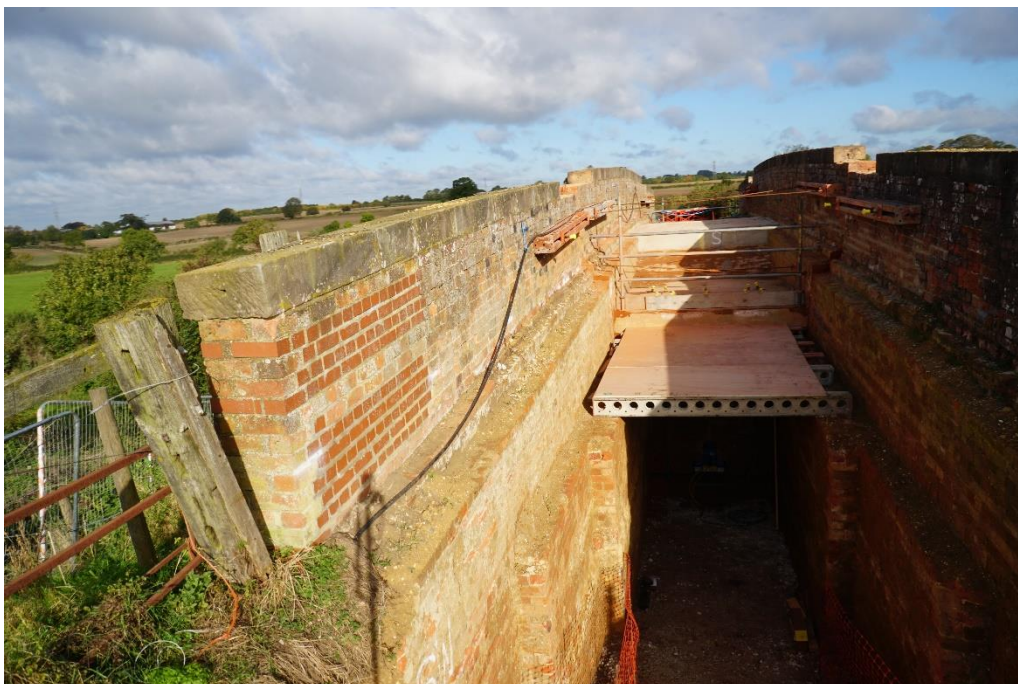
If you look back to the second picture you will see that the outer courses are horizontal at arch springing level and then progressively tilt backwards on very slightly tapered mortar beds. On the inside face, things are done more coarsely using bricks tipped up on edge to make steps. How and where the two meet remains unclear.

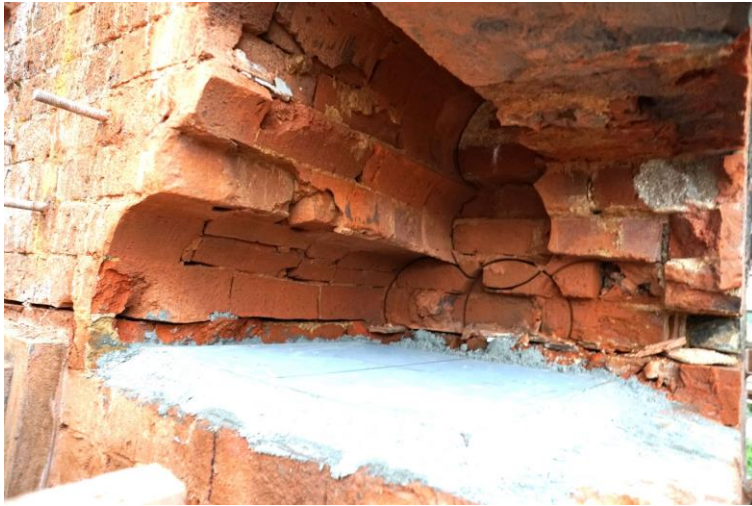
Cuts are very difficult to interpret as you will see from this where the South east corner jack was cut in.

At the right hand side here is the front face of the abutment. 5 cores were taken out to provide a seating for the jack (3 across) and space above for the ram. The bricks to the right were then deemed too exposed and were also removed. The jacks are not in place. The horizontal cut line is though and the arch is sitting on strips of steel. At the rear edge of the cut (left of picture) are three stretchers (so headers in the outer face. Next comes a stretcher in the outer face followed by bricks bonding with those below. Behind the skin, both horizontal and vertical joints are visible and aligned. The joint in the headers on the face and the one visible in the layer above within suggest that the bricks are stack bonded in the other direction. As the layers work upwards, the bond looks less complete and there is certainly a snap header in that top course.

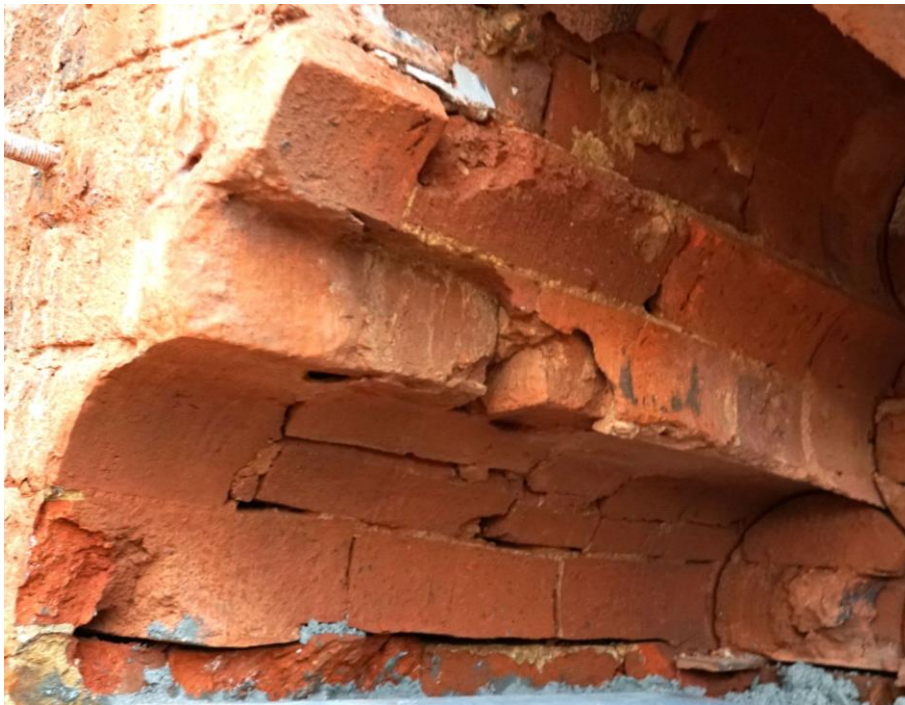
Turning to the front face, there is no apparent bond at all between the front half brick skin and the core material. This is simply confirmation of what we already knew. The abutment has been reskinned. The process of re-skinning is purely cosmetic in the worst way. It disguises not only the

poor material behind but also the fact that the apparently strong skin is not attached. It contributes nothing to structural performance. It is easy to forget that modern photographs are very high

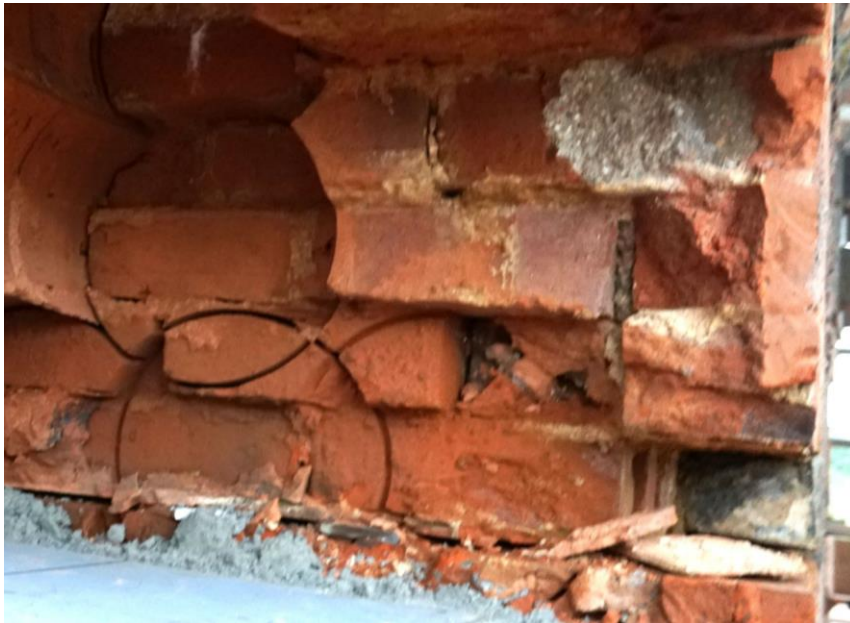
Here, the pattern of bricks one course up from the cut is much clearer, though it still looks, at first glance, as though there are two thin layers. The core actually cuts the bottom corner off one brick and then leaves just the very top corner of the next. The completely empty joint is actually vertical. What was lost in shadow at the smaller scale is the pair of headers behind which is, after all, providing bond 2 bricks back. The lack of mortar, though is quite evident and that despite attempts to grout the abutment before cutting. The mortar is obviously sufficient to cause dams.

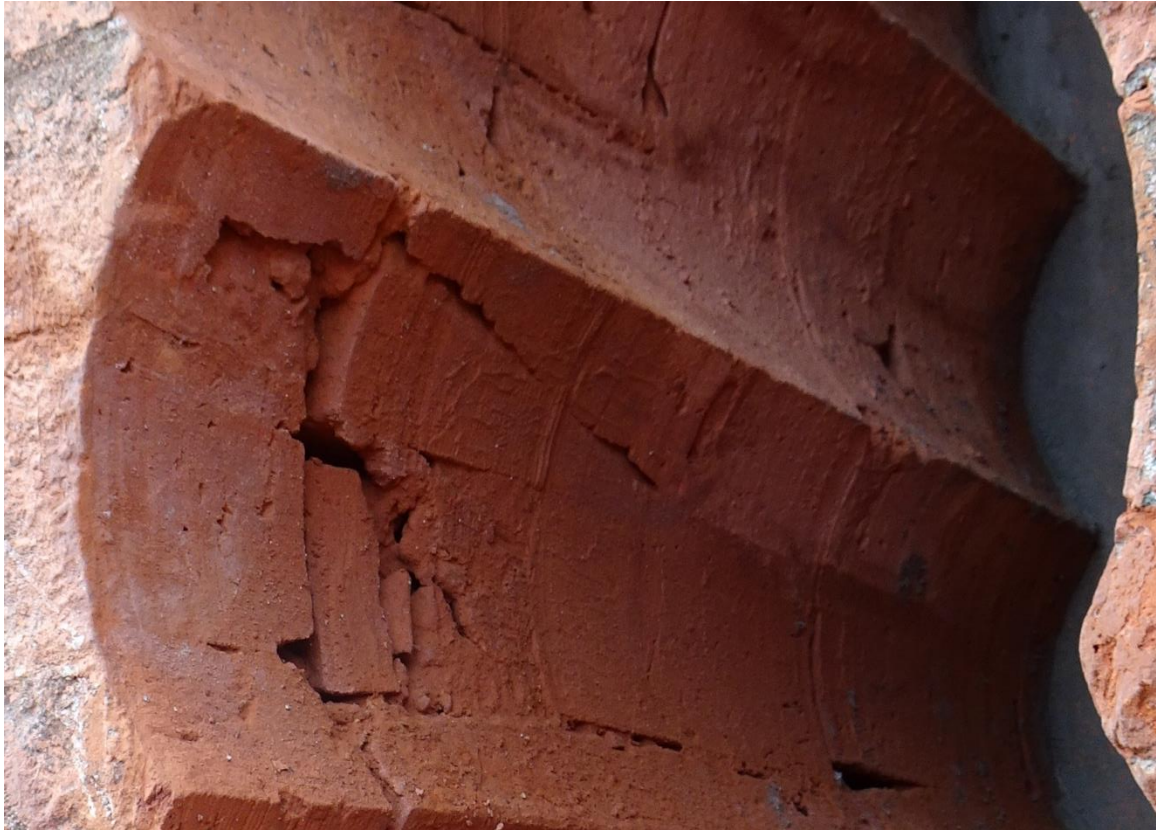
The coring for the bearing also provides a nice, visible vertical section through the wing wall. Once again, just here, we have snap headers and a loose skin so structurally the wall is 115mm thinner than the designer intended and not terribly well built behind that. There also seems to be very limited bond two bricks (450mm) further back. I presume this is where the sloping and horizontal courses meet. I wonder whether that was what the designer intended, really negligible shear strength down the neutral axis of the wall.

The closer look below shows another interesting feature. A vertical joint between two bricks that is obviously substantially inclined to the normal line of the core. I would say that those bricks are about 25mm out of line in the 225mm length.
