Bridge of the Month No75, March 2017 Twemlow

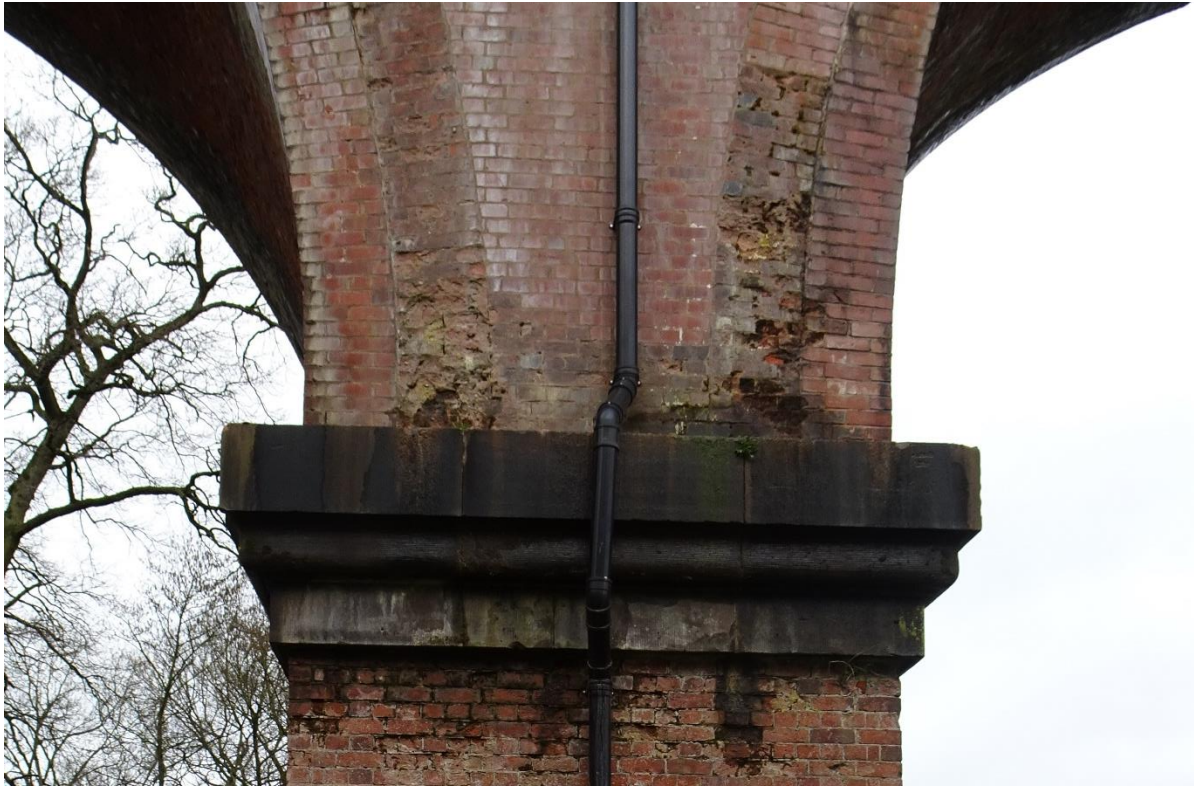
The engineer was G W Buck who did much of the bridge work for the early Stephenson lines, though probably not the Liverpool and Manchester. One of his characteristic styles is brick rings bonded through but in two layers.

Now back to that second picture. There is a lot of water coming out from the brickwork above and below the stone plinth. We can sensibly assume that the plinth doesn't go right through and that the

water is therefore coming down through the brickwork. Buck took his backing to about half depth As shown in the sketch, and sloped it down to the centre of the pier where a drain ran down to ground level. On the drawings he shows a larger pipe running up to the surface to allow the drain to be kept clean. I wonder whether those have been buried?

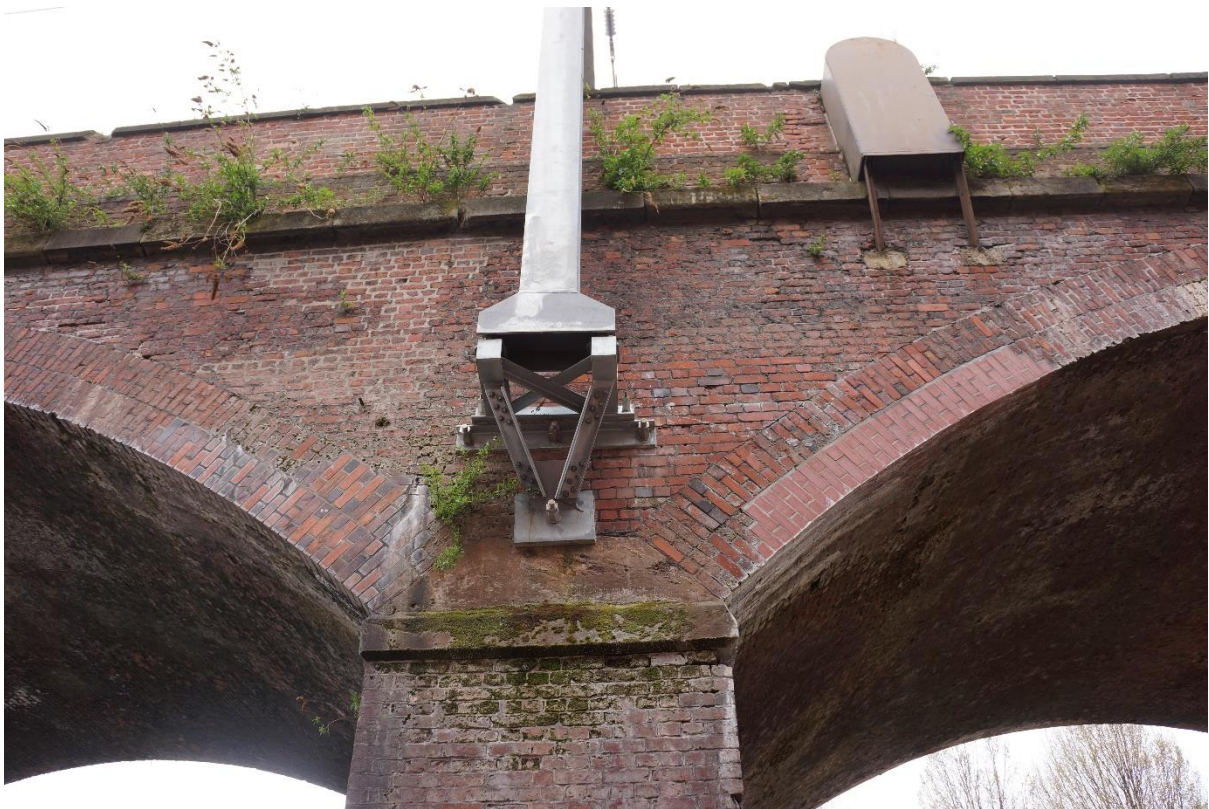
Shorter, flatter arches but the same detail. And at that point something occurs to me:

And before we leave, did you notice the cracks by the brackets under that box in the third picture? The spandel wall is lifting on a V above. I wonder whether that is damage from the work of chopping out the holes or the steel embedded is corroding and expanding.

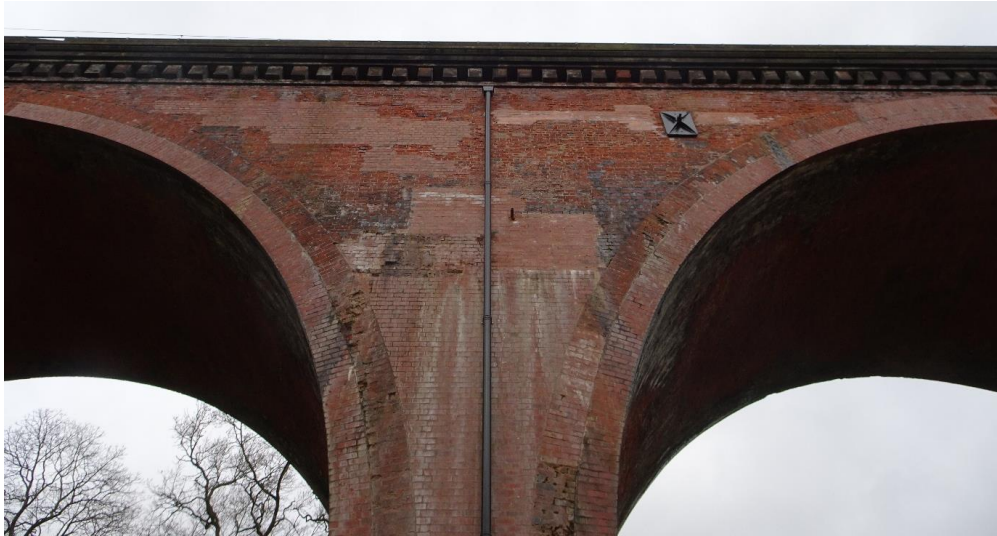
Looking up further there is a lot of patching. Many generations I should think. That drain must surely be new, reflecting the deck slab that was installed a year ago (or was it two?). There is a small rain projecting from the spandrel rather lower which might reflect an attempt to improve drainage at top of backing level.

To the right of that drain is moss growing very locally on the arch edge. Surely there is a crack to promote that.

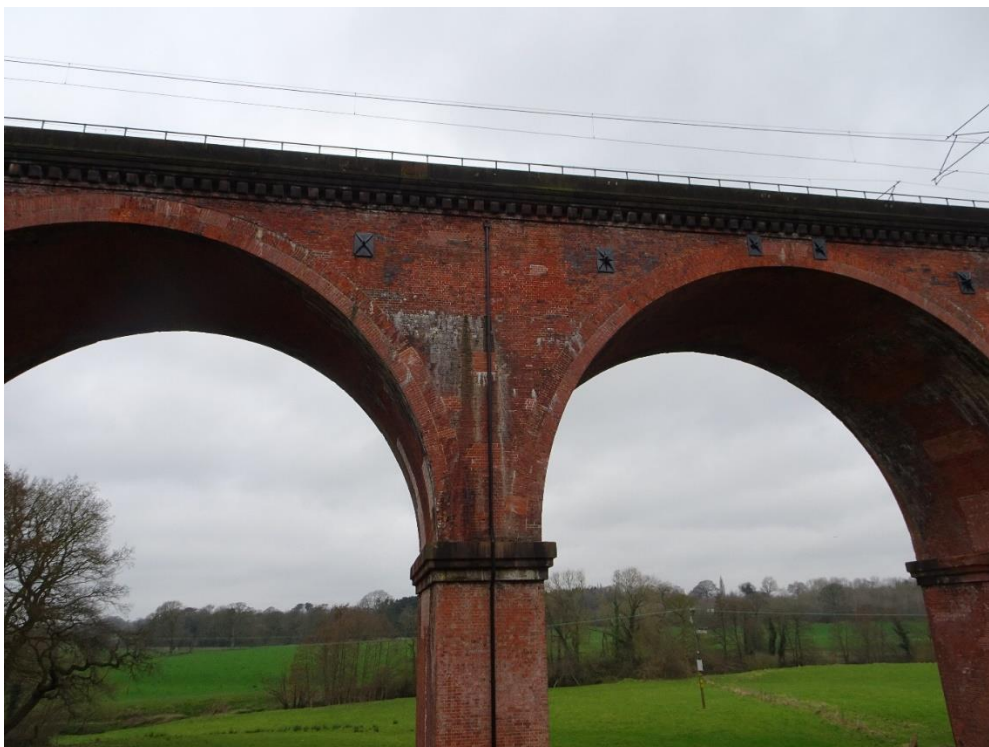
A broader view of a less patched spandrel shows lime runs, which once again reflect the level of the solid material (if solid is the right word).

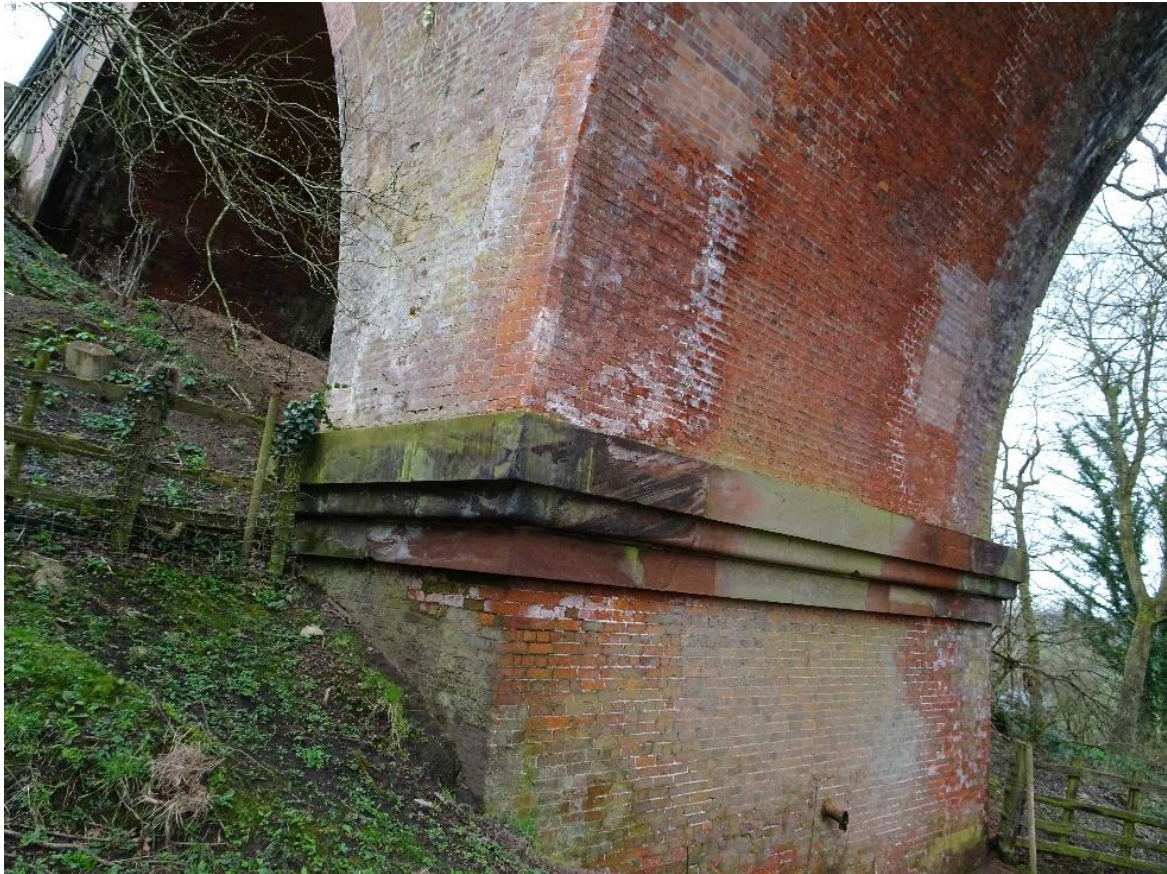
And here is that drain I mentioned. Down through the middle of the pier from the centre of the backing and discharging nicely above the foundations. Perhaps not ideal.

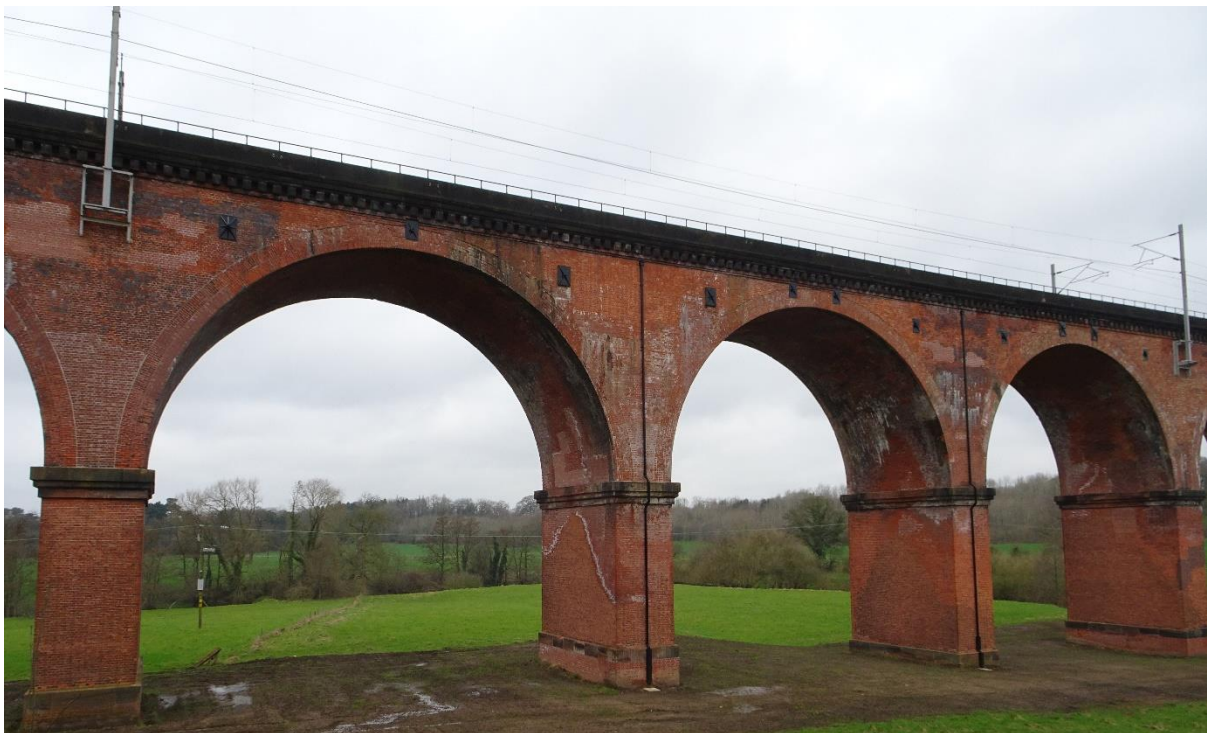
Zoom out again and the lime runs show under the arches too. That inverted V water stain on the pier needs a bit of further investigation but I was with friends and couldn't leave them standing in the cold.

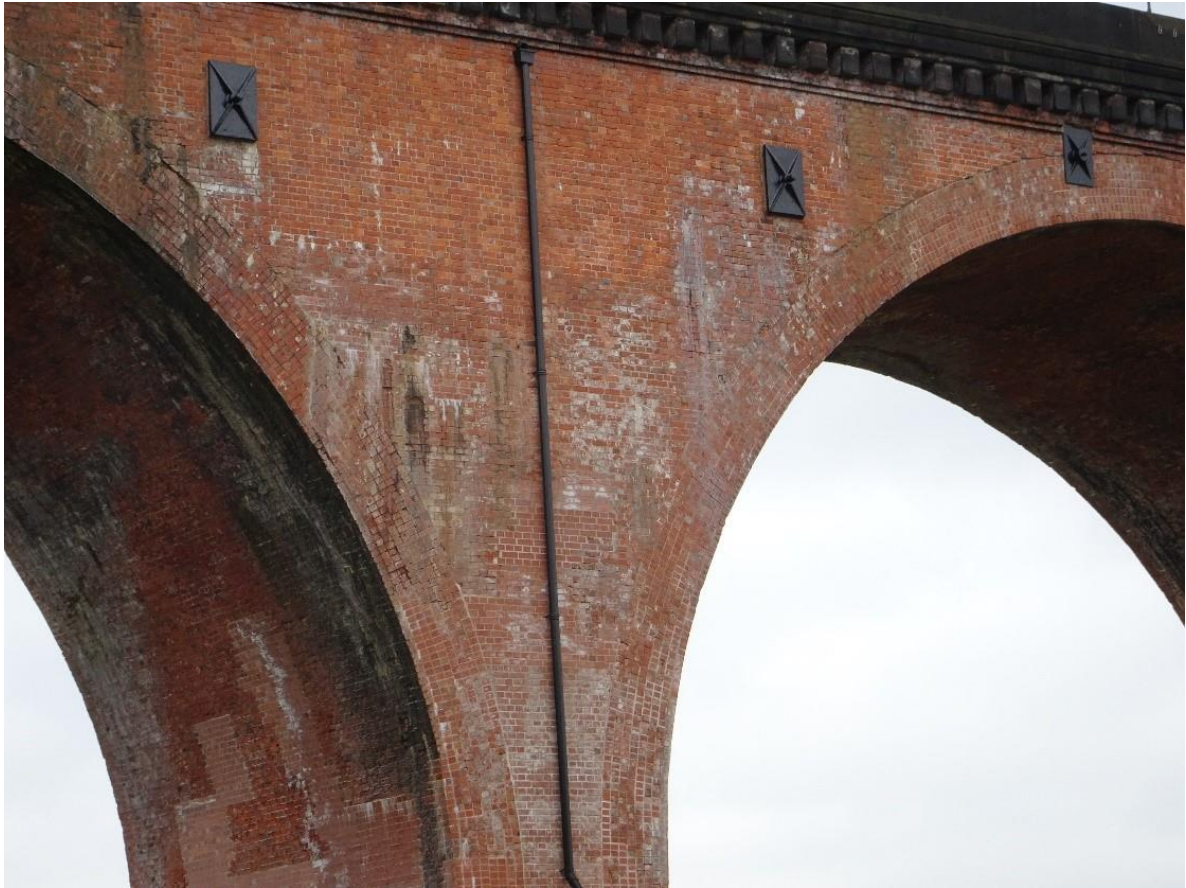
Here we have separate brick rings and a complete spandrel reskinned. I wonder what that is hiding?
And one last:

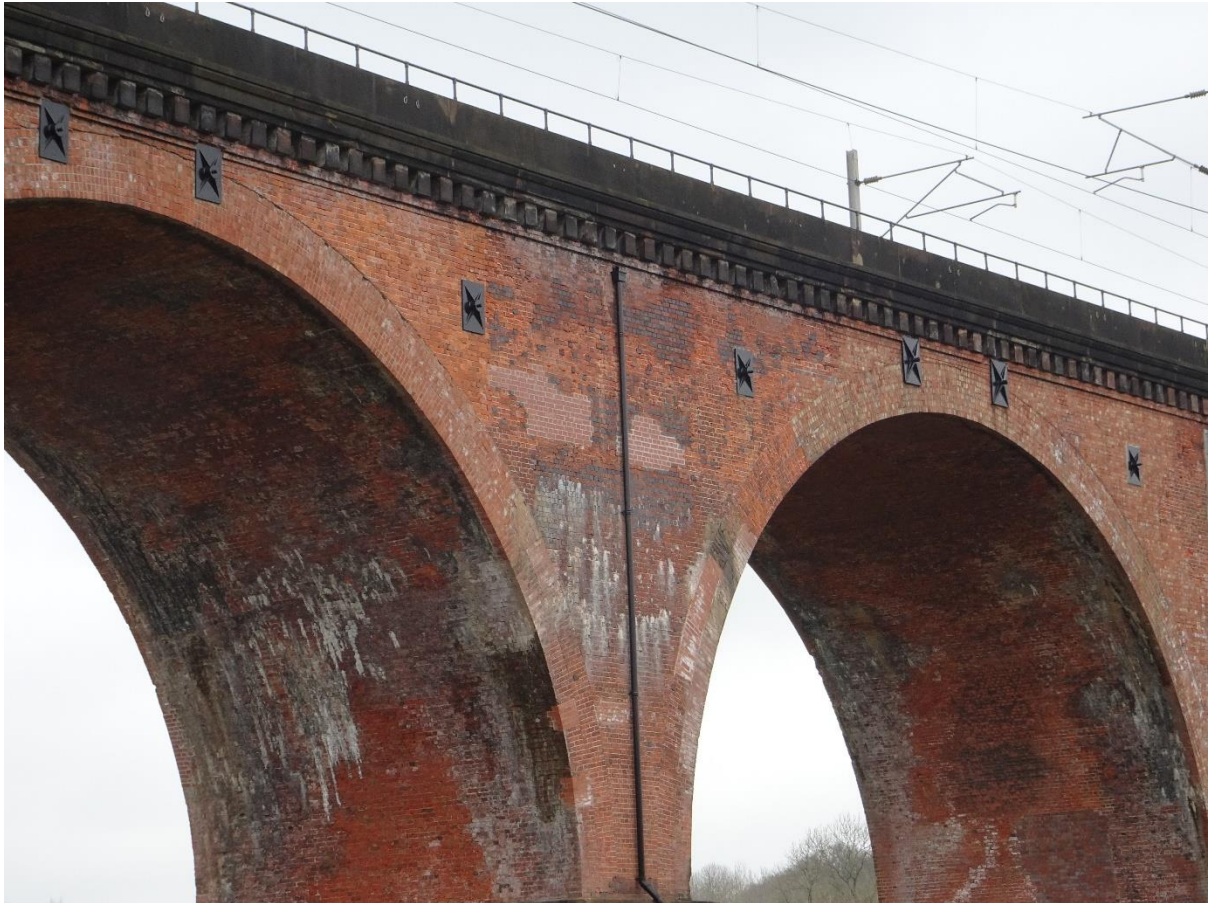
If you look closely, the headers and stretchers in the ring do match what is happening at the edge but one wonders whether they are actually snap-headers anyway.
