## Bridge of the Month No81, September 2017 Railway Viaduct Nr Todmorden

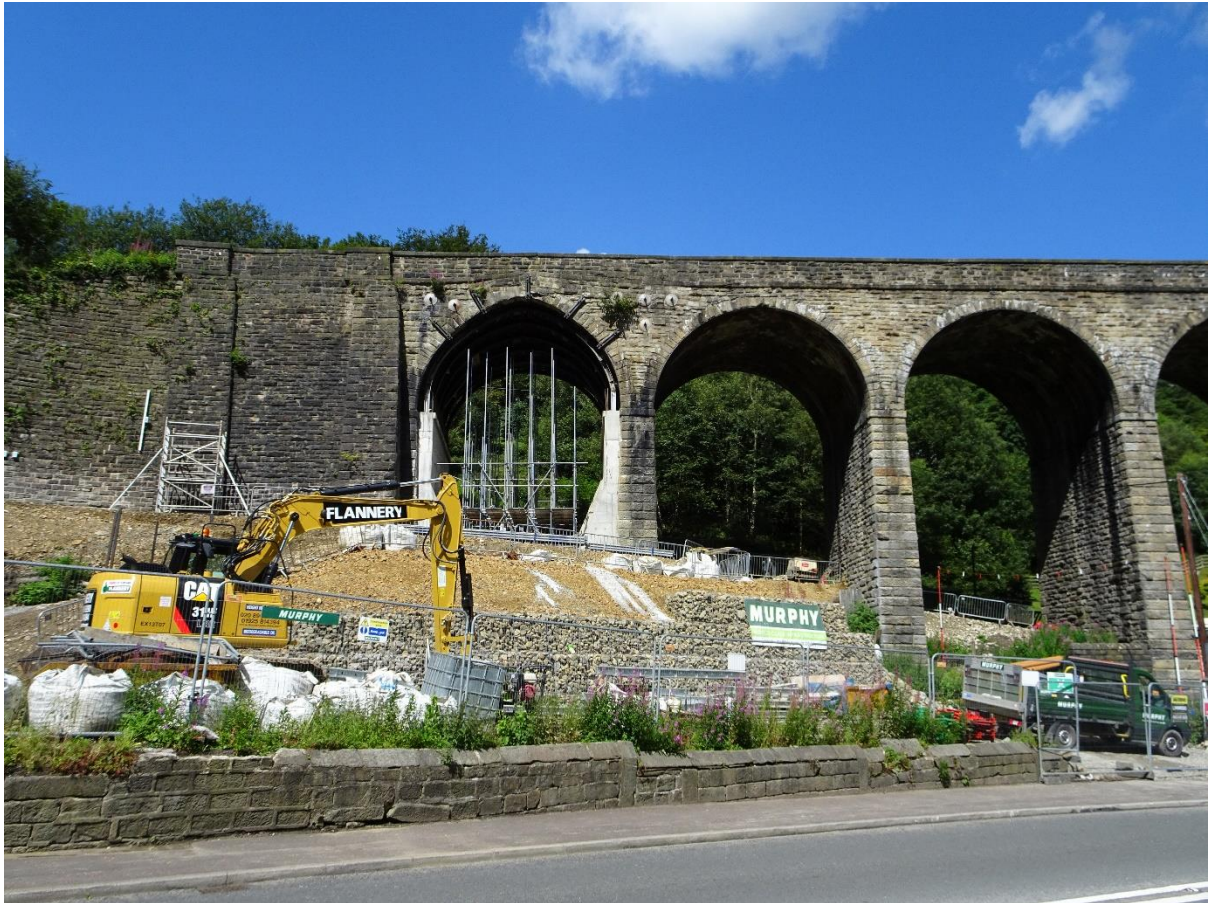
I still can't quite work out why there is so much going on when the core damage is obviously very old.

From this distance, you can see the hump, with a hinge at the crown and one about  $\frac{1}{4}$  span each side where the curve straightens considerably. You can also make a reasonable assessment of how far it has moved by looking at the kink at the top of the pilasters on the abutment. And, of course, masses of tying and strapping.

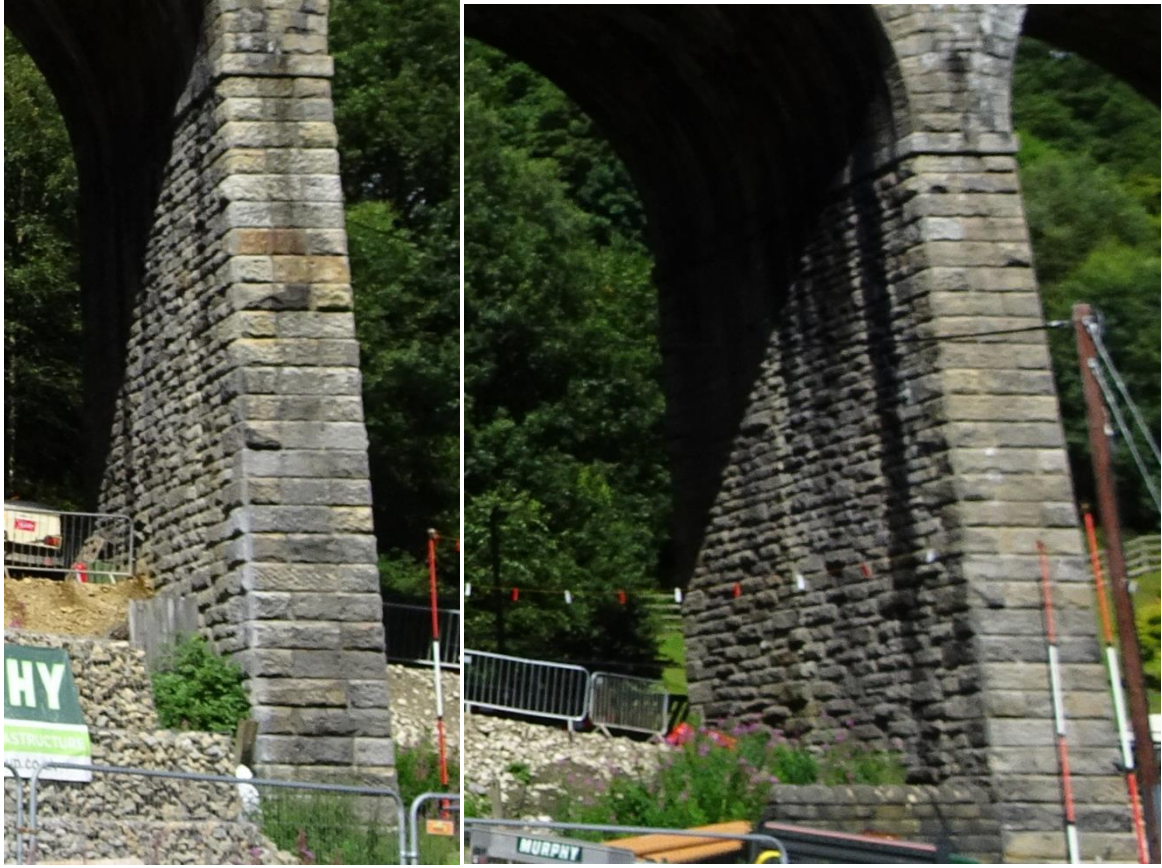
Looking at this picture again I thought I could see a join in the piers but the wonder of modern cameras allows a much closer view to be cropped from this image and it is clear below that the apparent marks are something else.

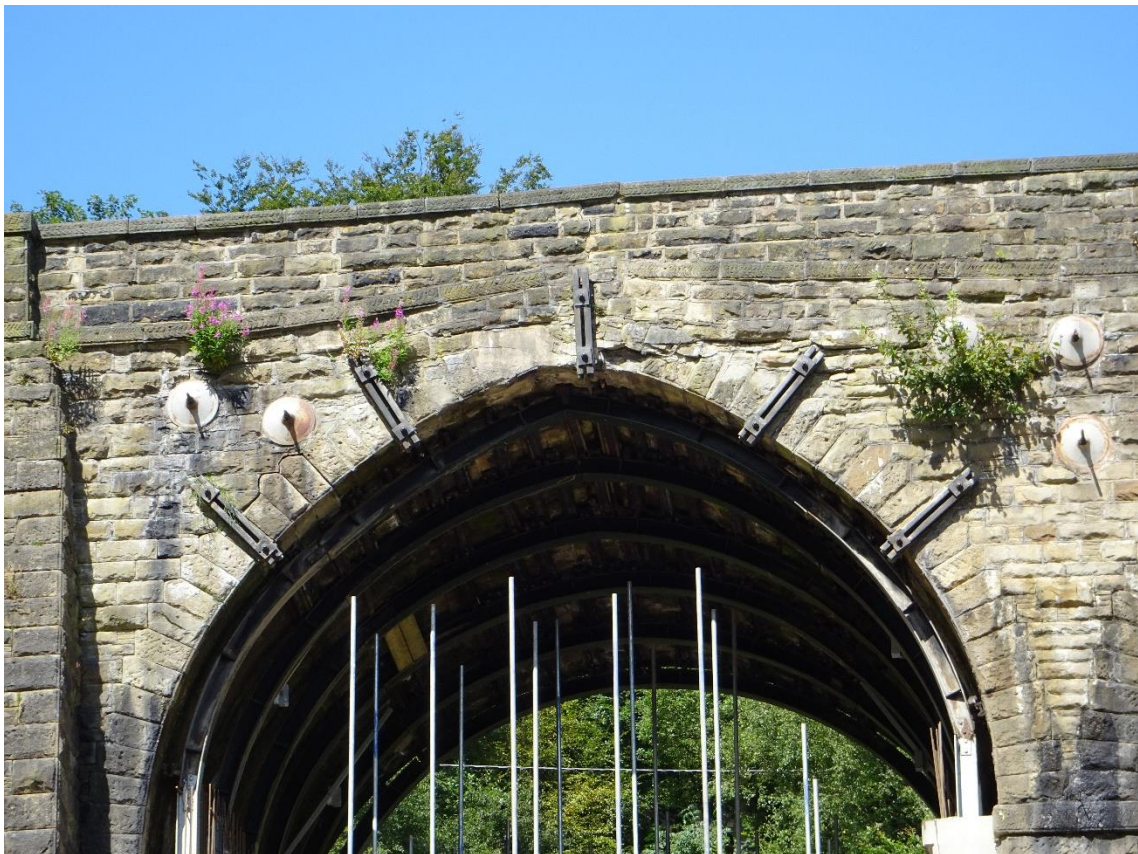
When you do this to an arch, push the abutments together that is, you are quite likely to get longitudinal cracking caused by the compressive stresses. I expect the cross ties are for that. Very pleased to see they have done the sensible thing and put ties above and below the arch rather than drilling through the ring which does irreversible damage and is especially bad in brick arches.

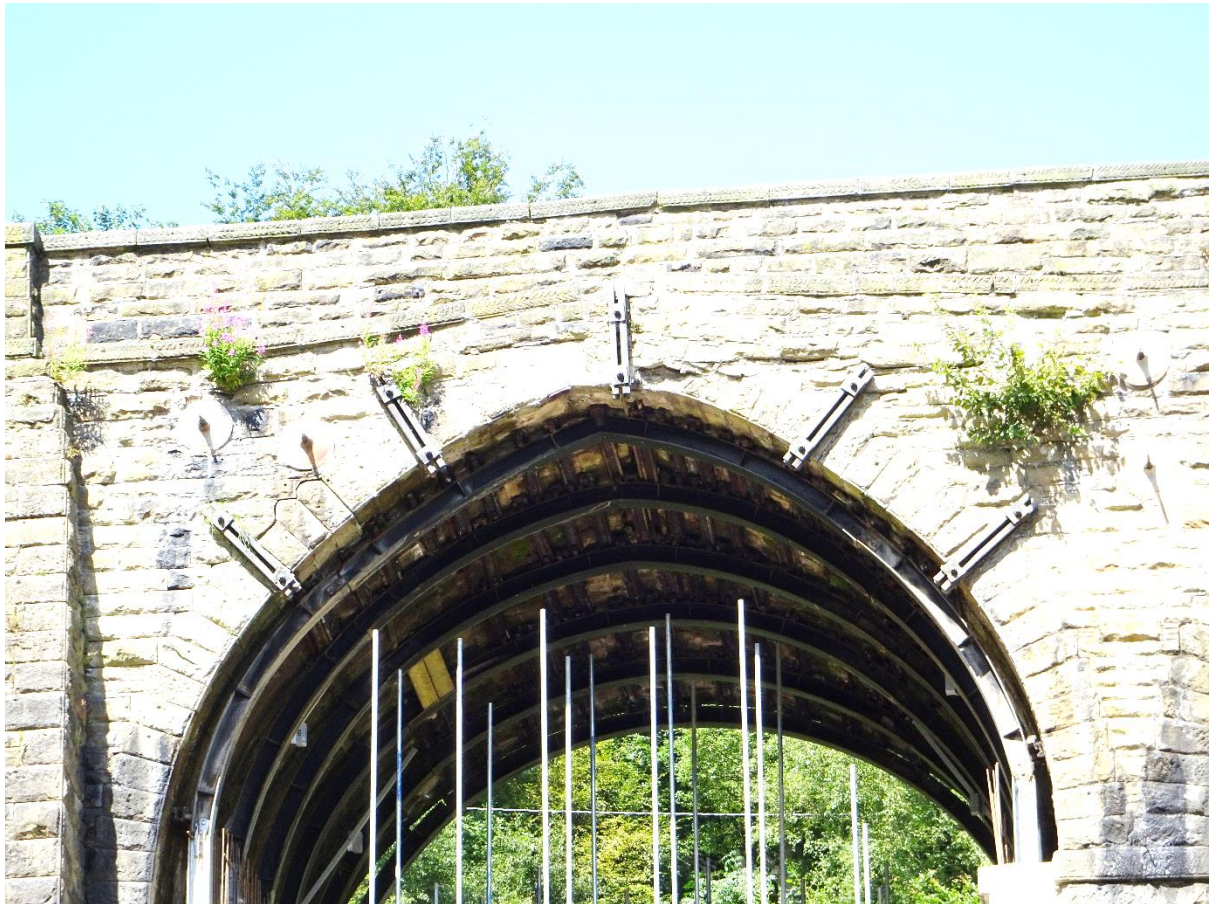
And what does that reveal, timbers between those steel rings, but much more significantly, look how the shape of the rings changes from sharply pointed at this side to a smooth curve at the far side. The abutment has rotated in plan, not just slid down the slope. I think that kink is visible here in the Google Maps satellite view. You can also see why it might have happened, with the abutment perched on the steep end of a spur.

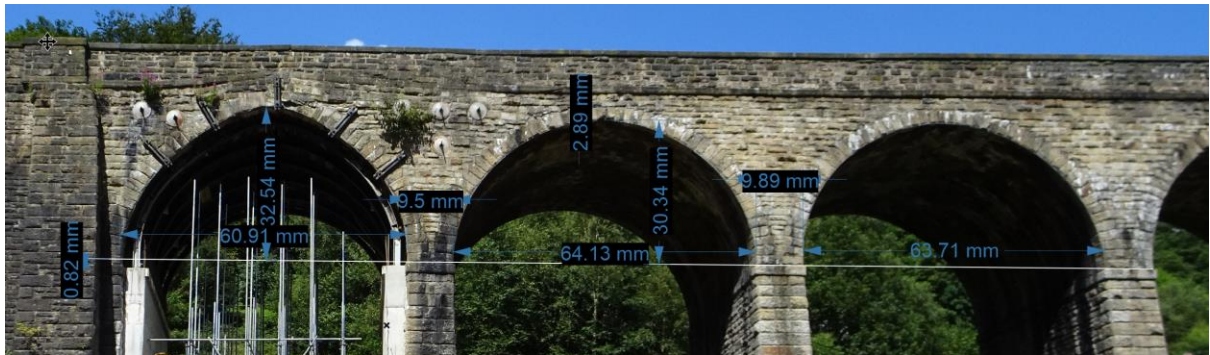
This pic is near enough square to the face in plan, though tilted up somewhat. The two right hand spans scale the same so we can work the rest from that. Let's assume they are 30ft.

The piers are then 4ft6in, the left-hand span 28ft6in, the left hand rise 16ft versus the original 15ft and the left hand springing has dropped 0.4ft. Quite a movement.

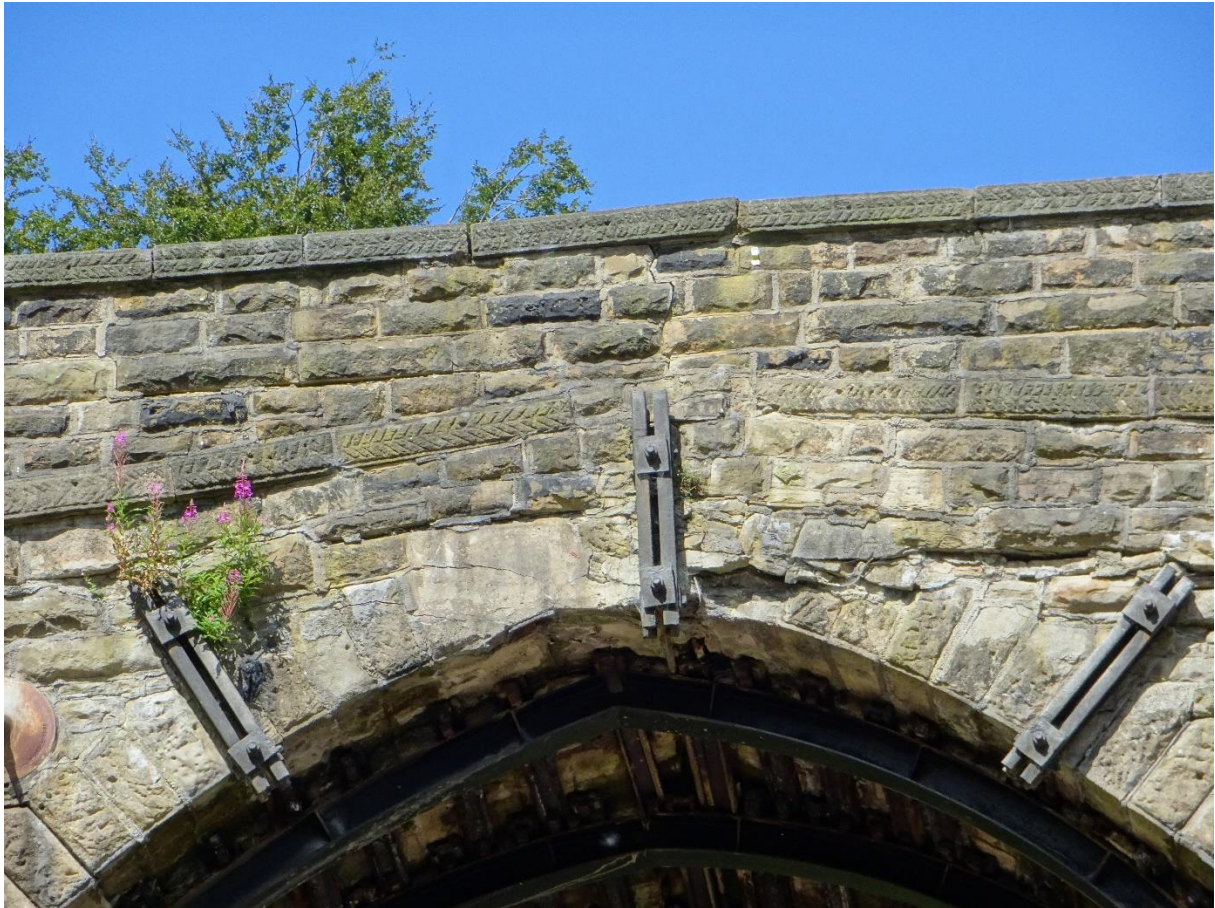
Here we see the spectacular zoom on that tiny camera. This image has not been cropped. The top of the ring is very badly crushed, as is the first course of stone above. The string course seems to have accommodated most of the movement by rising into a hump and the parapet has been brought back to level. I think that suggests this is very early damage and has been present for much of the life of the bridge. It is noticeable that the bond in the stonework is completely broken in the top two or three courses, especially to the left where they have been pushed sideways.

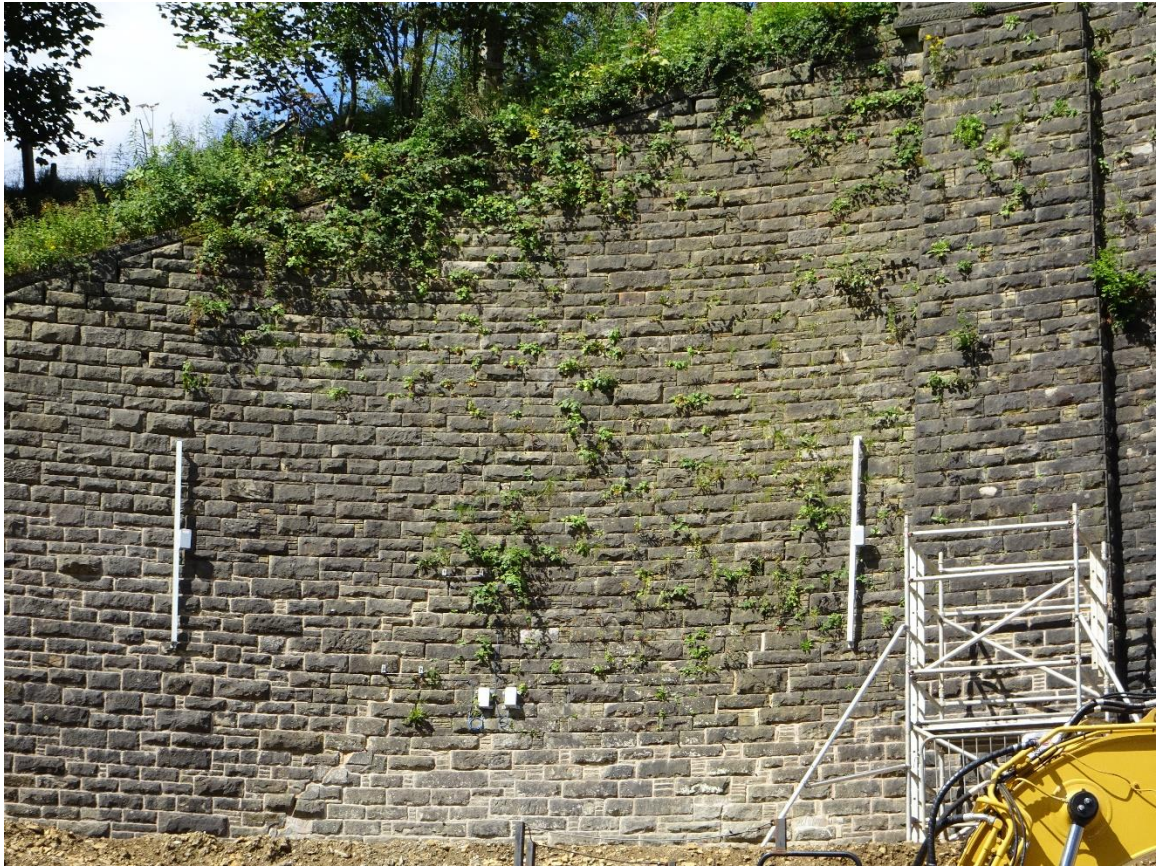
There are diagonal cracks right up the wing wall.

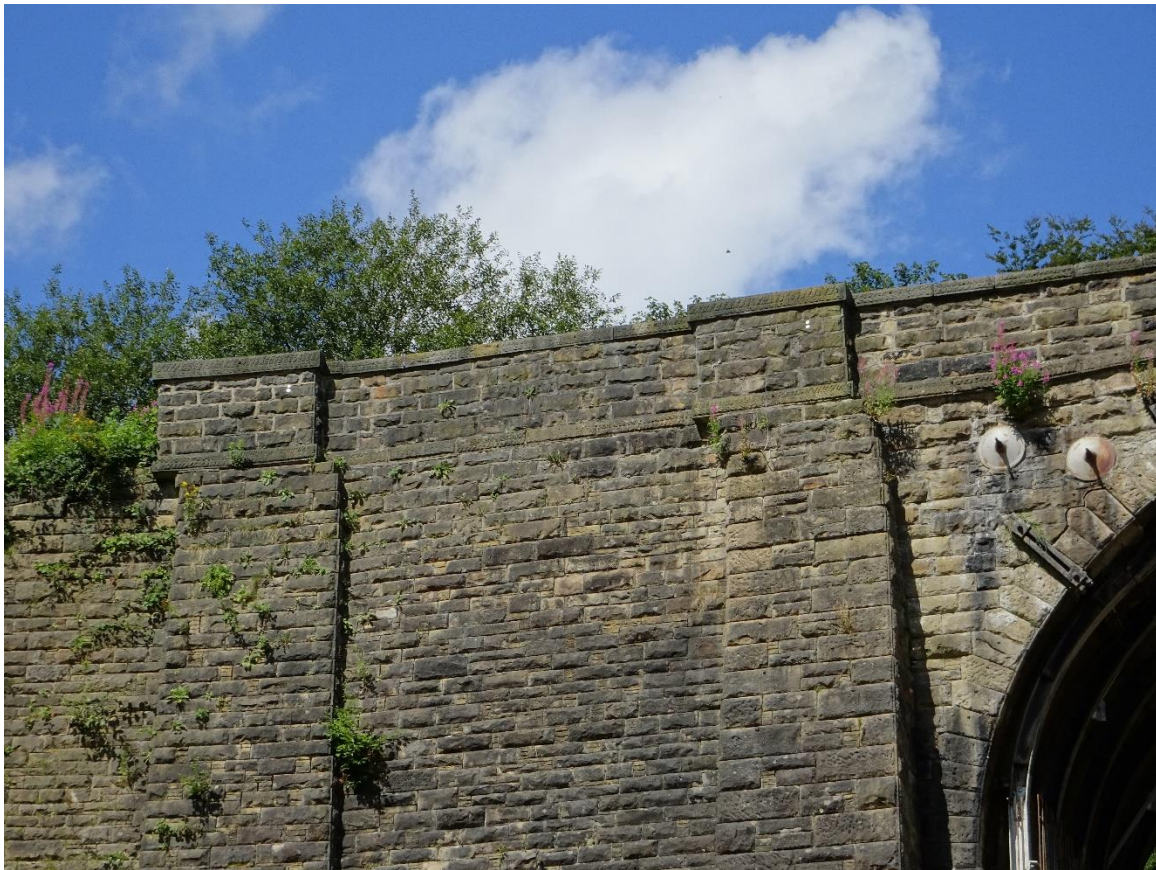
And the massive joggles in the top of the pilasters.

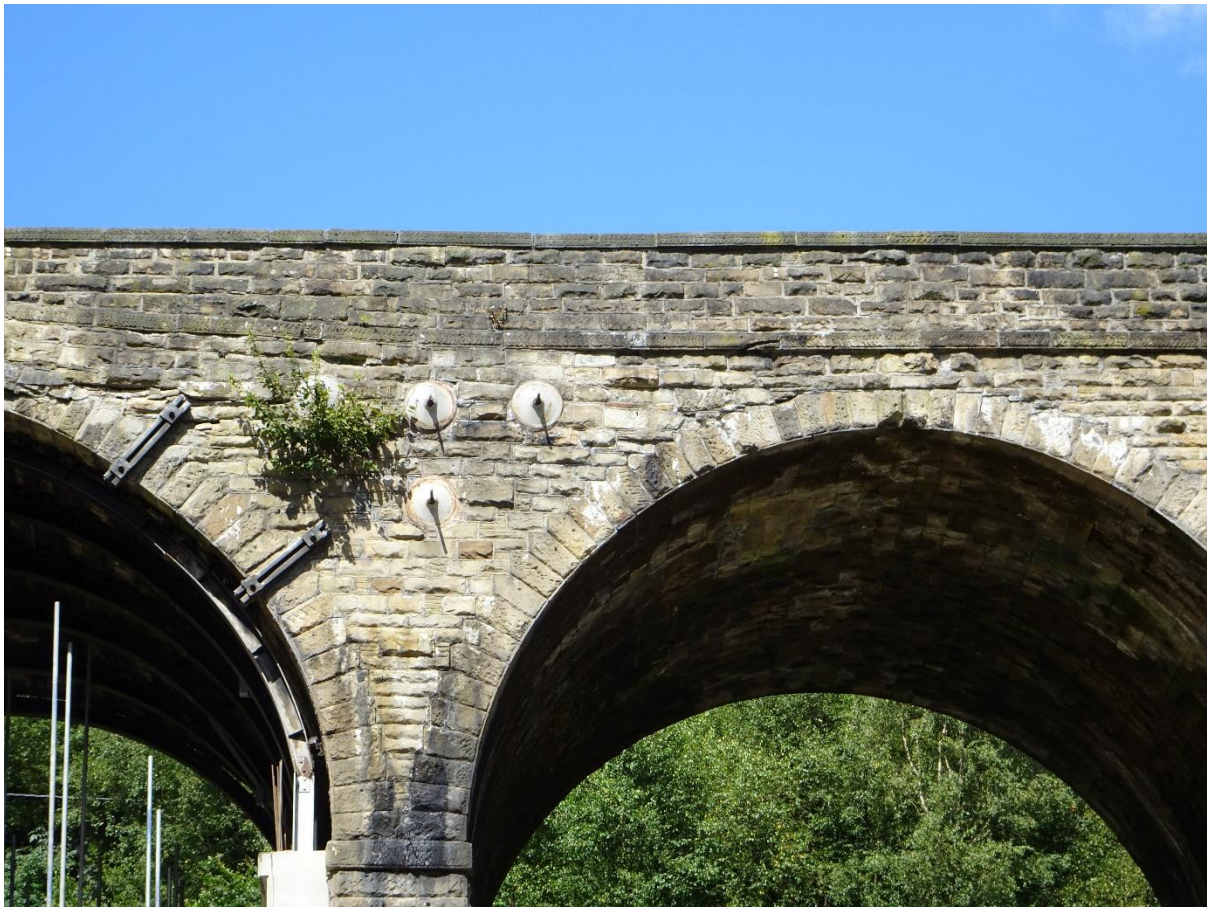
At the right hand side of the span we do, of course, have more crushing, but with such a long run of wall to push against there is little movement. Notice, though, a split in the string course above the crown here and some obvious damage round the top of the ring. As we move to the left there is much jostling for position as the stone tries to squeeze into a shorter, higher band. Since there is little growth across the rest of the structure we can assume that the bush there has found a crack to anchor in. And at the end of the steel arch there is a new piece, making it clear that the concrete there is creating a more substantial support for the rings.

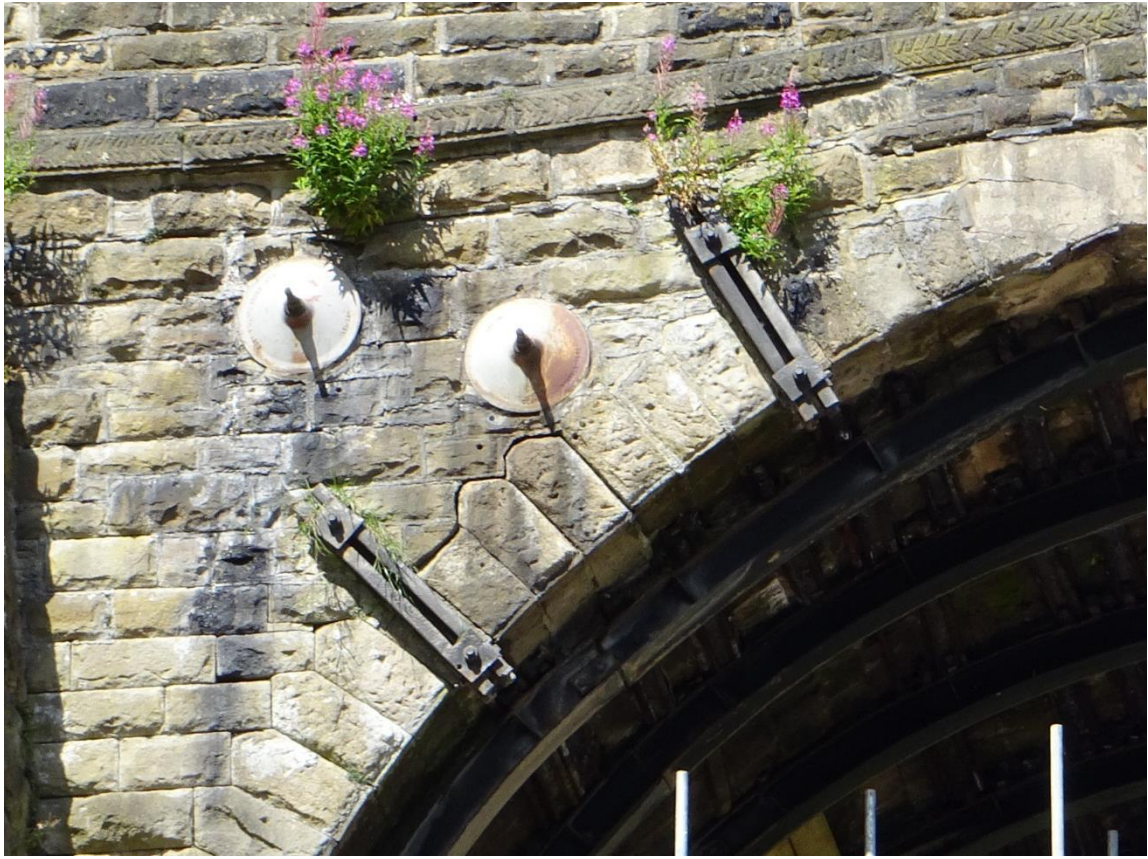
And now, this really is finally. The gaps and displacement around these stones shows that the steel rings have now lifted the arch to the point where it isn't working in compression.

Don't you love the herring bone dressing on that string course. Are the coarser patches replacements?
