## Bridge of the Month No85, January 2018 Dean street, Newcastle

BILL HARVEY ASSOCIATES LTD

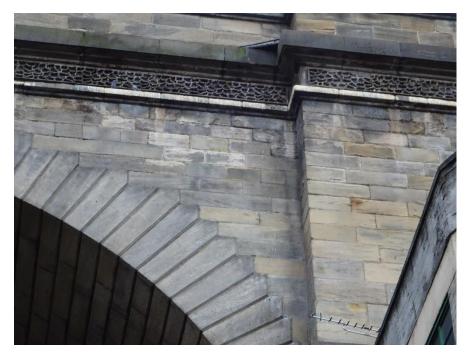
The elegant string course is beautifully decorative, on a scale to suit the bridge and the viewpoint.

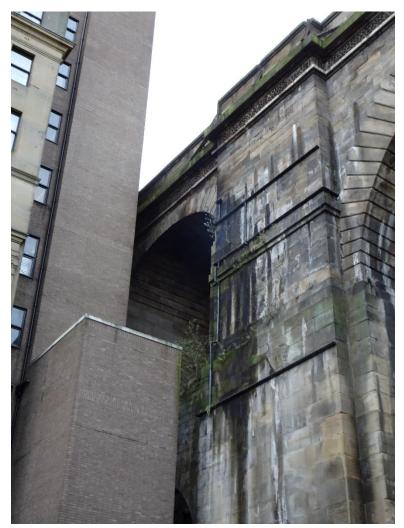
Note the weathering of the five layers of stone beneath the string. This provides a very clear indication of the level of solid backing. On the other side, the drainage emphasises the level because it has been severely neglected.

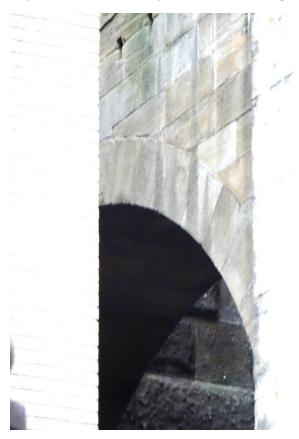
There is a lower level arch just visible in the next span. It doesn't go full width and is obviously there to provide a strut to carry the thrust of the big arch to the rock behind.

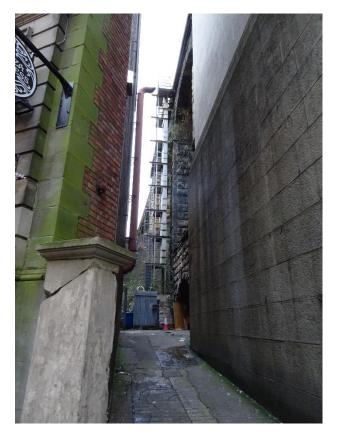
There is a similar strut behind the new part on the opposite side.

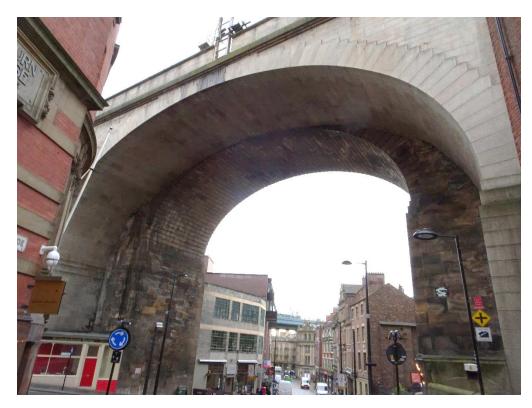
The bridge was widened up hill in 1896. The road gets significantly wider and a greater span was therefore needed 106ft instead of 80ft. Whether it was really necessary to import granite for the larger span is debateable. The cut through the parapet and ugly metal inserts are a bit hard to forgive, especially as they create an ugly water run.

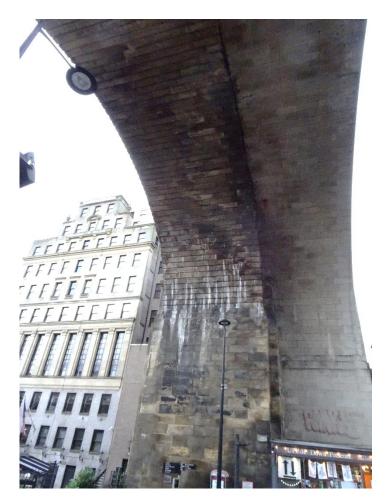
Looking from below, there is a lot to see. First, the different colour of the granite voussoirs at the edge of the newer bridge. Is the remainder actually sandstone? I will need to go again and look. There clearly isn't such a difference on the other side of this part so we can assume that, as usual, there is no spandrel wall on this edge. The water runs on the soffit of both halves give further indication of the top of backing level.

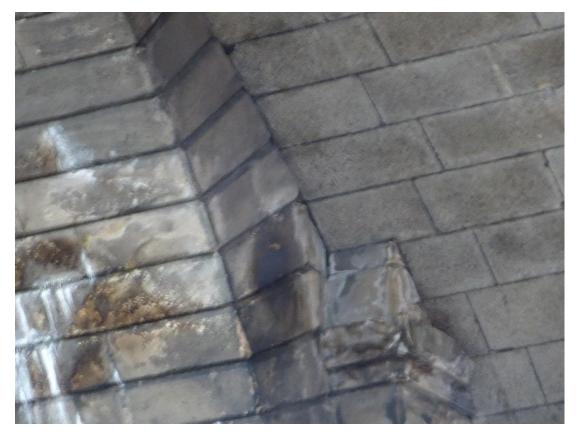
This is zoomed in and hand held. The low light makes it a struggle, but I am almost certain that the new voussoirs are cut slightly into the old. The scale says it might be a 50mm step which would be ample to interlock the structures. Another slightly blurry shot suggests that the chase extends almost to the crown and is effective in preventing with water runs so common in such joints.
