## Bridge of the Month No86, February 2018 Kohukohu, New Zealand

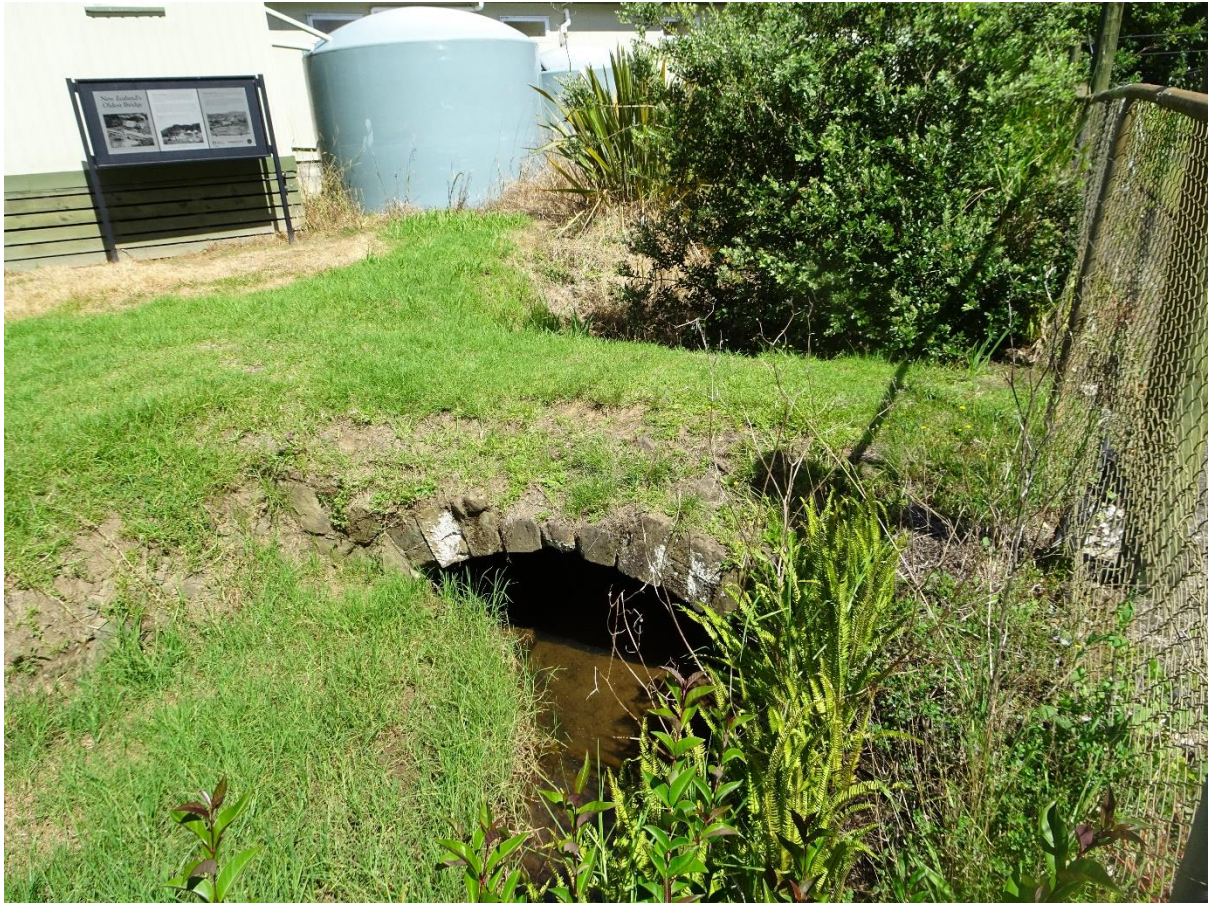
What is left is sadly neglected and has obviously been quarried for usable stone down the years.

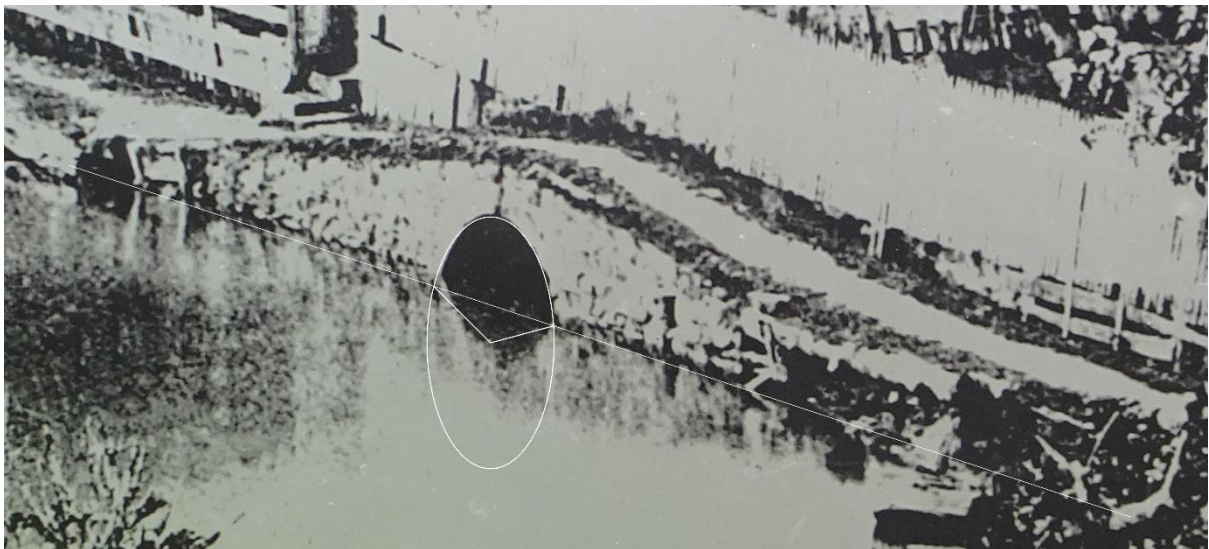
The arch evident here is very much less of a curve than the original which I suspect was semi-circular or very nearly so. The lake shown in the 1860s photo obviously silted up long ago. Note that the elevated viewpoint marks this as the upstream side.

Stretching the ellipse shown here till it is a full circle gives the angle above water level as 144degrees.

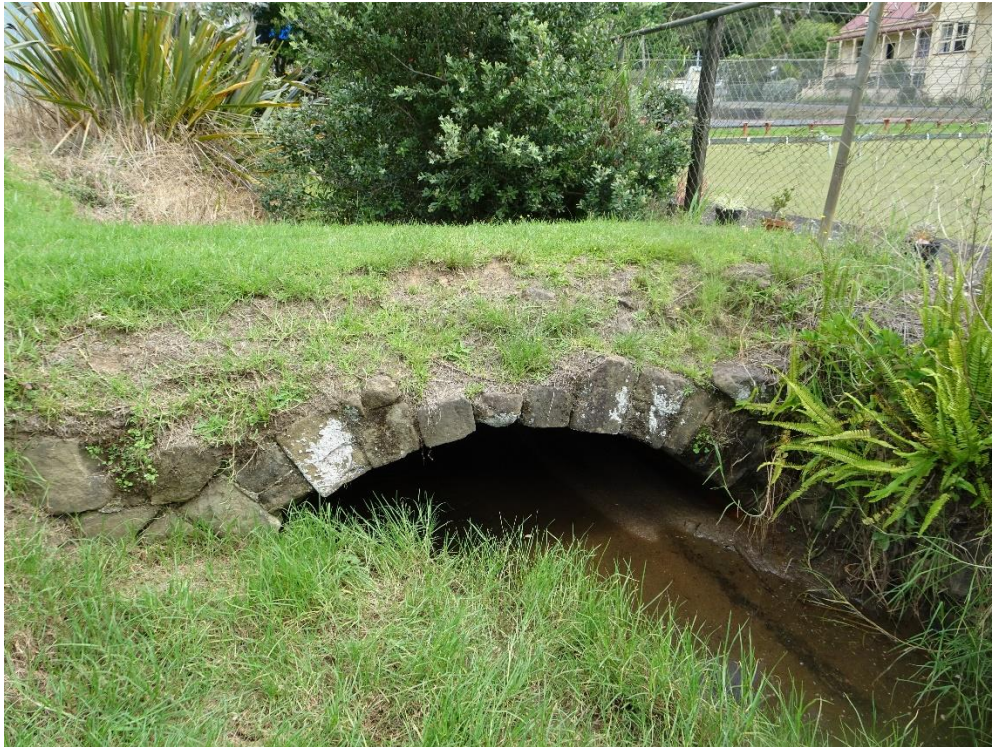
The spandrel walls and low parapets are long gone but it is interesting that the walls remain below arch crown level which is probably the top of solid backing. Did the quarriers take a clue from that or were the stones just better fixed?

Notice how the top half of the crown voussoirs are missing and there are cracks at a similar level in others. Looking at the upstream side shows a similar pattern. There is less access and more vegetation but here the split runs much of the way round the ring and suggests that the stones are bedded the wrong way.

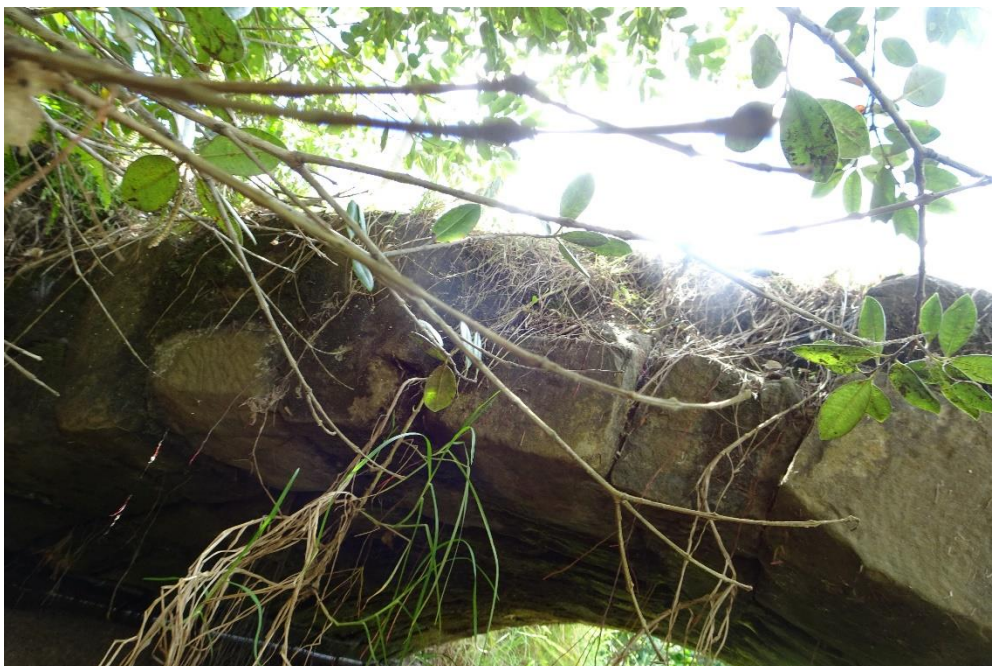
To be fair to the masons, the stone came from Sydney, probably as ballast in a ship, so would have been far from the quarry and quite dry when dressed making bed spotting more difficult.

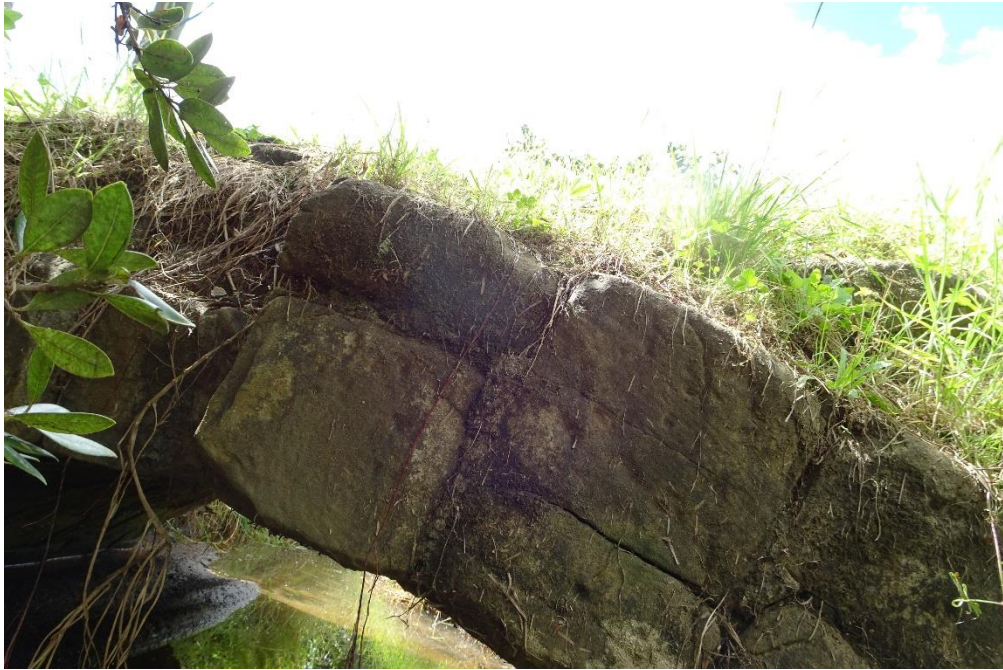
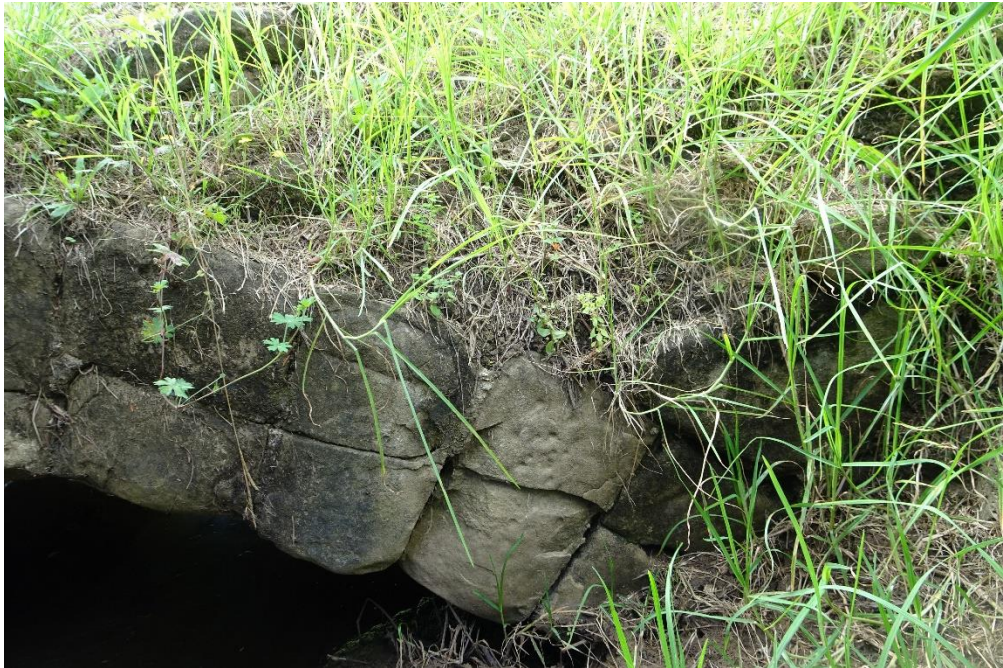
Hidden in the grass above are the lower stones of the spandrel, once again, still present below crown level.

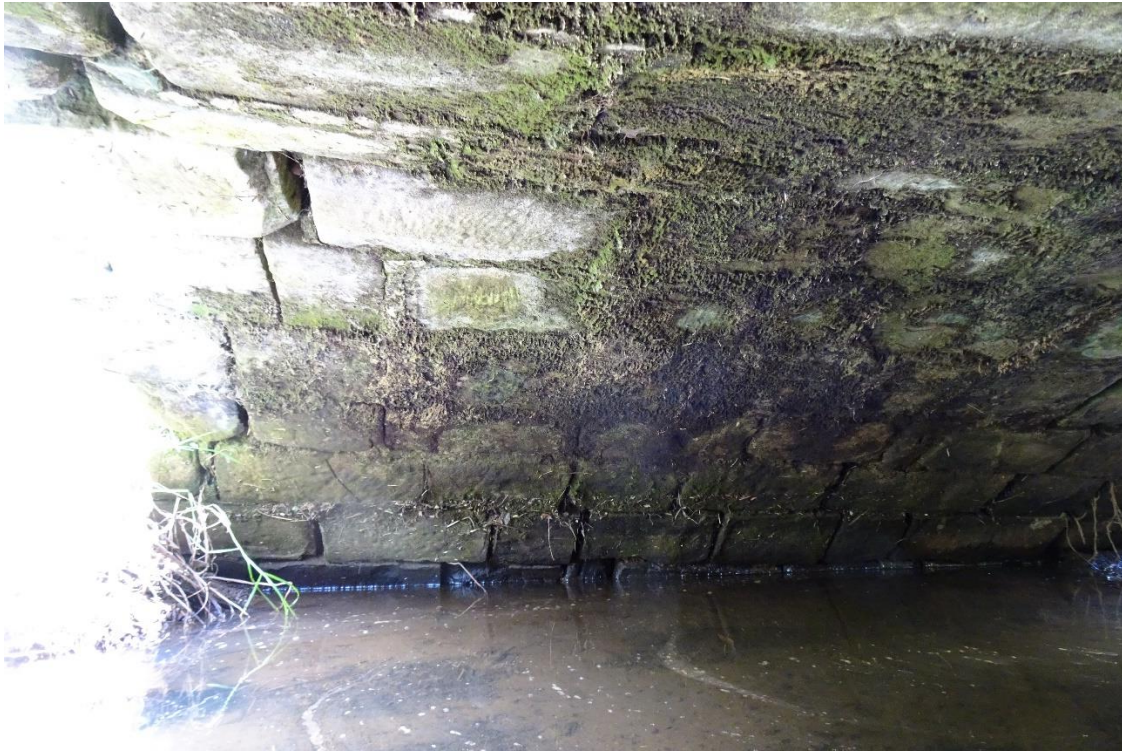
Here we see the northern half of the arch and it is immediately obvious that the curve continues into the silt. There is a substantial crack/joint opening at both edges, the right hand (downstream) one is most visible. It is much wider at the crown than at the end and moves steadily out towards the edge at the end as well. This is surely caused by pushing out from the crown.

Note also that there is a second crack about 500mm in from the edge which is closed two stones up from the silt and quite wide by silt level. This is surely caused by foundation movement, with the edge being held up on slightly firmer ground or having some form of bigger foundation. It would be interesting to know whether this very soft ground was piled to support the bridge.

Also in this picture, note that the bottom two courses are clean and lacking mortar. Looking at this it would be easy to think that the bridge was built in dry stone but the higher areas disprove that. Up

there, vegetation has taken on the mortar and not been washed off so we can be reasonably sure that significant floods are very rare.

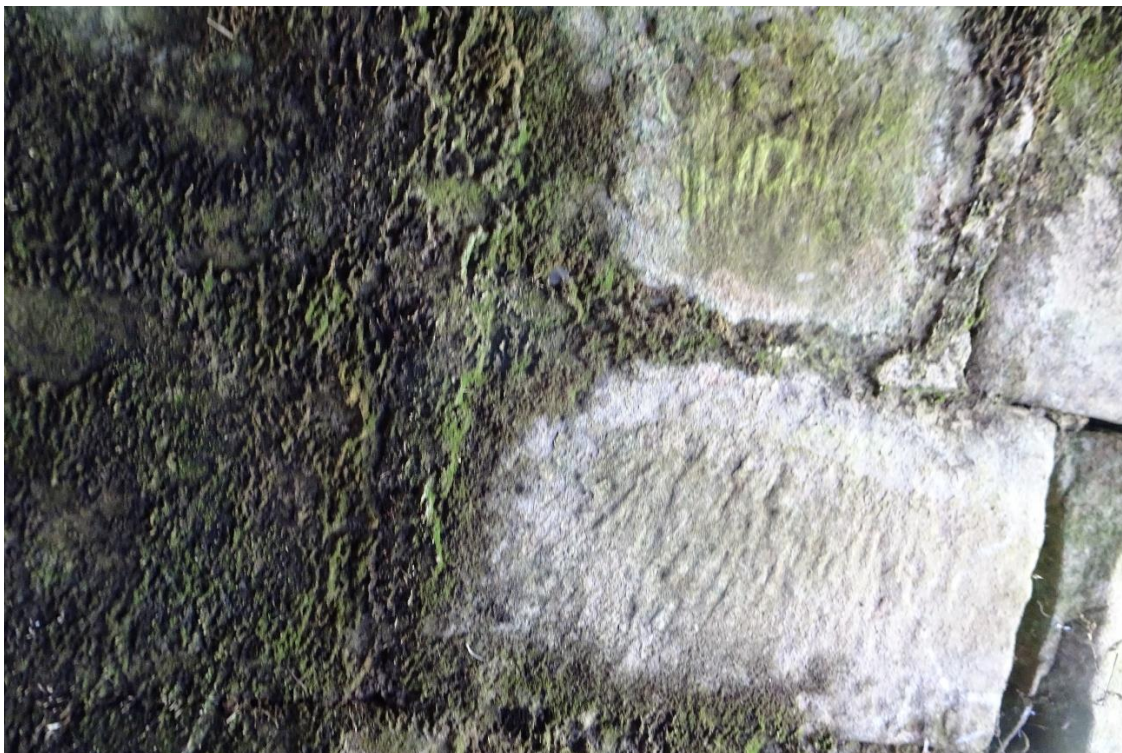
The south end of the crack is similar in form, though it seems to pass through at least one stone.

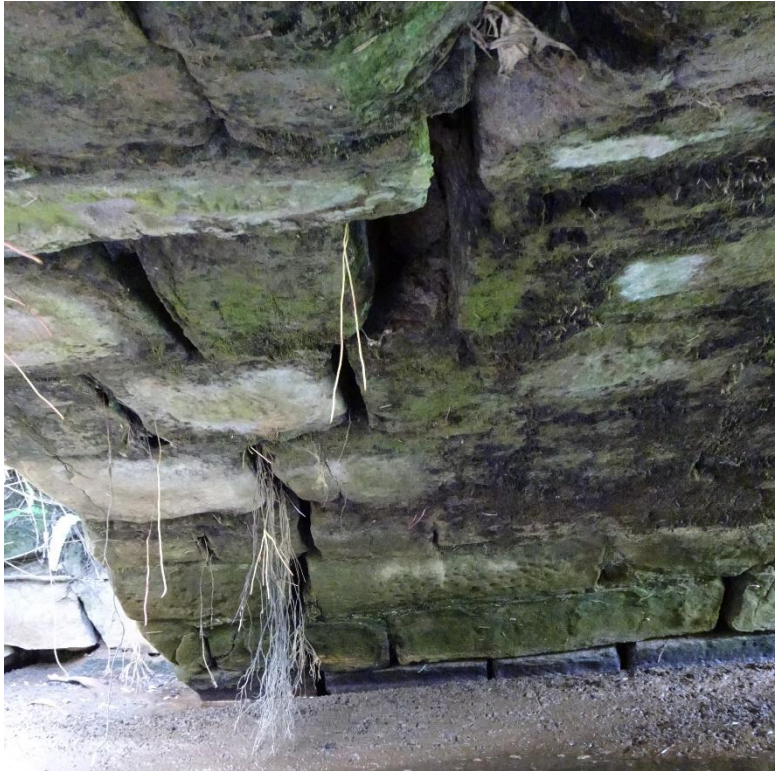
Even through the vegetation we can see that the mortar spreads across the face of the stone. This is probably "as built". The mortar will naturally spread across the centring as the bridge is built. The fact that it still does so reinforces the view that floods are rare.

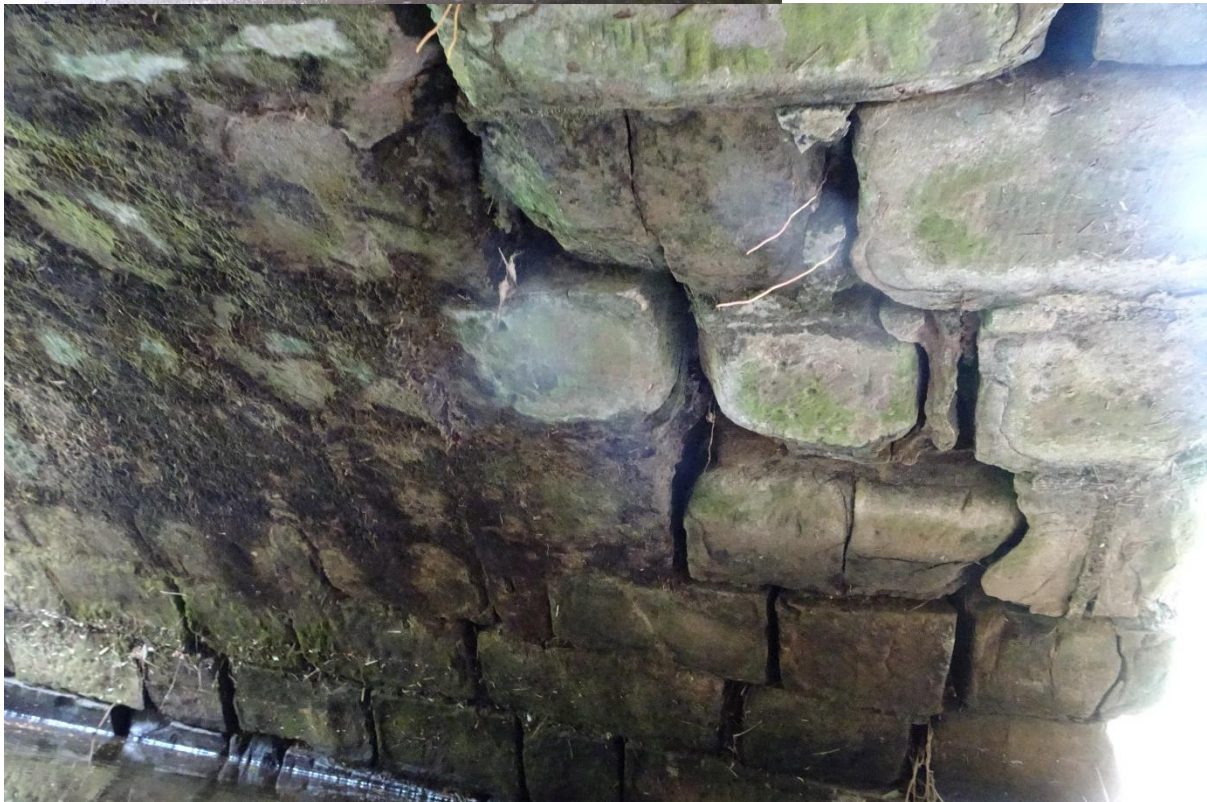
The crack at the upstream edge follows a similar pattern. Much wider at the crown and moving towards the edge at silt level.

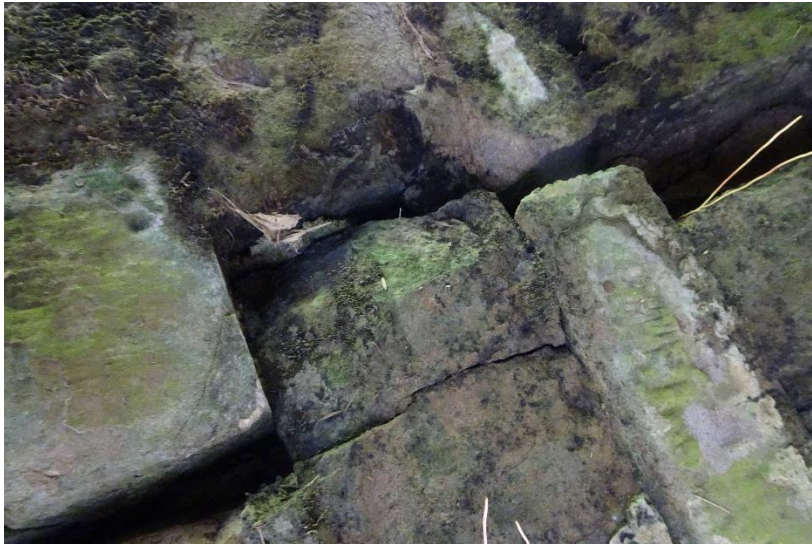
The south end of that crack is quite spectacular. It divides into 3 making it difficult to judge the width but it also passes through some stones. Here there is still mortar in some of the open joints but much of it has been washed out, presumably with water from above.
