Bridge of the Month 114. June 2020 Bowland

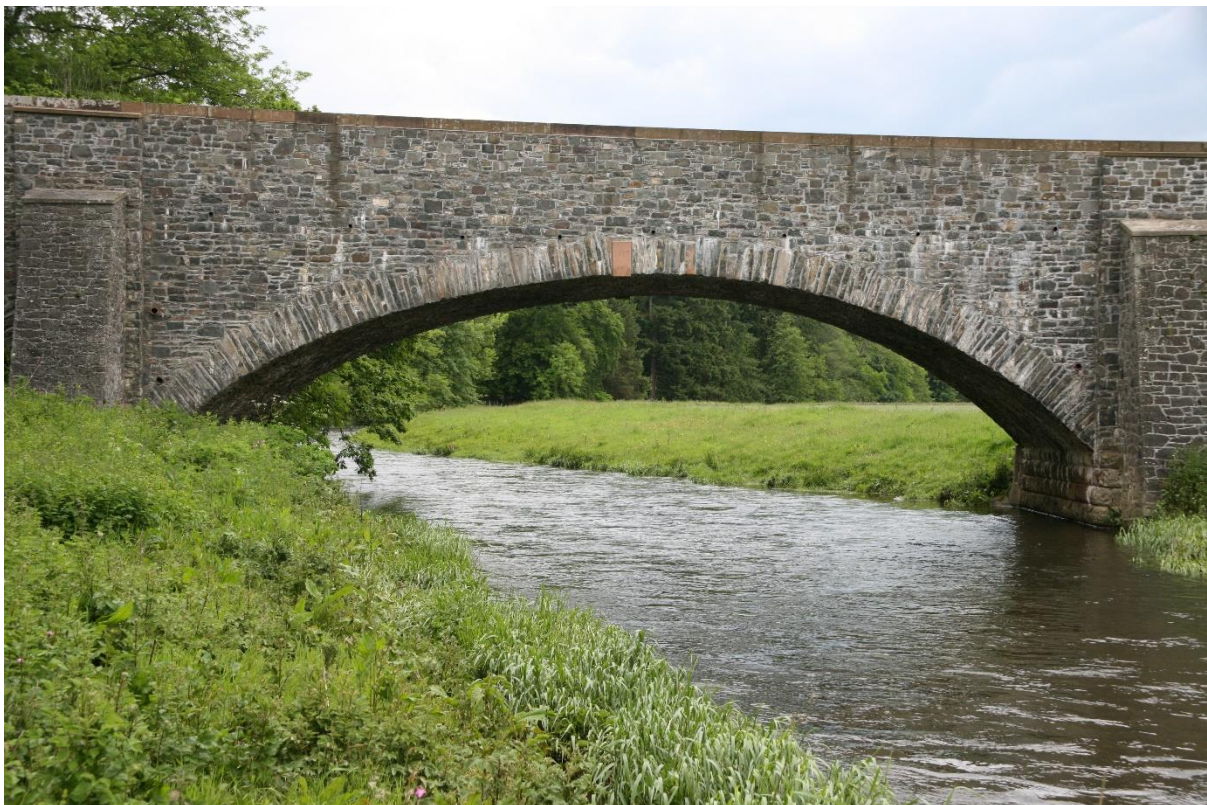
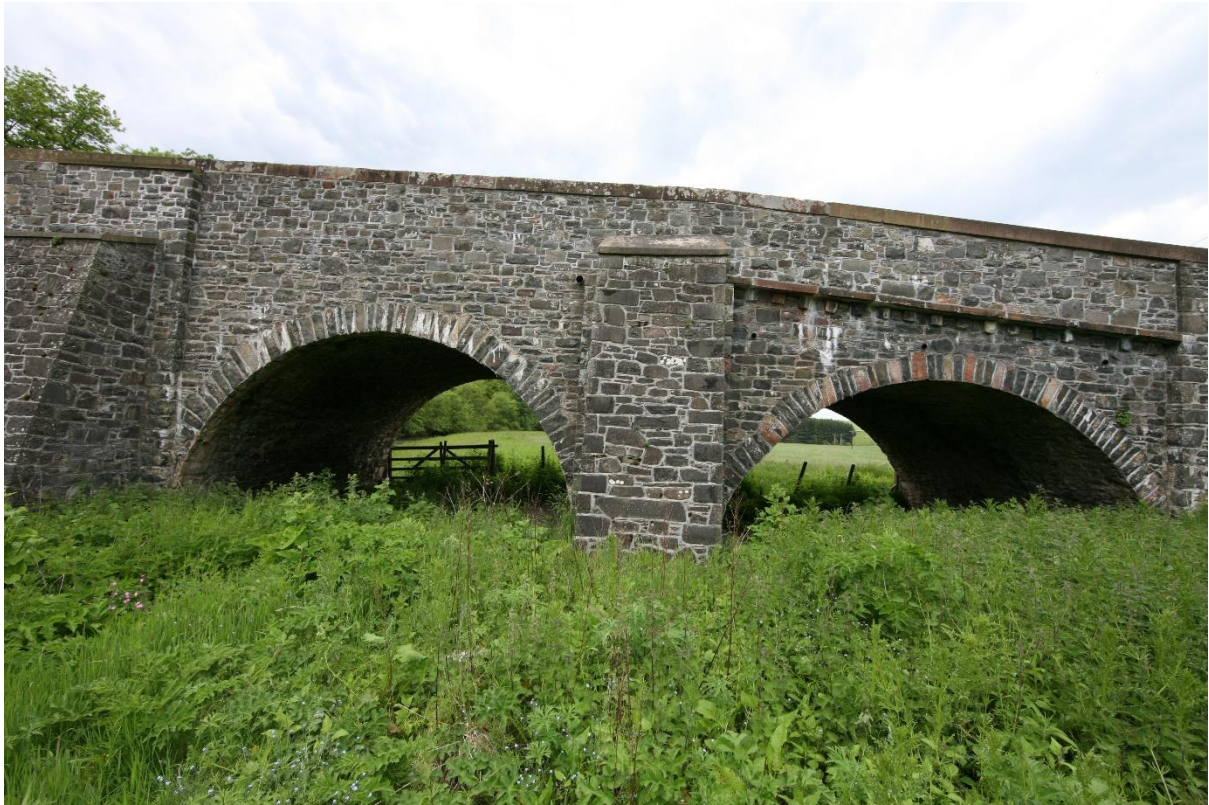
I think that, in both of these pictures, it's possible to see a side sway. The road rises from flood plain level to the right (east) on to a river terrace to the west and the lop-sided weight has surely caused the arch to creep. Aided, no doubt, by the high mortar content.

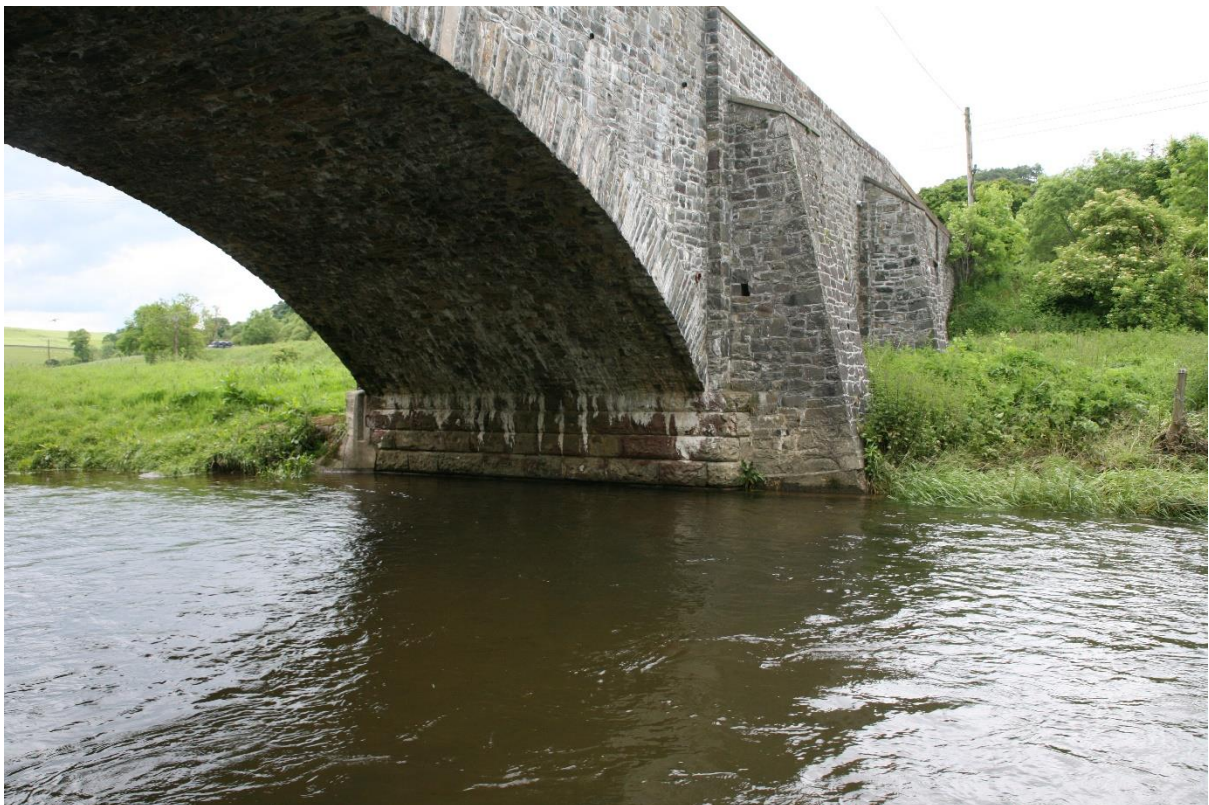
The side spans, or strictly flood spans, are interesting for being different radii, partly to accommodate the sloping road.

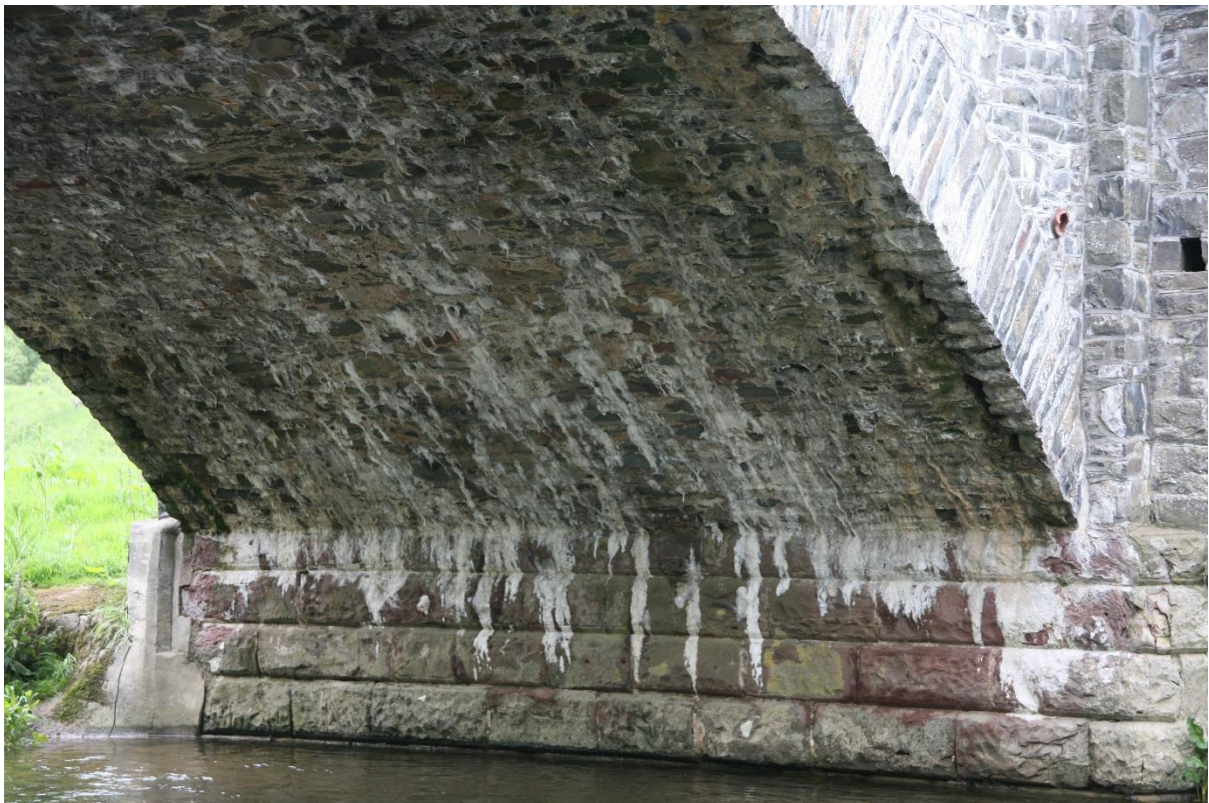
Here we can see how low the springing is set on the main span. If anything, it is slightly below the surrounding ground.

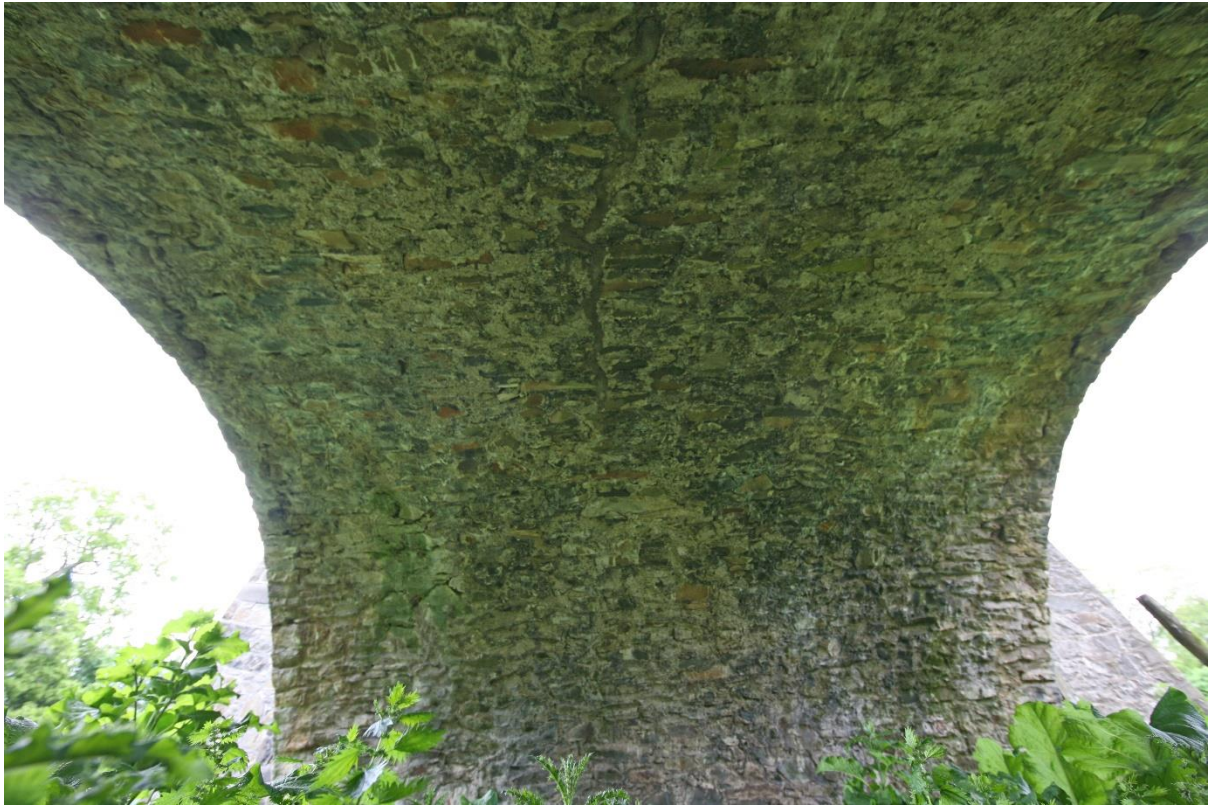
Once you zoom in, of course, the light balances better and the picture doesn't need to be pushed. We can be pretty sure from here that the long stones were chosen for the edges and the remainder of the arch is built up with smaller stones and a lot of mortar. Almost a concrete arch, in fact.

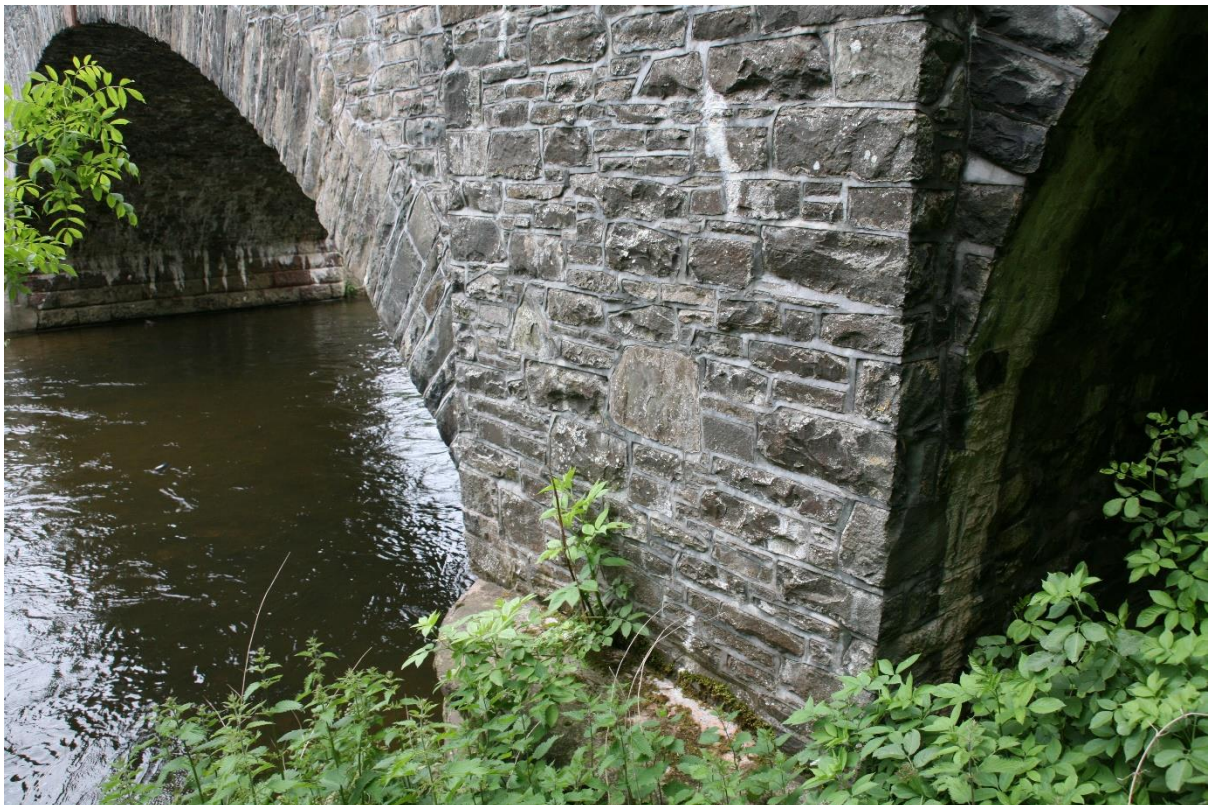
This is a side span. Interesting how it is dark in the middle and paler at the edges.

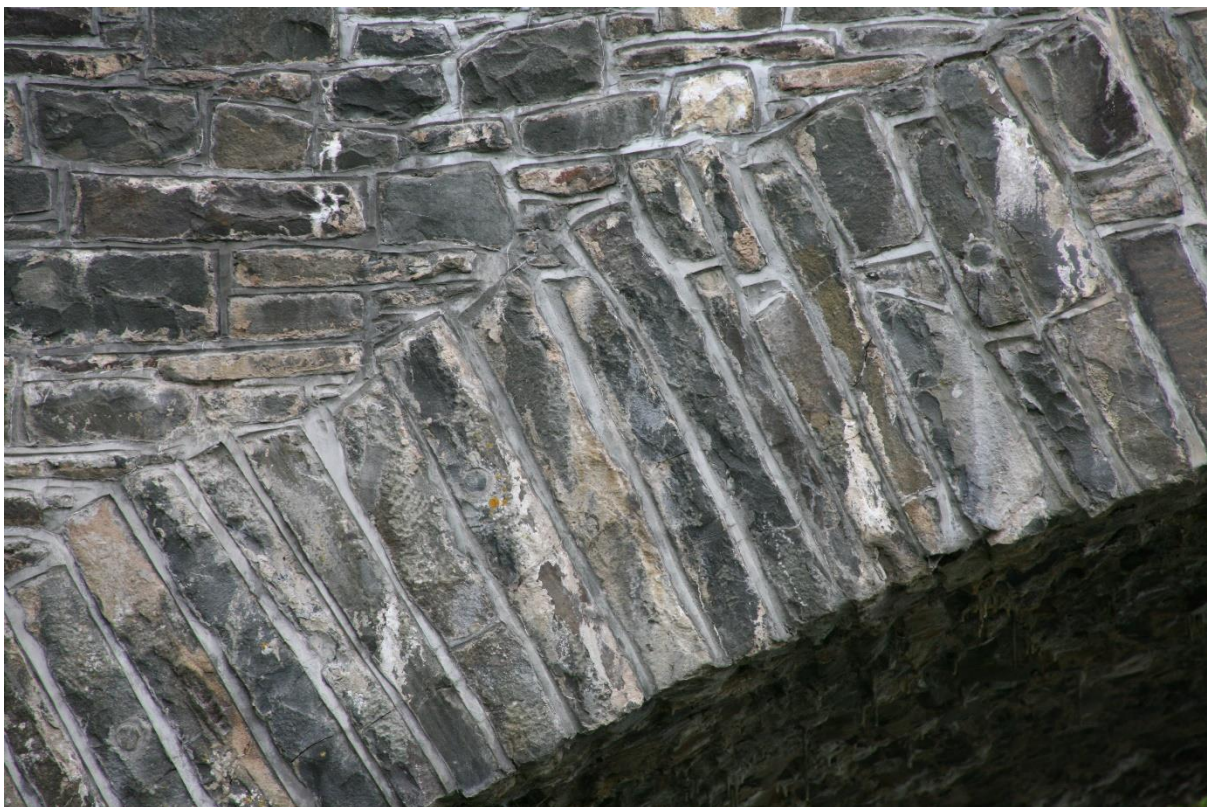
The “keystone” is actually only stuck on but at least gives us a date. That mortar looks awfully like cement, hope it doesn’t cause too much trouble.

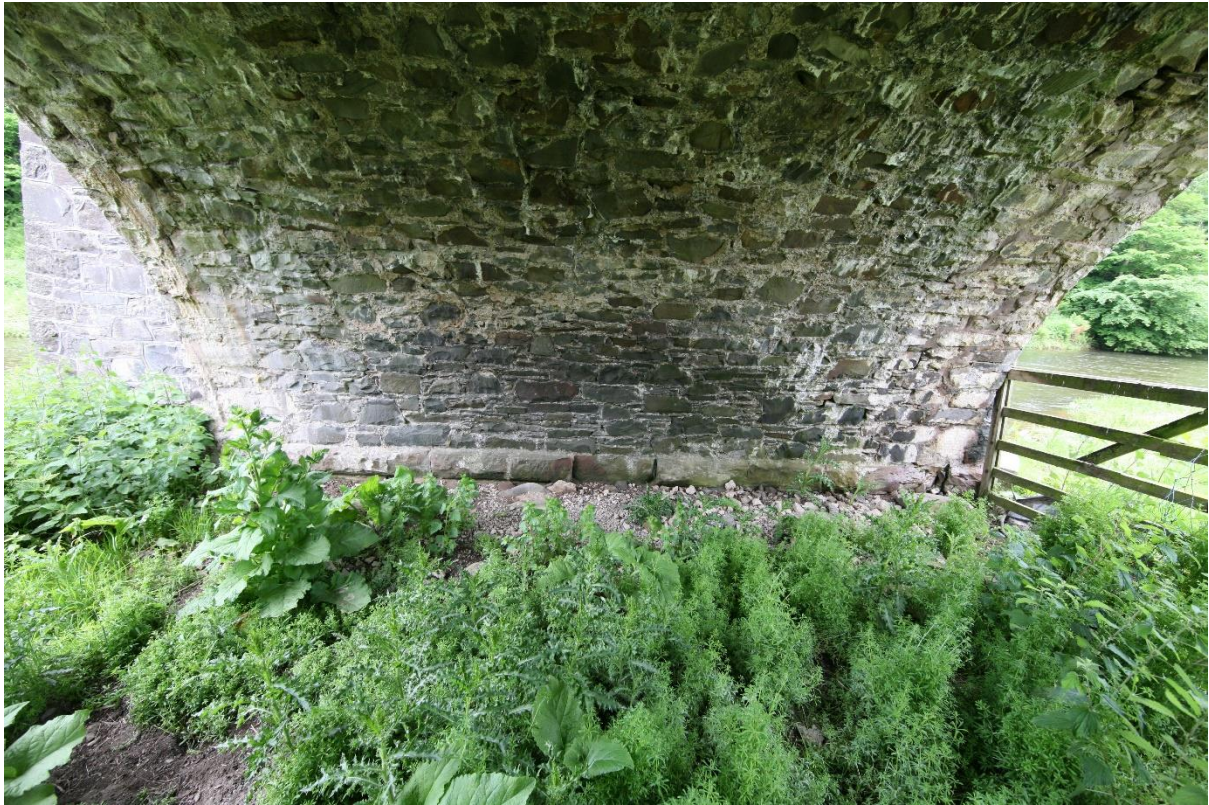
Here, around the quarter point there is a nice view of the stonework in the ring.

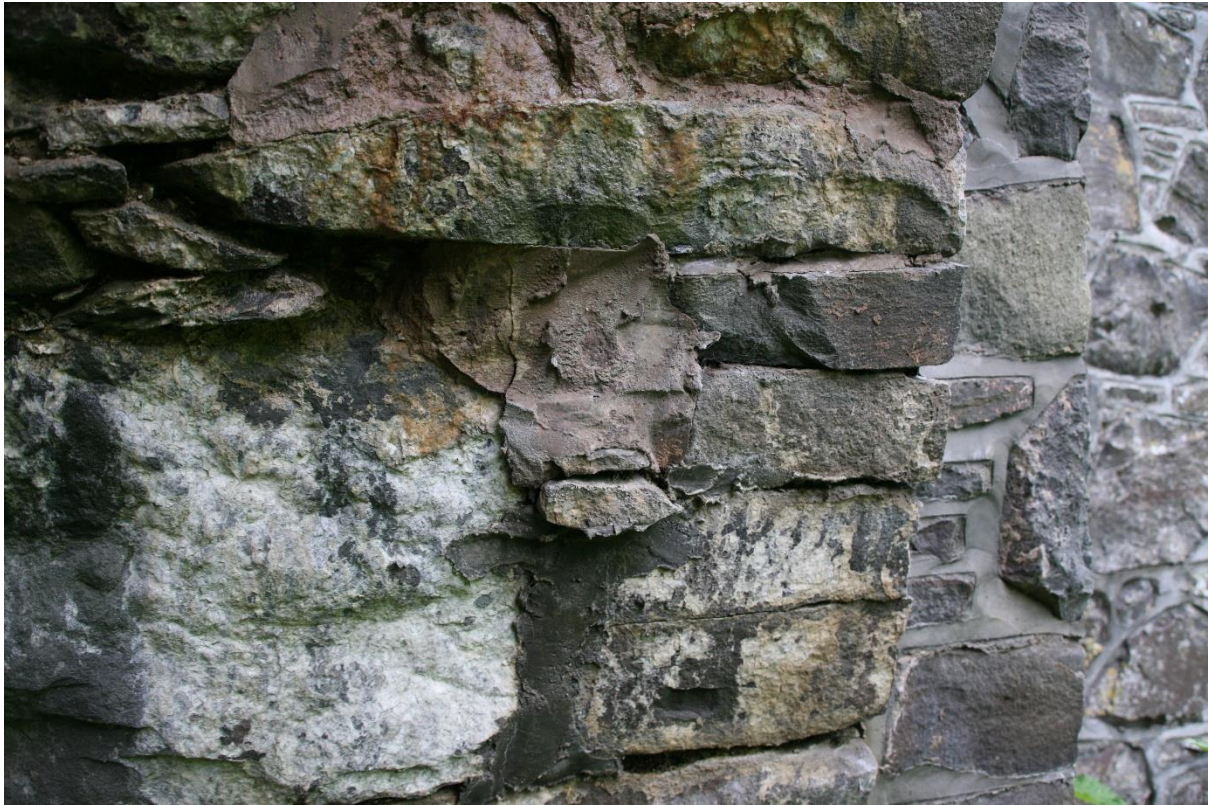
Some of the masonry contains remarkably small stones.

And in places, the repointing just got out of hand.

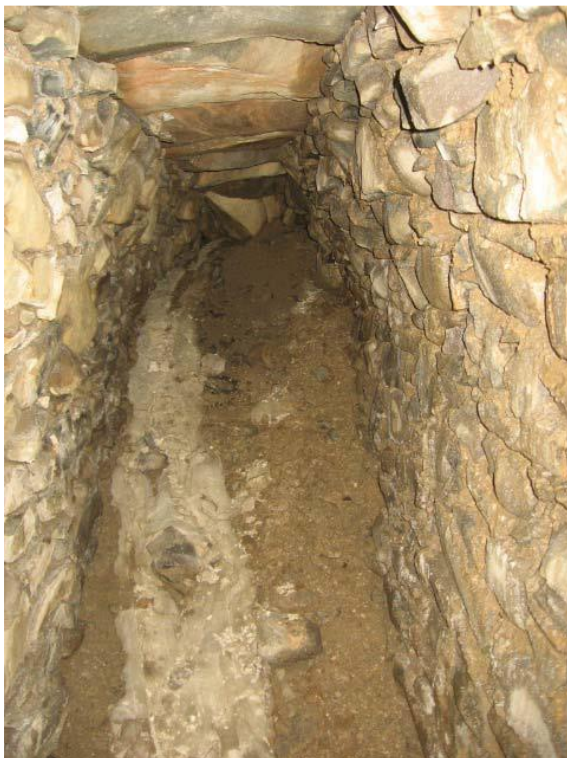
Figure 1: Internal spandrel walls topped with rough stone prisms

I hadn't come across internal walls on a bridge built of rubble before. I have thought often about the way the walls seem to lean in a little. It hadn't occurred to me till now that they might have been deliberately corbelled to reduce the effective span of the slabs above.
