Bridge of the Month 144 December 2022

Rugley

AKC/99 Rugley Railway Bridge is part of the Historical Railways Estate, a collection of structures on disused railways now managed by National Highways, and subject of considerable press coverage in the last year or so. I was visiting friends near Rothbury in the Christmas holiday and took the opportunity to take a look.

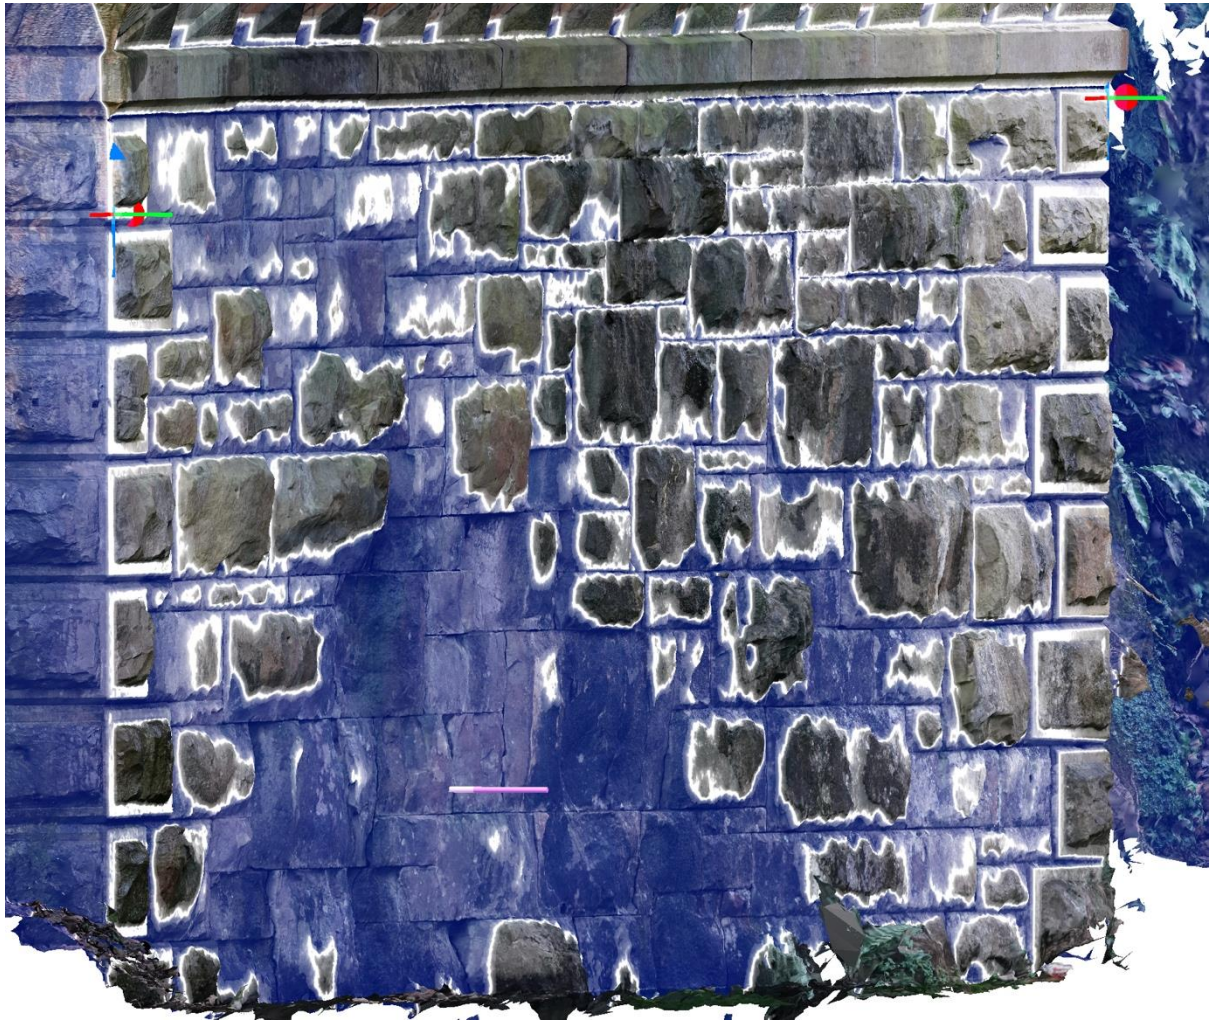
There is no sign of live load damage, and little sign of deterioration. The only visible area of damage is in the south abutment, where stones have spalled. It would be comforting to know why this has happened, but none of the fracture surfaces look fresh, the damage has not propagated into the arch ring.

Placing a plane across the south abutment face highlights the missing material. Perhaps a slight inward bow brought the front edges of the stone into bearing and caused the spalling.

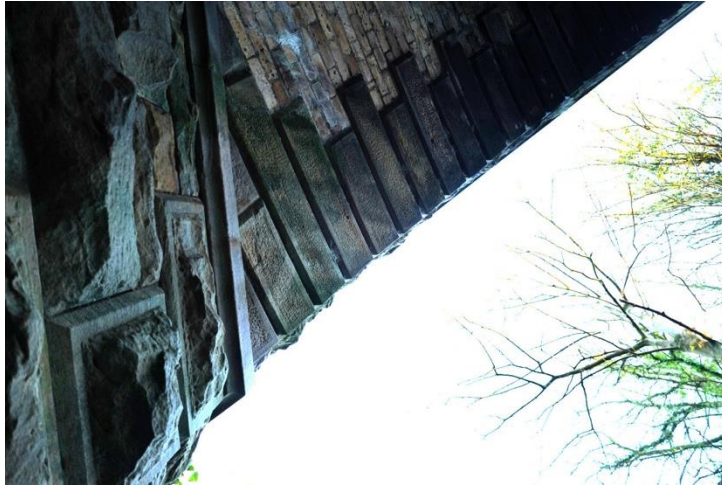
The geometry in the assessment report doesn’t stack up. The skew span is given as 11.05m (36.25ft), skew 11 degrees, and square span 10.8m (35.4ft). Neither span is likely as original geometry. Spans are typically whole feet. A half foot is conceivable, a quarter foot much less so. In any case, viewing on site it is clear that the geometry is circular in the square direction, so it is this span that should be sensible in feet.

Measuring on site I got 11.06m skew and 9.1m square. So where did the 10.8 come from? $11.05 * \cos(11 \text{ degrees}) = 10.84$, so perhaps it was calculated, but since we agreed on the skew span, why is the measured square span so different? Measuring a square span exactly isn't easy, but any error in direction results in over-estimation not under. The 11 degree skew angle didn't seem right on site. An upward facing photo at the corner makes this clear. Measuring the angle in the photo says around 35 degrees. $11.05 * \cos(35 \text{ degrees}) = 9.05\text{m}$, which is much closer to the measured span.

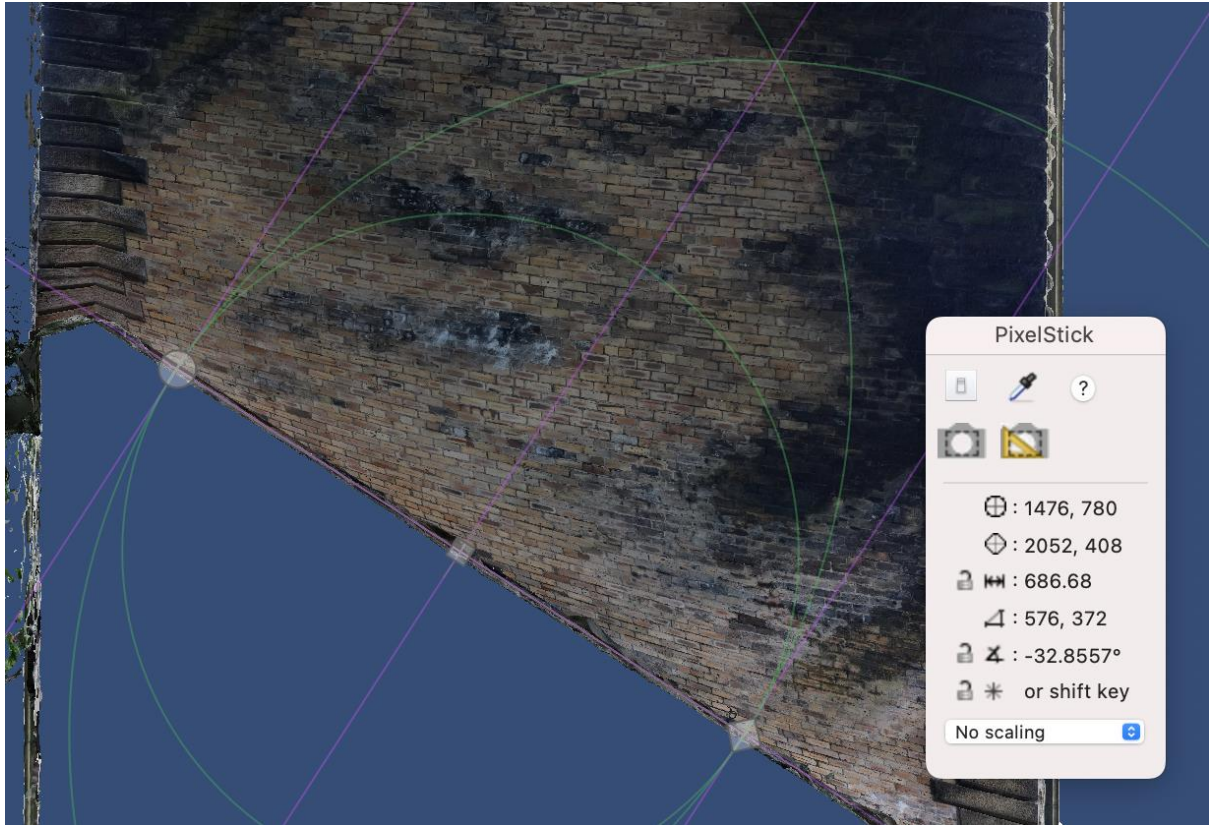
From this we can resolve the geometry properly. First, the skew. Measuring in an upward orthographic view (I use the PixelStick app on the Mac for this), or aligning a vertical plane with the elevation and calculating the angle from the plane normal both give a skew angle of about 33 degrees.

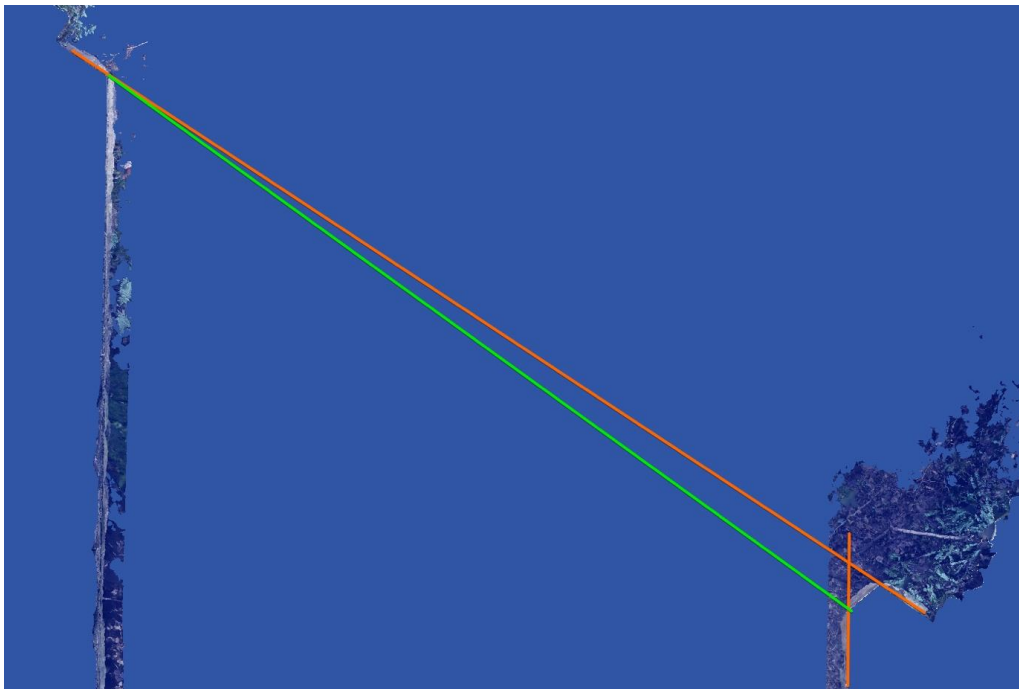
The cross section square to the abutments looks like a circular section. The skew shape is confused by the chamfered corners. In fact, I realised at this point that these corners also confuse measurement of the skew span on site, both I and the inspectors had made a non-trivial error here. 11.05m is the measurement from the obtuse corner, to the *inner* corner of the chamfer. The true corner has been cut off, and the skew means that the error isn't negligible.

So even with the right skew, calculating the square span from this measurement won't get the right result.

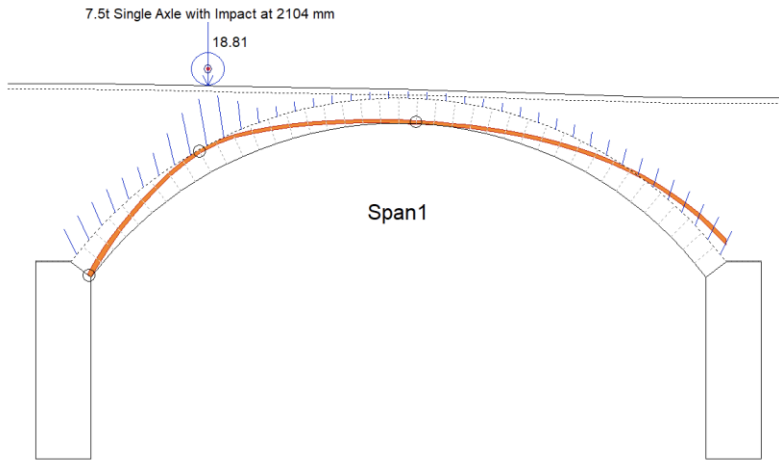
But this assessment produced a lower result from Archie-M than from MEXE. It did that by assuming *no backing*. The conclusions note that using a "higher" level of backing would increase the capacity, but the rationale for choosing a backing height of zero is not given.

In general, single axles are the most onerous loads for masonry bridges. With geometry as used in the assessment, and no backing, the thrust from a 7.5tonne GVW single axle cannot be contained in the masonry. This is the case that led to a 3tonne GVW capacity.

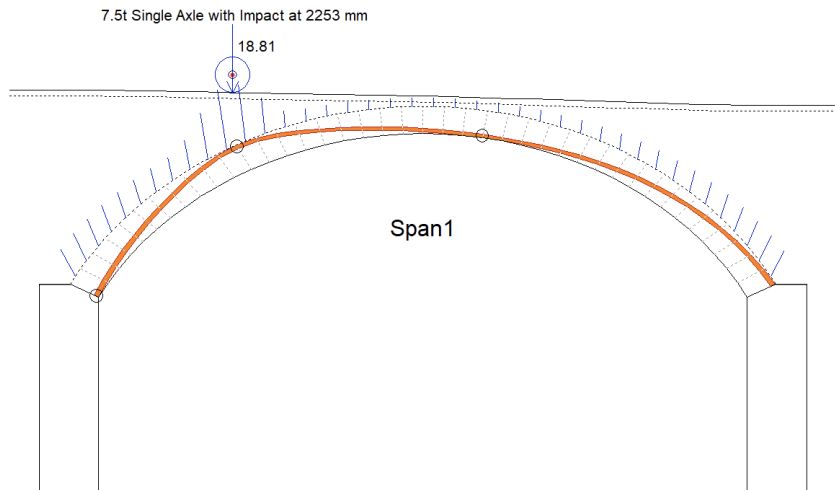
However, if we use closer to the correct geometry, the result is already different. Giving the square geometry of 9140mm span, 2740mm rise, circular segment, and asking Archie-M to apply the 33degree skew, we find that the thrust from the same 7.5tonne GVW load fits in the masonry of the ring.

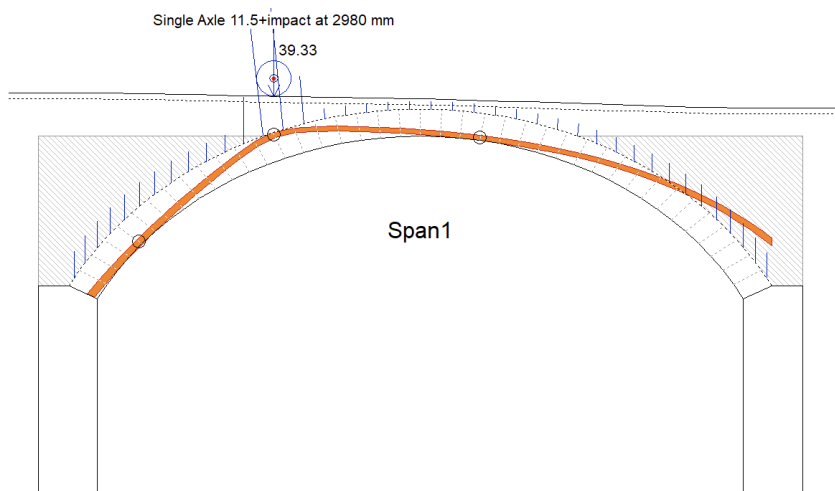
The idea that there is no backing is not credible. If we add flat top backing to intrados crown level – one of the most common patterns – we see that even an 11.5tonne axle with impact is carried with the thrust in masonry. Rubble concrete backing would provide a stiff load path to the rock of the cutting.

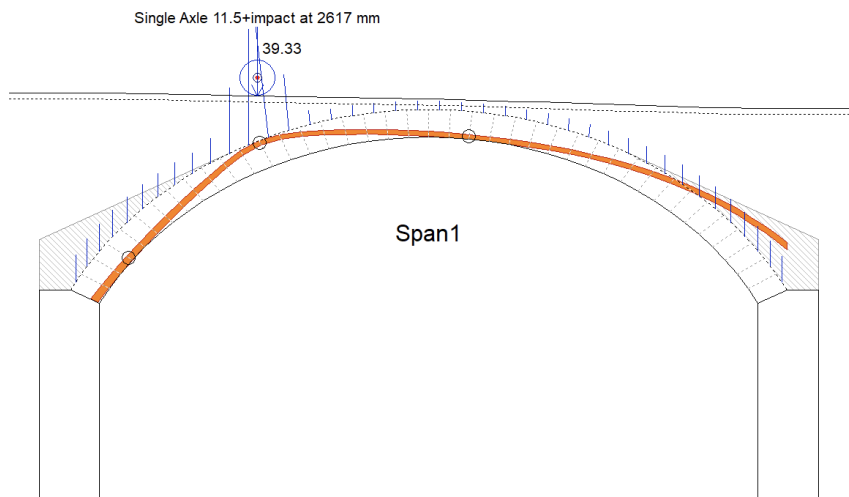
Tangential backing, even implausibly steep, would still contain the thrust.
