Bridge of the Month 153, “September” 2023 Plessey Viaduct, Northumberland

Over the weekend of 7-8 October 2023, a section of wing and spandrel wall collapsed at [Plessey Viaduct](#). This is a very serious issue, and it seems reasonable to devote the overdue September Bridge of the Month newsletter to it.

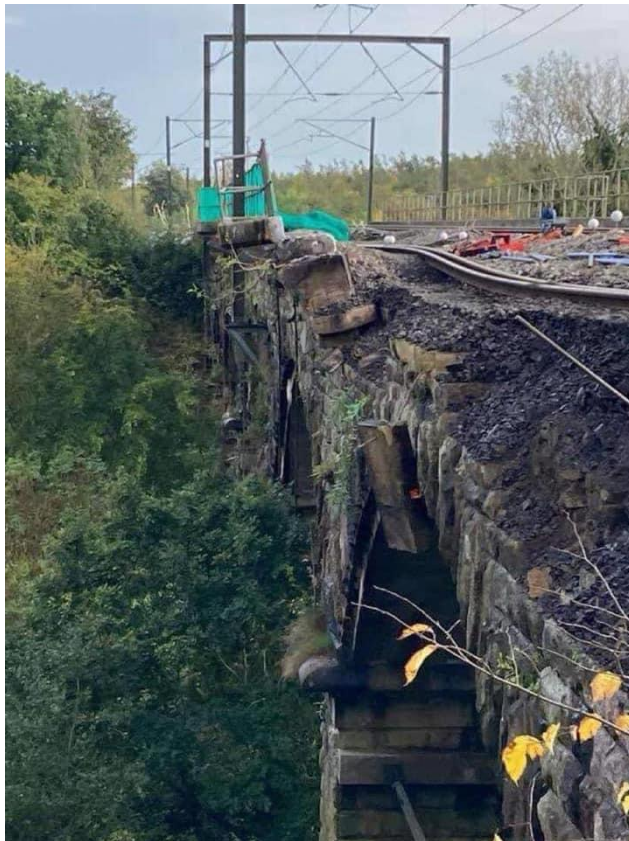
The photo left [was circulating](#) by the evening of Sunday 8th.

There was little if any tilt to this wall in 2020. Fast forward last weekend, and by Sunday night a stretch of spandrel wall has dropped to the ground below (first photo above).

Going back to the photo at the top after the collapse, it looks as if the concrete walkway units were tied down into the masonry with steel bars, perhaps resin anchored into the masonry at the base. Odd stones have been left hanging on the bars. Their presence would encourage the observed rotation of the upper masonry as a unit. A likely point of rotation is just below the end of those bars.

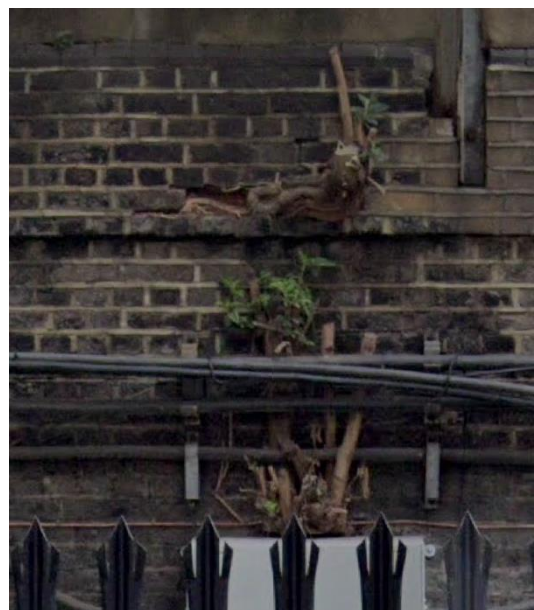
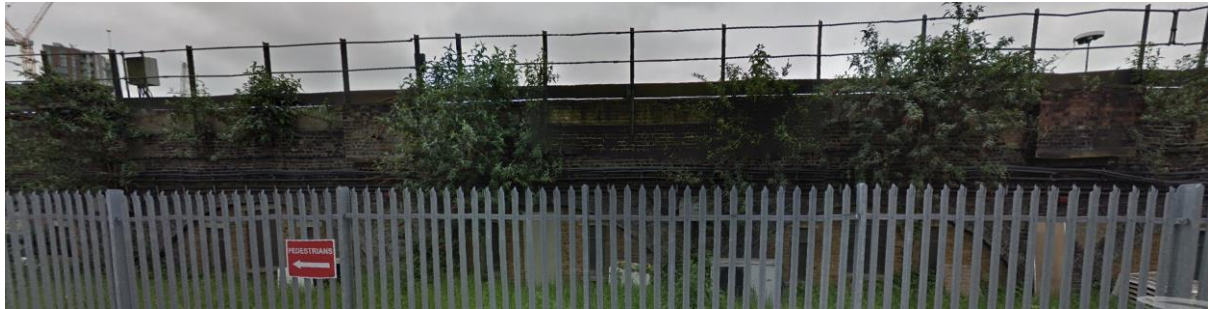
failure to manage vegetation on structures across the network is resulting in significant damage and undermining inspection value, and the vegetation on Nine Elms viaduct was far too extensive and mature, as shown by the Google Street View images above and below from shortly before the event.

That vegetation may have made a contribution to what happened, but I am far from convinced that it was a primary cause, let alone apparently the only noteworthy cause. And if it was – has vegetation management changed as a result?

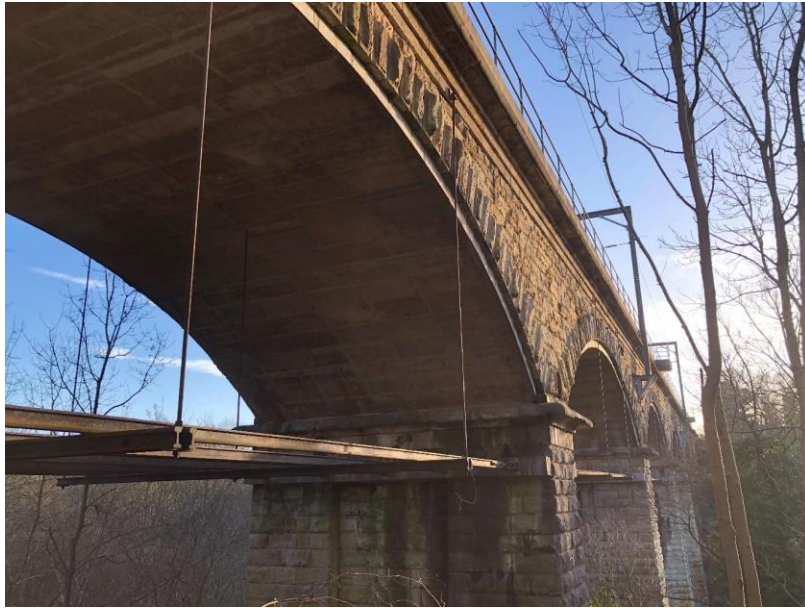
There is clear evidence of past concerns, in the form of interventions. These including a rather slender reinforced concrete under-ring, and longitudinal ties.

The under-ring is quite common. The reasons for its installation are quite possibly lost, but it seems likely that the condition of the original arch barrel within the width was considered inadequate.

The ties (the longitudinal rails are obviously too slender to act in compression) from bull-head rail, are more interesting, because they are less common. Are they contemporary with the under-ring or from a different cycle of treatment? The transverse rails and hangers are only there to support the self weight of the ties and stop those sagging.

Have these interventions made any difference? I'd wager no-one knows. The under-ring probably hid some ugly cracks, but has it changed the behaviour that led to them, and stopped them getting worse? Are the ties stiff enough to actually modify the behaviour of the stiff masonry? The only way to answer those questions is by careful measurement of behaviour before and after intervention, which is done approximately never, and often can't be done retrospectively. I was delighted to hear others making the case for *proving* interventions at a recent workshop on masonry bridges organised by the ERMABI project; I'd be even more delighted to help with the sort of testing that could do so.

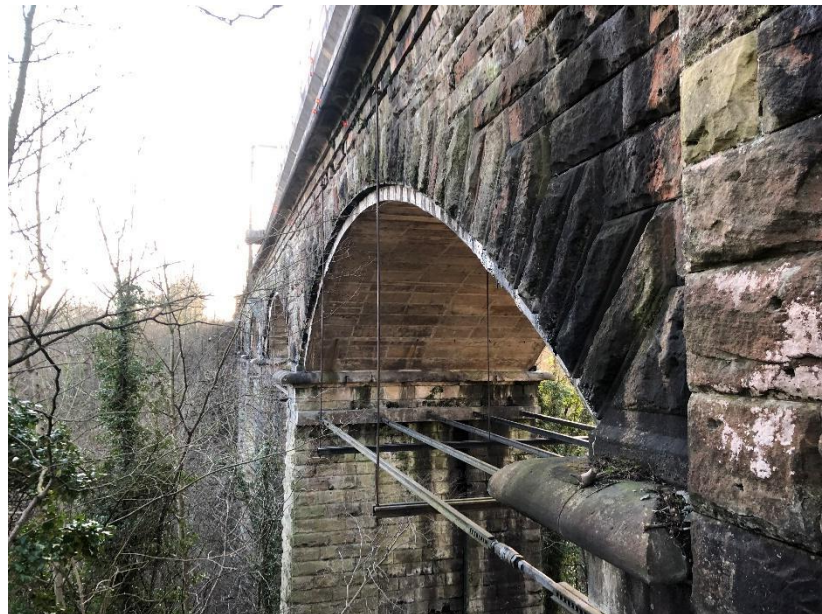
A slightly different view shows a bit more of that system. Chunky turnbuckles to tension the tie system. I wonder what the anchor in the abutment is, and what is hidden within the transverse concrete element.

The top of spandrel wall here is littered with survey targets (red flags, just visible in the photo right). Installing those targets and measuring them enough times to provide any useful

data is not cheap. This photo was taken in 2020; there had evidently been concern of some sort – not necessarily related to the recent damage – before that.

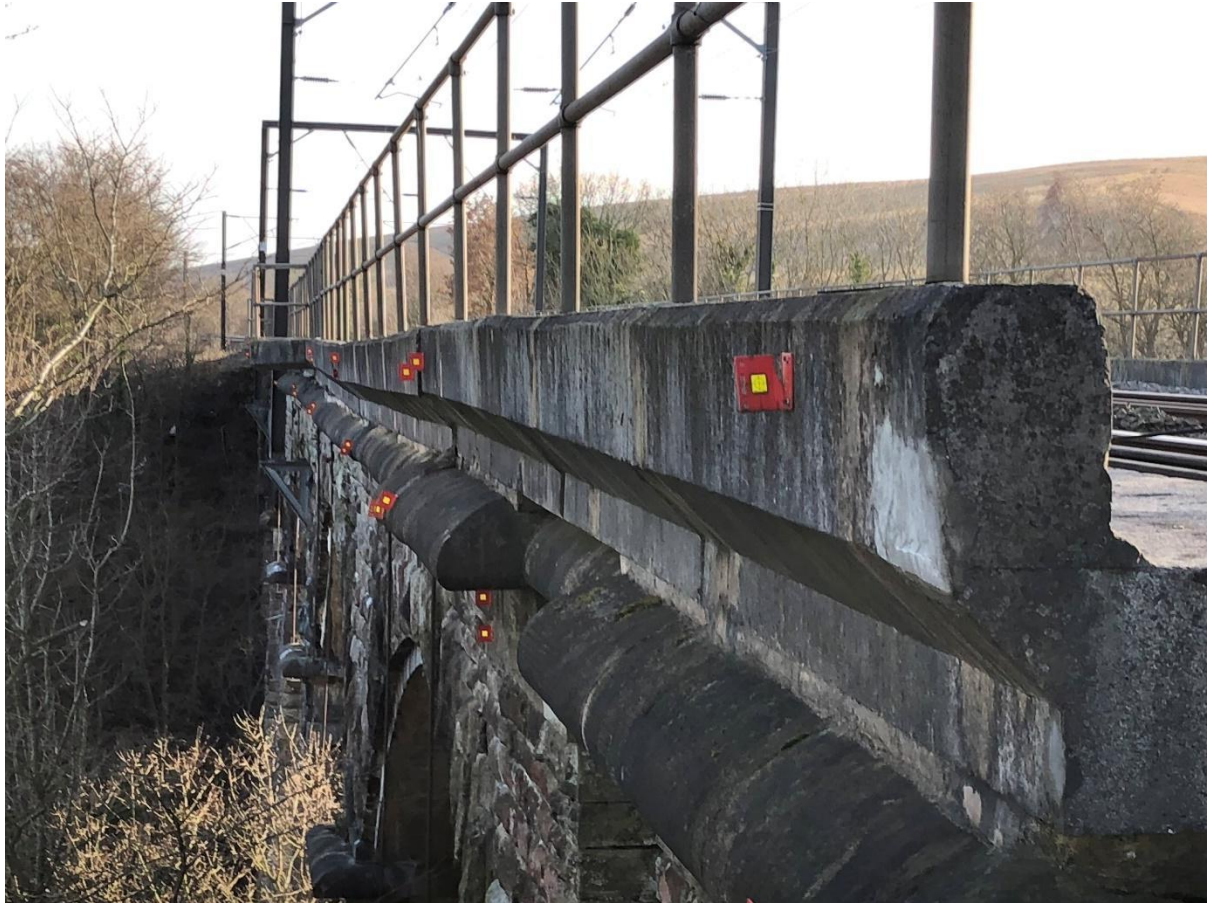
The photo below (again from 2020) is, I believe, the end where the damage has occurred. The nearest target is torn, and looks distinctly grubby, placing the start of this monitoring considerably earlier. There is no obvious tilt here at the near end, but a pronounced dip, the low point I think over the nearest pier. Perhaps the monitoring was related to that.

The near masonry is not really a spandrel wall, but wing wall over the abutment. Notice two sections of the string course stand forward. These areas mark the positions of two buttresses in the wall below.

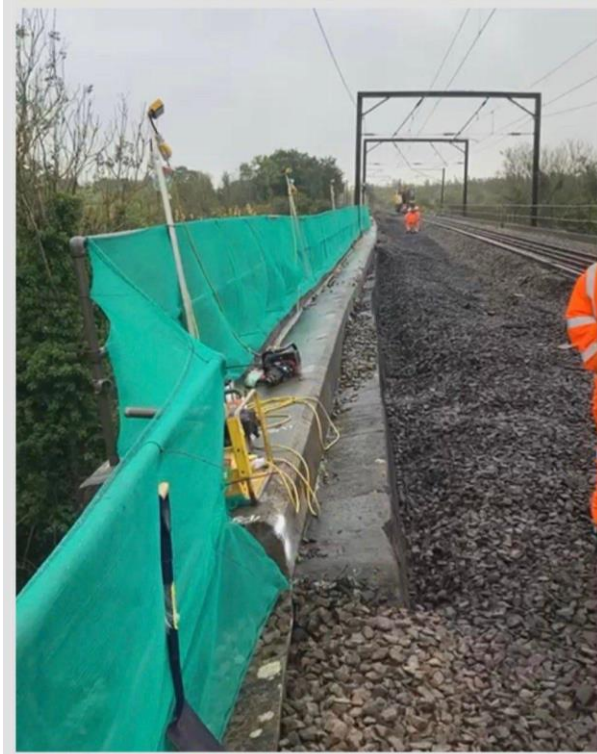
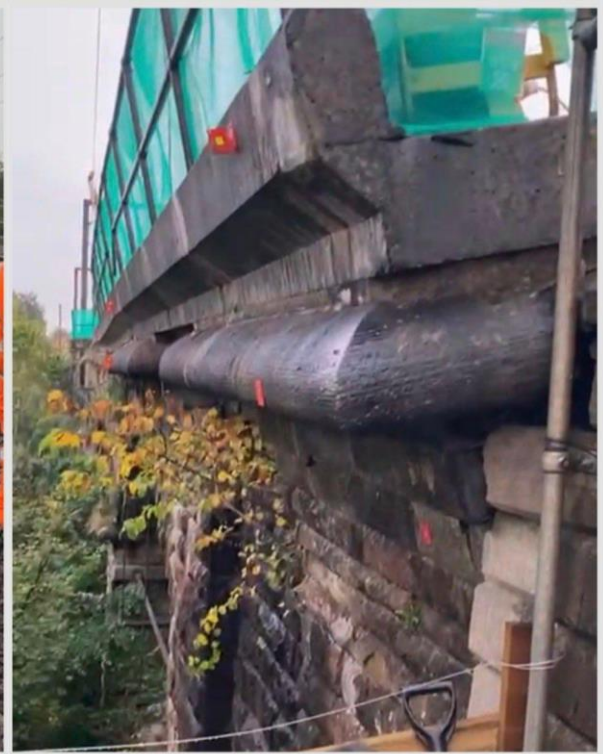
LNER also put out a notice, understandably vague, saying only that some structural damage had been found. The interesting bit of the LNER [announcement was that it included photos](#), clearly taken earlier than the one from the start of this piece, showing the parapet (and spandrel wall) definitely “moved” but still attached.

Looking at the photo above from outside the wall, we can see a concentrated hinge, well down the wall. Below, the wall is tilted little if at all. Above it has tilted as a unit. The view from inside seems to show ballast dropping into a gap left as the wall moved away.

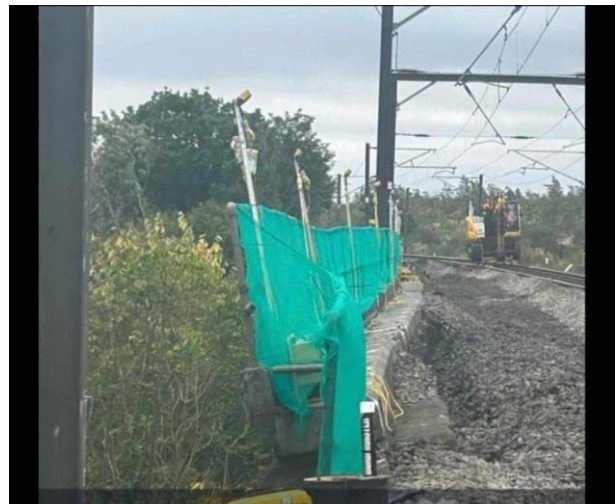
Twitter user Random Railways [reposted a photo taken some time between](#) (right), when the movement was worse but the full collapse was yet to happen.

The concrete walkway is narrower than the string course. The string course masonry is clearly visible into the distance in the LNER-shared photo. In the Random Railways photo it is not clear in the middle distance. Did the masonry rotate out ahead of the concrete? There could be some influence here from the buttresses – if the wall hinges at the face of the buttresses, the masonry between would rise out of contact.
