Bridge of the Month 156, February 2024

Yarnton Road Bridge wingwall collapse

On the evening of 10 February 2023, a Great Western Railway train struck debris on the track at [Yarnton Road Bridge](#) in the Oxford area. The debris came from the wingwall of the brick masonry over-line bridge.

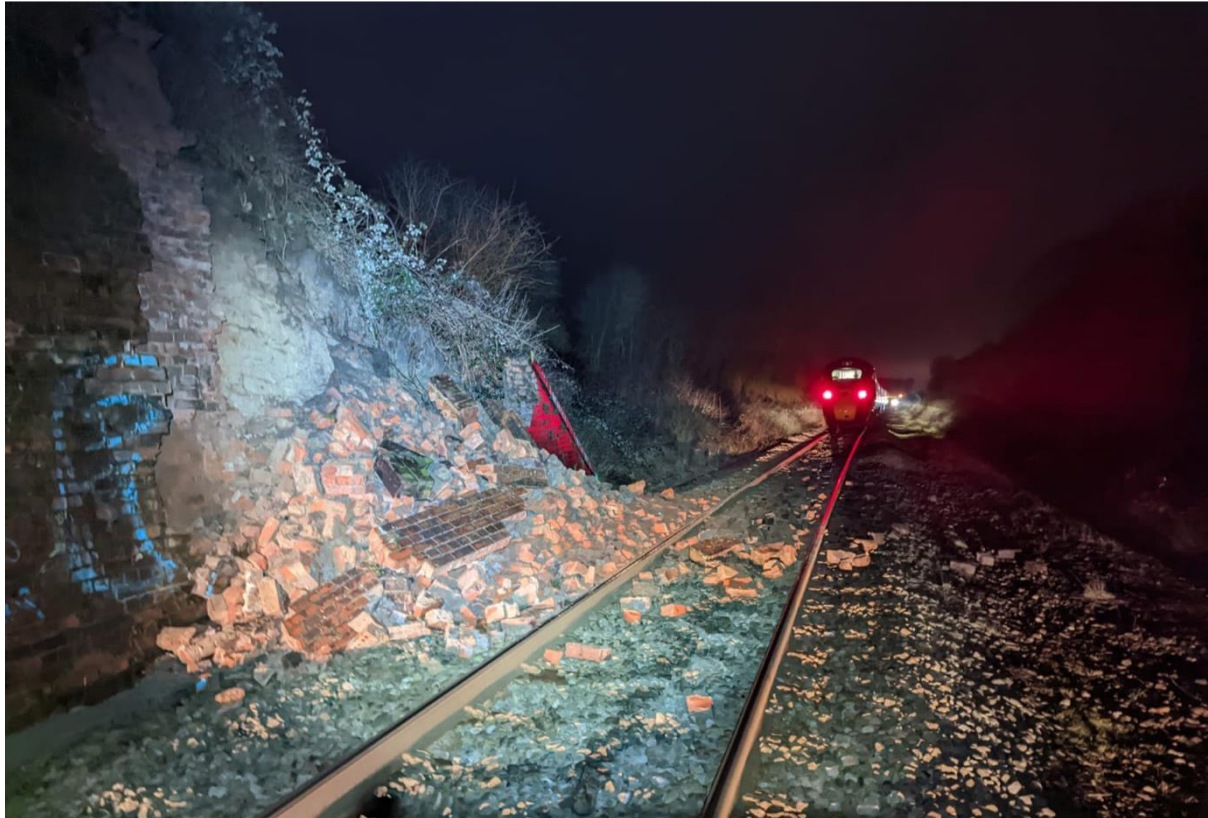
Back to the matter in hand. The immediate aftermath looked like this (photo credited to Network Rail).

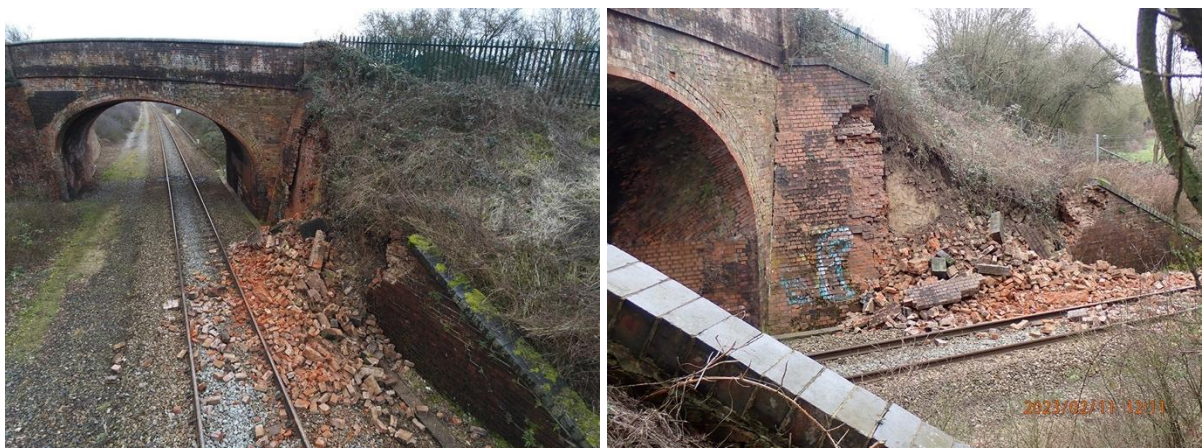
Two views from the following day show interesting features. To the left, a large void is visible between the outer skin of masonry and the wall behind. To the right, there is a very sharp, vertical break, with no remaining masonry to the right. The second of these features doesn't seem to be commented on by RAIB.

The exposed slope where the brick wall has completely collapsed seems to be largely intact. That is confirmed by RAIB, who note that there is no evidence of the collapse being driven by a large slip failure in the embankment.

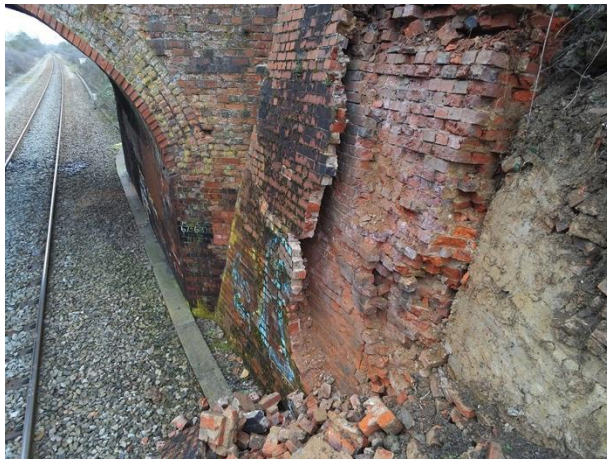
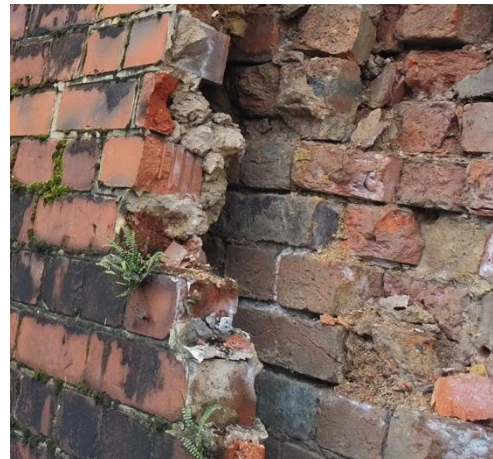
Closer views of the damage shortly after the collapse (below) show the scale of void behind the outer skin. Of course, the collapse itself will have tugged at the remaining masonry, so this void will be exaggerated. What is very clear is that there are only snap headers, and no bond between the half brick skin and the older masonry behind. That may not be the whole story, as the near part of the old wall has lost the top half brick. Whether this came down in this incident or previously is not remarked on; was the rubble properly examined?

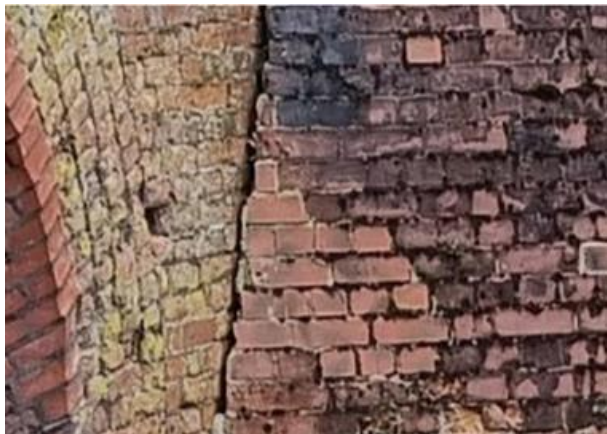
It is not absolutely clear, but it seems to me that the thicker wall behind may have terminated at the near edge. The upper part above left looks like a relatively clean end, and seems to project back behind the cutting face in front. A line of deeper damage to the old masonry at the top of the frame needs explaining.

Exam reports recorded a “mitre fracture” between the wing wall and the bridge. This close up from one of the photos above shows the feature. This is clearly not a fracture, but a gap where there has never been any bond. That may have been understood by the examiners, but if so then the word “fracture” should not have been used. Note also the reskinned inner arch ring, with sloping coursing reflecting the substantial skew angle. The older brick ends do not look lozenge, suggesting that only

the inner ring was laid in spiral courses, which is not uncommon.

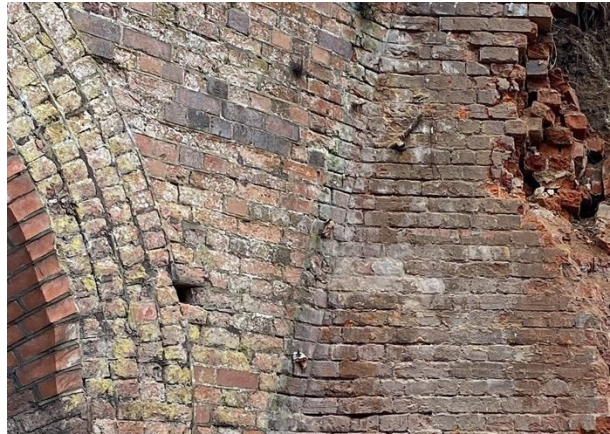
With the remains of the later skin removed, we can see (below right, Network Rail photo) that the original wing wall was neatly bonded to the spandrel wall. There is little sign of a

fracture here, though patch repairs may hide earlier damage. This brickwork is a lovely illustration of the attention to detail given to mundane structures at the time.

Regarding that inner, original section of wall, the part near the spandrel wall of the bridge exposed by the clear up looks quite sound, though the outer/upper parts are in poorer condition. In the last photo above we can see that the original (previously hidden) thick section of wing wall has been broken back. The [wide photo taken later](#) in the works shows that it was broken almost back to the spandrel wall. Was this necessary? What did it achieve? The spandrel wall has lost its buttress as a result.

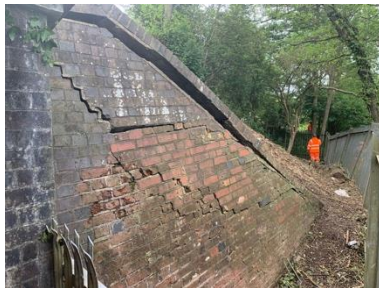
If there is thick mortar *and* an open crack, then movement has been going on for a long time and is ongoing. Why would it stop? As, for example, at Nuneham Viaduct (left, photo [posted to LinkedIn](#) several months before the recent emergency closure). How were those cracks interpreted when they were filled up with mortar, before they reopened as movement continued?
