Bridge of the Month 157, March 2024

Old Leckwith Bridge

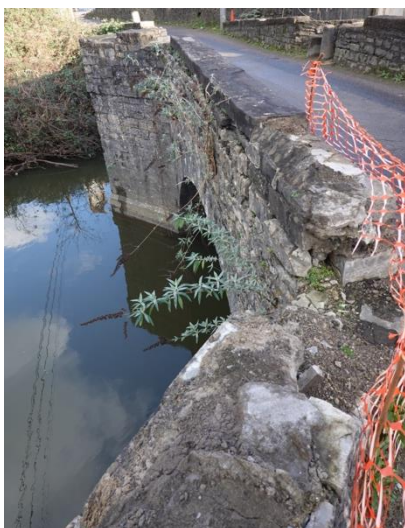
A significant amount of parapet masonry has been lost. Mercifully the damage has not yet extended below road level. The gap in the parapet left is from vehicle impact and will have been lost into the river Ely. (It isn't clear what the mesh netting is supposed to achieve.) Long runs of missing coping stones seem at least as likely to have been deliberately cowped into the river or stolen. Vandalism and theft are both much more likely when a bridge is obviously neglected.

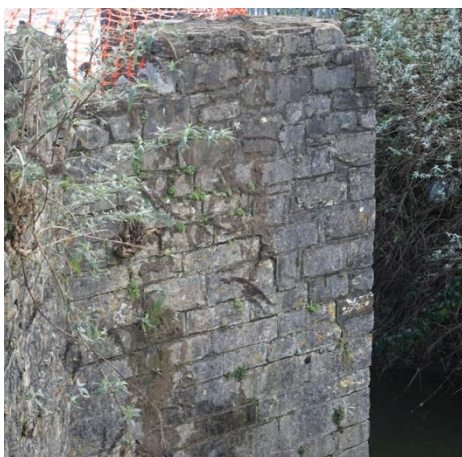
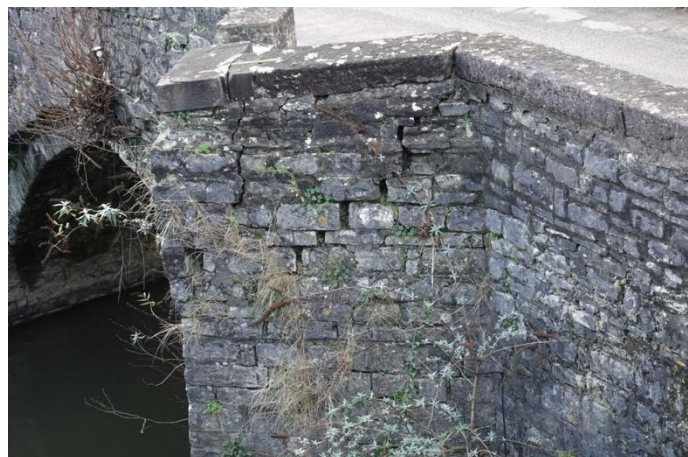
There is a high probability of more extensive and more serious loss of material. Some of the cutwaters show characteristic damage from vehicle impact: a diagonal crack tapering down to the nose (below left, right). This issue [plagues Bidford Bridge – CCTV footage](#). Once the

fracture exists, the force needed to finish the job is much reduced.

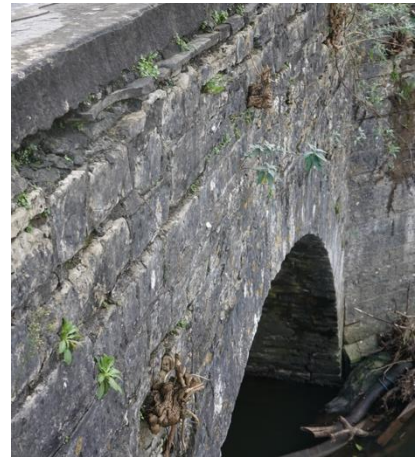
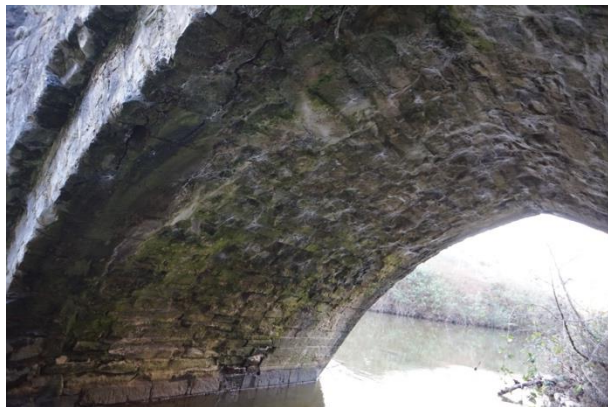
The coping stones don't seem to fit everywhere. They look rather different than the rest of the masonry too, so probably a later addition.

Evidence here too of the buddleia being cut back – but this is superficial treatment, as it doesn't stop regrowth, and the roots continue their attack on the fabric.

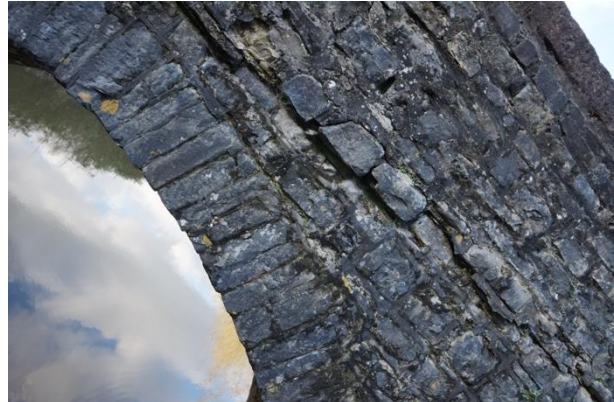
I took some photos with a pole camera to get a glimpse of the soffits. A photogrammetric model would make interpretation much simpler, of course. This one shows a fracture inside the spandrel wall, which was obviously large once, then filled with (cement) mortar, and has now reopened. I'd guess the "repair" was decades ago, and the crack width isn't huge now, so the movement is slow, but it hasn't stopped.

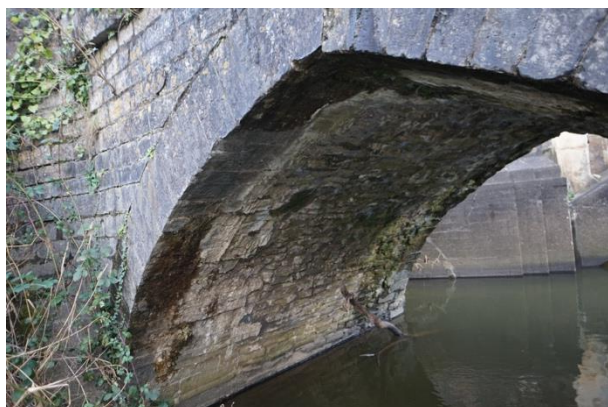
This shot (right) captured an outward displacement of the parapet over the central span on the downriver (southwest) elevation. This has developed since the bridge was pointed, again probably a few decades.

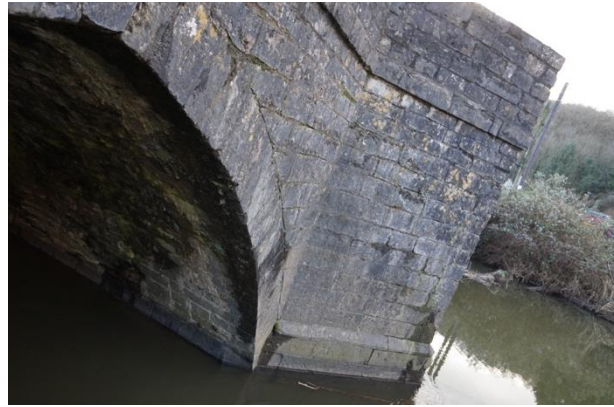
It turns out that the upriver (northwest) elevation is different. This is the northeast span. While most of the width is rubble, this edge of the ring and the spandrel wall are of ashlar. A repair, or a widening?

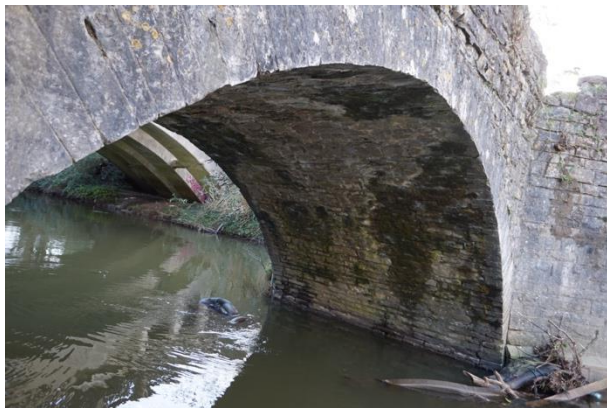
Same span, looking to the other springing, I'd say there was a diagonal fracture in the cutwater running down to just above the lower step.

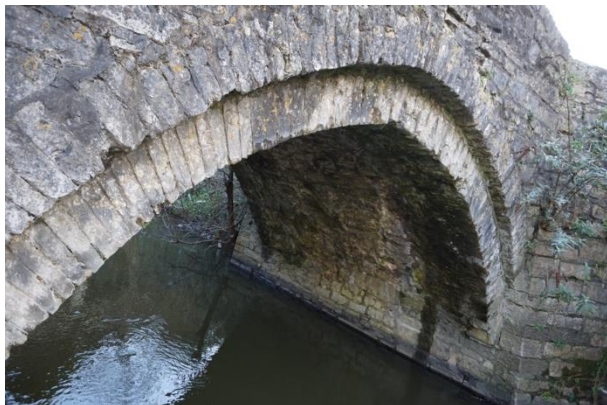
The middle span (left) again has neatly dressed voussoirs. The parape, which is riding out, looks to be of rougher stone.

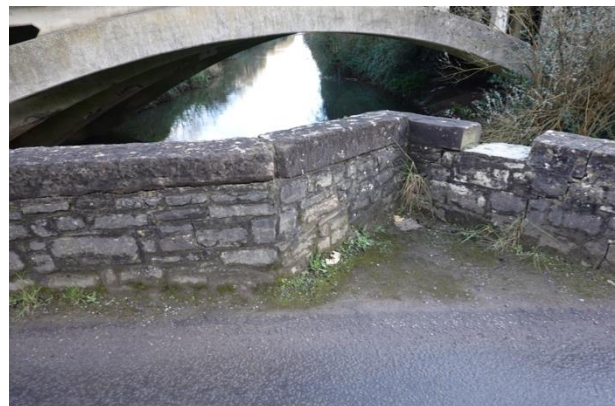
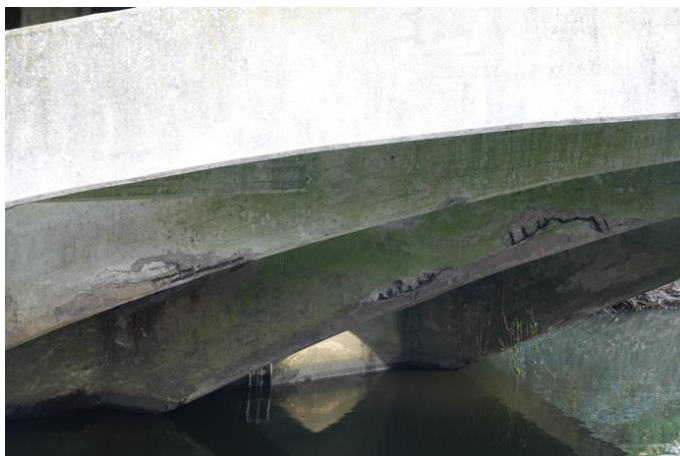
Unfortunately the 1930s bridge isn't in great condition, and its position doesn't suit the development at all. The plan therefore is to demolish it, and build a new one for motor traffic on the other side of the masonry bridge. The masonry bridge will remain open to pedestrians and cyclists only.
