Bridge of the Month 158, September 2024

Monnow Bridge, Monmouth

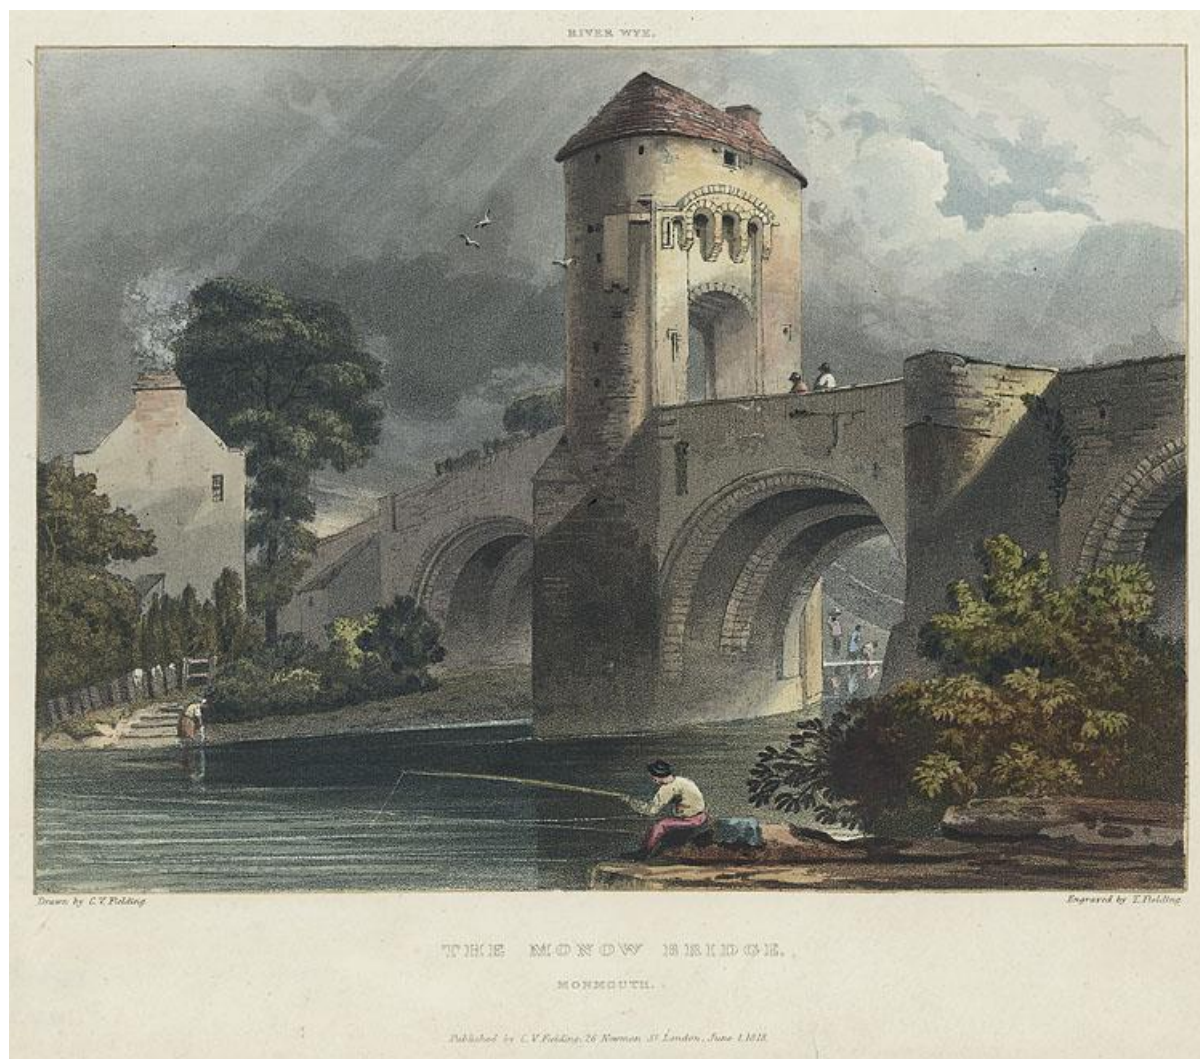
The original gatehouse seems to have had a portcullis. The slots for this are still present at lower level, but the upper part is obstructed by [machicolations](#). Whether these were ever used in anger I don't know, but users of the bridge today must run gauntlet of unpleasant projectiles from the pigeons that now gather above.

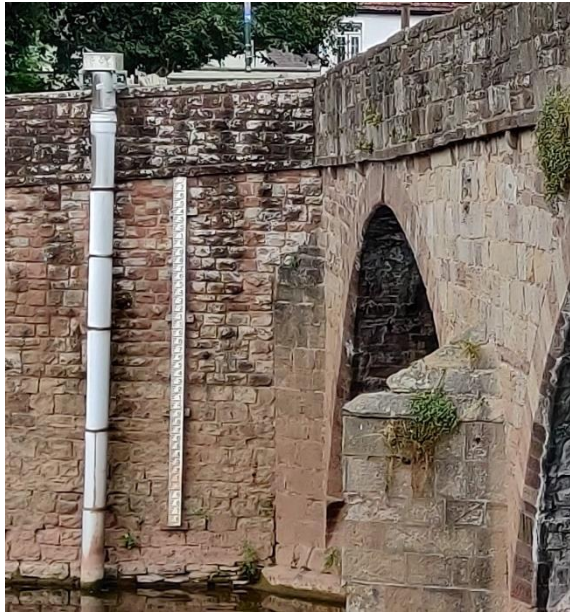
The present-day version of that southwest river wall now exposes a small portion of what could be a further cutwater. Was there once another span to the west? Or is this simply part of a wing wall? The plan angle isn't quite the same as the cutwaters, but the cap looks more like cutwater than wing wall.

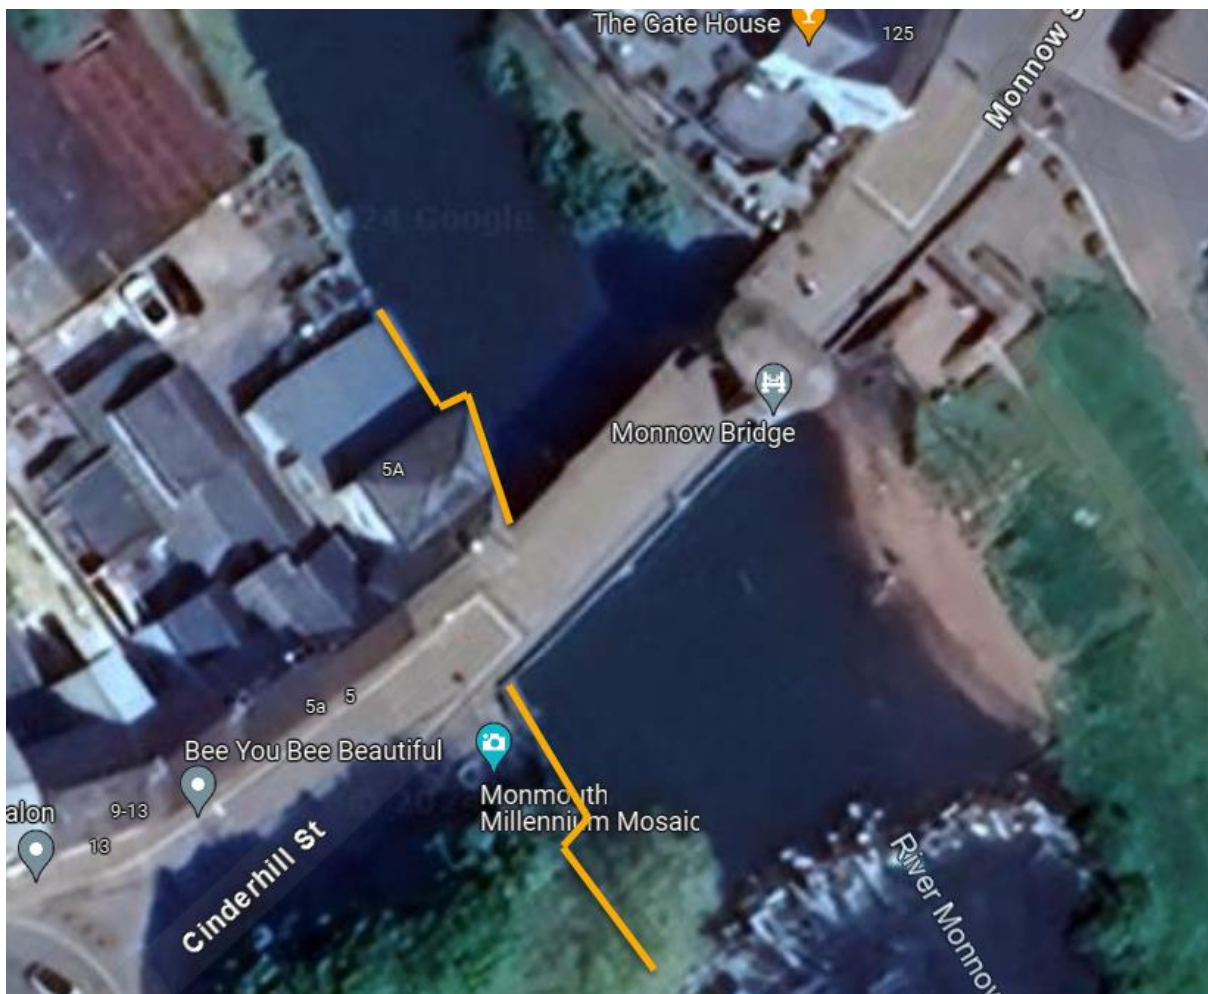
Looking at this in satellite imagery, the west river wall alignment is interesting. Bridge house on the upriver west bank projects well into the west span. The river wall immediately downriver has been brought out to near the springing; it steps back about 10m south. The natural extension of that southern section of wall past the bridge aligns well with the west end of bridge house, suggesting that this

might be built entirely on claimed land. I should bring a camera pole with me to get a look under the span at this end.

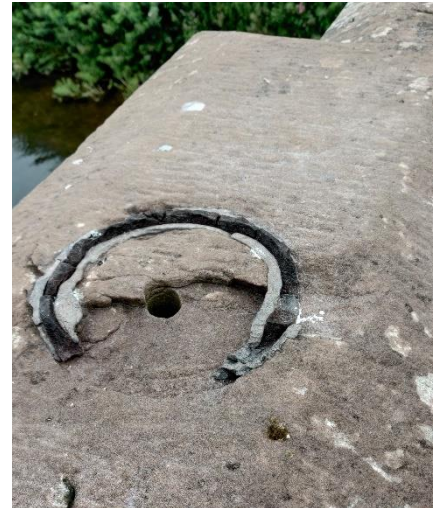
The parapet widens slightly on the upriver side over the west cutwater. A ring of cast iron fragments embedded in lead remain in a groove in the stone, concentric with a through hole. Presumably the remains of a lamp post, tied down through the central hole.

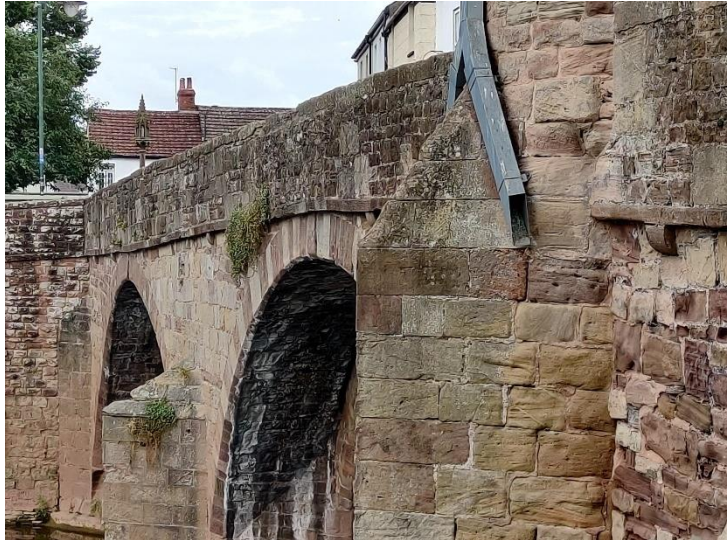
The string course on the downriver side sags over the west arch. The sag is already visible in the 1866 photograph so must have developed soon after the downriver widening, probably immediately on decentring.

The parapet over this dip also bows out slightly.

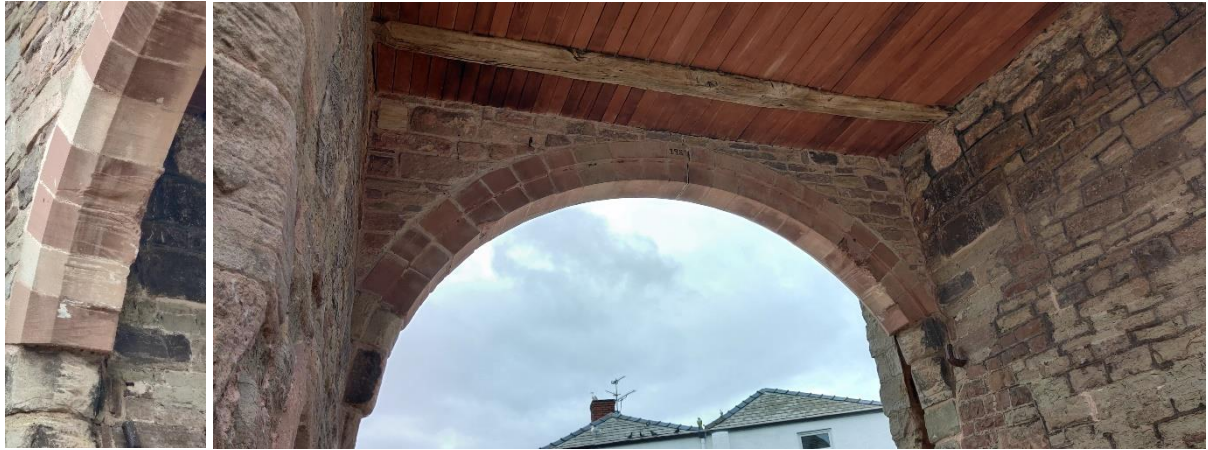
The gatehouse has suffered badly from vehicle impact over the years. Coflein [has images](#) of the town side arch knocked out completely, with the remaining masonry arching to the upper window. The voussoirs on this side are still have very rounded corners, perhaps the arch was rebuilt from the existing stones.

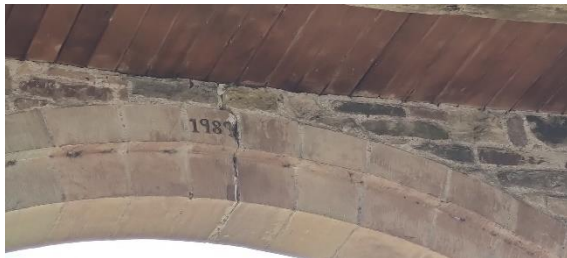
The arch over the road on the Overmonnow side of the gatehouse was rebuilt relatively recently in freshly dressed stone, but it was in place for long enough to accumulate lots of impact scars. It is dated 1989 (I think) on the inside face. The road was finally closed after construction of a new road bridge in 2004.

The replacement arch has an open crack at the crown. This crack should give anyone working on under-ringing an arch pause. There is no thrust in these voussoirs; they must be hanging on the mortar above. If that mortar let go, they would drop into contact, so this isn't dangerous, but it isn't what was expected

The crack seems to extend up from the ring into the masonry above, which suggests it is associated with an outward movement of the springings, and that this movement has taken place (or continued) since the repair.

The spalled stone that makes the last digit of the date difficult to read isn't easily explained without invoking cyclic movement. This is a southwest face, so temperature could play a part in that.

I'd like to see some monitoring of the crack in the gatehouse arch with sufficiently frequent recording to establish the speed of any progressive movement and whether there is a cyclic component. And if the roof isn't maintained, the interior of the gatehouse (sadly not open to the public) must be at risk.

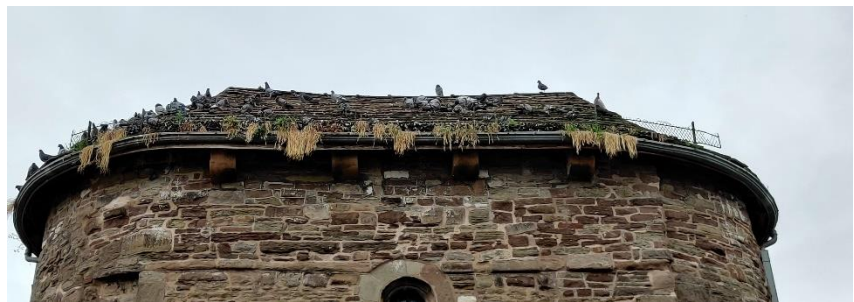
The growth of vegetation in the gutter is getting severe, no doubt aided by accumulating guano from the resident pigeon colony. The vegetation is not visible in any of the Google StreetView

images from 2009 to [2018](#), confirming my feeling that it was a recent problem. The pigeons themselves may be a recent thing, encouraged by people feeding them on the bridge.
