Bridge of the Month 161, January 2025

Baledgarno Den, Angus

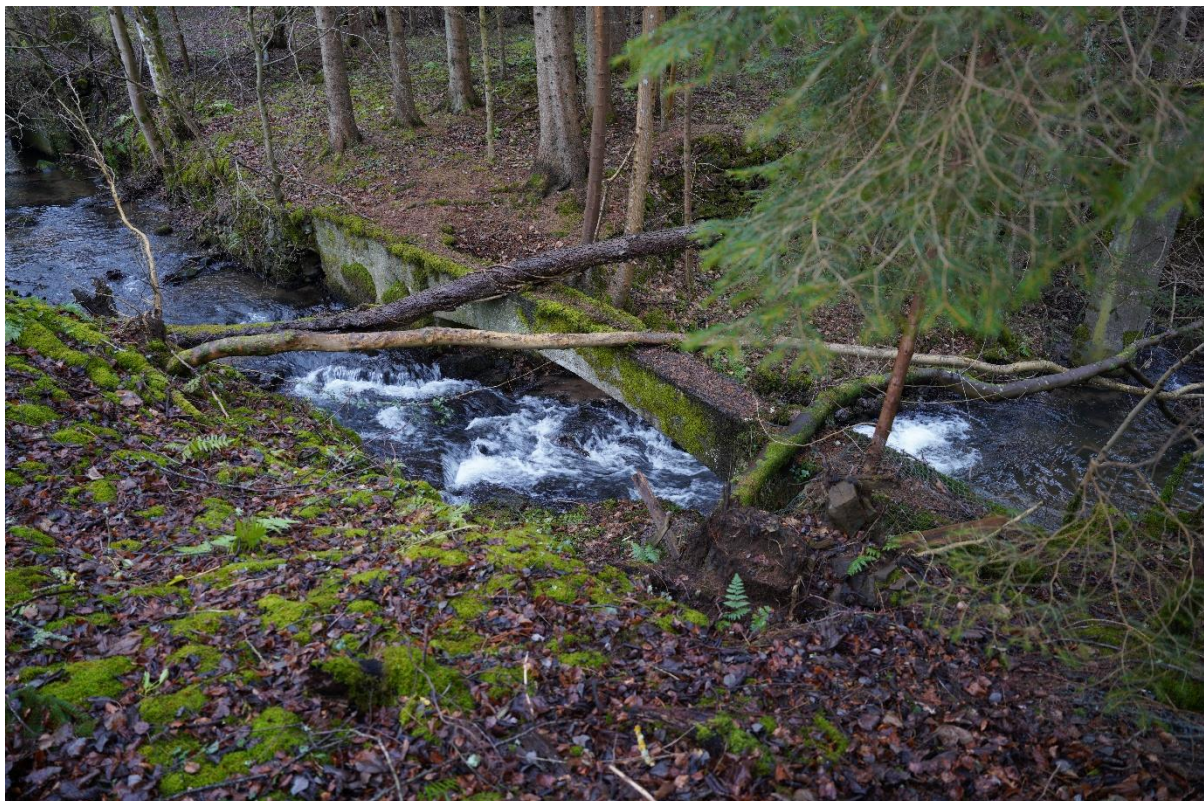
This surely isn't a bridge: it is too narrow, needlessly long span, and there is a proper bridge just upriver. For water control? Perhaps, though in what way wasn't clear.

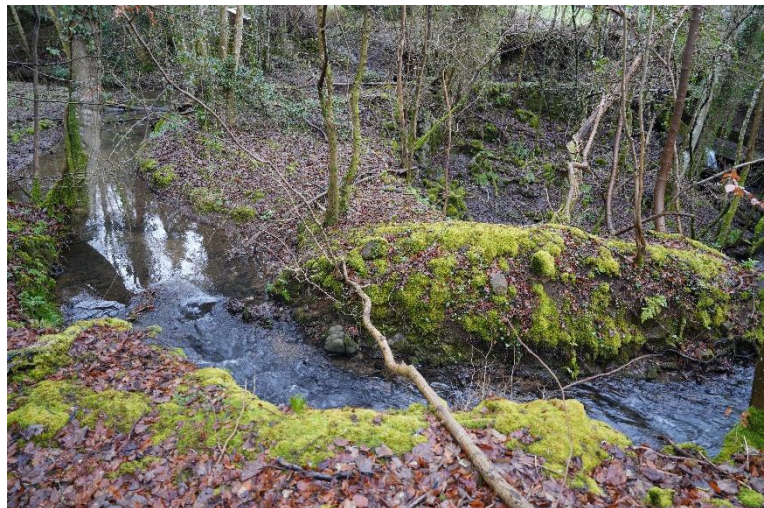
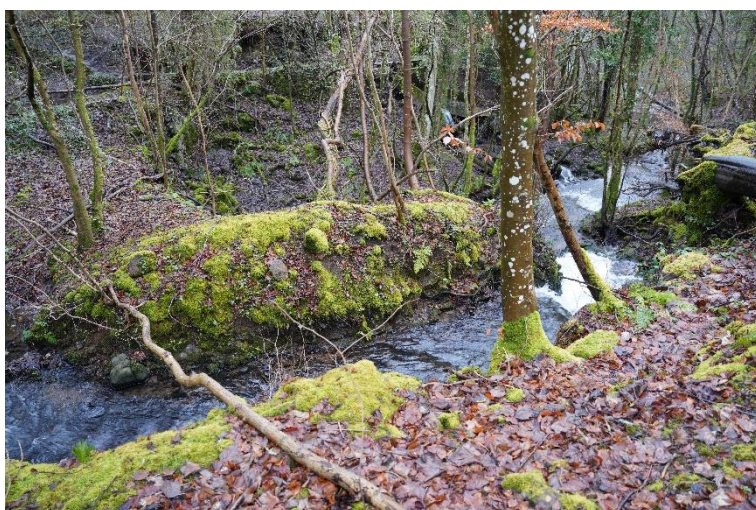
The burn enters from the top left, where it splits and runs both toward us and along the top of the photograph. The ground within the horseshoe of streams drops down sharply enough that there must surely have been something like a waterfall here originally.

The two streams then make the drop in level and immediately recombine (below).

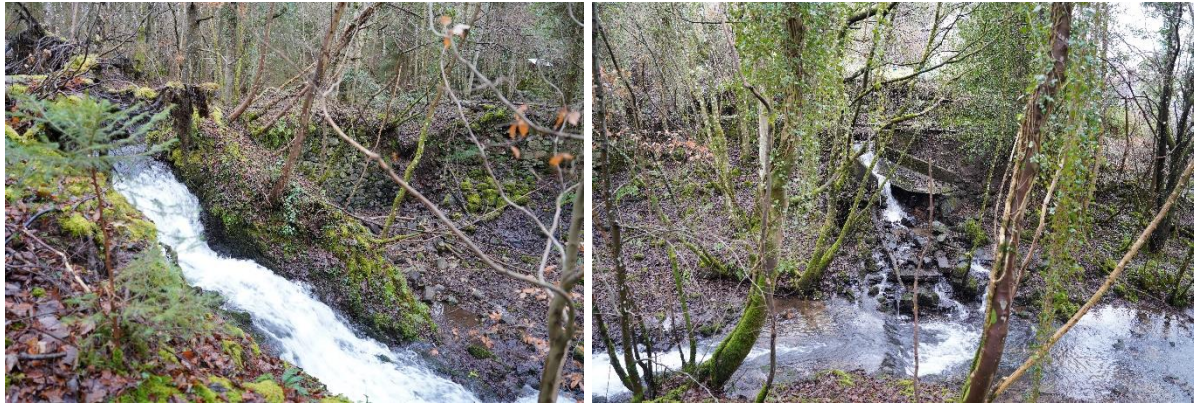
what seems now to be simply a waterfall (below left), while the far branch comes via the broken up remains of a concrete spillway (below right). Between the two, the ground is retained by a dry stone retaining wall (visible in the middle, below left).

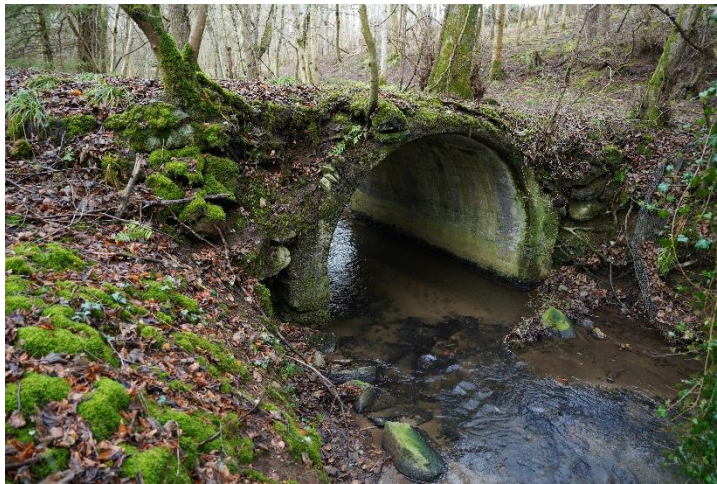
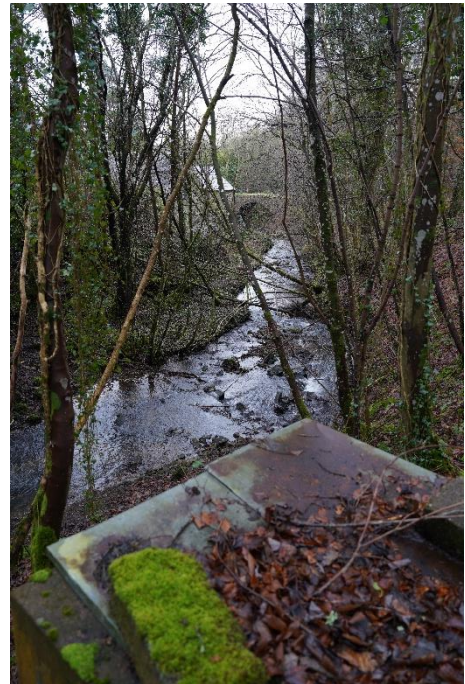
Retracing our steps, we get back to the bridge glimpsed as we turned downstream (above left). It turns out, like so much else, to be of concrete. Semi-circular, the low abutments are no more than walls for the arch to sit on (right). I suppose there is some rubble behind the arch as backing; whether the stones we see are part of that or the remains of a wing wall is unclear.

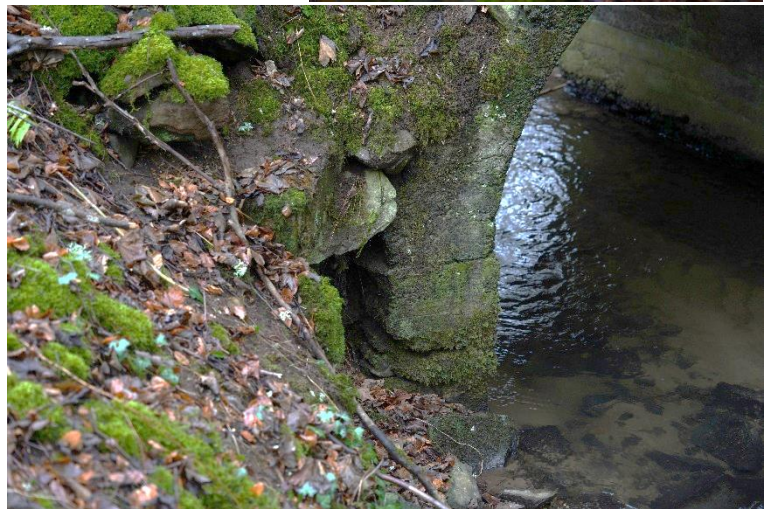
Perhaps the arch is reinforced, but the quality of the concrete and the lack of rust staining suggest not.

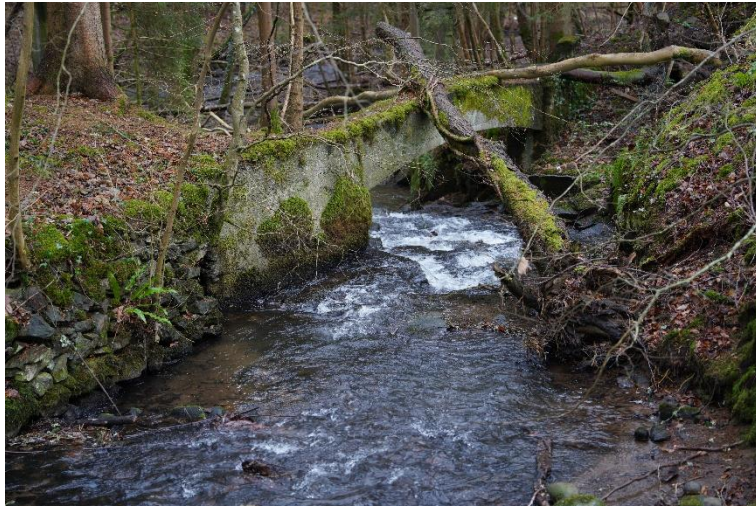
Does a different angle on the narrow “bridge” from before shed any light? Its abutments are slightly wider than the arch, but not much. It is possible there was some concrete below in the river, since undermined and carried downstream in floods. A close look at the far abutment reveals a nib beneath the arch that could have retained stop logs. Perhaps this was simply to divert flow into a channel to the

right. If so, there is little evidence of that channel now.

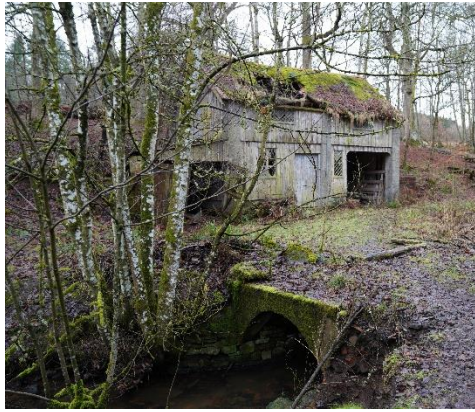
Across the river in timber, presumably a workshop or store, and the mill itself in a mixture of stone and timber. Leaded windows, damaged but not completely gone, must long predate the plastic gutter. Sadly the rot is well developed.

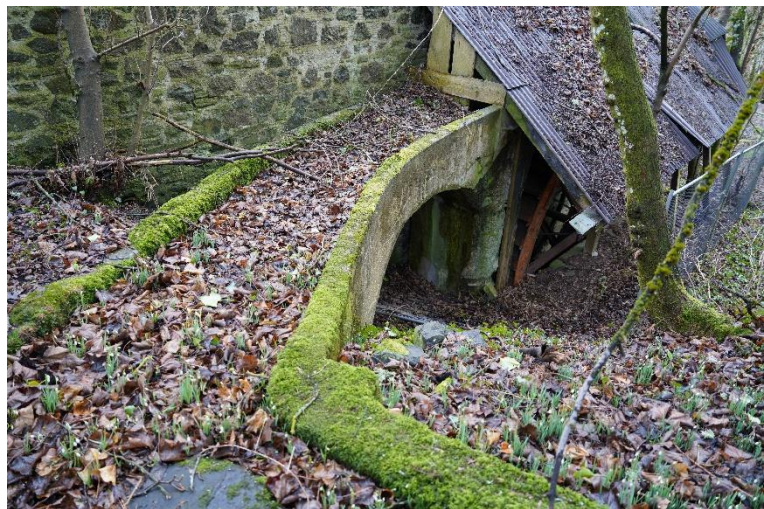
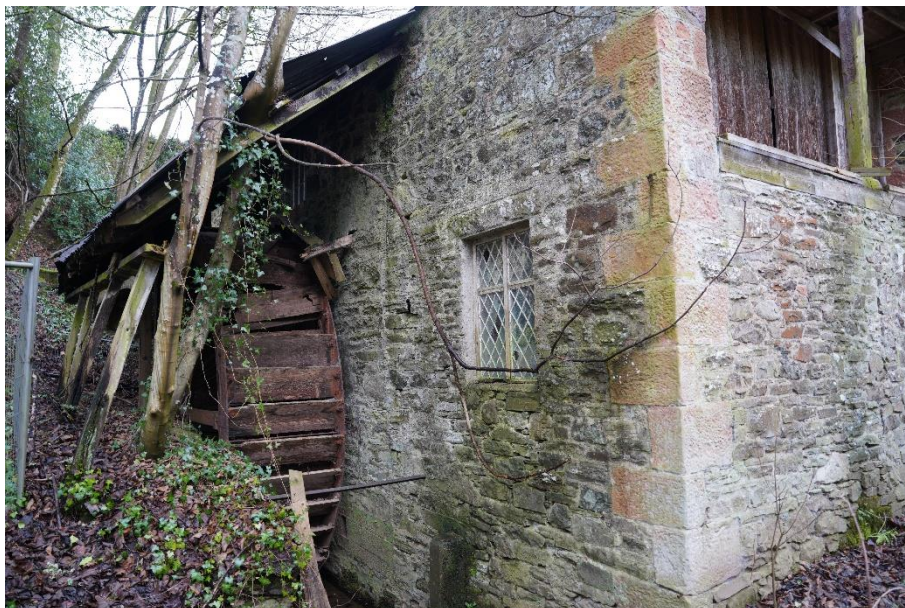
Yes we do! Though not for much longer.

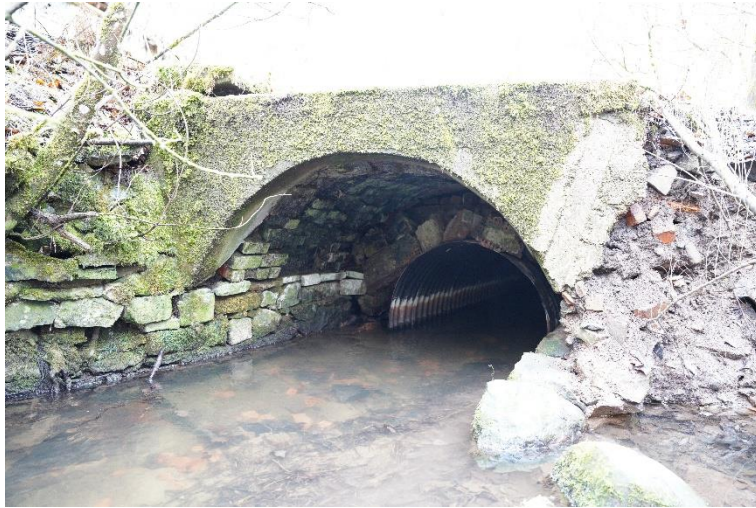
The right wingwall has gone, and the bank behind is being taken by the flood flow eddies.

The concrete spandrel wall provides an edge to a narrow strip of, apparently, a dry brick arch over dry stone walls.

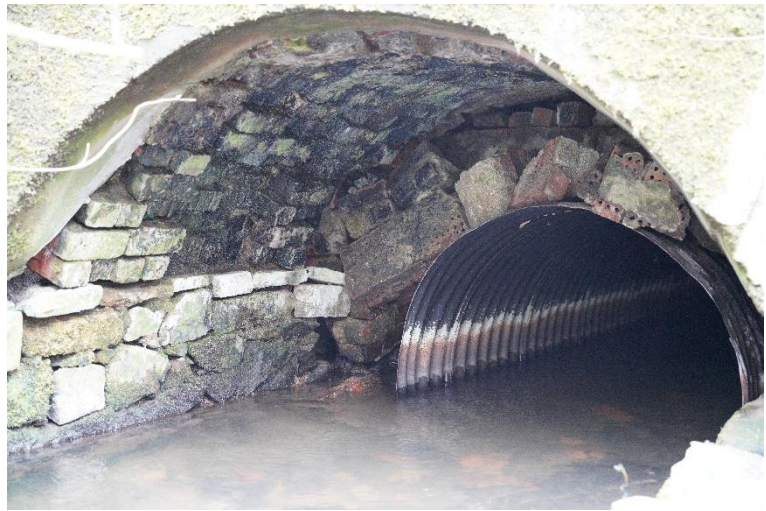
This doesn't look like the remains of an arch, the brick rubble is in straight segments. Just rubble dumped on the corrugated steel? Again, I'm intrigued about dates.
