Bridge of the Month 165, January 2026

Bridge at Semer Water, North Yorkshire

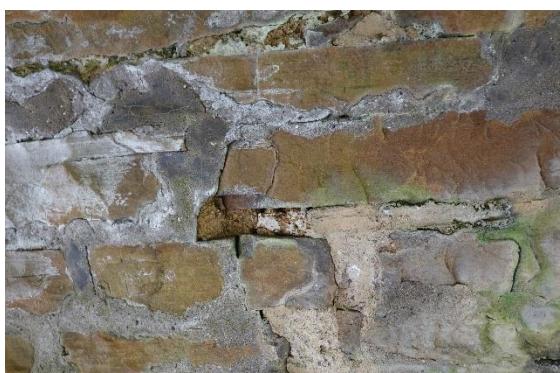
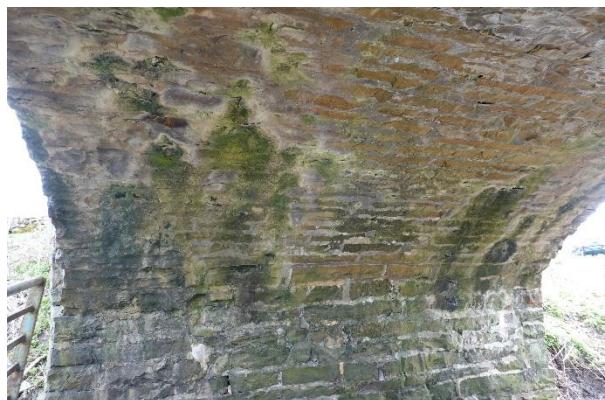
The expressed arch rings look chunky. We can't tell whether that thickness goes all the way through the width, but there is no obvious change in masonry visible on the soffit.

It's difficult to make much more of the soffit because it has been horribly pointed in cement mortar.

The pointing is breaking down in places – it's difficult to tell, but cracks away from the mortar joints suggest there may be some slight movement in this area.

The older mortar exposed where the cement has flaked off is very brown. An earth or earth-lime mortar?

The cement mortar elsewhere highlights small movements, but gives no hint as to cause (right). None of this would be visible in more sympathetic mortar.

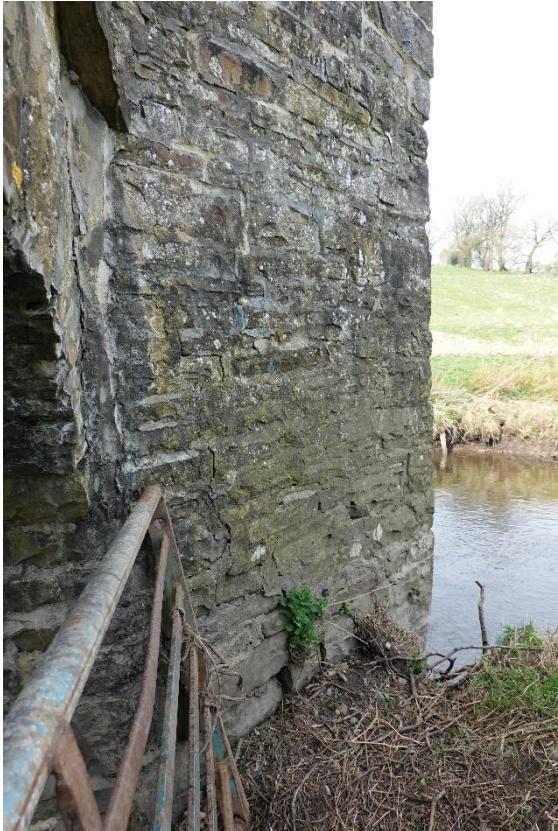
I noted cracks a bit like this at [Leckwith Old Bridge](#) – there as at Bidford on Avon clearly a result of vehicle impact above. This particular crack is surprisingly located for that to be the cause. Is the push here coming from the spandrel wall, perhaps from frost jacking?

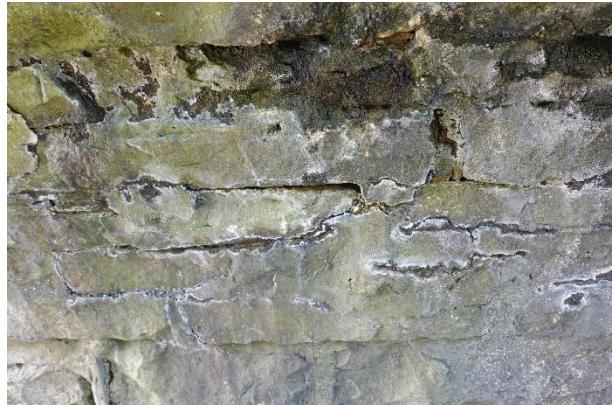
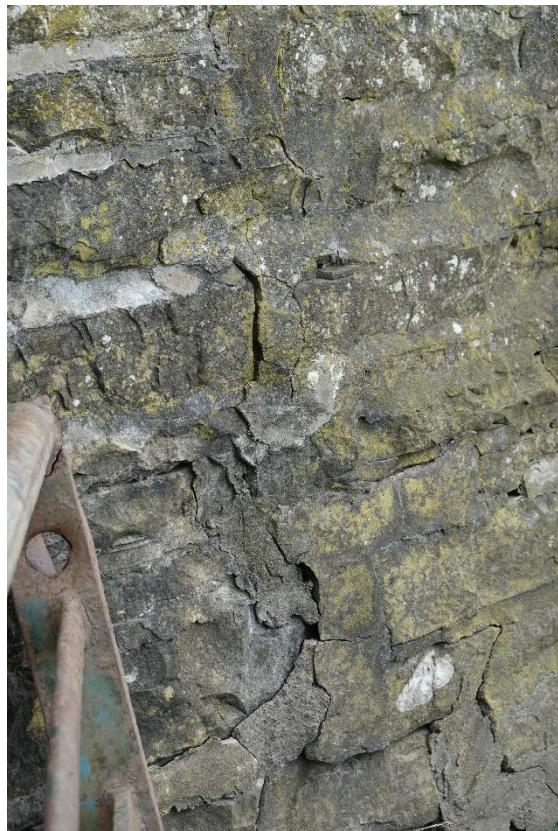
The bridge has cutwaters to both faces. The upriver south cutwater (left) sports a clear crack at low level near the main bridge elevation. The mortar patching (detail below) suggests that this isn't new, but it is still moving or has moved again since last pointing.

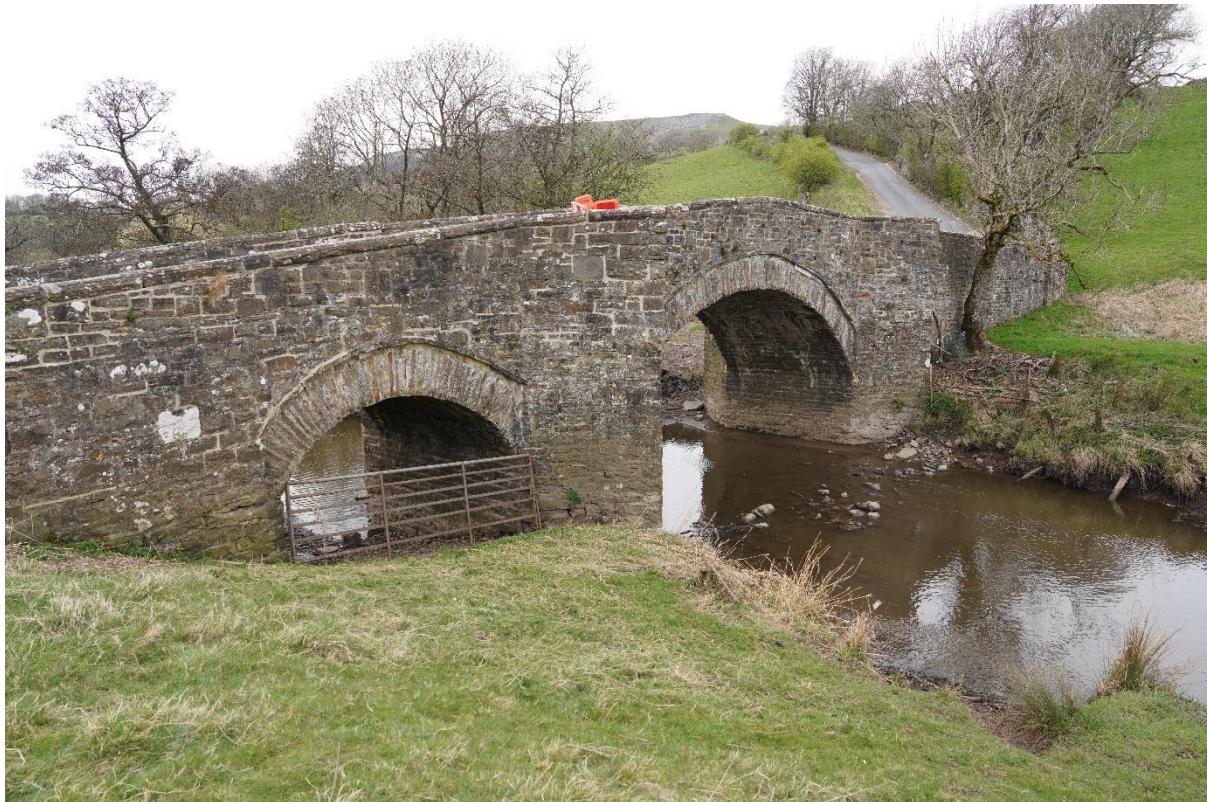
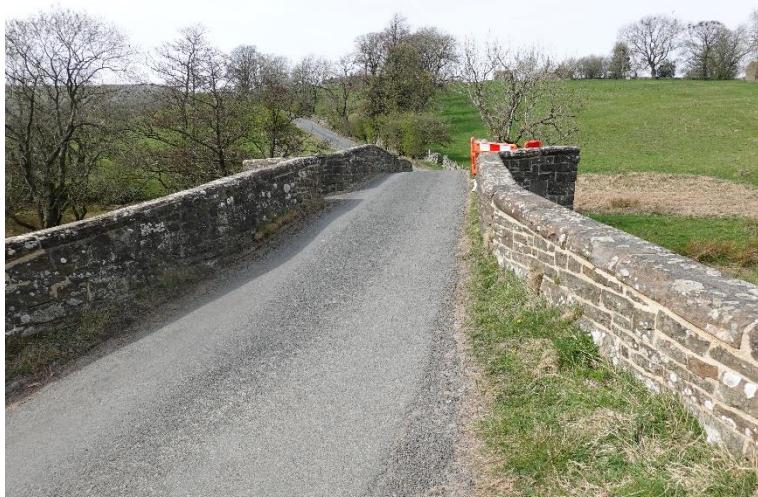
Looking along the elevation (right) the cutwater has a pronounced lean in the top half, and wide mortared joints suggest past displacement.

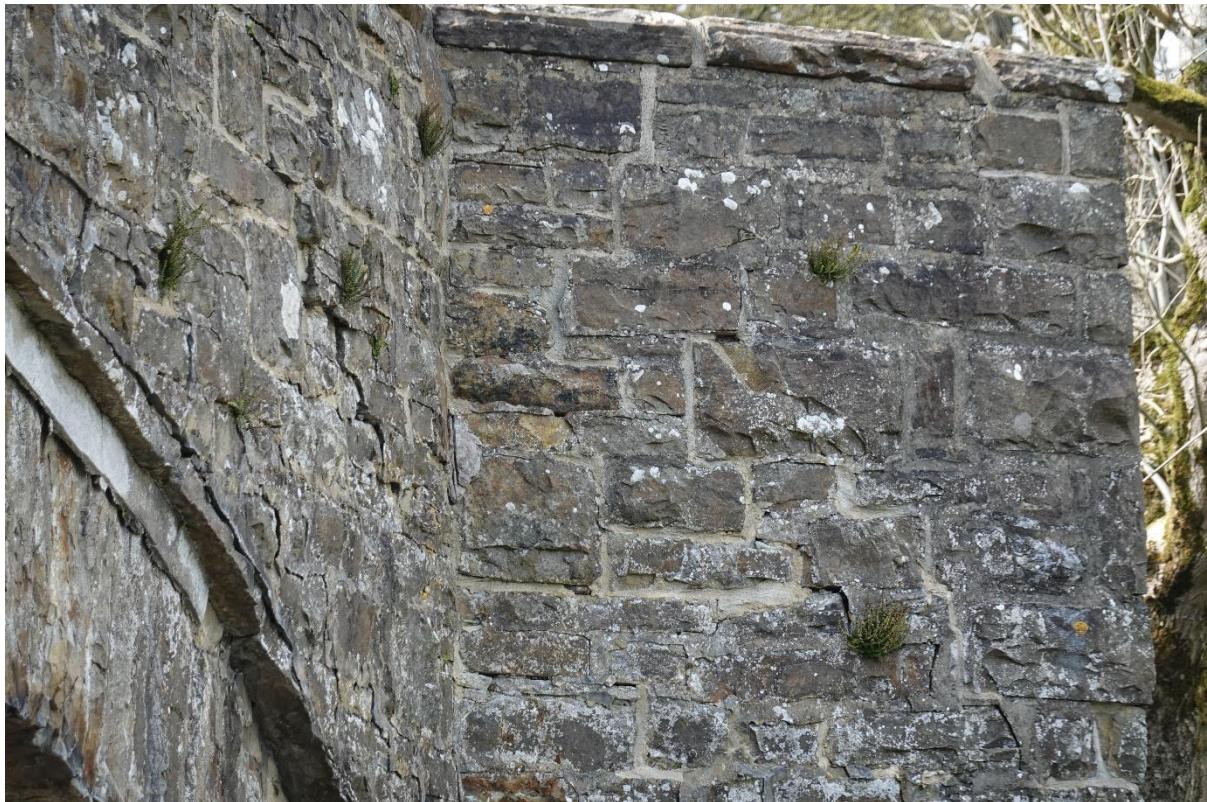
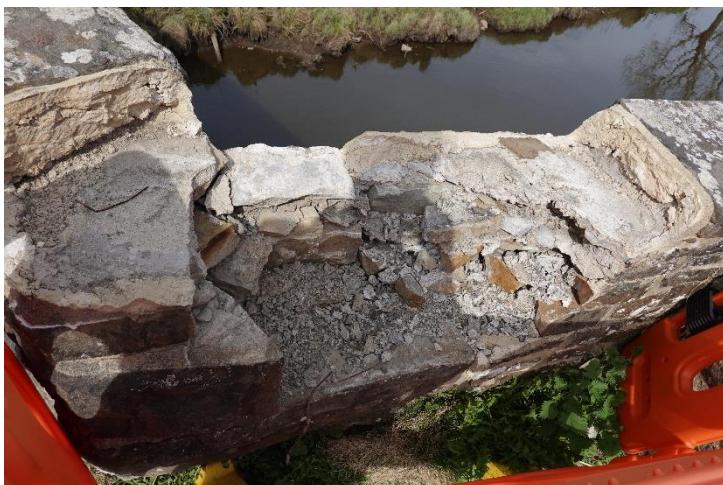
A closer look reveals more recent damage: cracks and displacement between the spandrel wall and the corbel over the ring; a further displacement in the spandrel wall, and a diagonal crack in the cutwater.

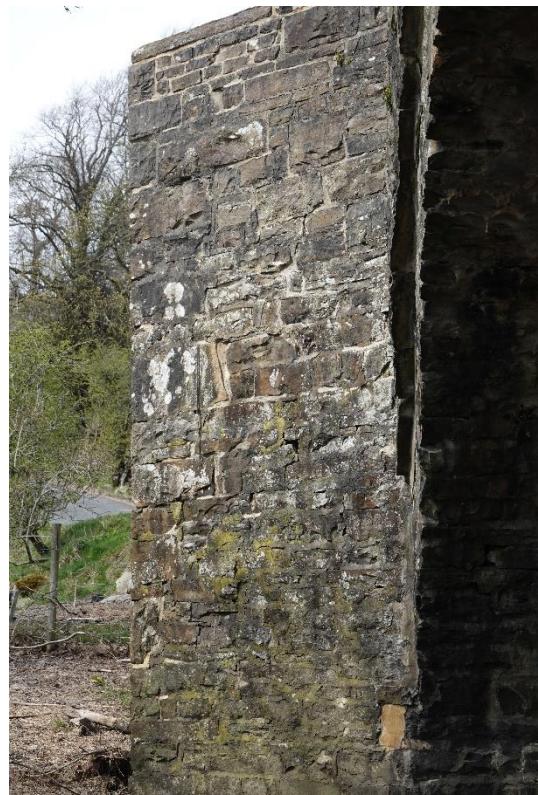
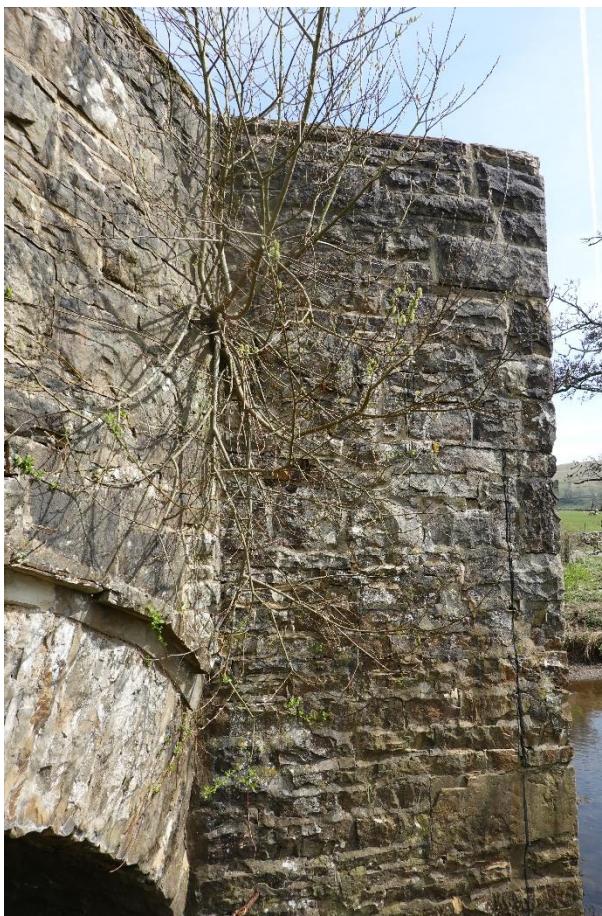
Downriver, north cutwater, on the inside of the curve so surely protected from most of the bad driving, yet there is still a crack (above, between the cutwater and parapet to the north).

On the south face (right), there is a clear diagonal crack running out to the nose at mid height.
