Bridge of the Month 121. Jan 2021 Stanway Viaduct

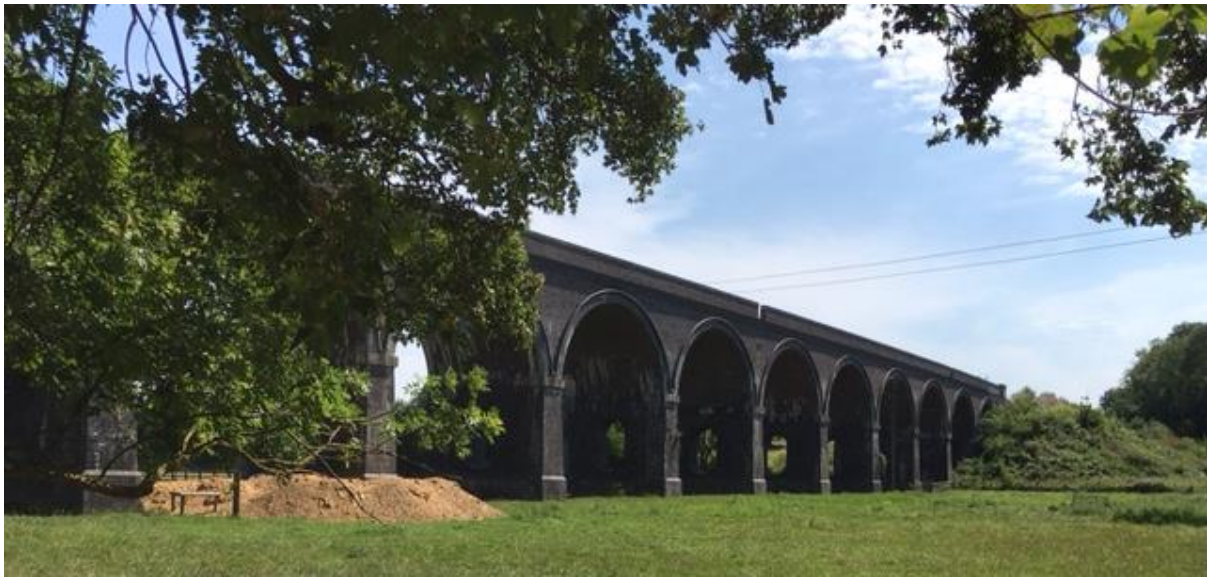
The photo above shows a clear demarcation line at about half arch height, which says something about the backing. The general construction bears a close resemblance to Foalmead viaduct in Langport, Somerset, built a few years later to provide the more direct line to Exeter from Reading. Again, there is a clear demarcation line at mid height of the arch. And the structure seems to have been built with the same bricks and other details so the drawing we have of Foalmead should tell us something about Stanway.

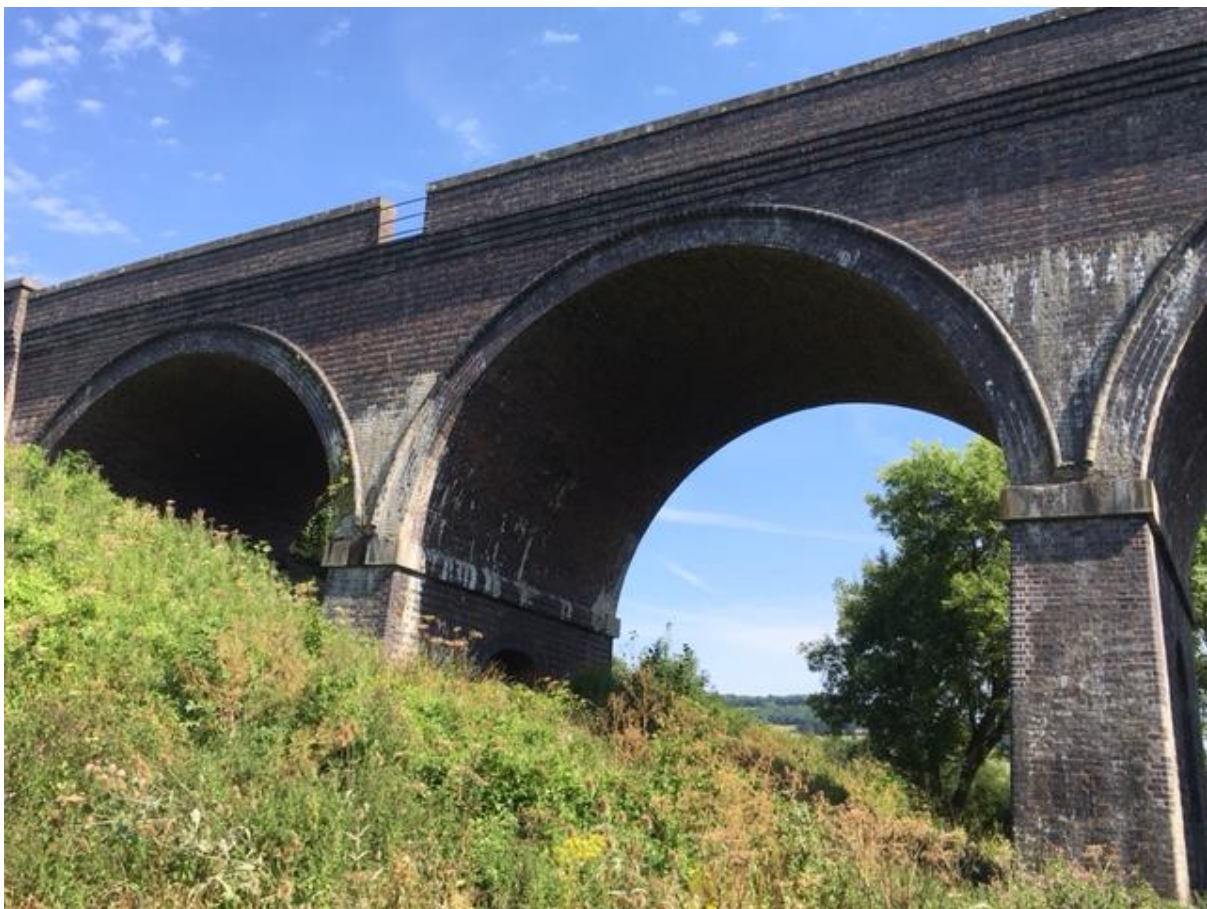
At Stanway, there are stone skewbacks. I suspect there is more to see in this picture if we lighten it a bit.

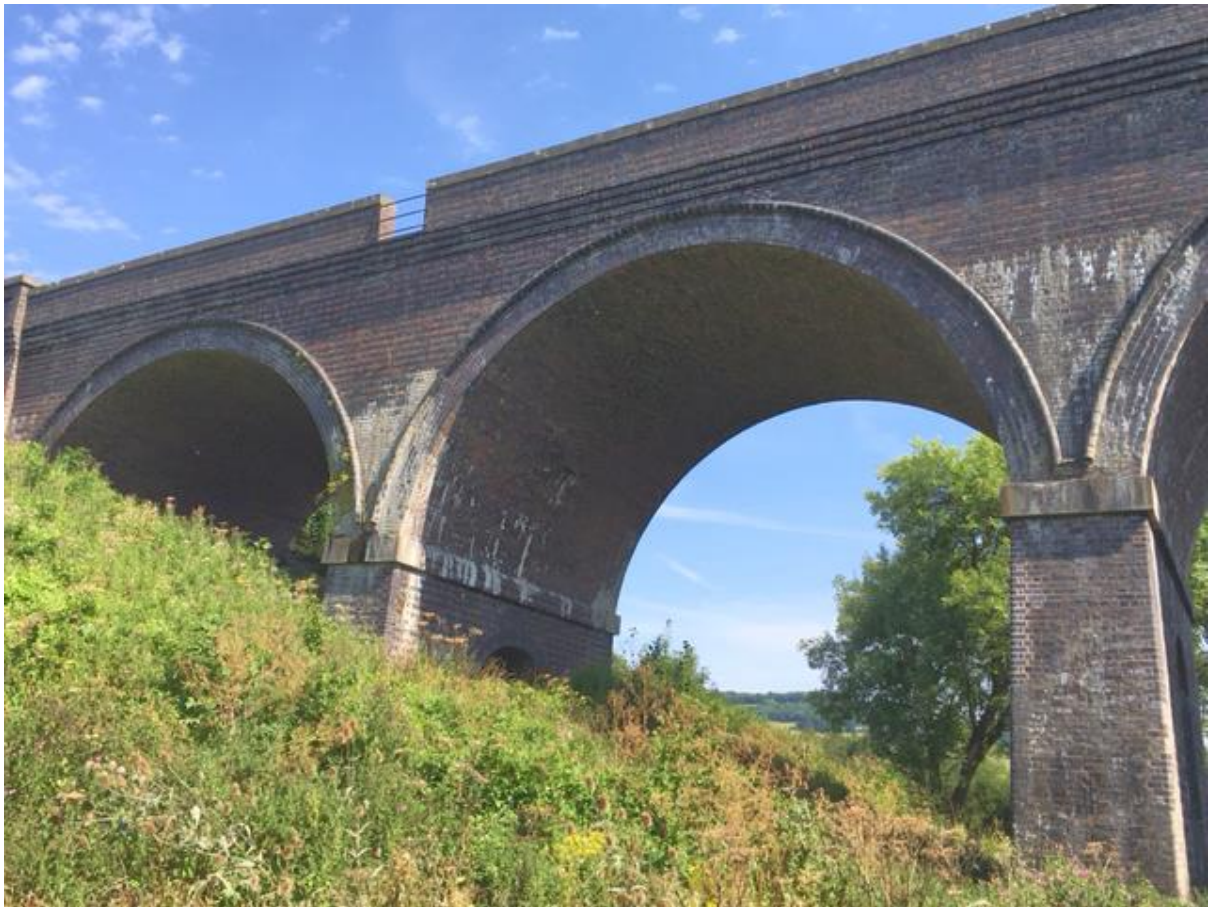
Indeed, we can certainly see a drain there.

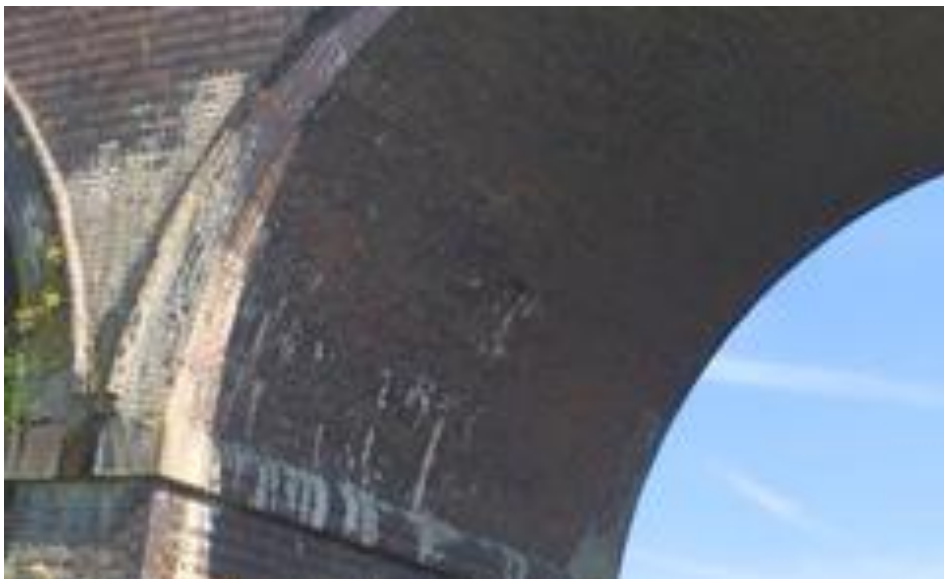
Blowing it up, though, I am running out of detail. This will definitely need a closer look. That does look remarkably like a crack across the width, though it could just be the start of the rebuild after collapse.

But back to that closeup. It shows that the stone skewbacks are only the quoins. Stonework was obviously expensive.

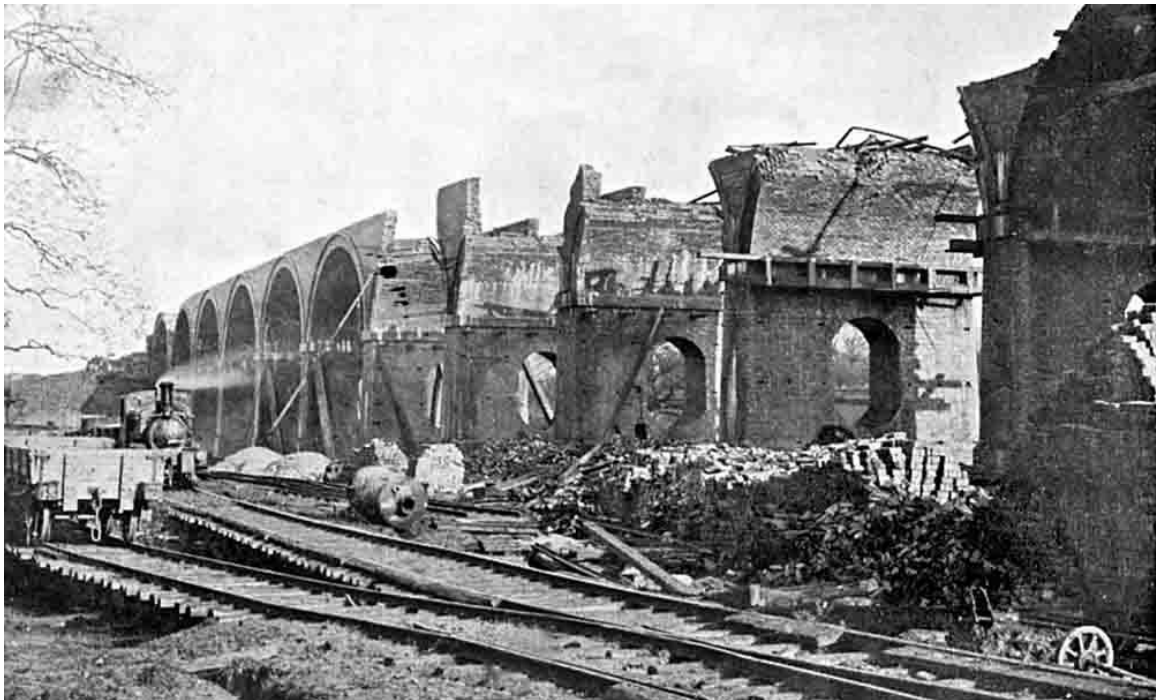
Oh yes, I didn't mention the collapse yet did I. Several arches collapsed during construction, leaving the piers and pier blocks standing.

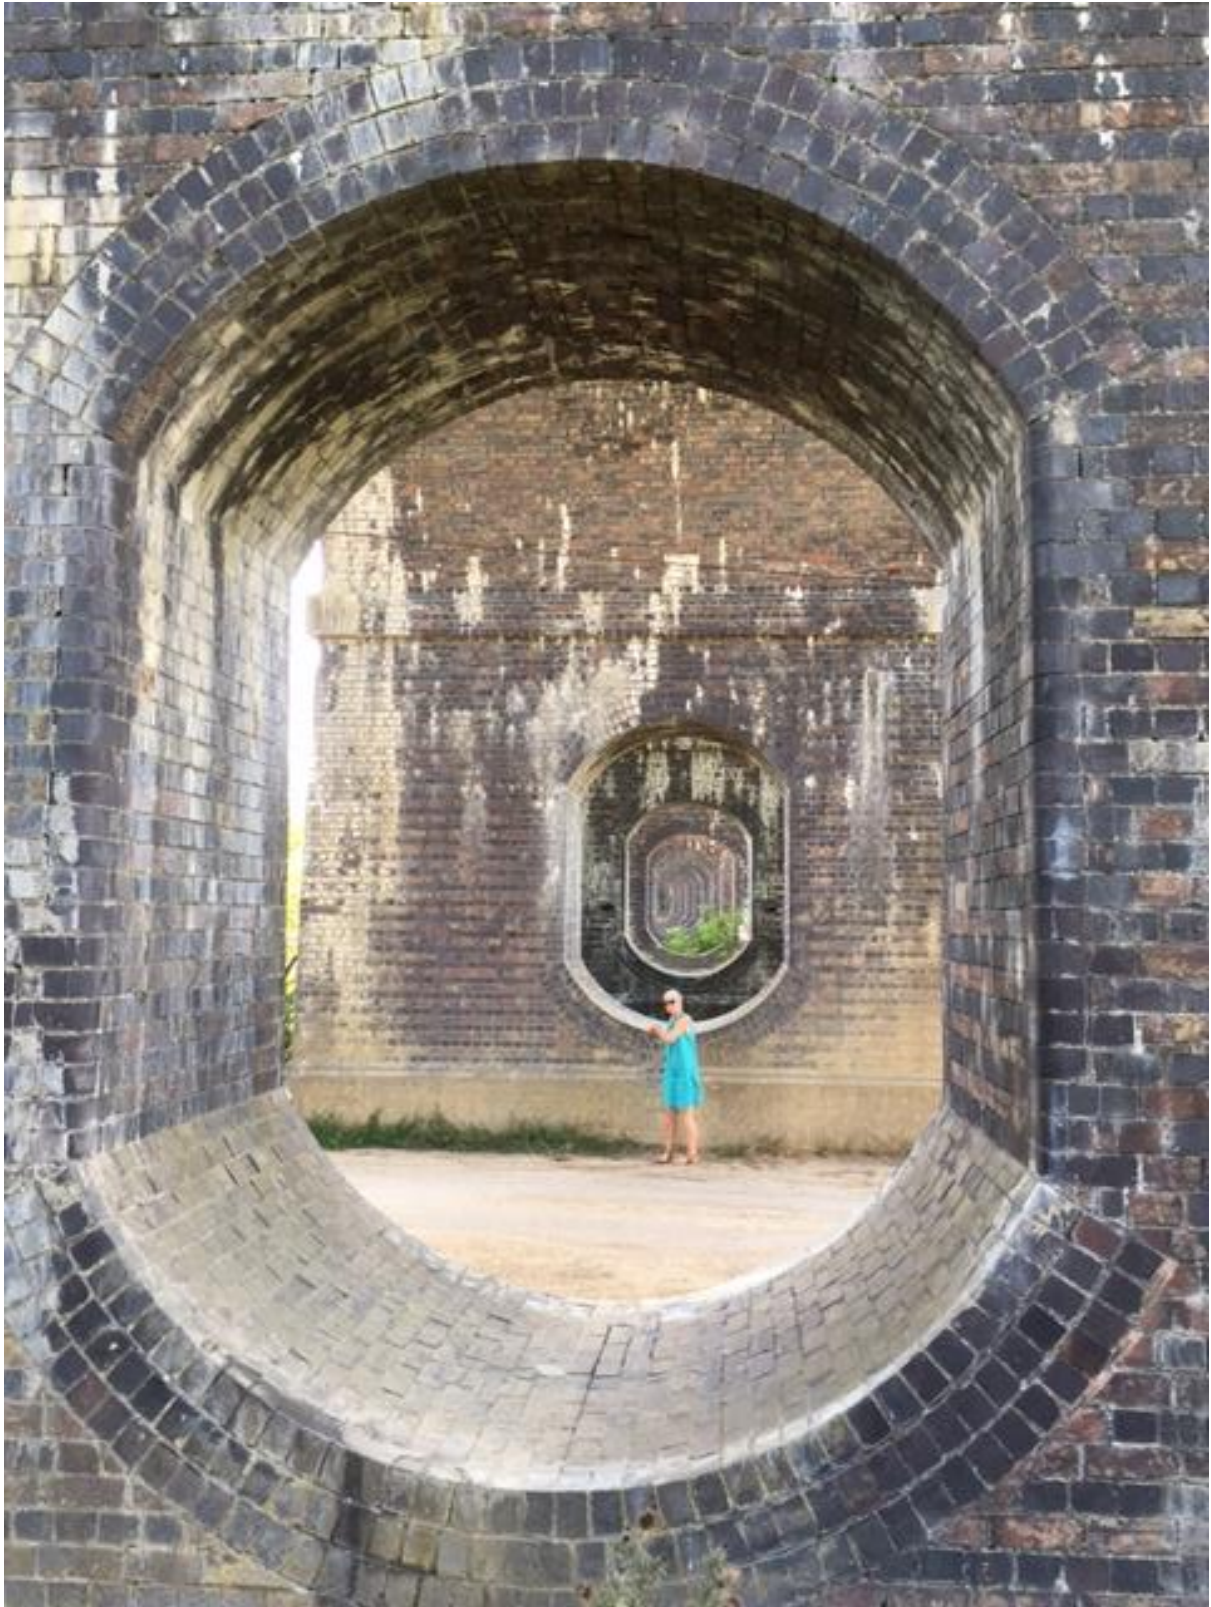
Then look closer, first at the bottom. A definite crack, maybe two or three, in that invert, where the foundation has hogged. Interestingly, the crack at the crown, which is much more commonly noticed, is decidedly less prominent here.

Then, just half a brick in at each side of the gap is a vertical split. This is evidence of the load from the viaduct being supported mostly on the inside edge of the legs. There is likely to be corresponding damage on the outside where the lack of pressure and slight movement often leads to mortar and even brick loss.
