## Bridge of the Month No 112, April 2020 Lennox Bridge, Mitchell's pass.

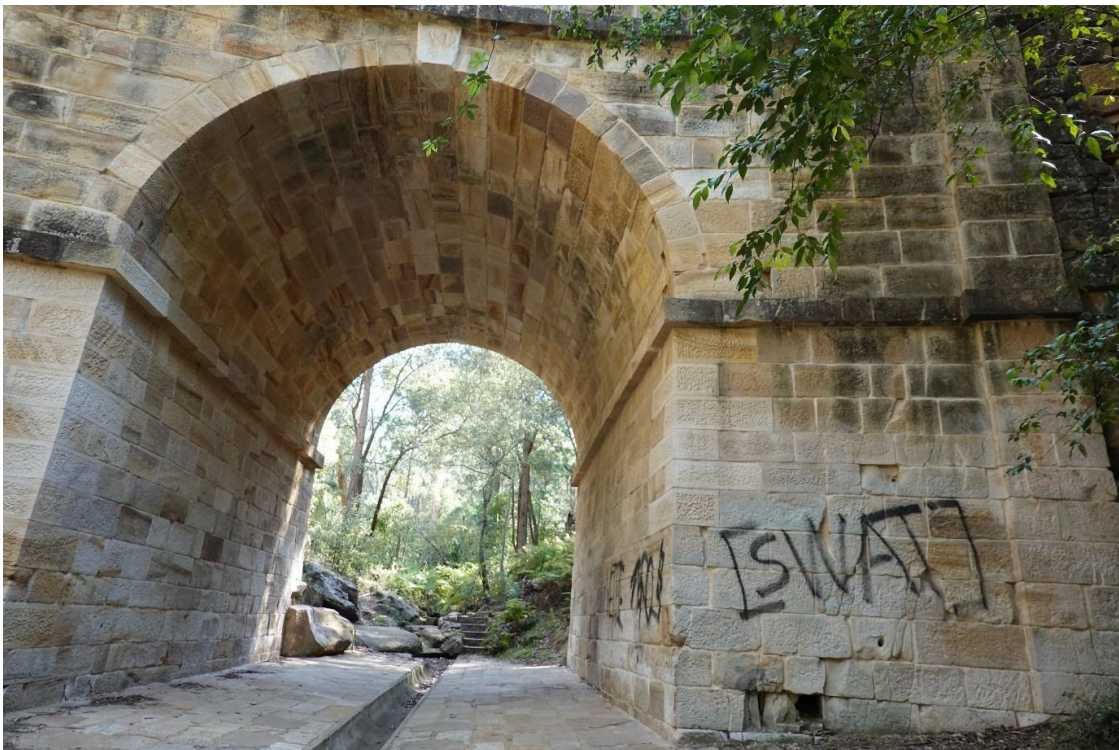
Some of the stone used has proved a little less durable than others, but there can be little doubt that some of the damage we see is mechanical.

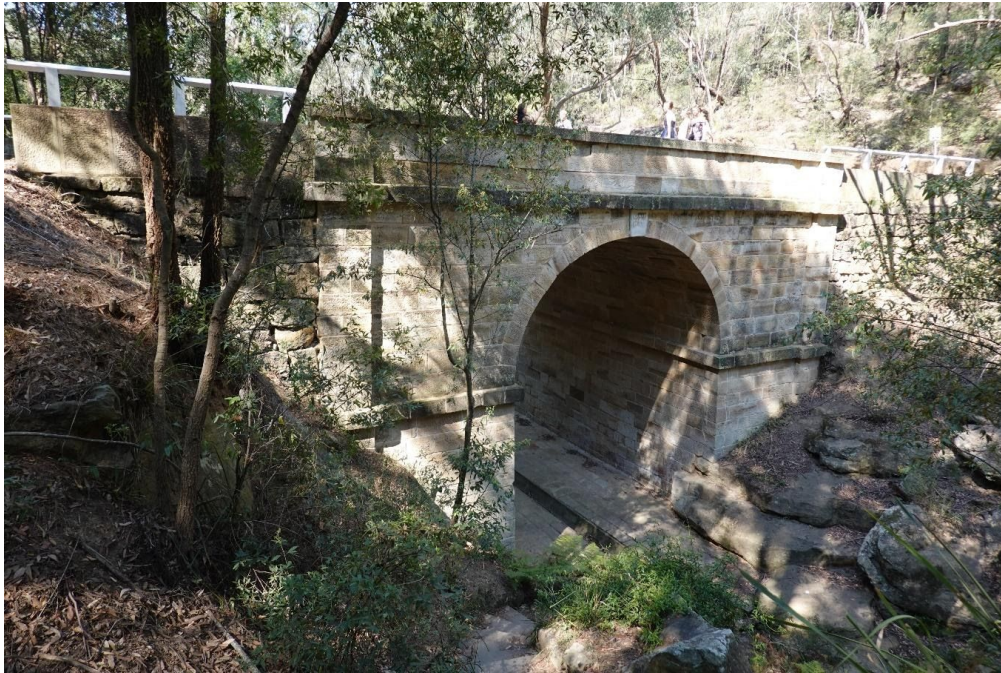
The site is only a mile from a busy community, but peaceful and almost deserted. This picture from upstream doesn't show the curve to accommodate the hairpin bend on the road. I suspect, from the change in construction, that the dressed wing walls represent the thickness of the abutments.

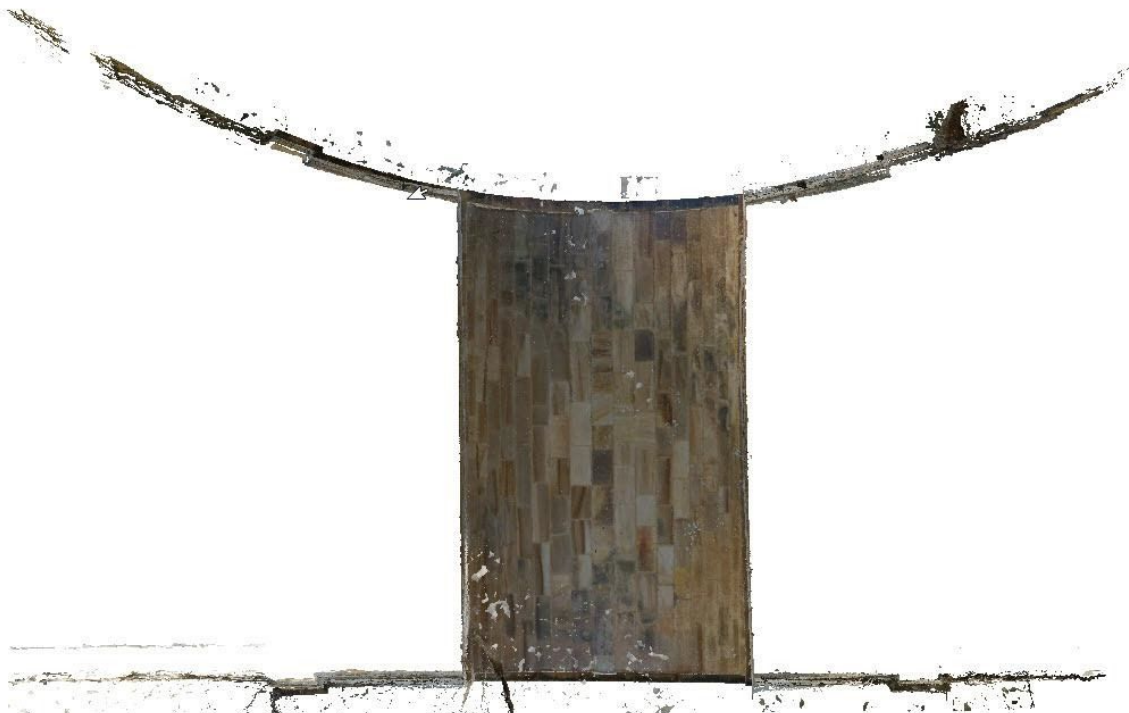
We have a 3D model of the masonry but not the road, so only an upward view is available to show the layout.

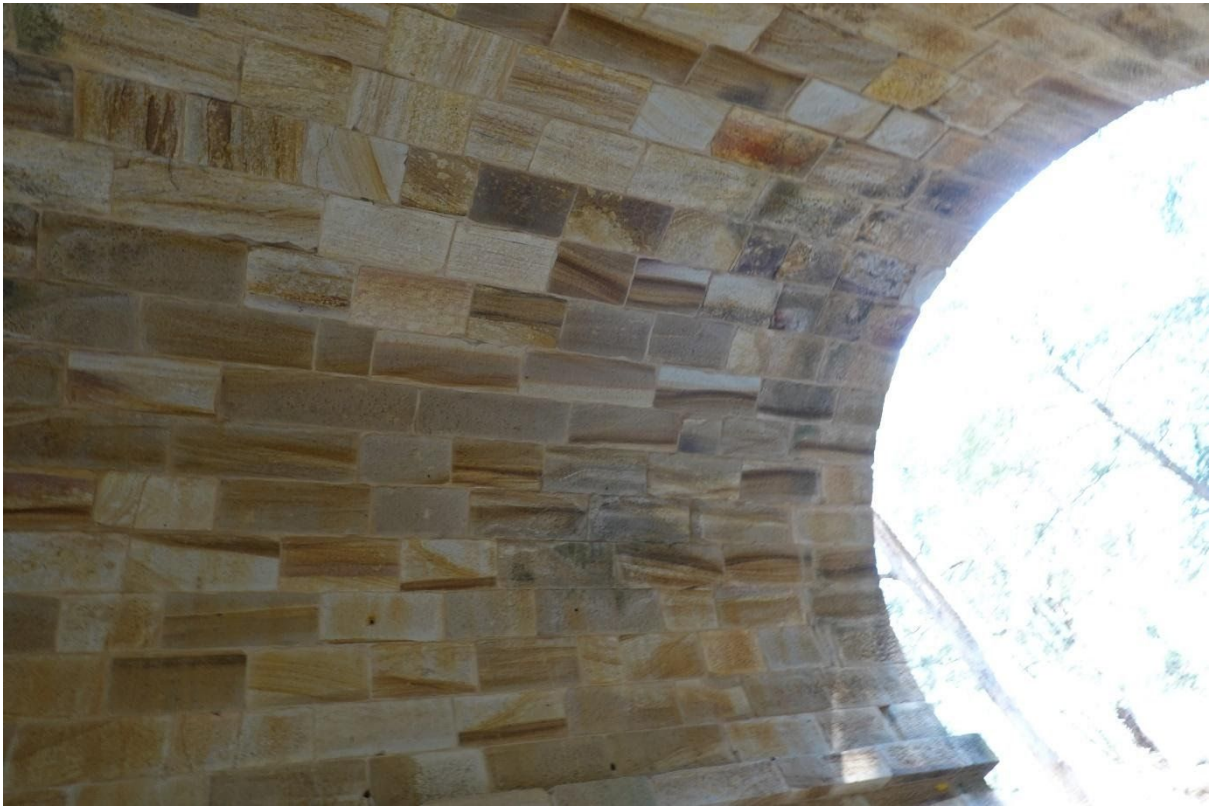
There is a crack up the upstream end of the right abutment that begins here. The cause is surely, at least partly, lack of tight fit to the bedrock causing the lowest stones to try to tilt out.

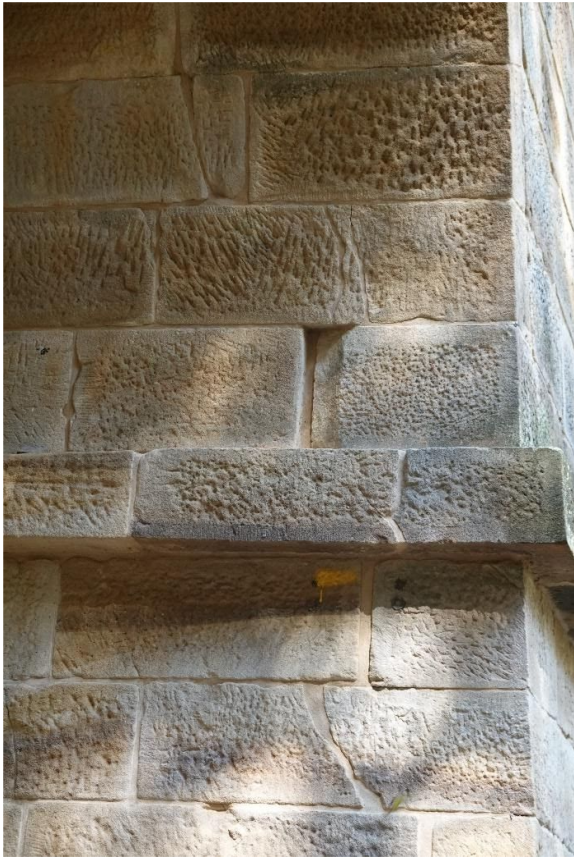
The crack then works up through the springing and into the arch.

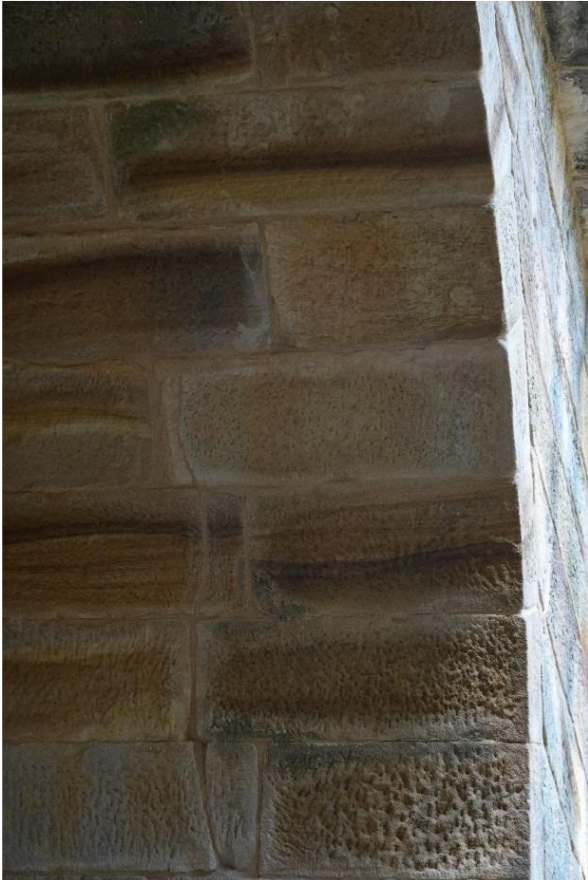
Here is the crack tapering out to nothing in the arch.

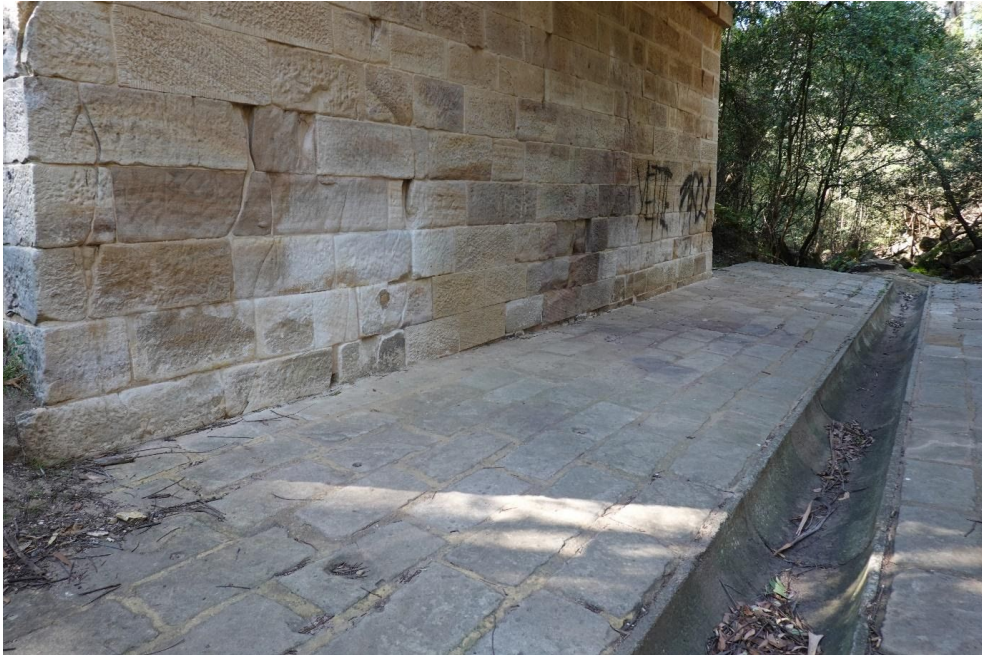
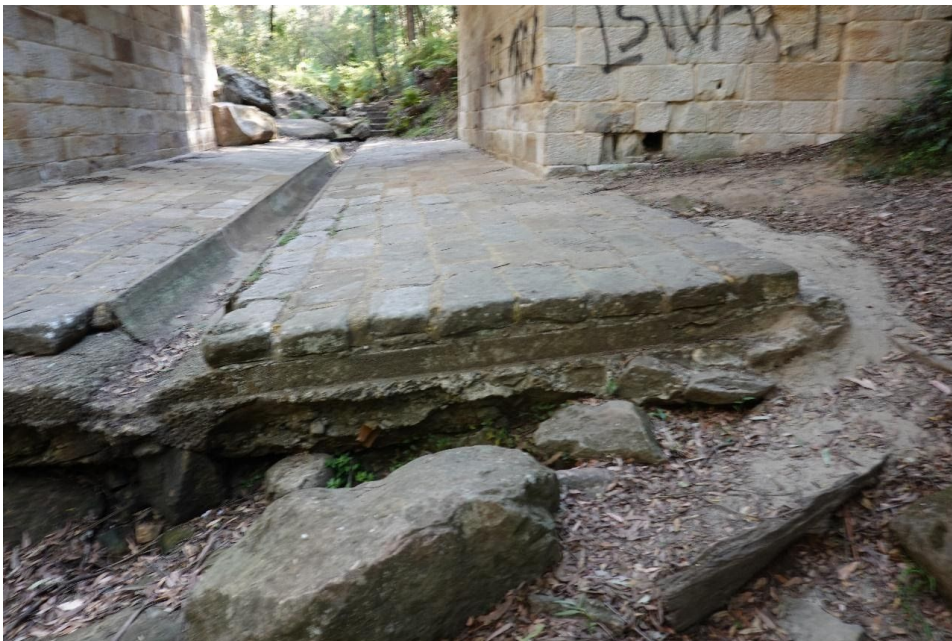
There are other cracks through that abutment, but none of them can be regarded as threatening to a bridge that is close to 100 years old.

The river was dry when I was there (as was everything else, with much of this side of Australia on fire at the time). There is obviously enough rain at times to erode the foundations of that paving. A little work here soon wouldn't go amiss: there is no convict labour available now of course!

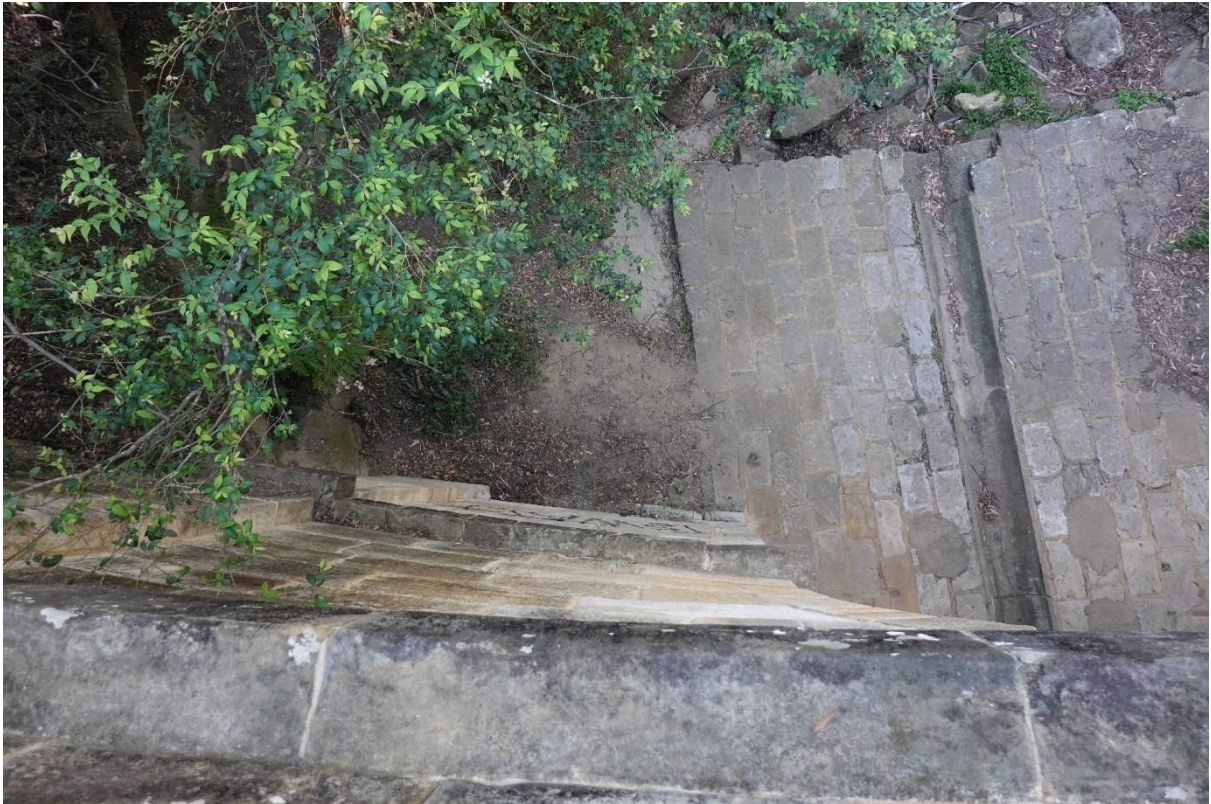
Oh, and before I forget. The double curve of the wing walls is beautifully done. I wonder what masons as good as this had done to warrant transportation as a punishment?
