## Bridge of the Month 126. June 2021 Cannington Viaduct

[Cannington Viaduct](#) is said to be the largest structure built for a light railway in the UK. Construction was approved by parliament in 1899, so it is a 20<sup>th</sup> Century railway. The top of the viaduct is at 100m above the sea (about 2km away), and it presents the appearance of being perched on a hill.

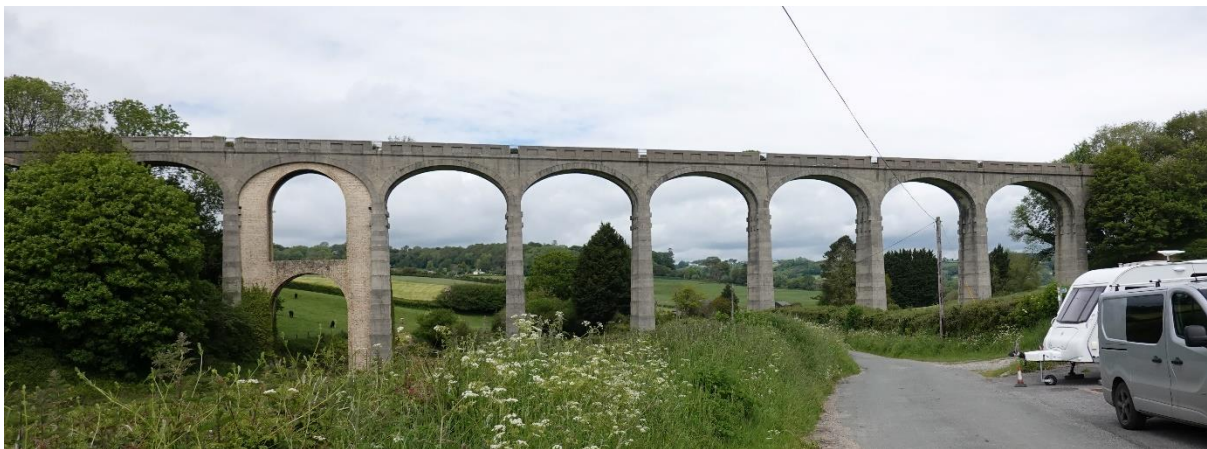
There is an arch hidden in the trees at each end of what is visible.

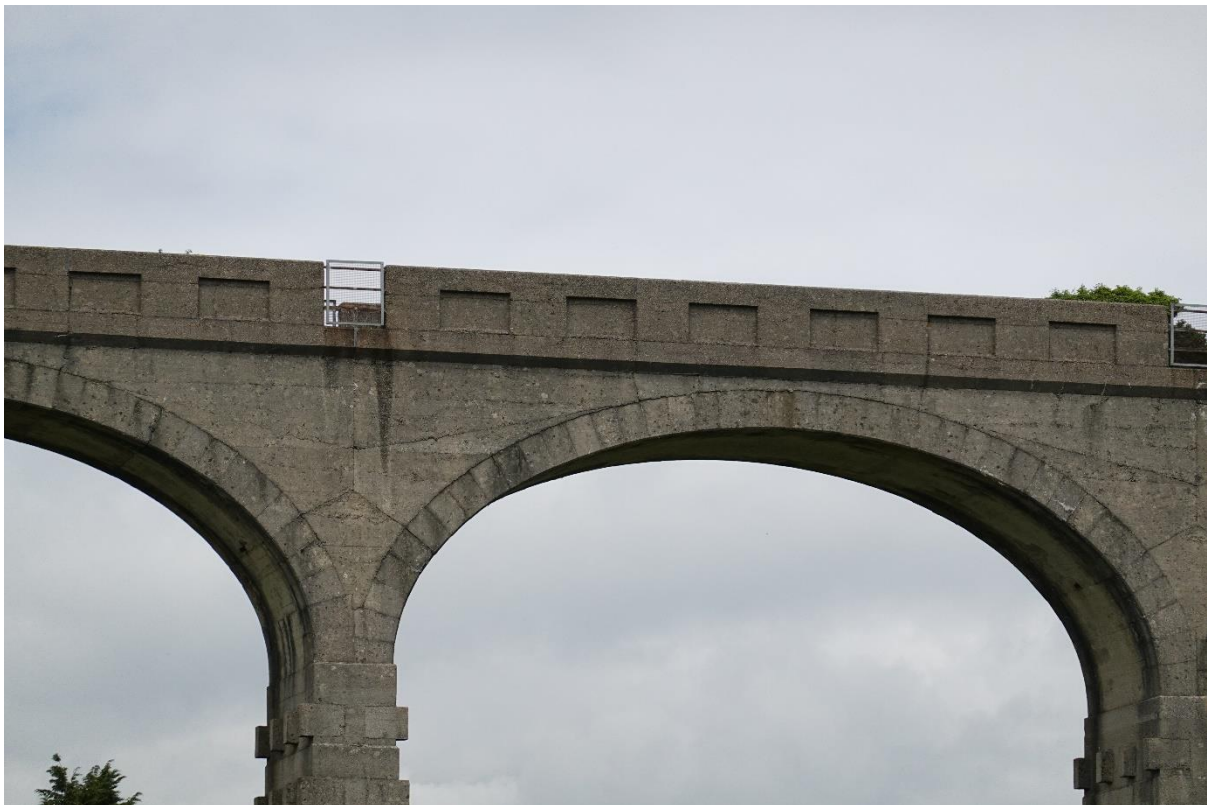
The construction is very unusual and there is a great deal to draw even from this one picture.

Most of the work is in-situ concrete but the corbels for the centring and the voussoirs are precast. The surface runs downhill to the right in this picture. And the voussoir joints are offset across the pier with an elongated one to the left and a stub starter on the right. The inclined joints in the spandrels are similarly offset. The drains, just visible in the photo, obviously run up the lower joint to the pier centre and then vertically to the V in the upper joint.

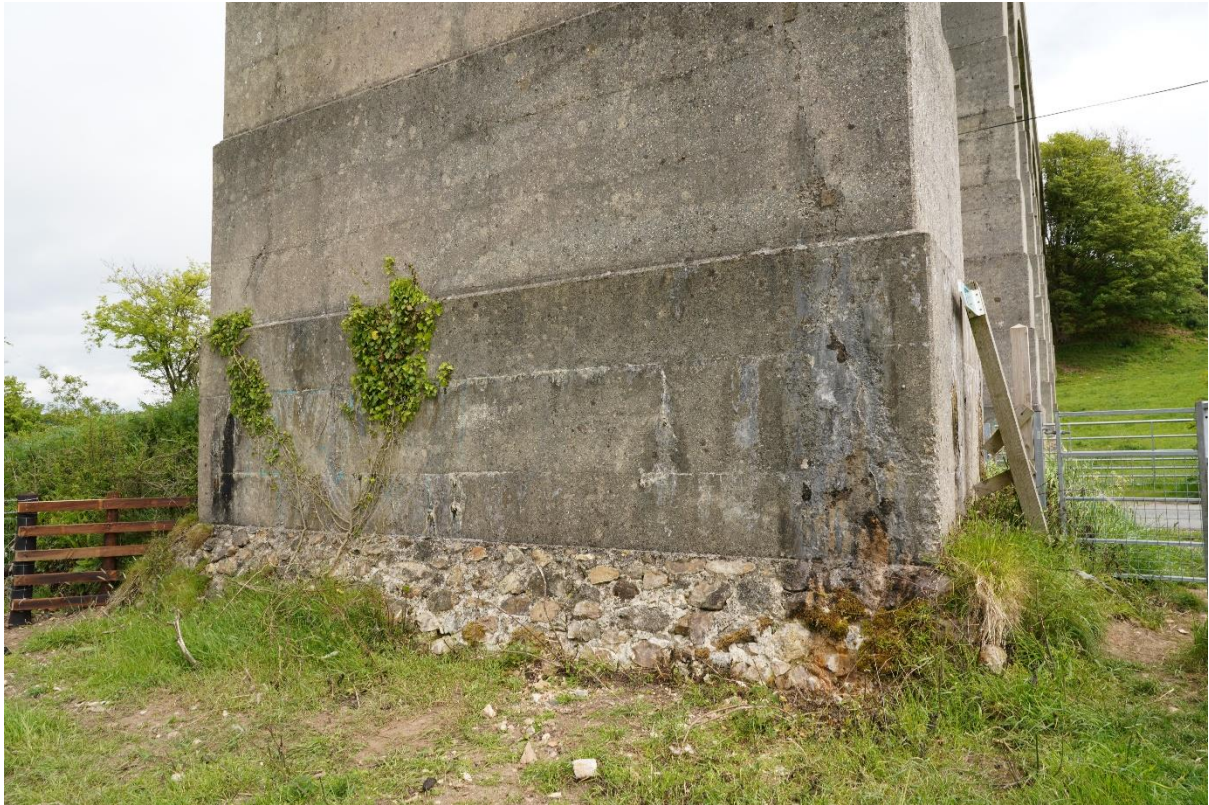
The general nature of construction is well illustrated here at the roadside. The foundation is what the Romans would have called concrete. Lumps of stone, bedded in mortar to form a plinth. Above that we can see that each step in the pier was built up from three layers. The concrete and other materials were delivered by Blondin ([https://en.wikipedia.org/wiki/Blondin\\_\(quarry\\_equipment\)](https://en.wikipedia.org/wiki/Blondin_(quarry_equipment))).

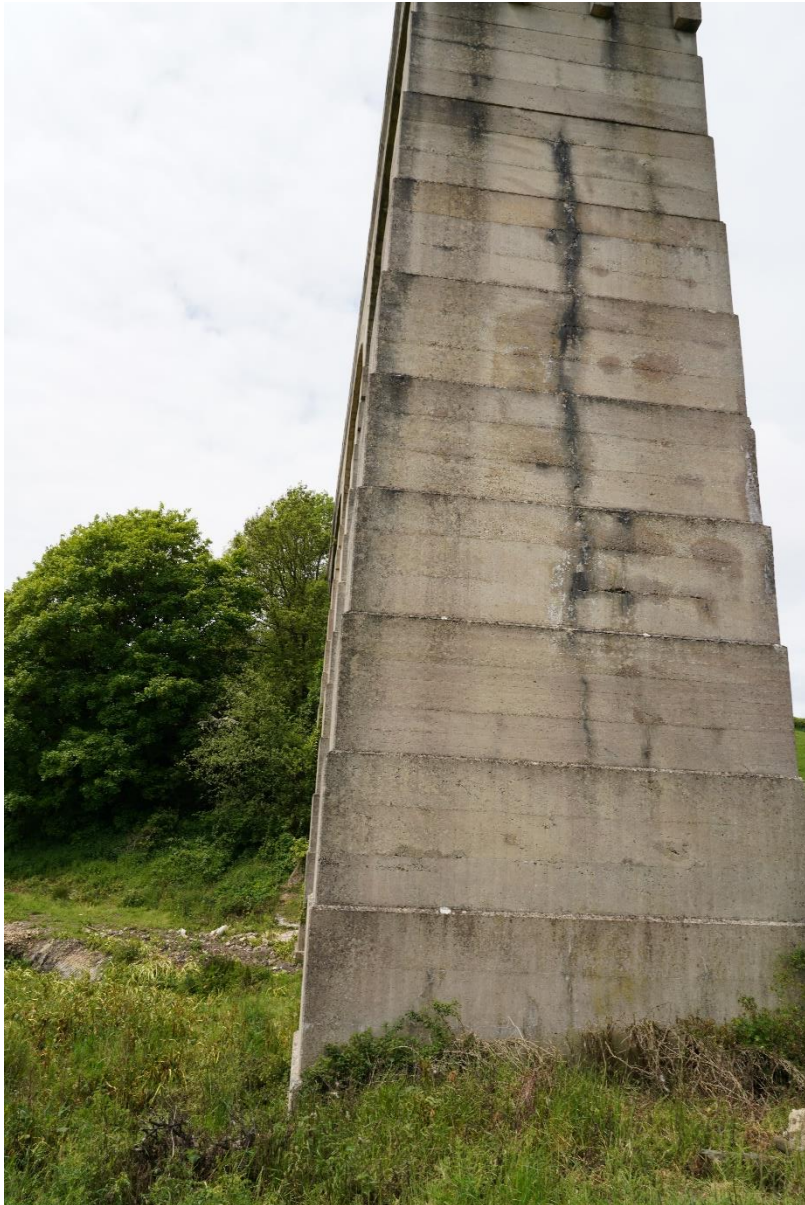
The next pier from the road is obviously splitting vertically. There is no obvious reason for this but there has been serious trouble elsewhere.

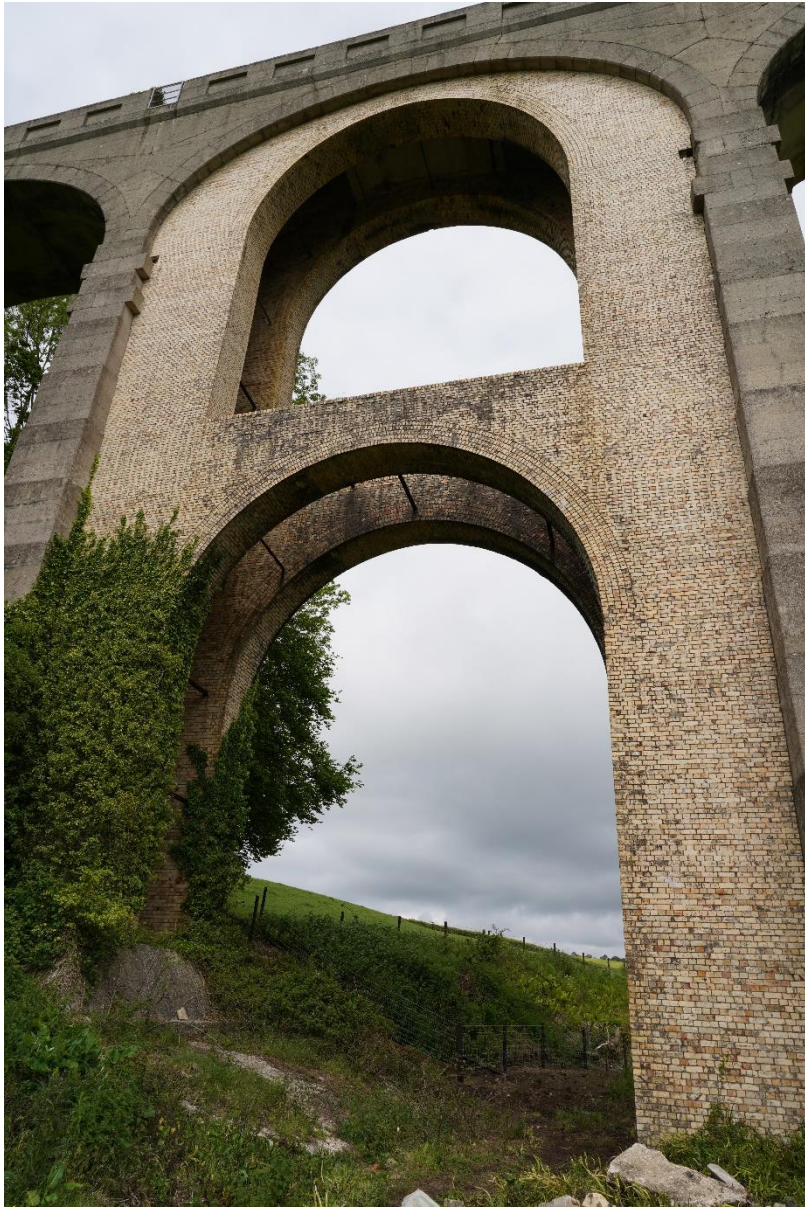
Span three from the east has a pair of ribs below. They are built of brick so obviously an afterthought. This shot shows how steeply the land rises at the viaduct ends and that seems to have resulted in the foundations sliding a little.

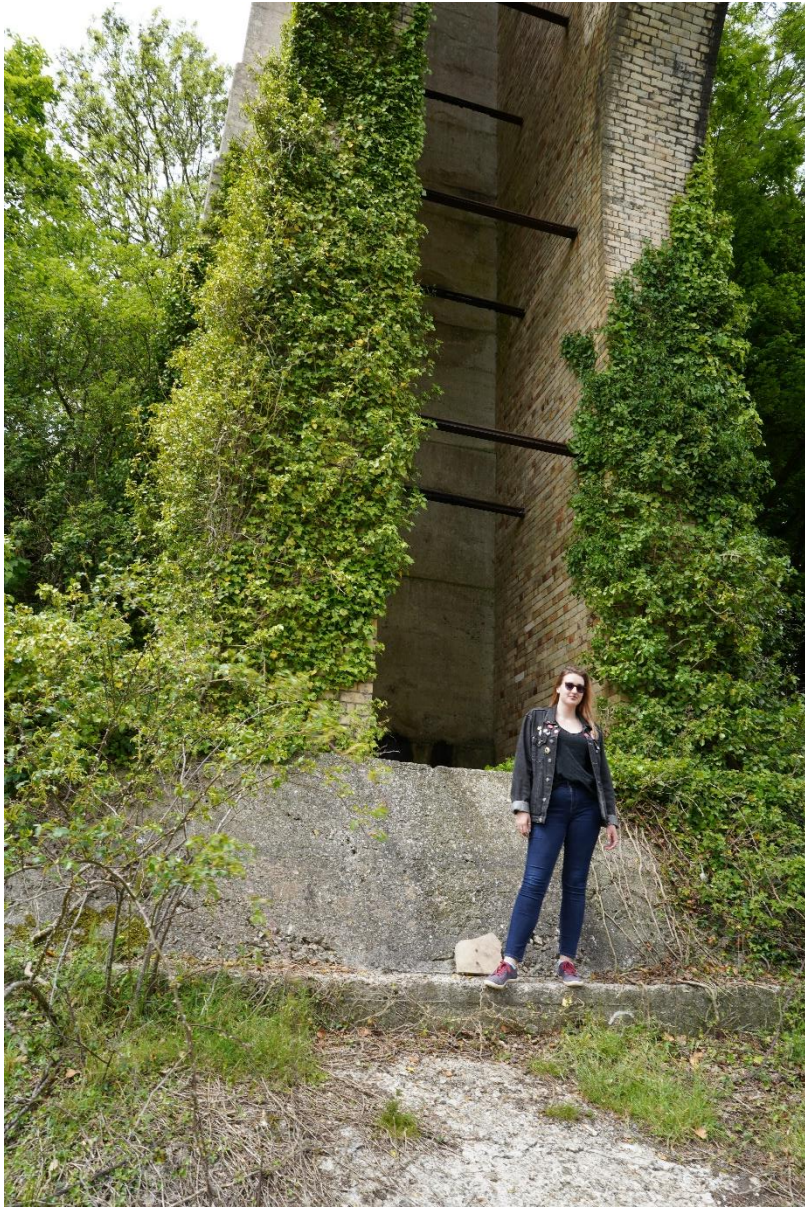
Here we have Bel to give scale to the construction. The concrete plinth here is an addition, as is the concrete surface on the valley side providing a prop from the pier below.

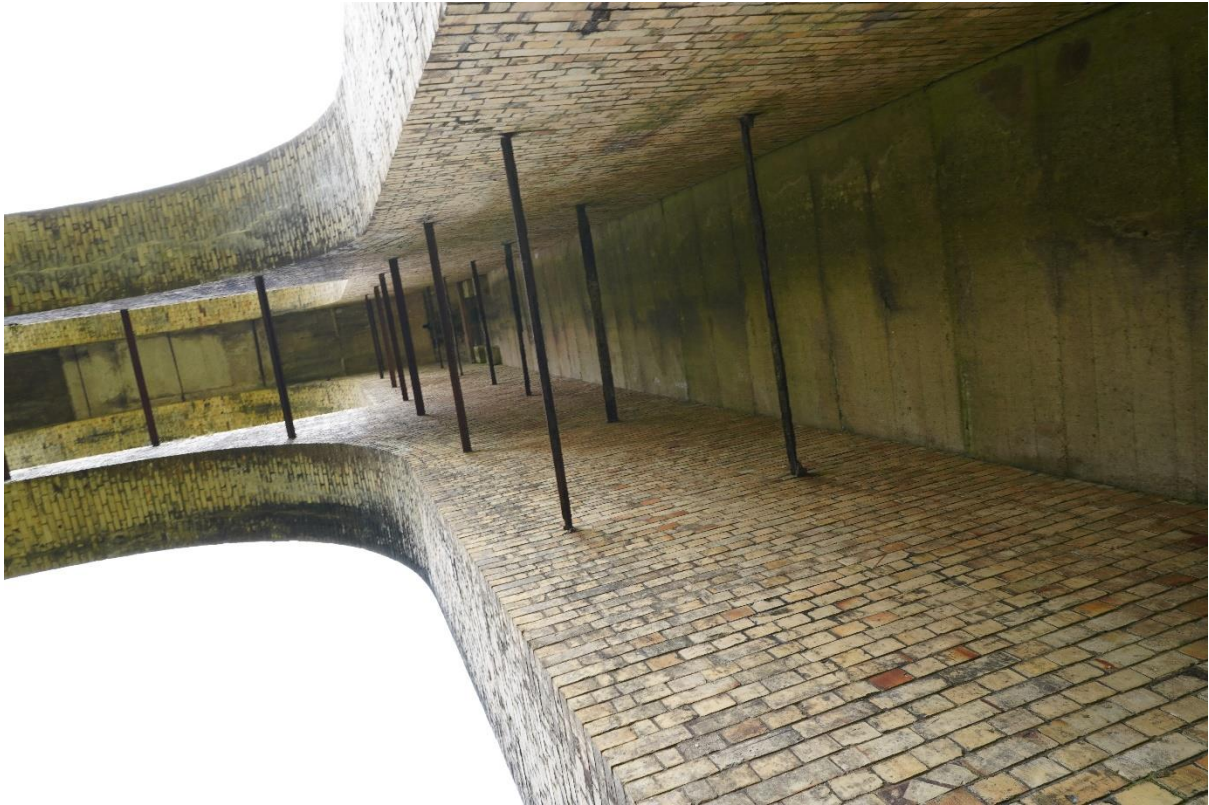
Looking up, the two brick sections are tied across with light gauge rail, much of which is rusting away.

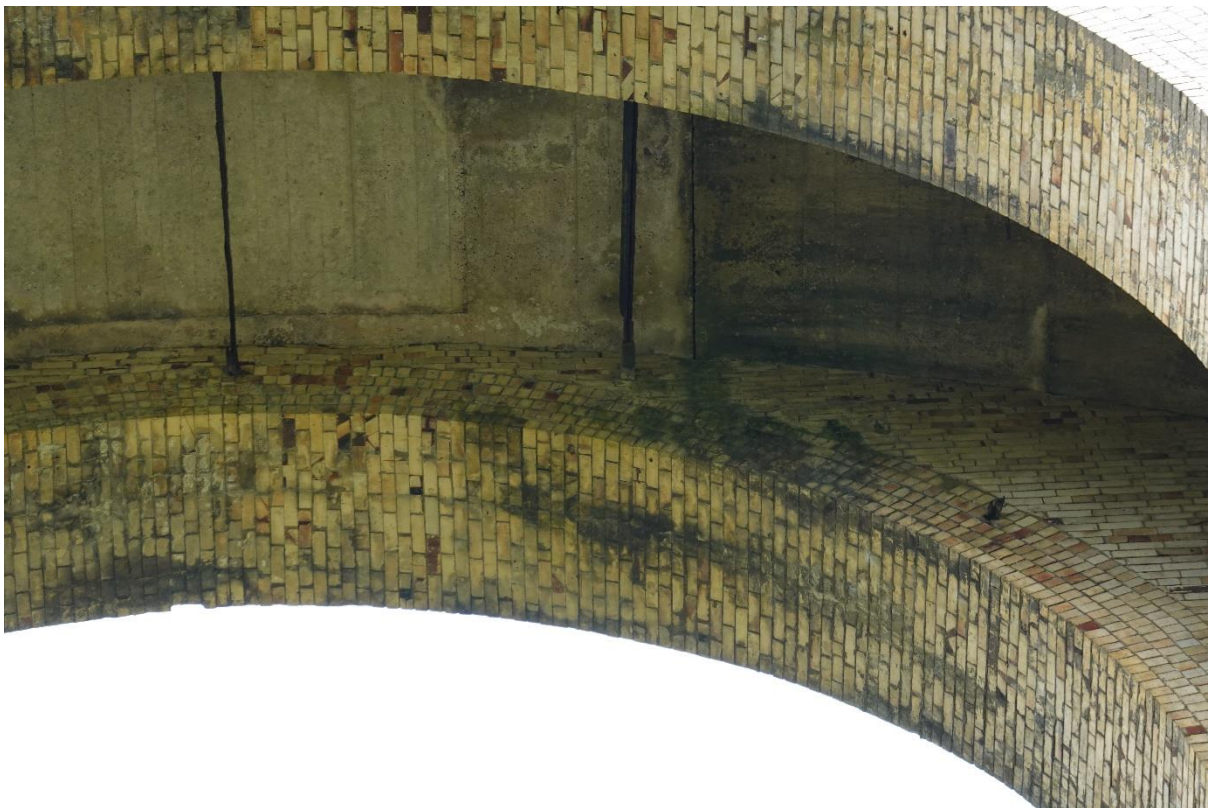
There is a hinge in the concrete arch at a construction joint. The articulation here suggests that the full height pier to the right has settled more than that to the left, which raises questions about

strutting the higher one off the lower at ground level. Perhaps there is rather more than just a surface strut.

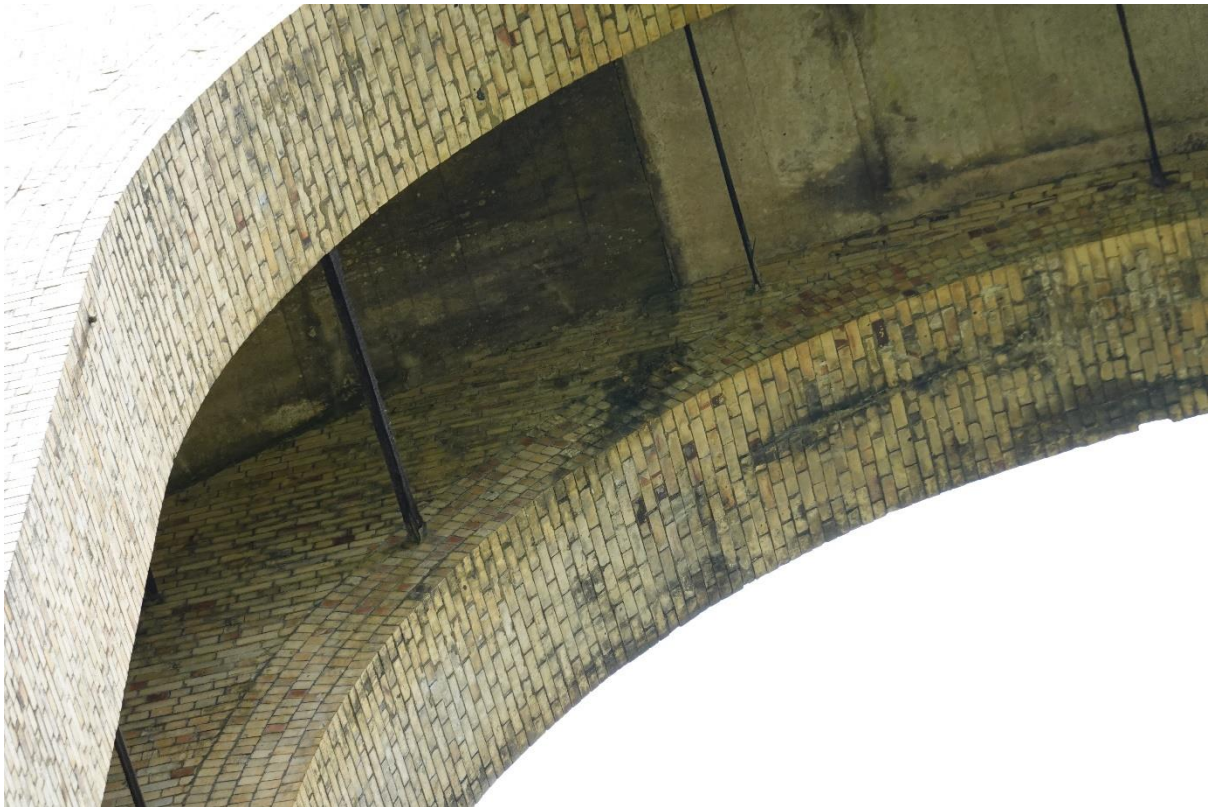
The equivalent point at the other side of the span is also leaking water. There is probably a crack here at the upper surface of the arch.

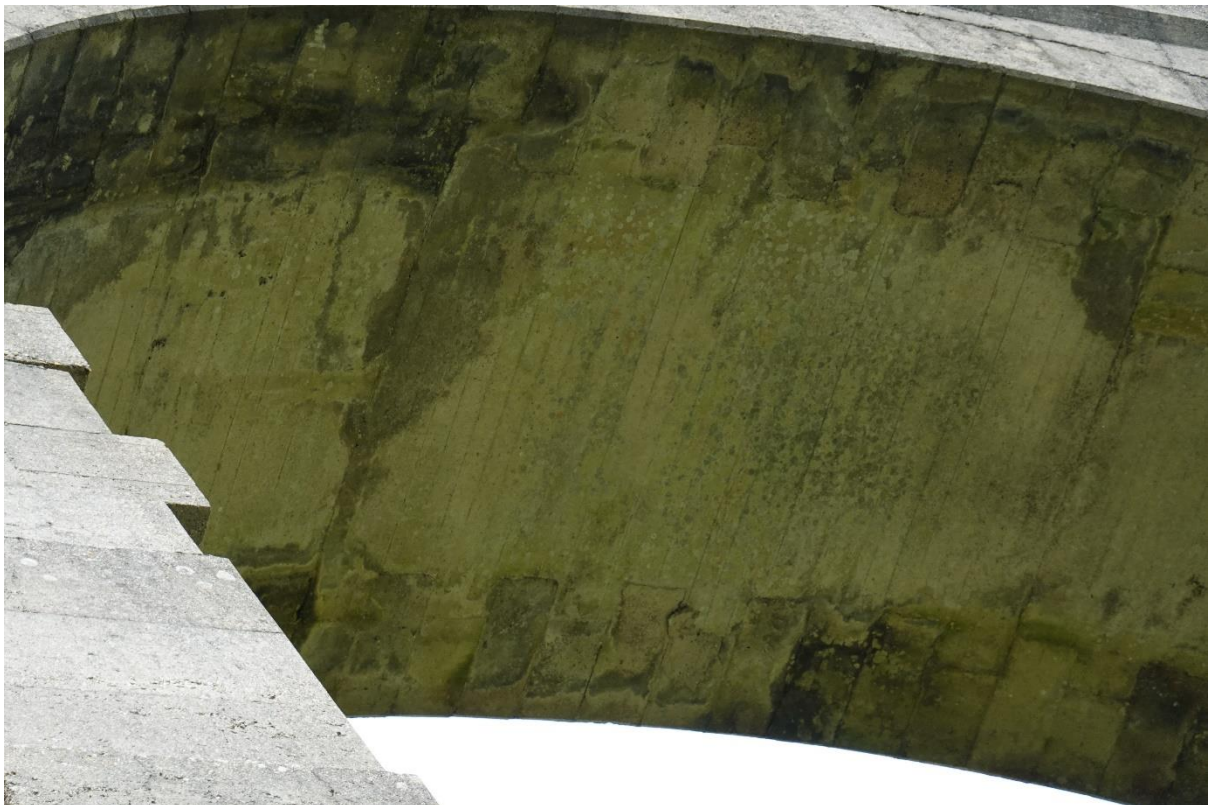
This view of the soffit shows the nature of construction with alternate long and short voussoirs and shuttered mass concrete between.

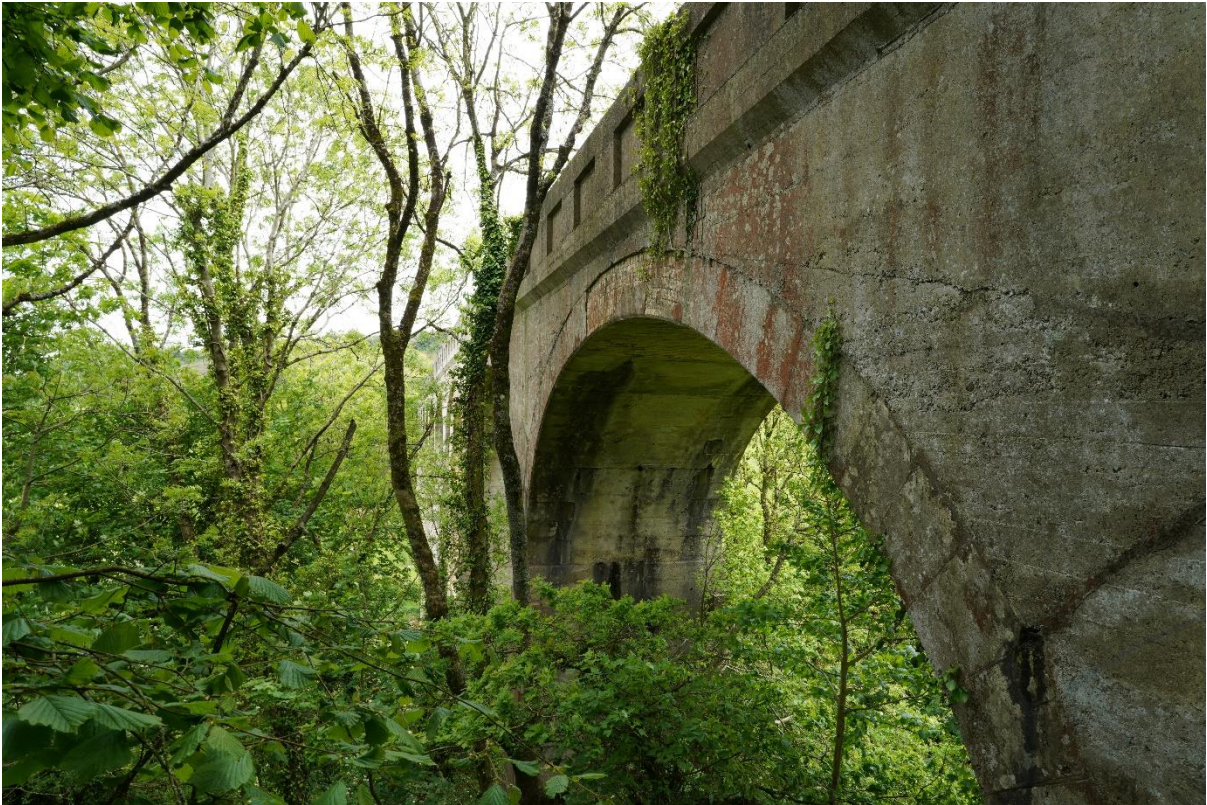
Climbing to the abutment shows the main arch ring in the end span to be rendered brick.

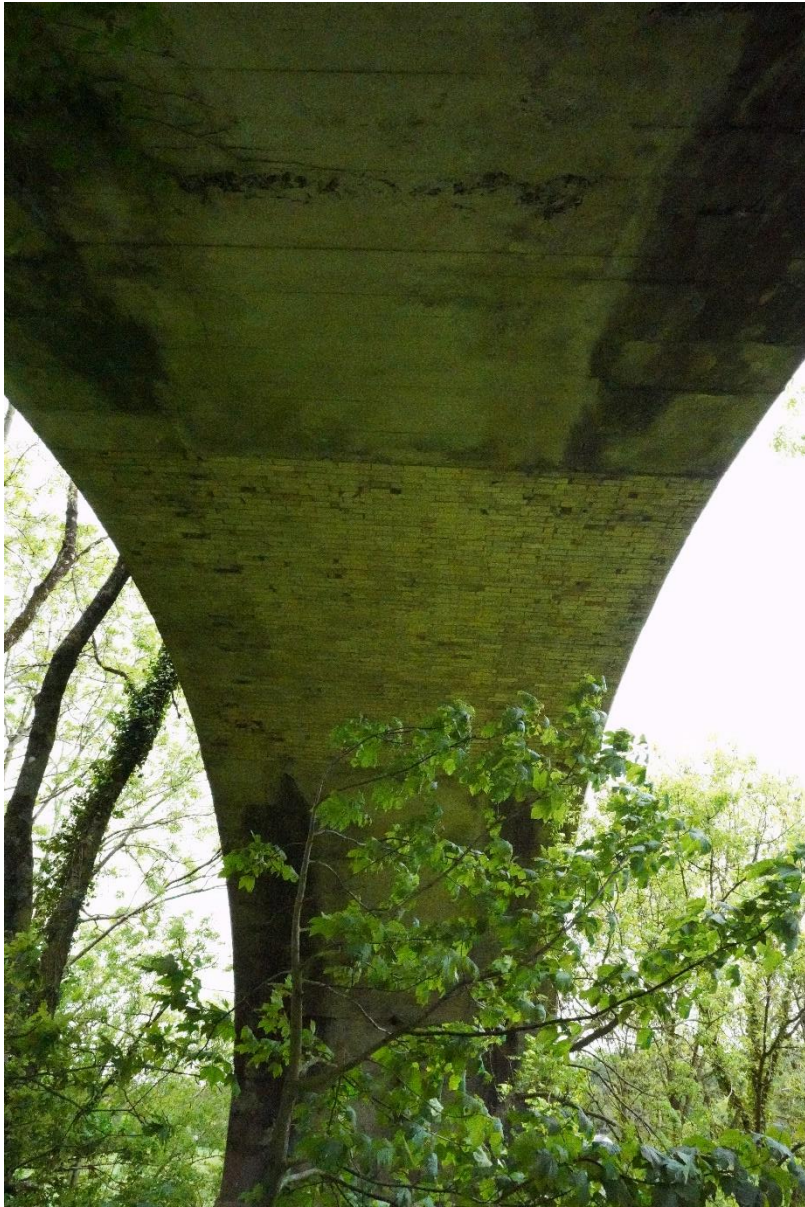
From below, we see that the brickwork is just for the mid span section of the arch. Presumably the abutment also settled and put this arch into compression, causing it to buckle upwards and need replacing.

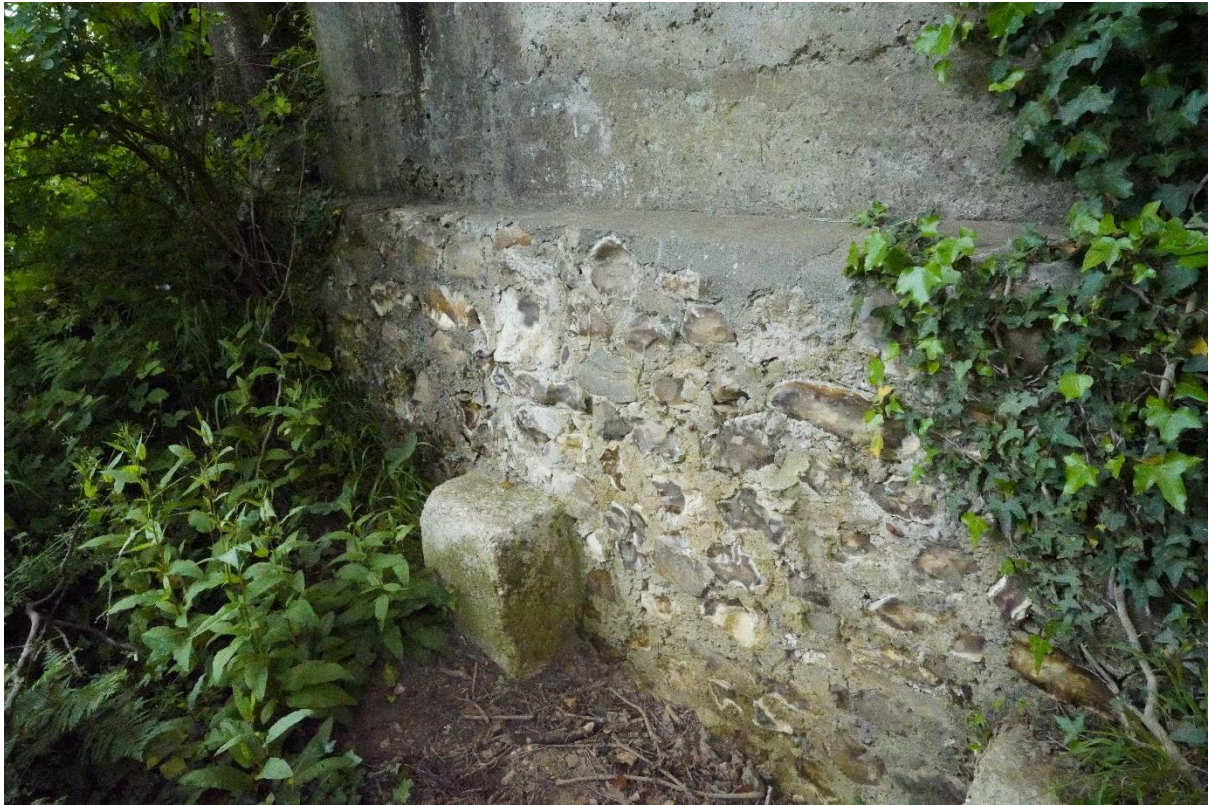
The abutment foundation, set high on the valley side, is similar to the first pier we looked at.
