Bridge of the Month 132. Dec 2021 Stoke Canon

Stoke Canon is a village a couple of miles north of Exeter. It is between the river Culm, close against the east side of the valley and the Exe similarly close against the west. Across the culm flood plain is another [mediaeval causeway](#) that I have only just got round to looking at. These pictures show the western end close to the village and the eastern end against the steep valley side.

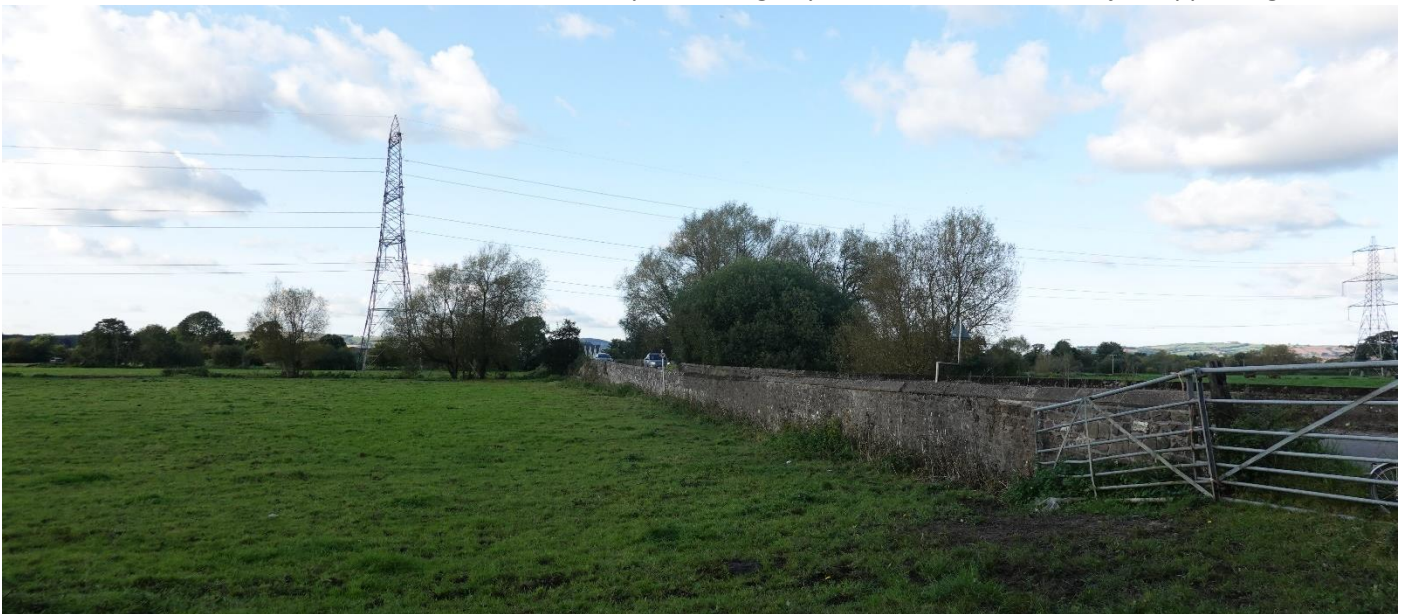
Here is a view from the east/south with the causeway stretching beyond the trees with a car just appearing.

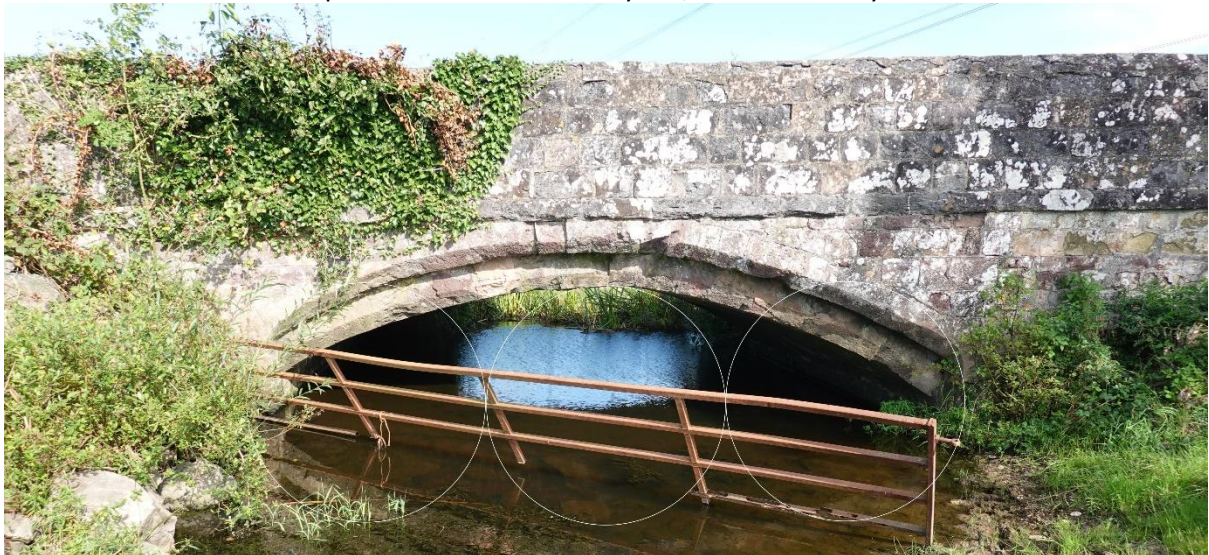
At the west end is a flood span that looks remarkably flat, but is obviously mediaeval.

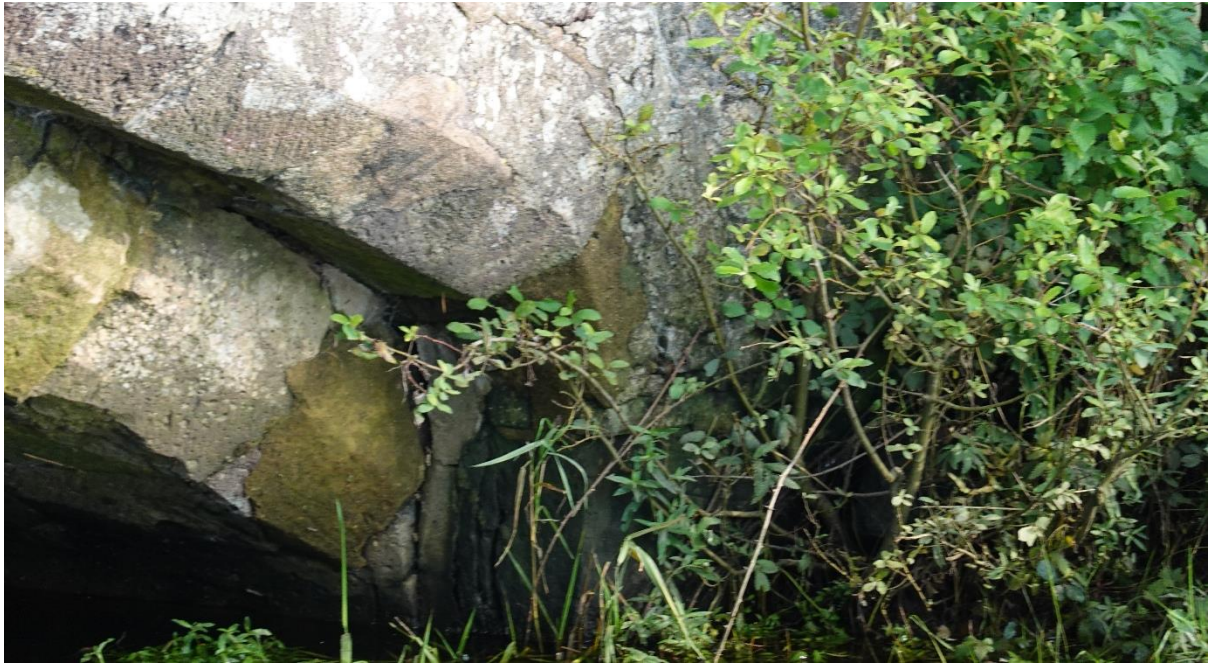
Overlaid with circles along the springing line we find a span rise ratio of 6. Really unusual.

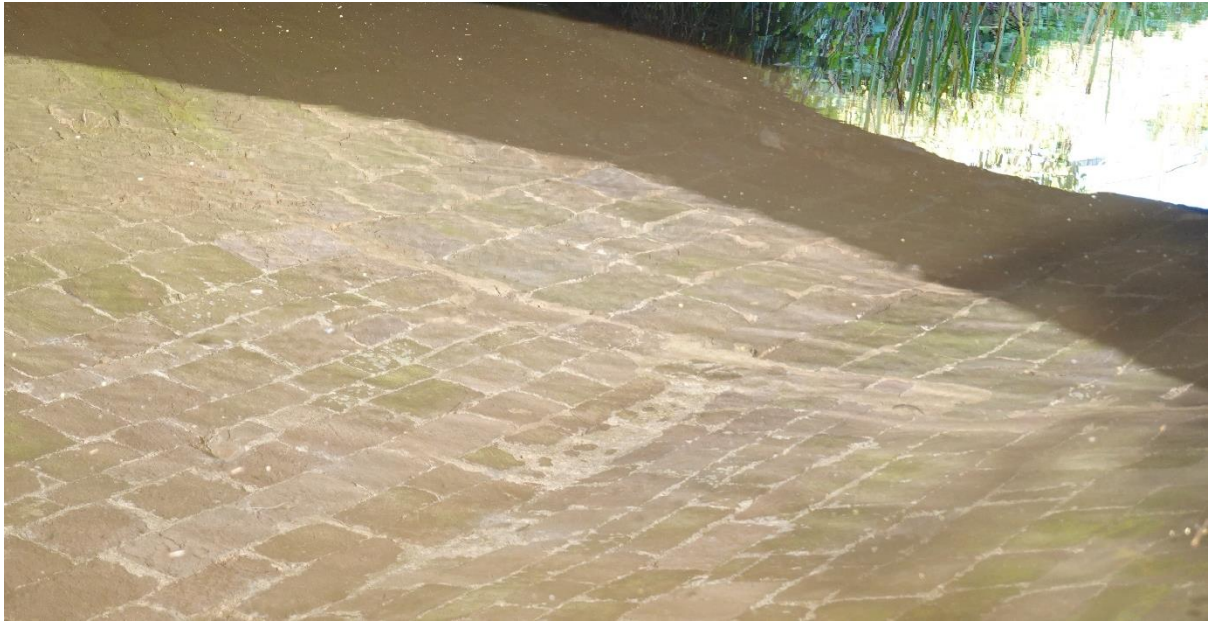
Looking underneath, and with the benefit of a reflection, the bridge may be old but is still in excellent condition.

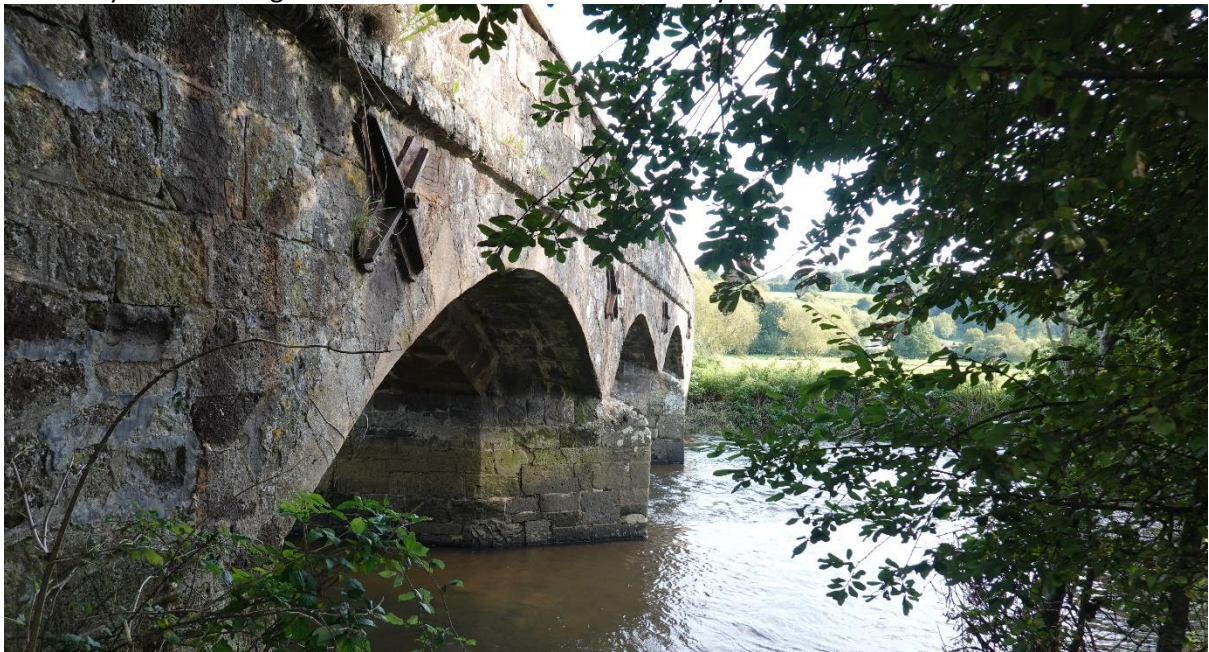
From a slightly different angle, you can see where the old bridge ends and the widening begins. Unusually the widening is all on one side but we will see why later.

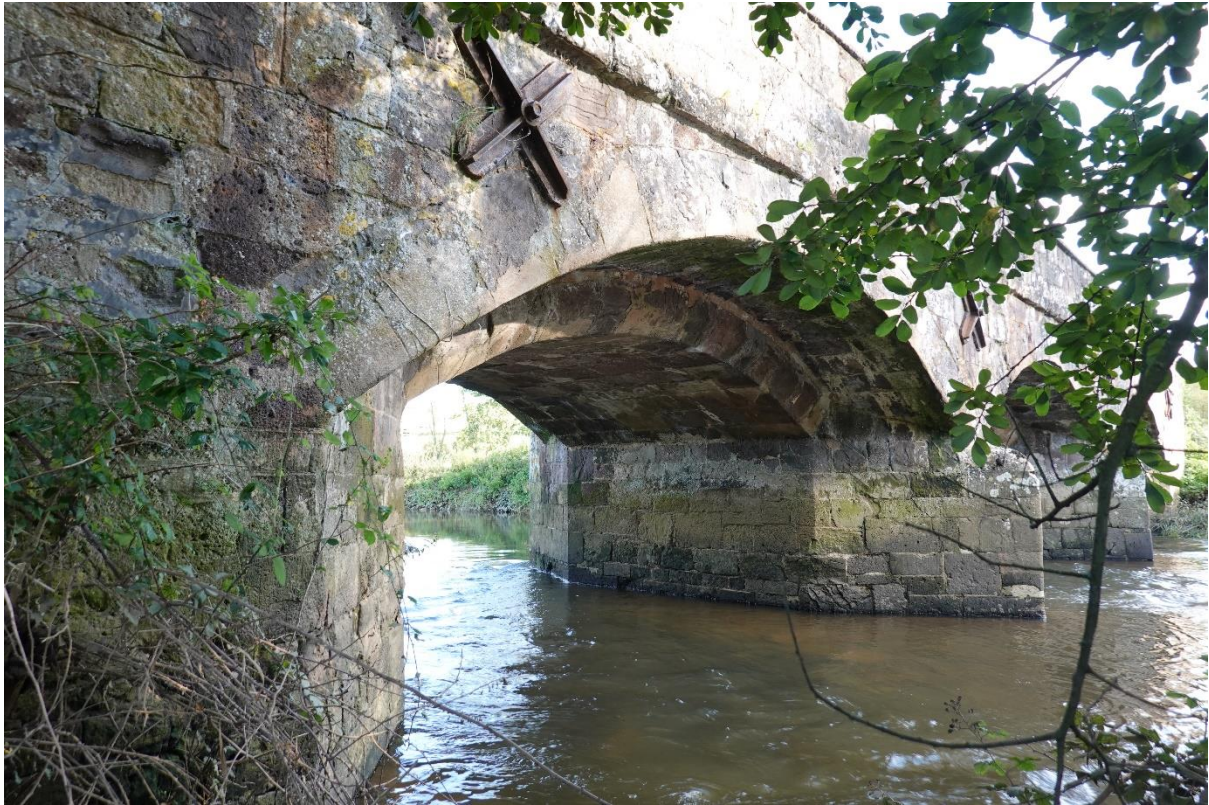
A little to the east is the river Culm proper, with a 3 span bridge widened a little on the near side.

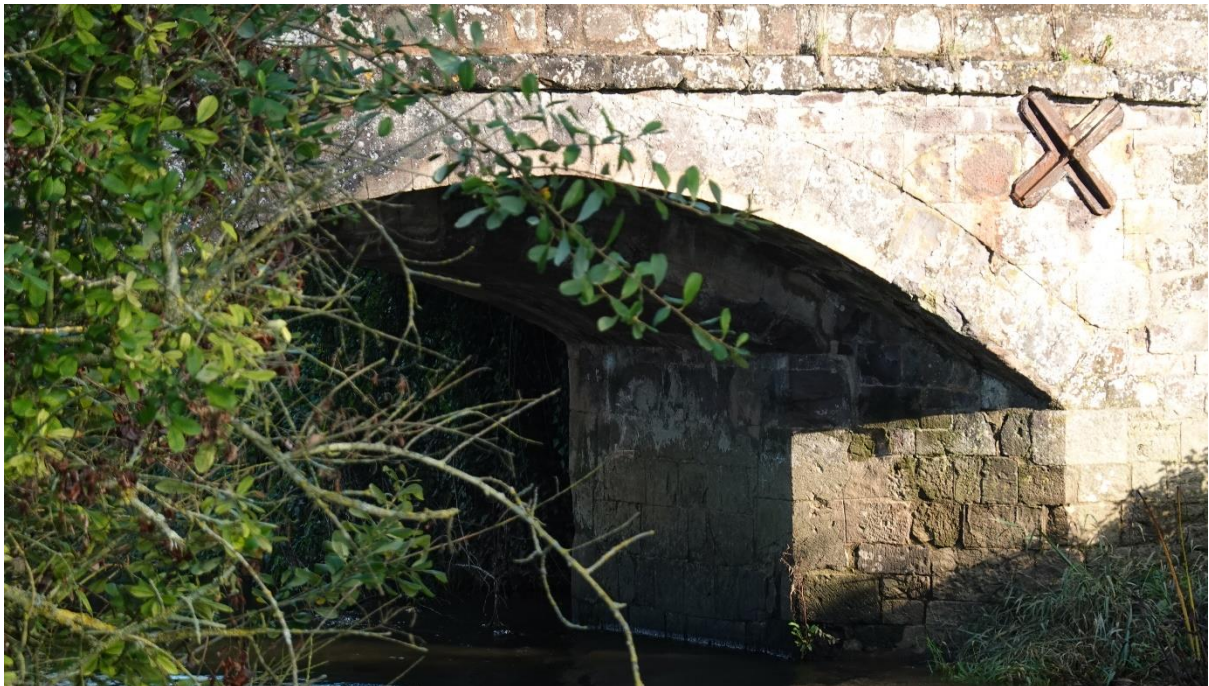
From a little closer we can see through and find there is a widening on both sides sitting on the original cutwaters. Solid foundations then!

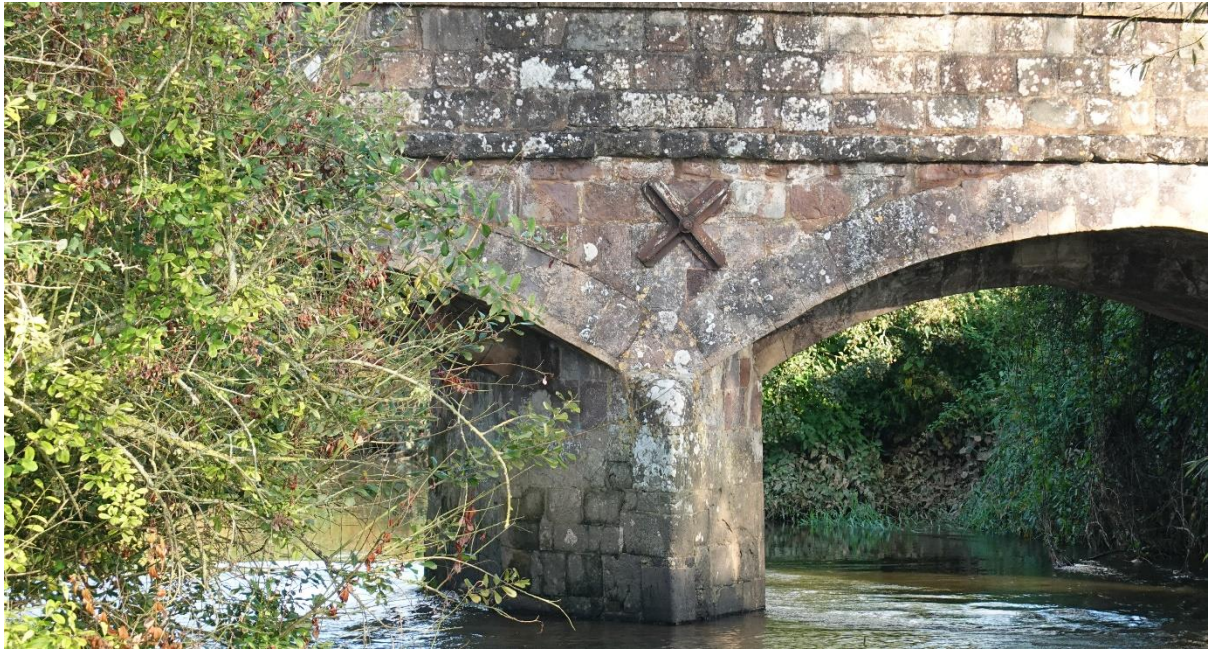
Judging from the different stone, it is possible the abutment had to be widened to take the new arch.

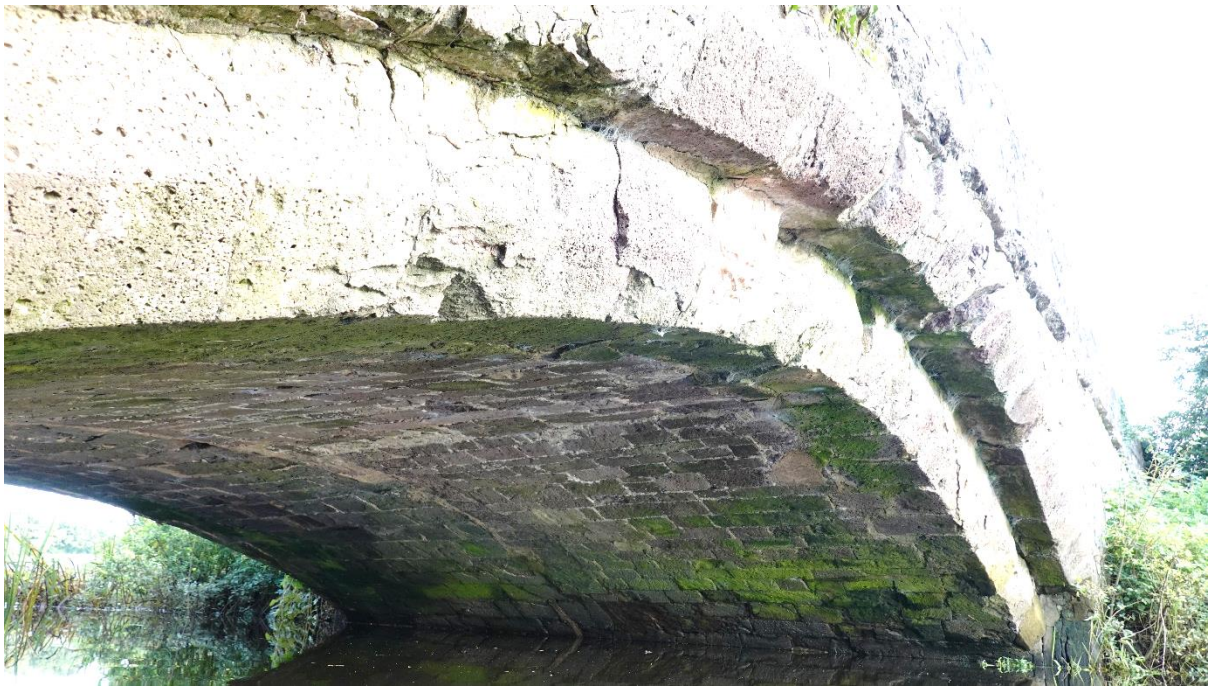
I wonder whether the spandrels really needed tying together.

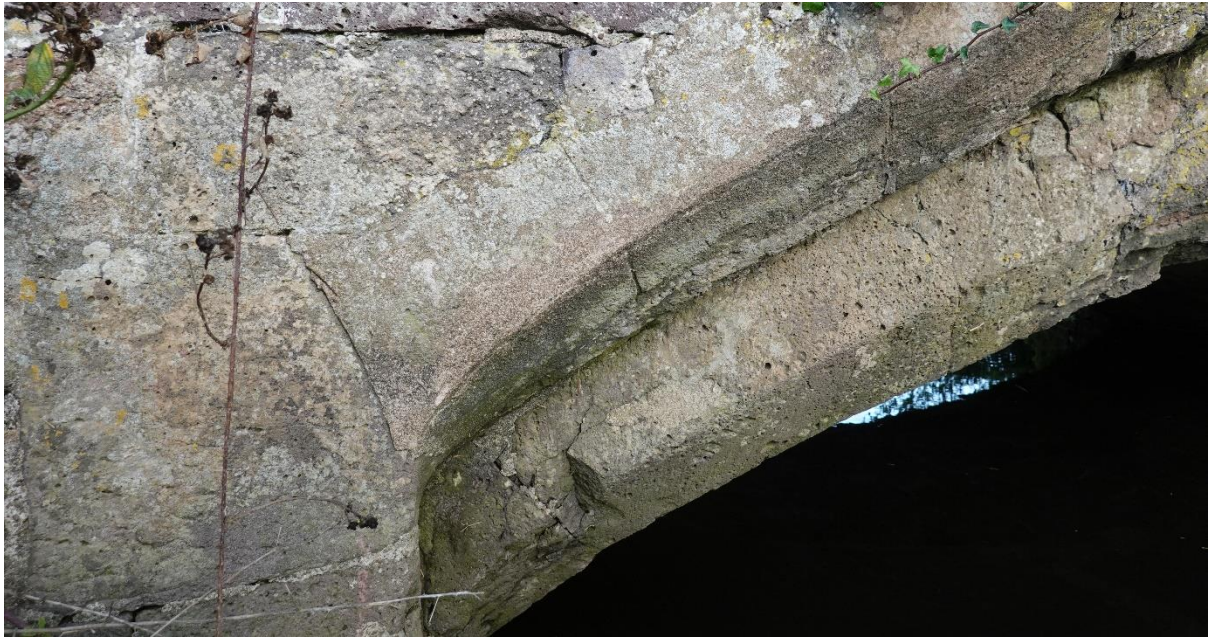
Back to the west end and I got the camera low enough to see the soffit properly. The masonry is in much worse condition where it is regularly wet and dry.

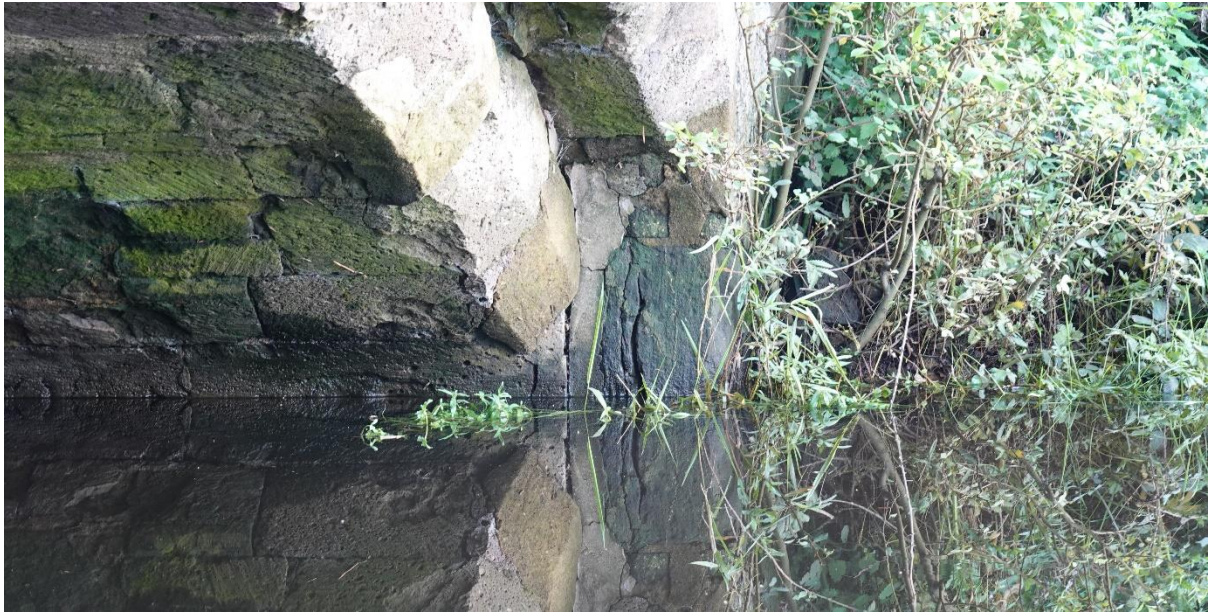
Looking through we get a view of the widening, which matches the original for curve much better than would be normal. Either the stones were driven in hard or the centre was set slightly high.

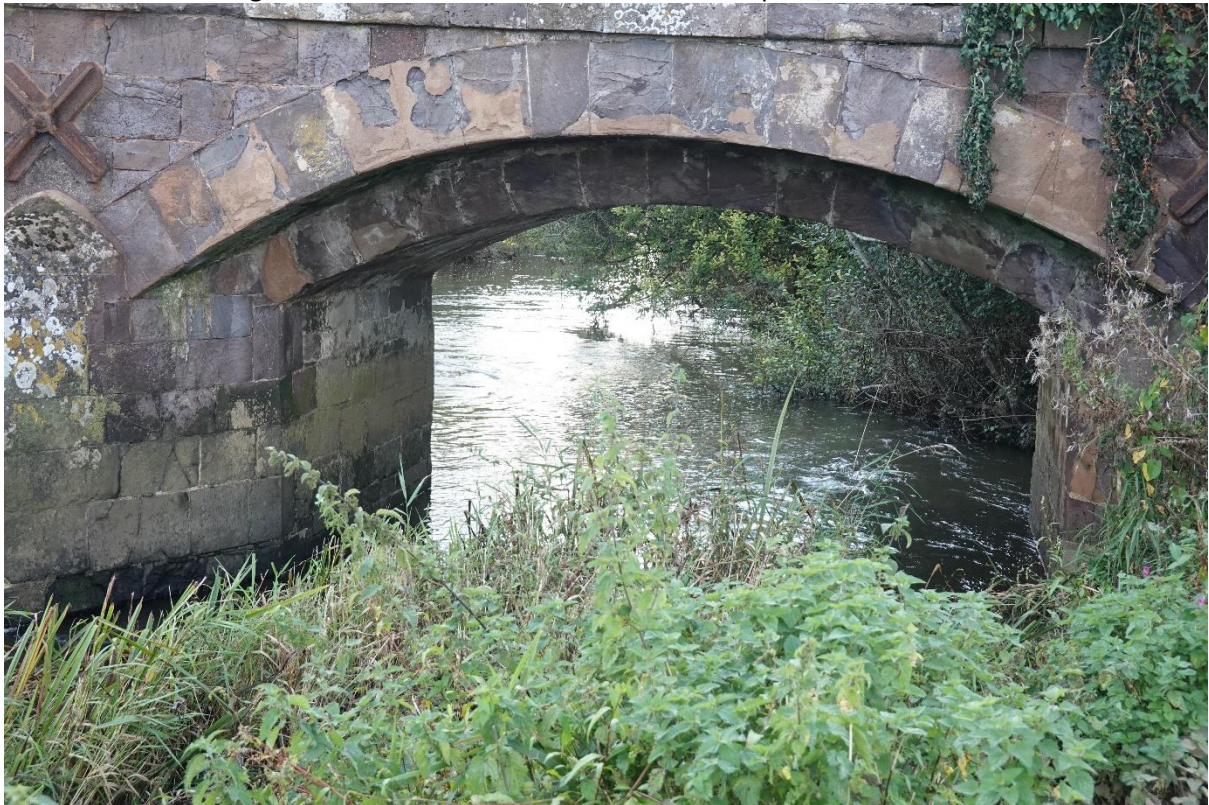
Here is the river bridge from the north east. Even on the multi spans, the arches are flat.

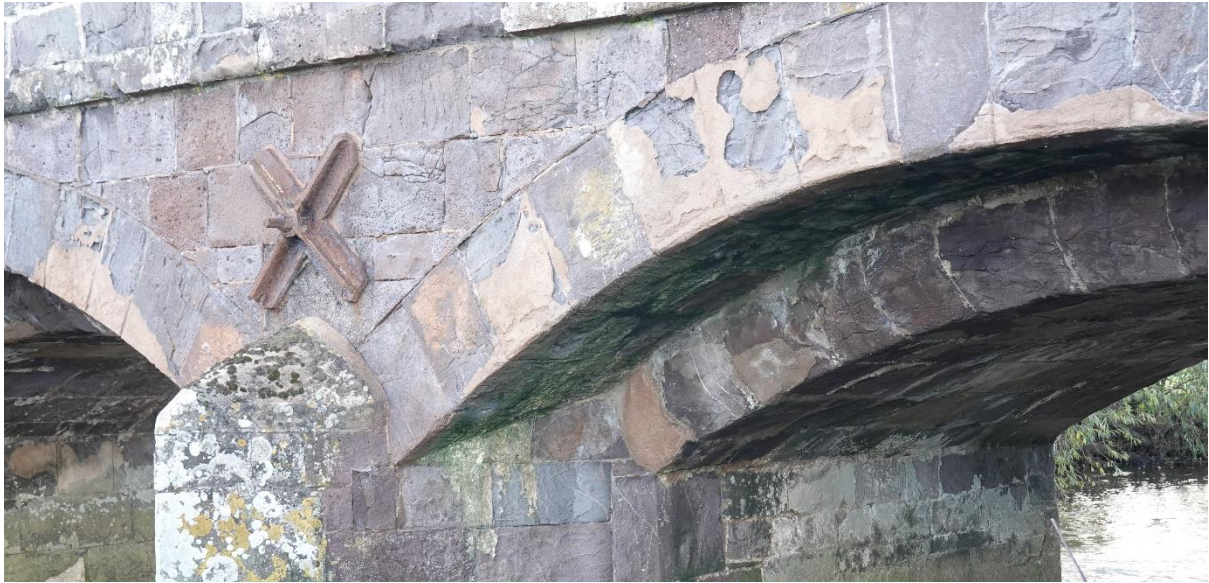
A definite sag in the string course, so these widenings dropped when the centring came out.

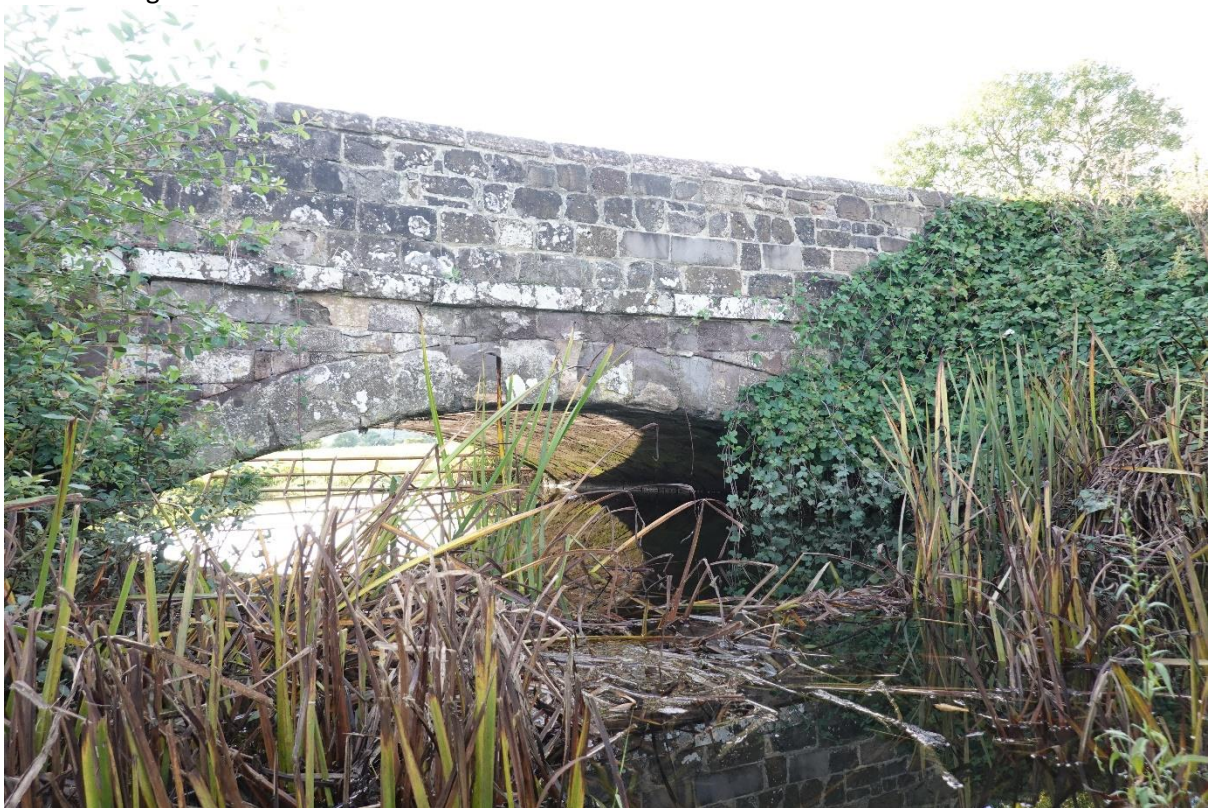
Constant curve and gradually increasing span means the springing point drops across the width of the widening.

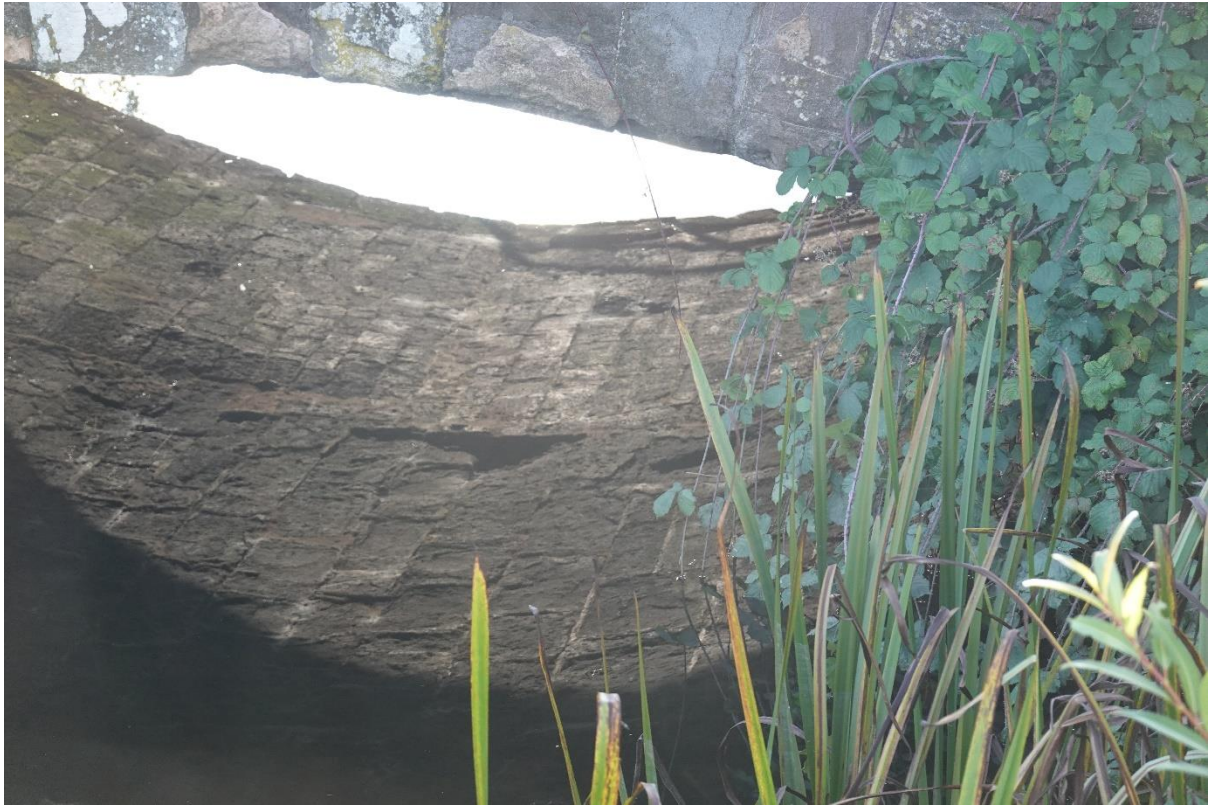
This is the flood arch at the west end again. Can't get close but can get a reflected view of the soffit. The broken-out stone near the crown means that the new (near) arch is flexing very slightly more under traffic. Of course the old bridge is also stiffened by the now buried spandrel wall.

The apparent cracks at the far side are shadows of the gate reflected on to the soffit.

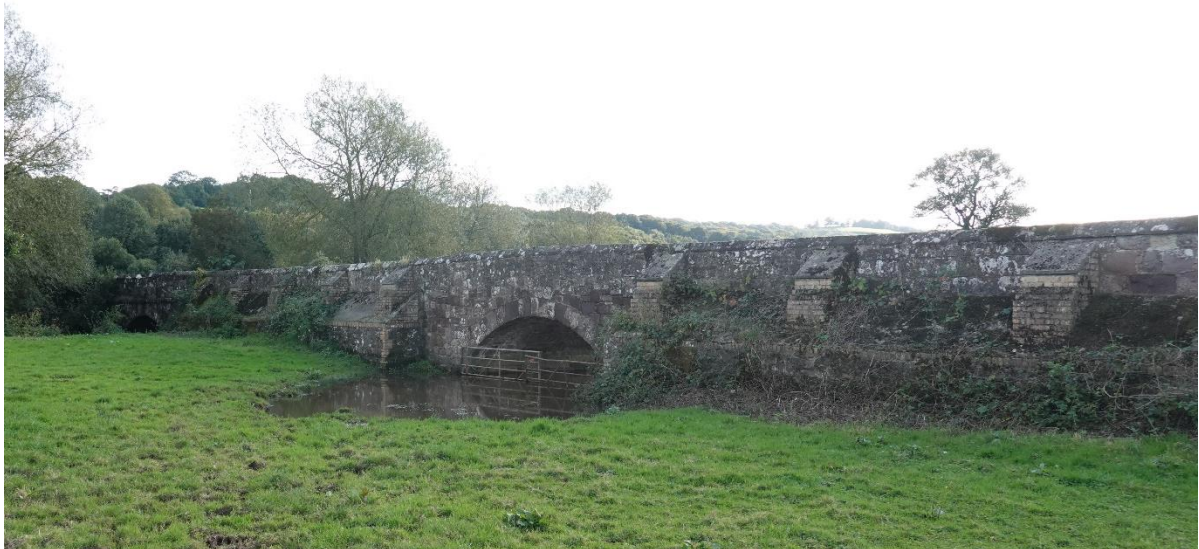
Nearer the middle of the length is another flood arch. As flat as the rest.

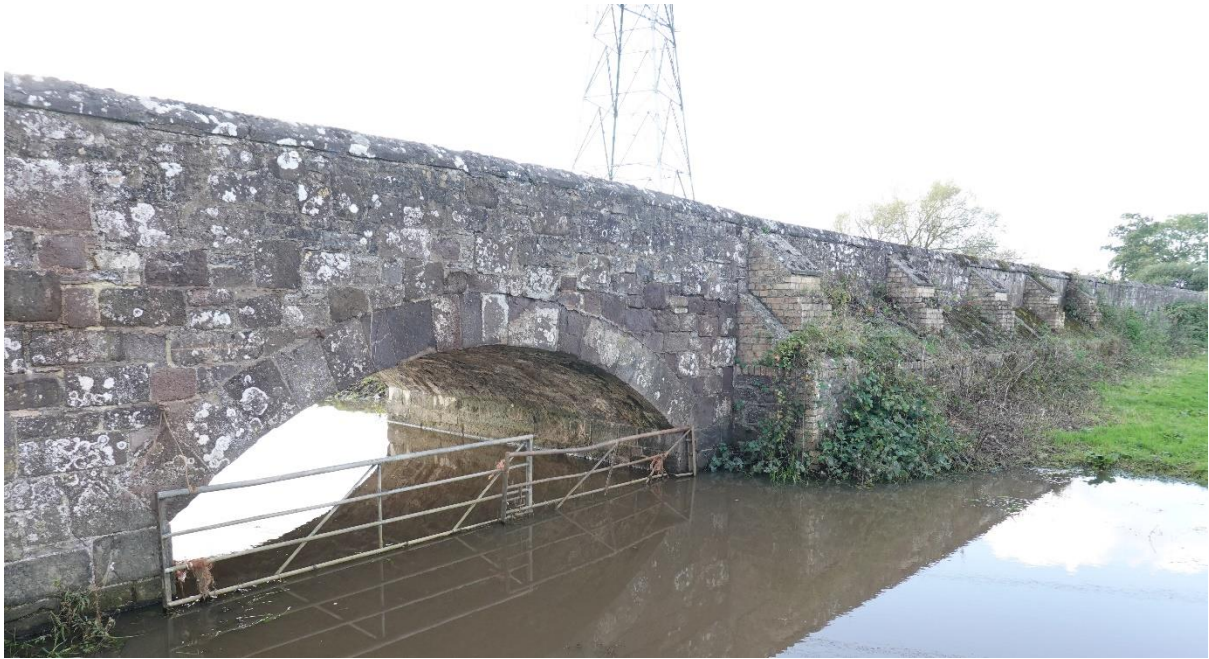
As at Clyst St Mary, the walls are tilting somewhat. Because this road is well trafficked, buttresses have been added.

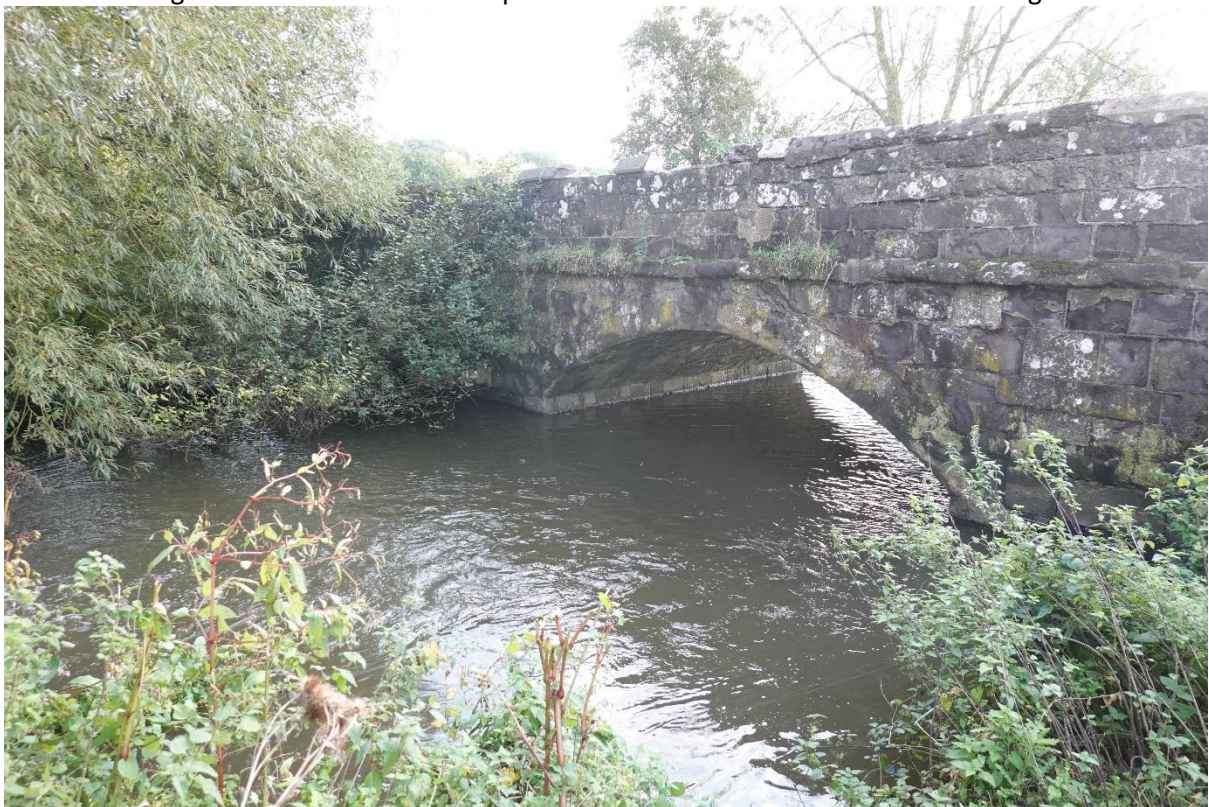
Further east again there seem to be two spans with a small branch of the Culm running below.

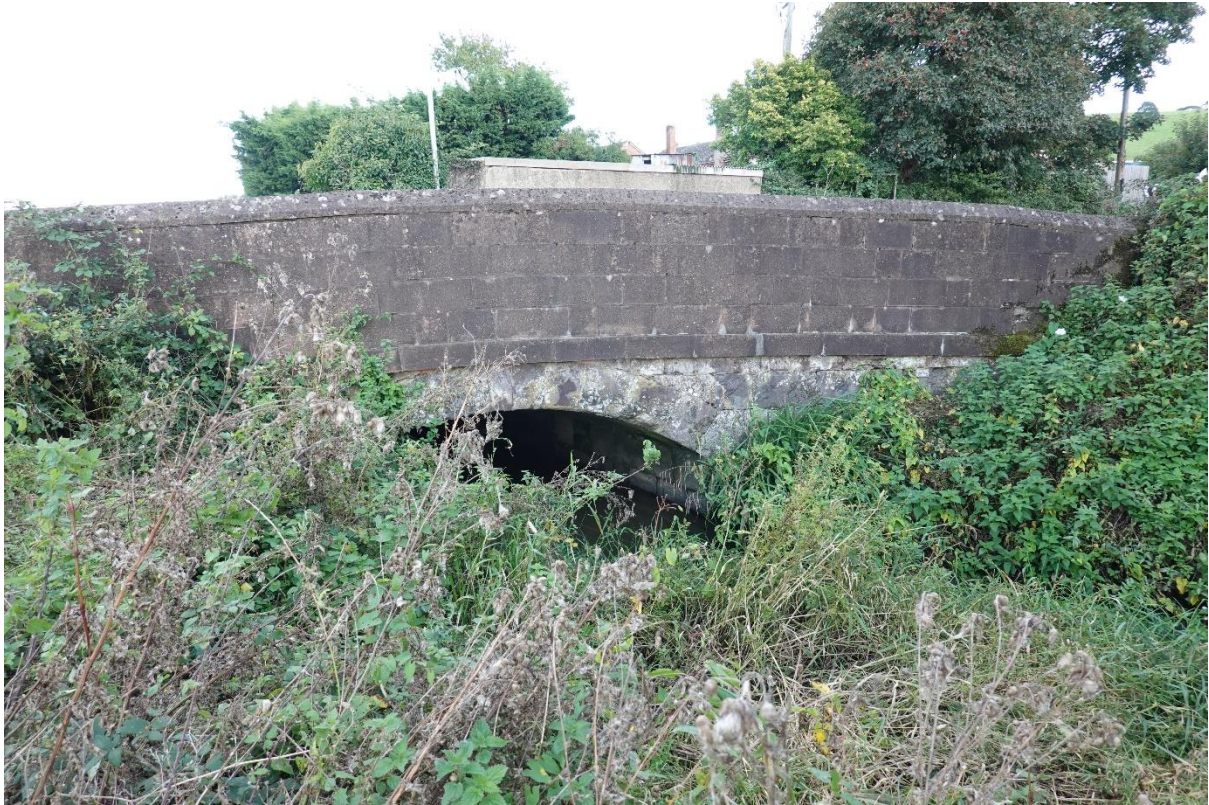
And at the very east end is a smaller span that appears to be skew. I couldn't get closer to get a better picture.
