## Bridge of the Month 134. Feb 2022 Torksey

Torksey, in Lincolnshire, is the site of a much [more famous railway bridge](#) over the Trent but we were there to observe a test of a [small brick arch over a drain](#). It was the depths of winter (well, November) and never seemed to get properly light.

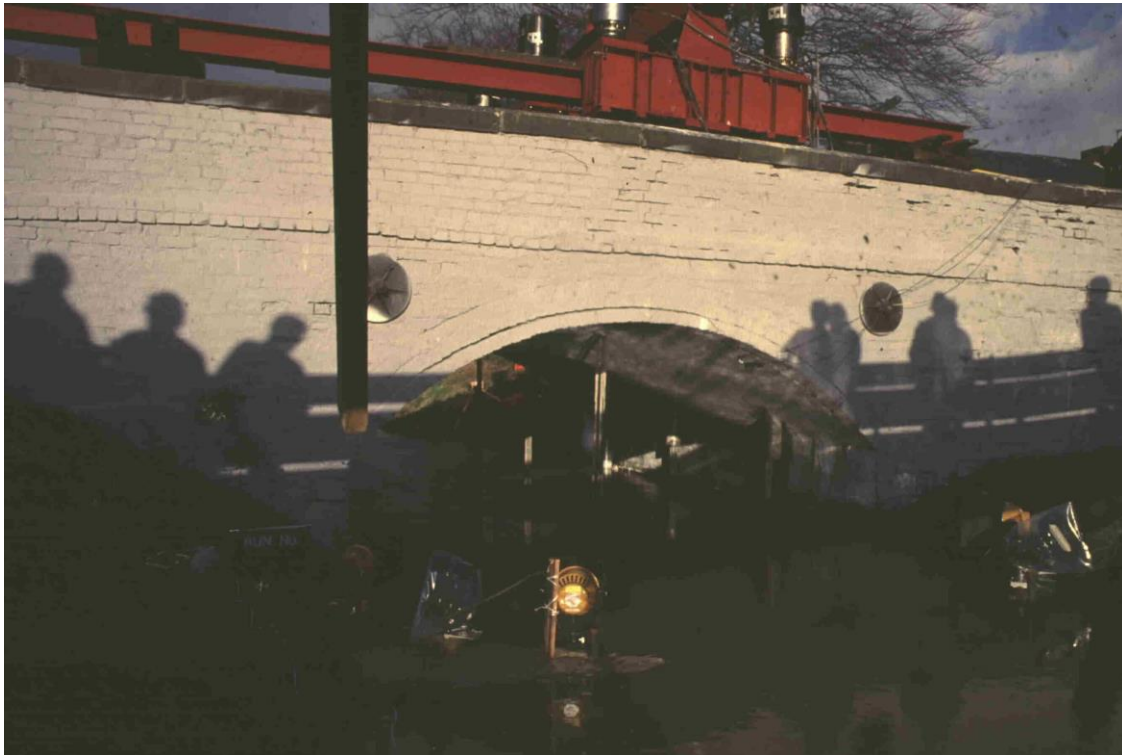
Nearly everything in that view is relatively new work. The arch itself is original but the wall, and the ring that supports it are in modern brick. As a result, the test was as close to 2D as it is possible to get in the field.

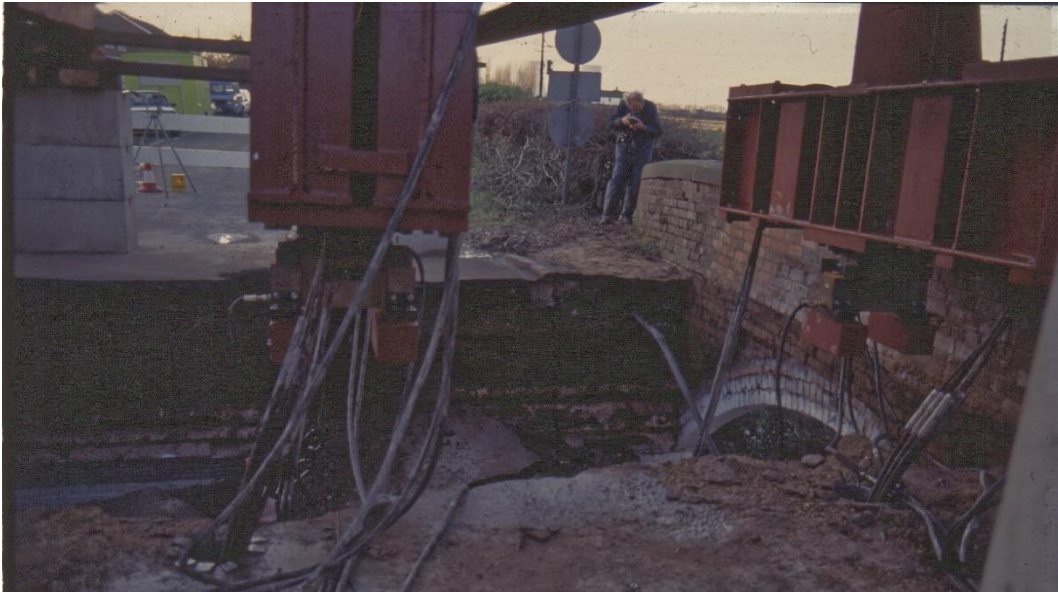
The TRL report notes that "Both spandrel walls had moved outwards, taking the outer sections of the arch with them." A look at the photo below tells us that the inner face of the arch ring at this point is clean brick ends, not broken brick. We can deduce that the walls were taken right off, or perhaps collapsed, and a new ring was built to support the new walls. The face is remarkably smooth through the full depth, which is why I say then arch is likely to have behaved as 2-dimensional.

Also visible (just) in this photo is the backing above the arch. That will have made a substantial difference to behaviour as I will discuss later.

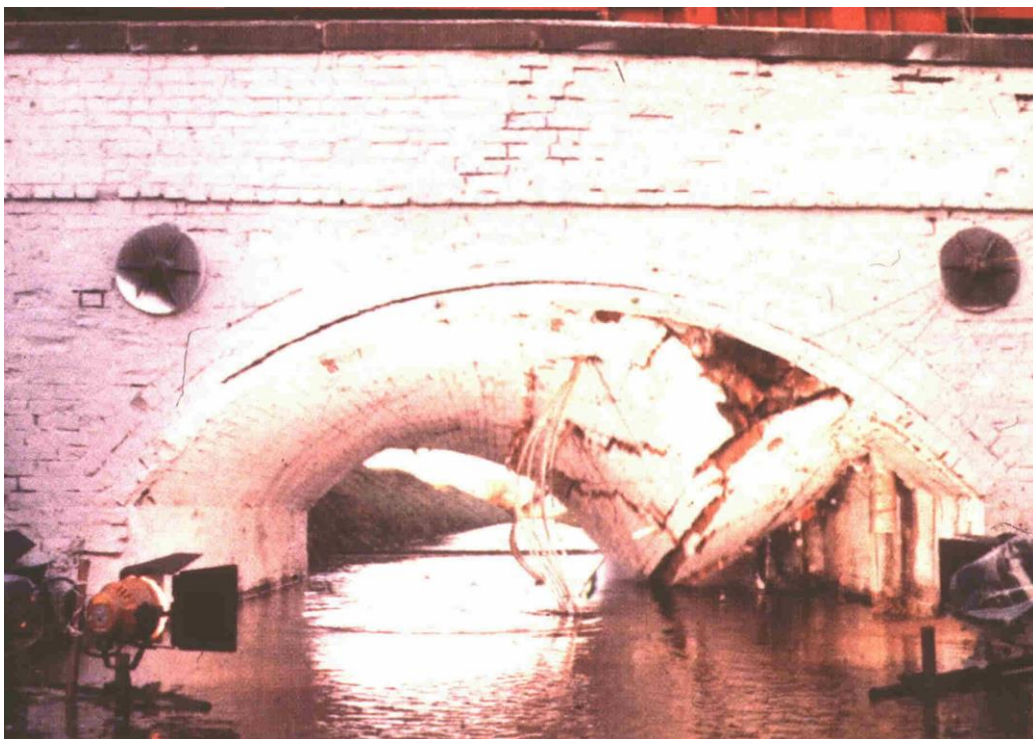
The only other photo of value comes from the TRL report and shows the arch in the process of collapsing.

The ring separation is obvious here but when did it happen? Almost certainly after the peak of the load deflection curve.

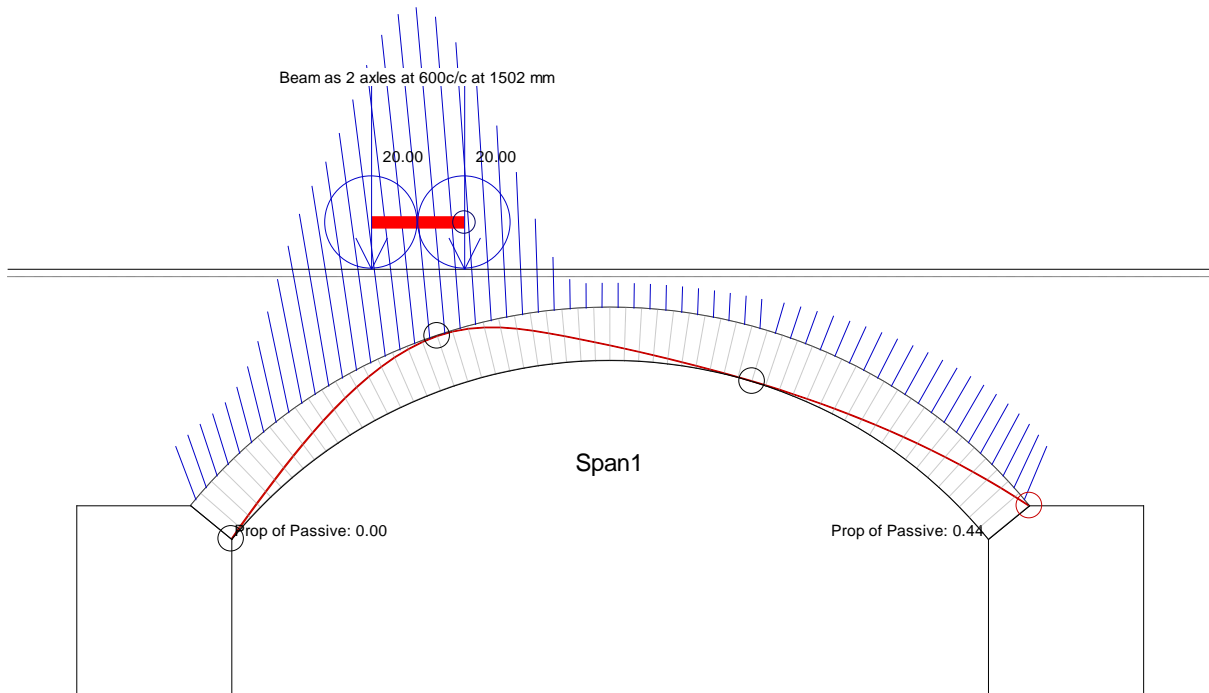
First, an almost pure mechanism. With the material strength set at 30MPa we get a line of thrust not a zone.

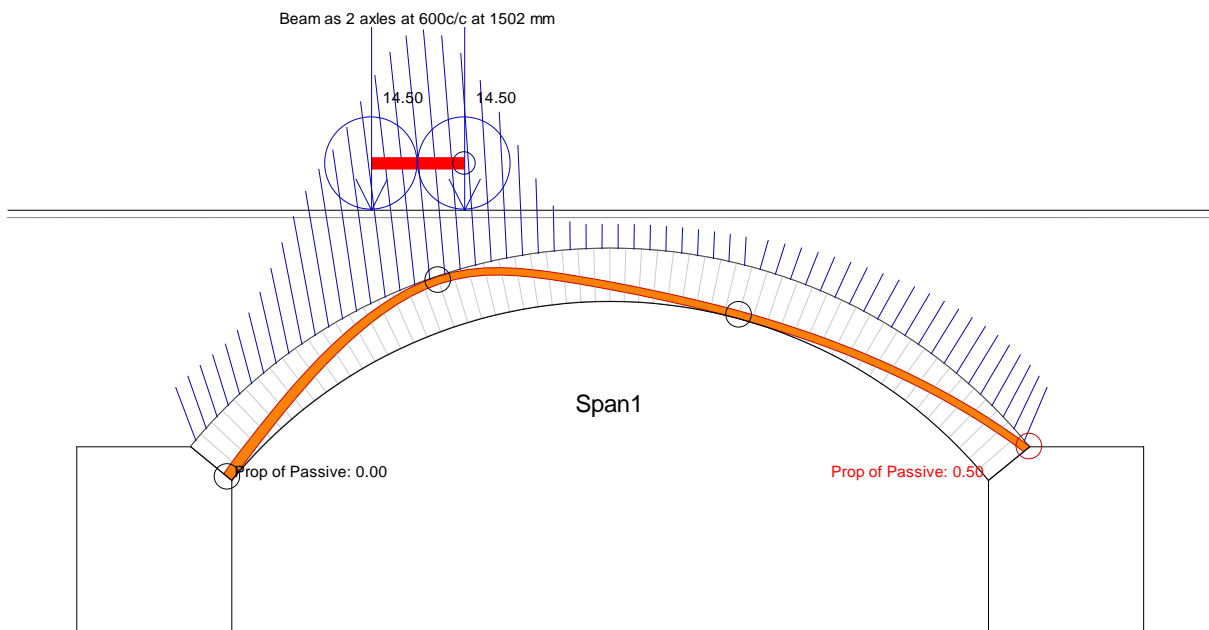
Reducing the material strength to 2.5MPa reduces the capacity dramatically, though unlike Chrisfield's program, Archie doesn't allow the use of full passive pressure. The load here is reduced to 810kN at failure, against Chrisfield's 1043kN.

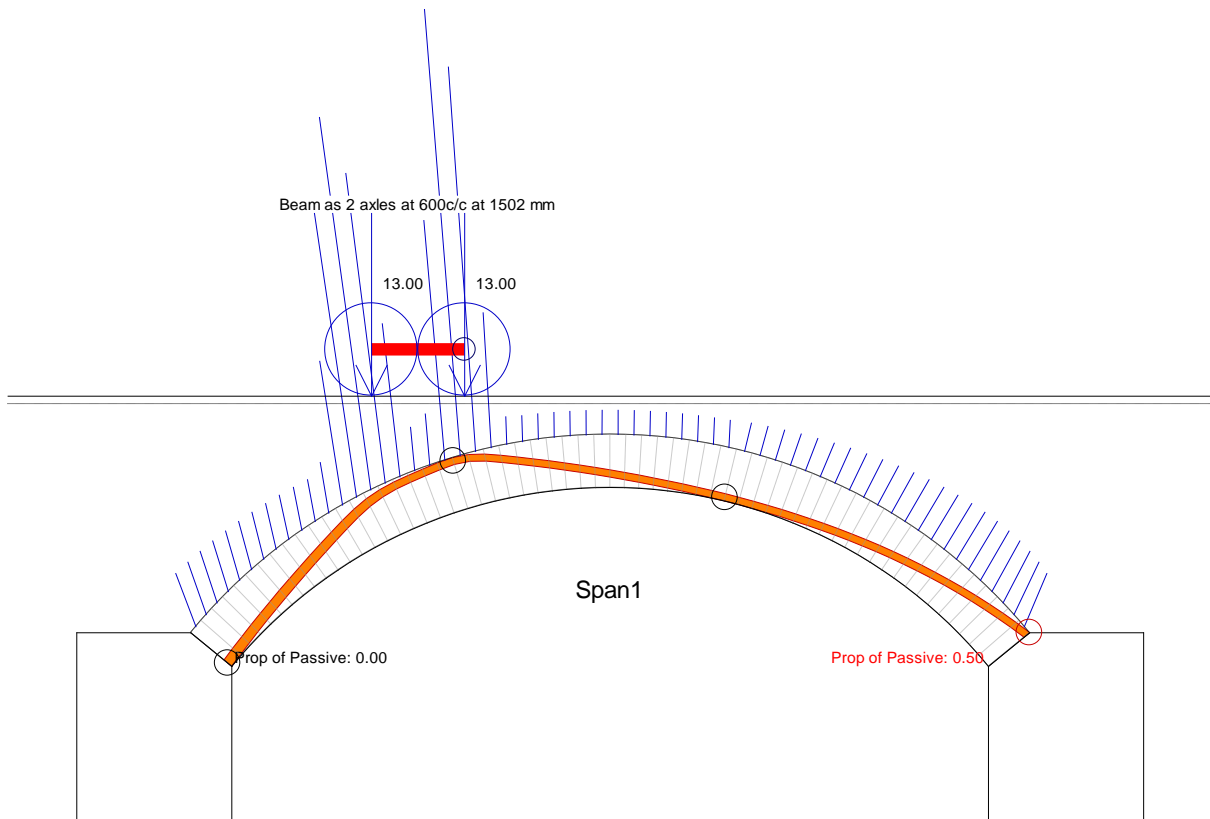
I should note here that I have represented the loading beam as two discrete loads 600mm apart. The distribution here is the standard allowed by Archie which is almost certainly over generous with such shallow fill. Reducing the distribution changes the picture a little.

With the narrower distribution the capacity drops further to around 720kN.

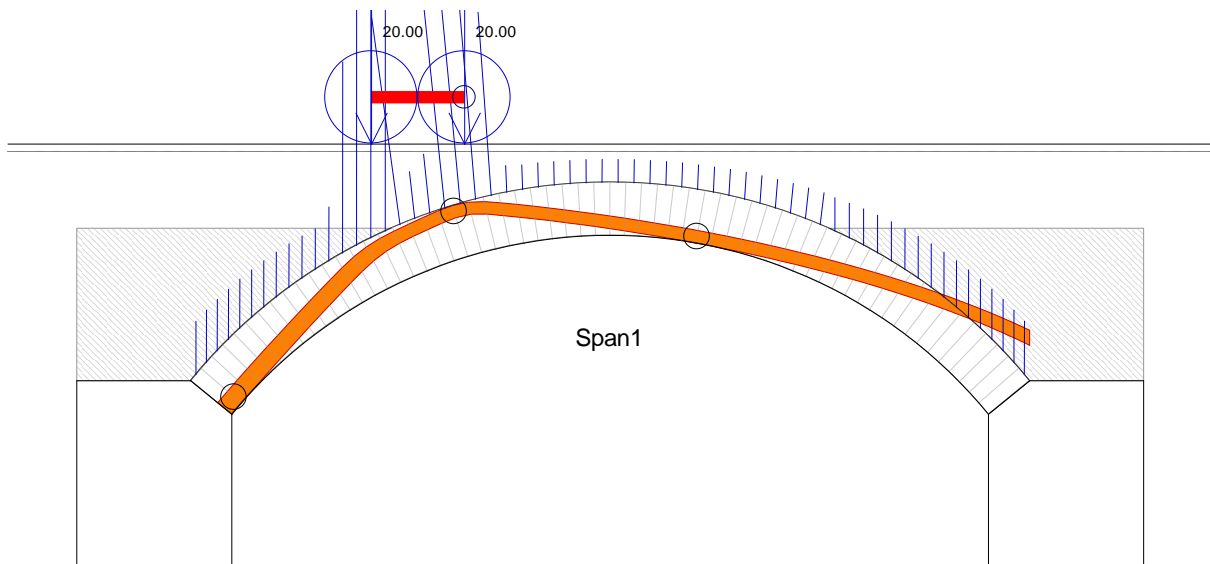
Now let's look at the effect of backing.

Notionally, that's a no fail but we need to think a bit more about it. The first thing to note is that the back edge of the loading beam is over the backing. Then we can look at the implied stress patterns of this thrust. This is a new feature in Archie, yet to be released.

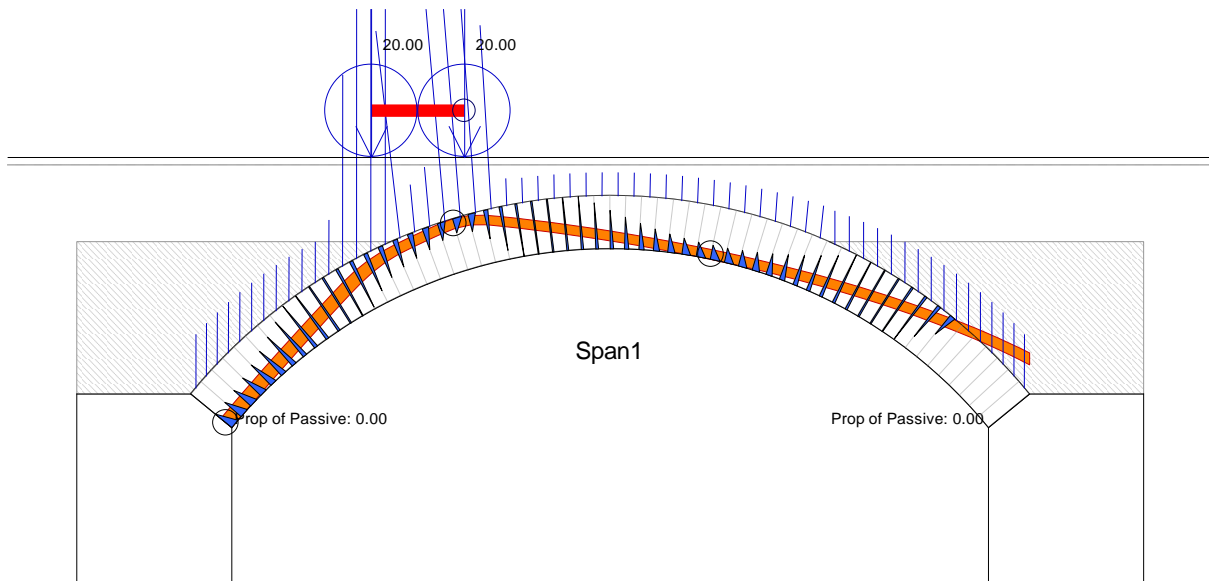
Over the middle portion of the arch, the stress moves from entirely in the top ring to entirely in the bottom over about 1.5m. The shear stress is distributed over about 1m. Calculating from the stress changes yields a peak shear stress between rings of 0.23MPa, but there will also be a contributory peeling effect as the radial crack opens through the stepped joints from ring to ring.

If the rising hinge is close to the crown, as suggested by the last thrust line picture above, perhaps around the 3m mark in the plot, it will have risen considerably more than the 20mm shown here. A still photo of the bridge at the 830kN load would have been invaluable in interpretation.

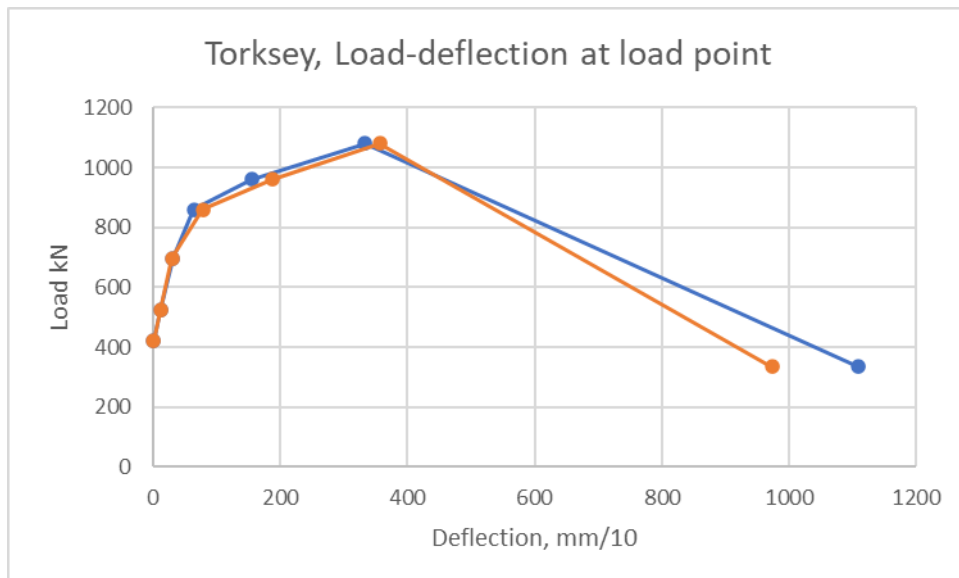
One worthwhile thing is not look at load deflection curves, though in this case they are sparse. There is no record of the zero load case, or even of the result of preload from the testing equipment, which was 26 tonnes, already double a normal traffic load. The deflections are recorded at zero with the load at 42 tonnes. The increments then go 52, 70, 86, 96, and 108 tonnes. The deflection curve under the load is shown below.

Here I have plotted the maximum load at each increment. The bridge then relaxed a little while the deflections were being measured. Regardless of that, we can surely say that something serious happened at a little over 800kN, and possibly something else at around 700kN.

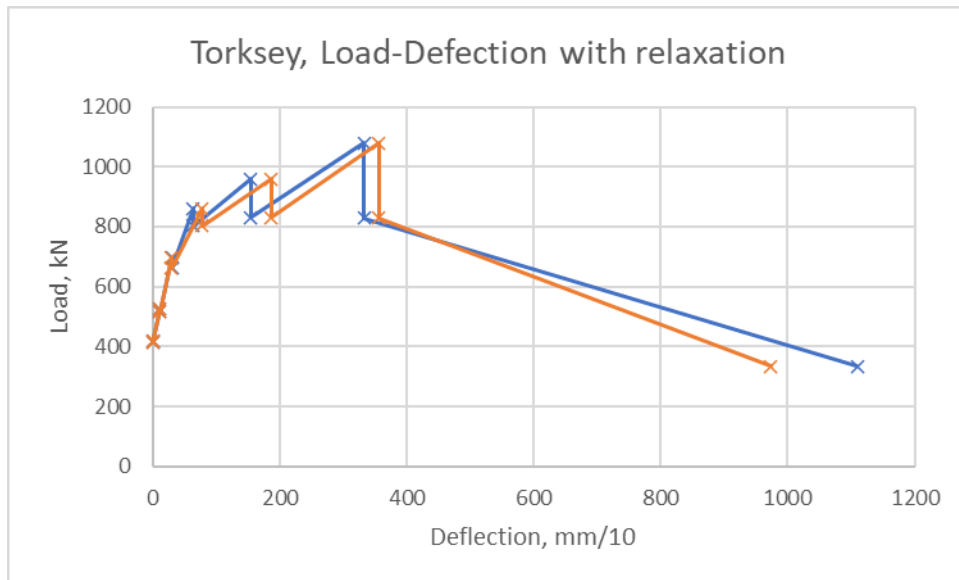
If we had the fall back loads at each increment, the picture changes somewhat. Now we can say that the bridge really did not want to sustain a load over 830kN and crept from 10mm to 30mm deflection under that load.

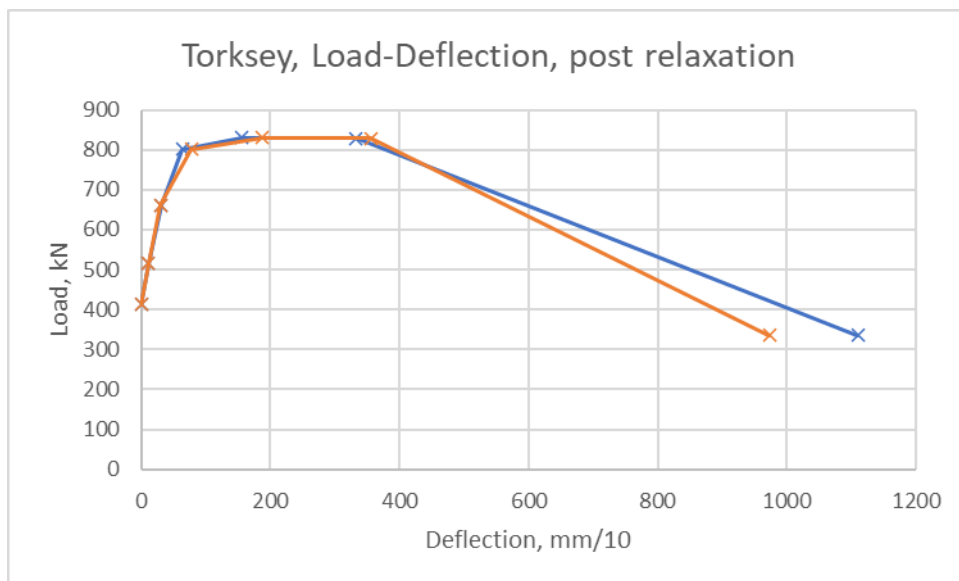
Assuming the lower load at each increment rules clarifies the picture further.

Now there is a clearer transition at about 650kN and the upper one is surely at 830kN. Once the deflection reached about 35mm the capacity began to reduce (as might be expected in a structure where shape is critical). The final sustained load of 335kN indicates where ring separation led to total collapse.

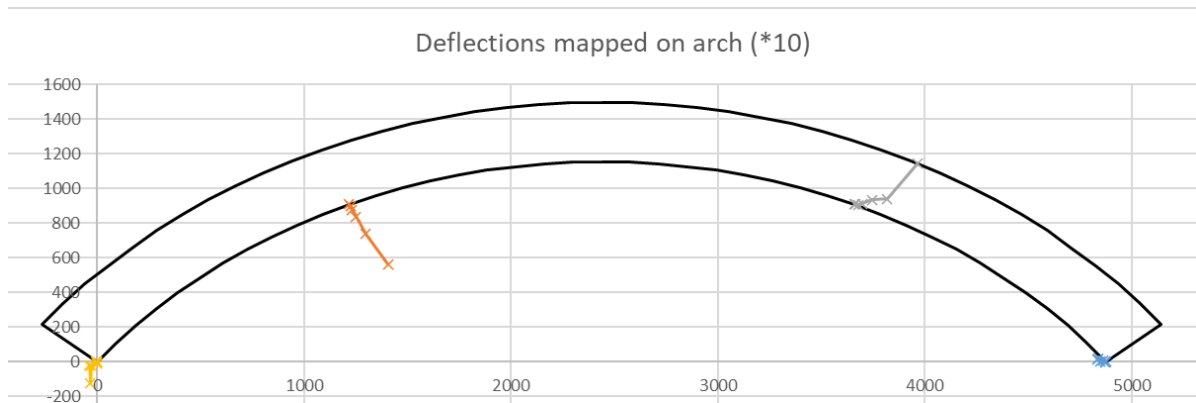
As a final contribution I would add a map of deflections against position showing how the bridge as a whole deforms.

Note that the abutment movements are very small. The abutment under the load settles noticeably (12.3mm) under the maximum load but recovers to only 2mm deflection once the load is removed. The fact that the load point deflection to the right (left in the photographs) increases as the load increases indicates that the points being measured are to the right (mid span side) of the crack.

The measured point away from the load was positioned on the assumption that the arch was just an arch and would form a four-hinge mechanism at failure. In the event, this point pushed largely to the right until the peak load was passed and then lifted considerably, 20mm compared to the 17mm drop at the load point.

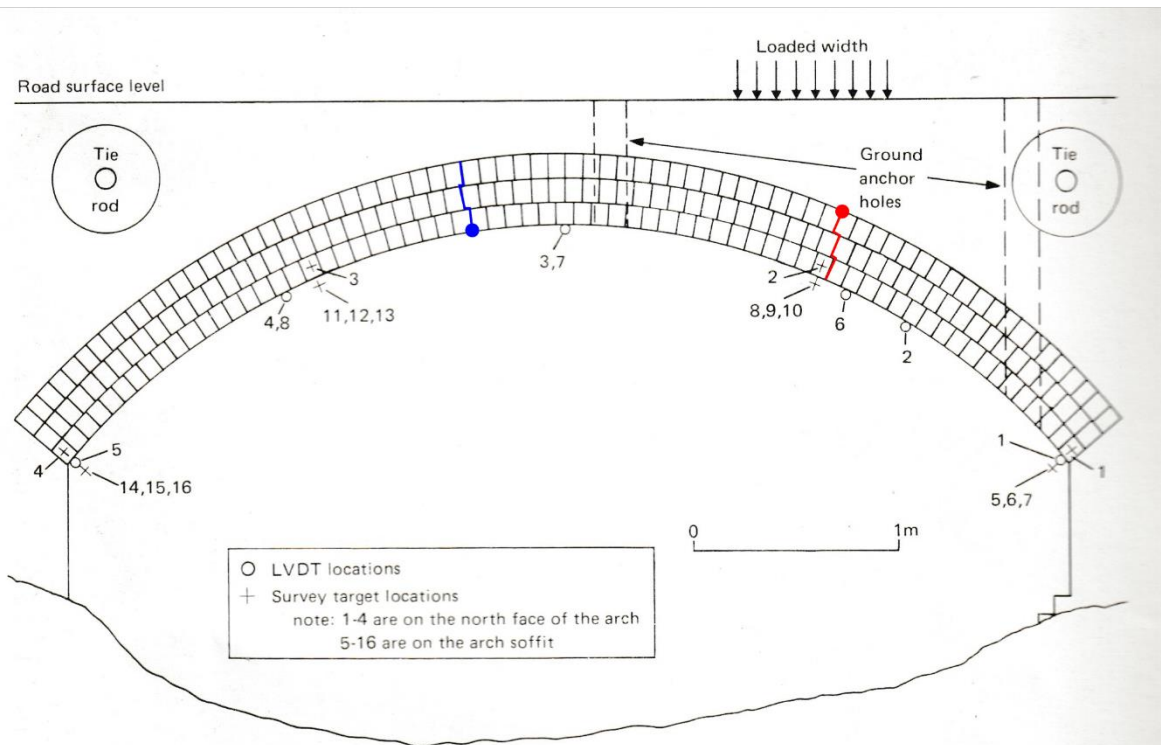
This was the fifth such test carried out in the series, the third done entirely by TRL. Below I show the drawing of the test layout and my interpretation of hinge positions.

Note how close to the abutment face the near ground anchor is. This makes it quite surprising that the abutment went down under load. The red line is the falling hinge with a dot at the end that remains in contact. The blue line is the rising hinge. The rising hinge might be closer to the crown, the falling hinge is unlikely to be closer to the abutment but the large horizontal movement in the gauge points suggest that they are on the crown side of the crack. The right-hand fixed hinge on the intrados might have been located close to the bore holes for the ground anchors. The left-hand fixed hinge might be close to the top of the backing but the fact that gauges 11, 12 and 13 show distinctly upward movement, it must be closer to the end than that by some margin, perhaps at the closest point to the tie rod.

This diagram doesn't show the arch backing. Even if we assume the arch is the critical structural element, backing is significantly stiffer than soil and will have a marked effect on behaviour. Backing is mentioned in the report, but at no point is then level or nature of construction noted.
