Bridge of the Month 141, Sept. 2022 Kennet and Avon Canal, Bridge 175

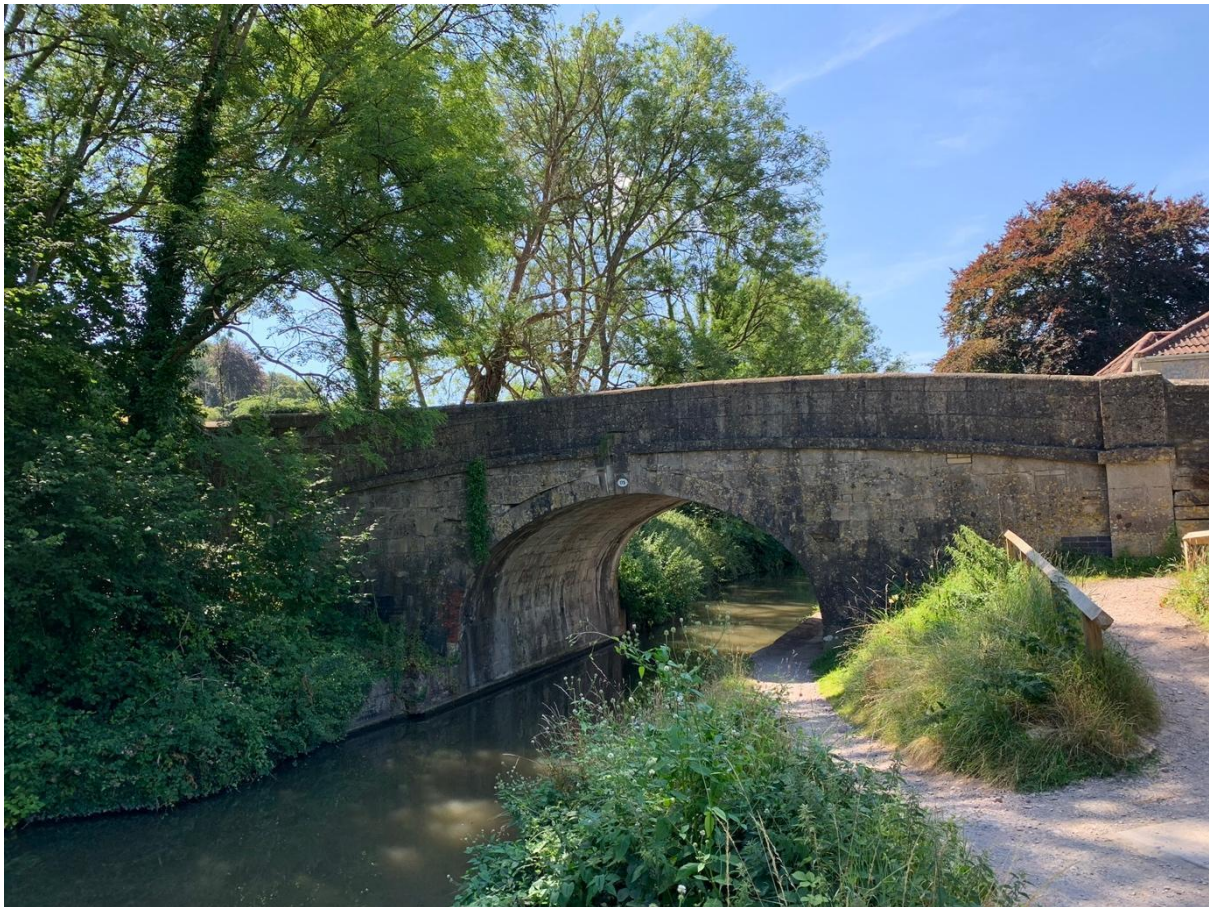
Bridge 175 is [here](#). This simple little bridge is typical of John Rennie's efforts. A slightly closer look is worthwhile.

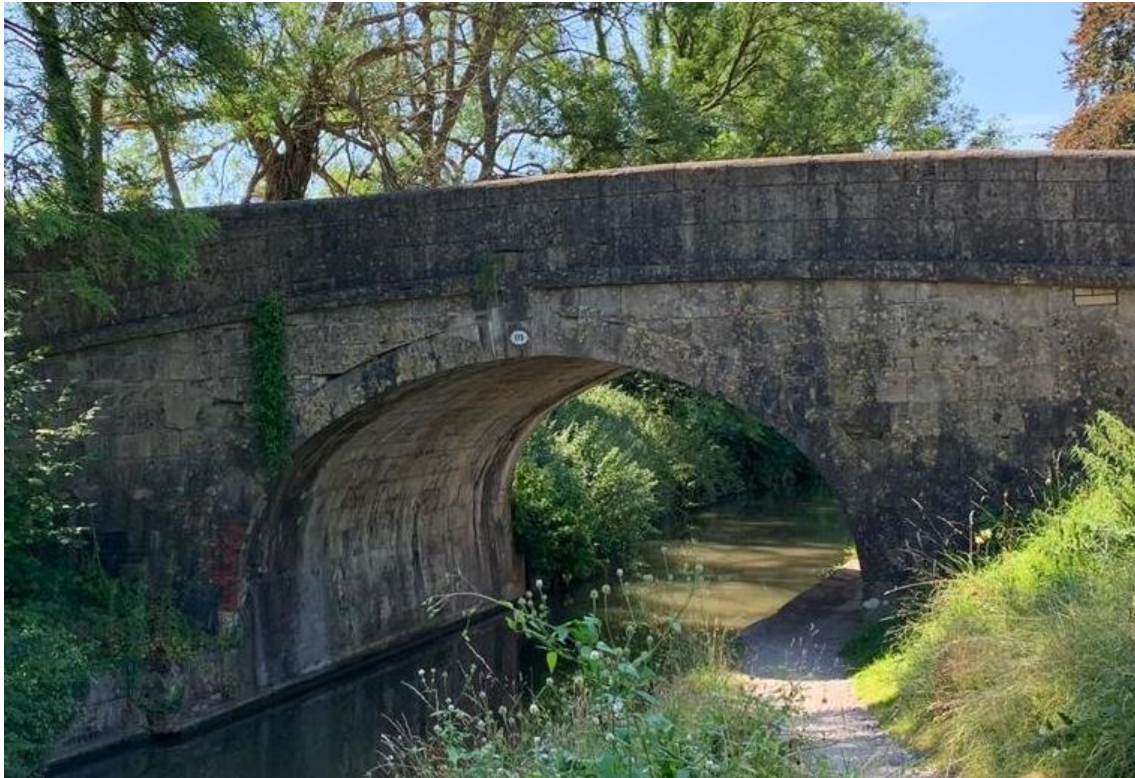
The bridge is of ashlar throughout. The arch is three centred to provide headroom, at one side for the horses and at the other for the barges.

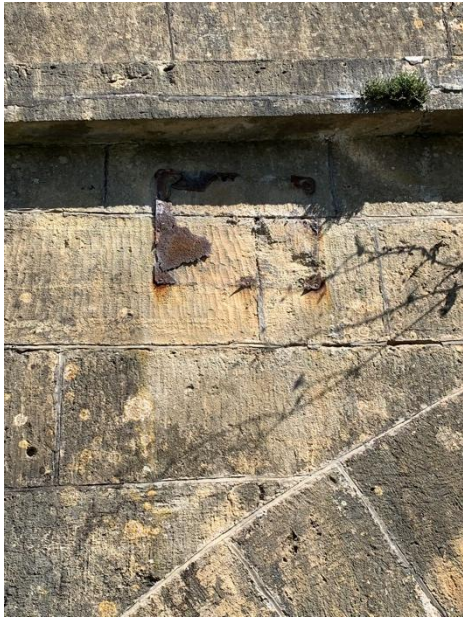
That looks awfully like cement mortar re-pointing. If so, it will cause untold damage in the coming years.

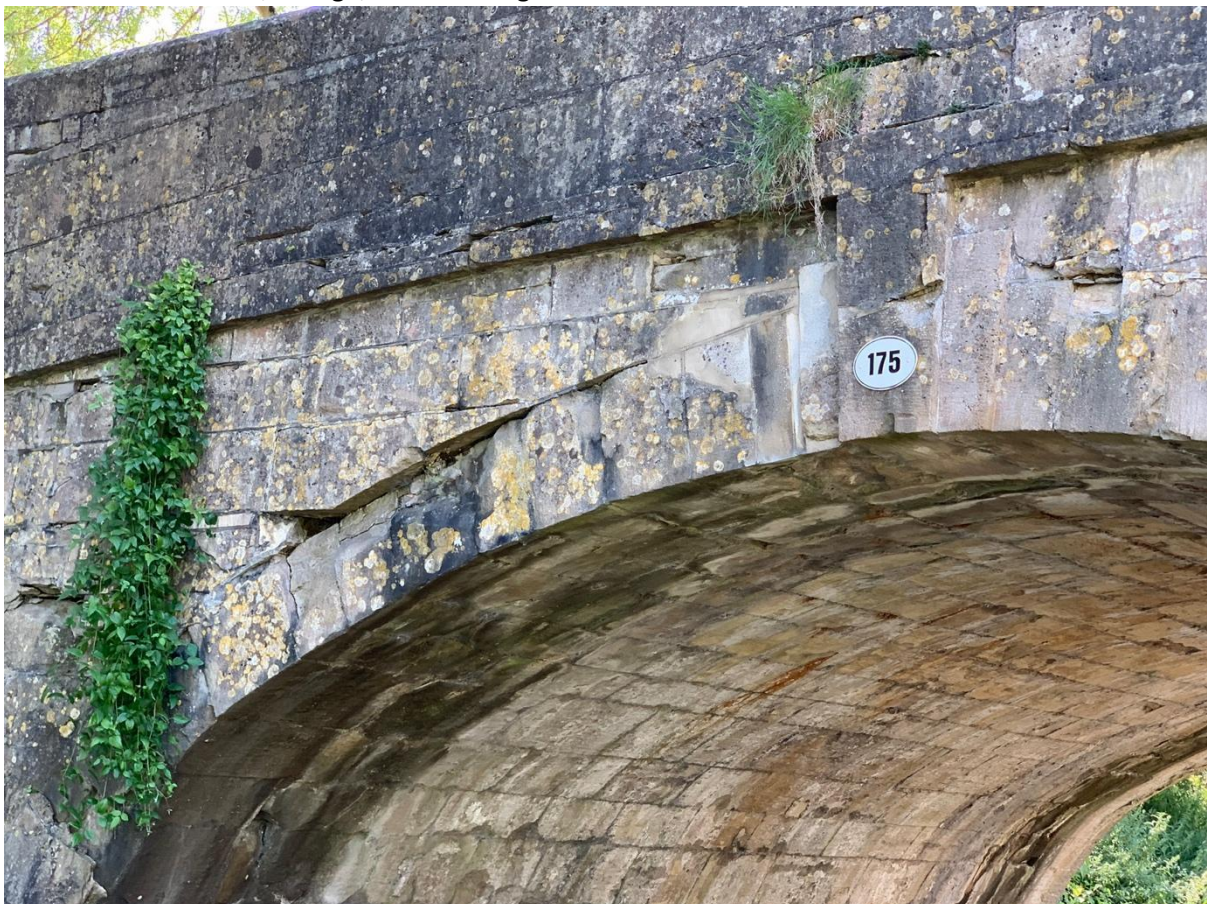
The real interest here, though, is this damage.

What I think has happened is that the right hand (tow path) side abutment and the arch has been forced to articulate at the top of the backing, flaking the edge off the arch. To be certain, a more

detailed survey would be needed. The most important lesson, though, is that the root cause of the damage is many metres away from where it has manifested.
