We stop as frequently as opportunity allows with friends in Walkley, Sheffield. While there, I have enjoyed several walks in the Rivelin Valley, a lovely woodland valley packed with industrial archaeology, very close to the city.

Rob, out on a walk recently, took this photo and sent it to me with the comment, “Even I can spot the defect here.”

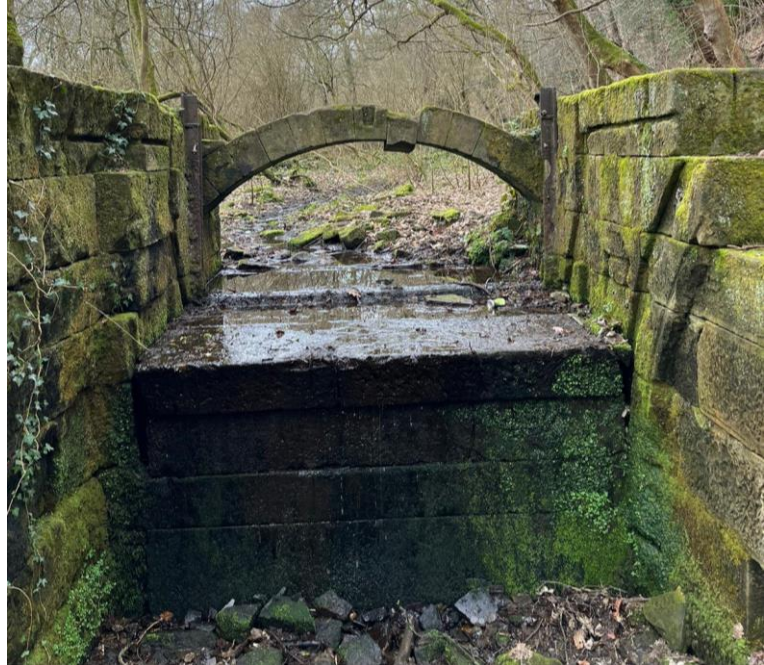
As odd as this is, it is obviously also fine. It’s a defect, and in a general sense could be regarded as *damage*, but it is not damage in a structural sense, and as far

as I can see there is no sign of distress (related or otherwise). These distinctions were [highlighted by Patrick Sparks in a twitter thread](#) last summer.

The question that sprang to my mind was: *how?* What set of circumstances allowed or caused a single stone to drop relative to the remaining arch on either side?

The real question was *how*? The movement here is a bit like taking a tower of blocks, and displacing a single block in the pile, while those below *and above* remain in place. Like Jenga, but with a single piece at each layer.

If you wanted to do that, your options are to hold the blocks above and below back as you push, or to tap the piece you want to move very sharply, so you overcome static friction and get some movement, then stop before the blocks above start travelling with you.

Now exactly this was probably done sometimes when building arches with dressed stone voussoirs, with the classic oversize keystone being tamped in. Dropping a heavy weight on the top of the stone would drive it in. Doing so would very slightly lengthen the arch, lifting its weight off the centring. But this isn't the crown voussoir, and isn't oversize, and I think we can dismiss the possibility that it was intentional.

I don't know how likely flooding is to pass this way, off the main river as it is. Perhaps more so after abandonment but before use of the valley for recreation took off. A flood would lead to some buoyancy, but water alone certainly wouldn't remove all thrust from the arch to allow a stone to drop. Debris forced underneath the arch would be more likely to result in displacement at one joint, or perhaps an upward movement of a stone.

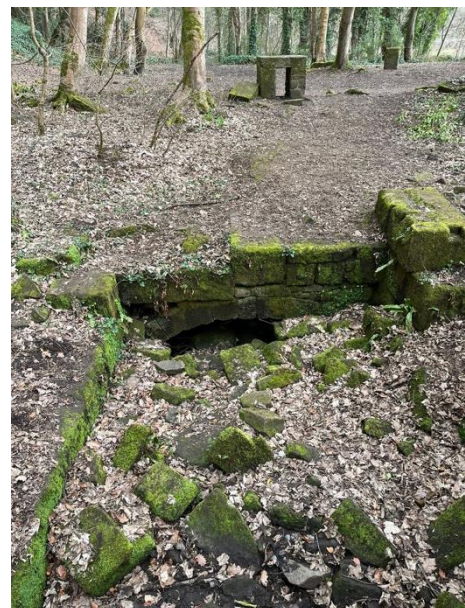
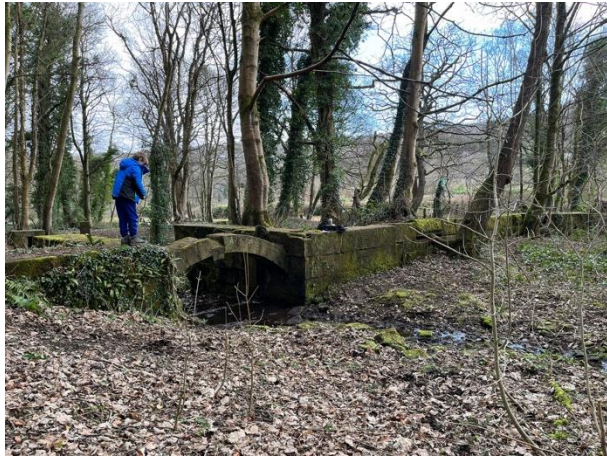
The photo of Sam with string above shows the silted-up pond that fed the wheel. The original shot shows a drop into the wheel pit, now also part filled. Right, we are looking downstream, at the filled wheel pit and, just visible, the entrance to the tunnel that carries the flow back to the natural river. The valley is a seemingly endless series of these diversions and returns. Look around on the 1850s map and see the number of wheels marked.

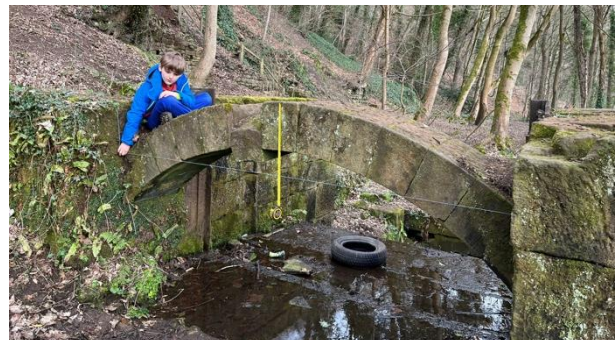
I asked some questions, and – for no particular reason but interest – for an estimate of span, width, and depth. Rob and Sam kindly made a project of it, and went out again, armed with some string and a tape measure, and took some additional photos. Here, Sam is getting set up for a rise measurement, waiting for his assistant to get back from taking a photograph.

Sam is of a mathematical temperament, and I asked Rob to see if he could think of a way of measuring the rise. He suggested measuring up from the ground at the springing and crown (not using those words, I'm sure). Not bad. Some further discussion highlighted the challenge of uneven ground, and the alternative of measuring from a string line was developed.

The dimensions they came back with were 2800mm span, 455mm rise, 300mm ring thickness. The dropped stone is about 90mm low, with a possible slight difference in offset on either side. (I couldn't stop myself questioning whether the rise could be measured to the nearest 5mm, because what are friends for.)

Those dimensions are interesting. In old money, as Bill would have said, rise and ring thickness are 1.5ft and 1ft, which are very plausible. But the span at 9.19ft seems a bit long. 9ft span, 1.5ft rise gives a neat 6:1 span:rise ratio and an equally neat 7.5ft radius. Very likely. The extra couple of inches in the span could probably be explained away: a bit of tape sag, the abutments have relaxed slightly, some measurement uncertainty.

That's not quite the end of the story, because the photo shows the measurement being taken at the accessible extrados, where we would expect to see a lower rise than at the intrados. I think the difference may be nearly 100mm. Could that low stone lift the arch enough to cancel that out? I suspect not but I ... must ... resist ... getting further into the geometry of this right now.

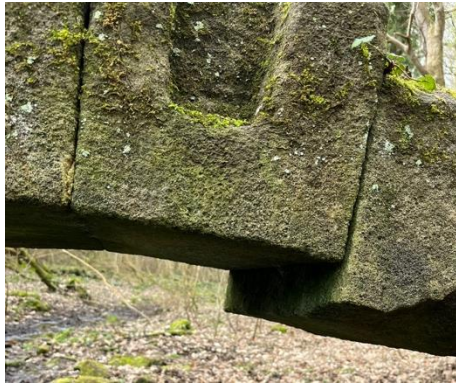
Looking again at the previous photo: there was no real need for a bridge as such at this location, it was not a long walk round to cross below the wheel pit over this tunnel. I didn't notice when I received the first photo, but there is a carved notch in the stone at the crown, clearly carved out to receive something. It's clearer in the photo to the left, which was taken to show the offset across the full width. The arch, with its notch, are evidently part of the flow control for the wheel. Perhaps the works was able to transfer load from water

onto the arch in some unusual way, letting the stone drop.
