Bridge of the Month 147, March 2023

Old Bridge, Bridgend

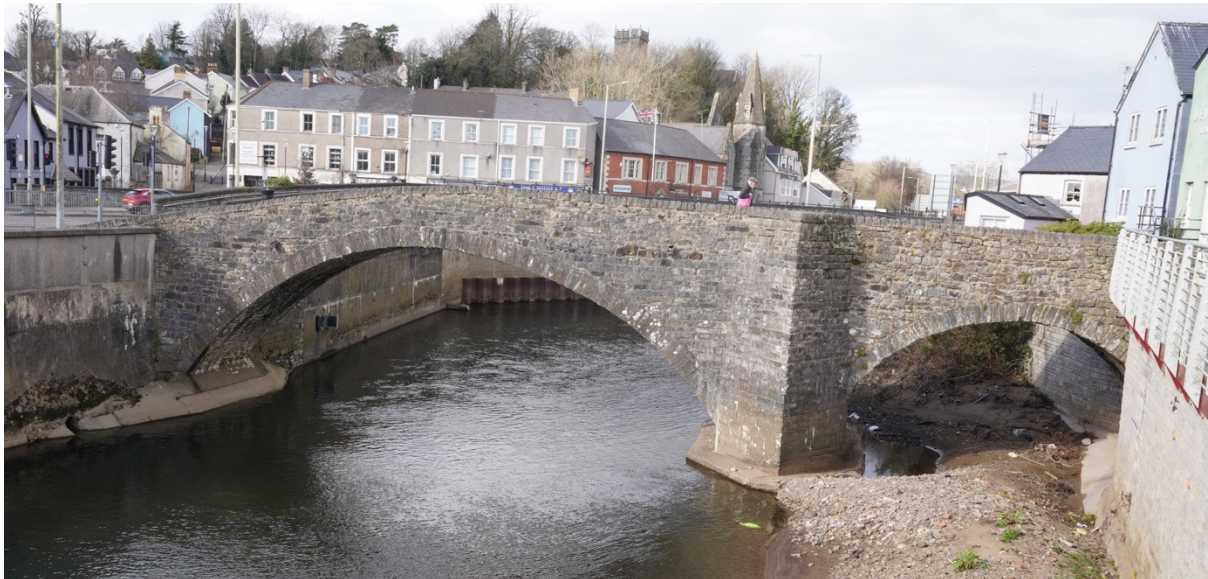
It is immediately obvious from the photo above that the two visible spans are unequal. My first thought was that two spans were replaced with one, and indeed it seems that a flood took the pier out in 1775, and this was presumably the trigger for the 18th century work.

The construction of the two spans differs enough to suggest that the smaller span was not rebuilt at the same time as the large, but whether it is of 15th century vintage I wouldn't like to say.

The small span is slightly distorted, with a flattening over the crown and a bulge to the right, away from the large span.

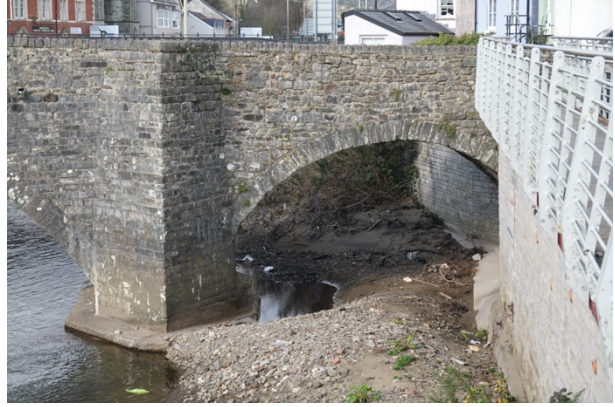
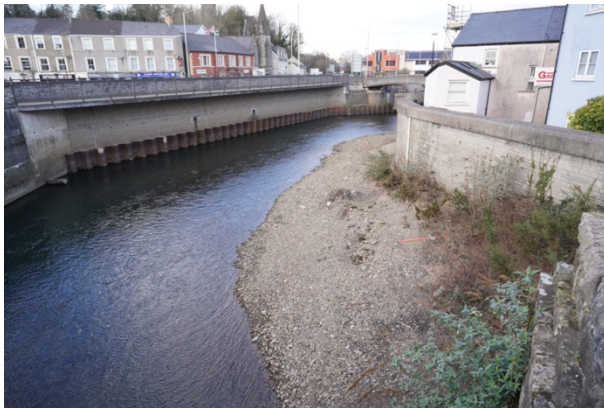
The metal fence in this photo is part of a cantilevered walkway along the river bank, necessary because buildings and private yards come right up to the river wall.

Note the silt and gravel (and general detritus) under the smaller span. If we look upriver, we can see the reason for that. We have expensive looking hard engineering works, holding the course of a river that wants to move. It can't get past the sheet piles, but it can still dig down on that side and dump material on the inside of the bend.

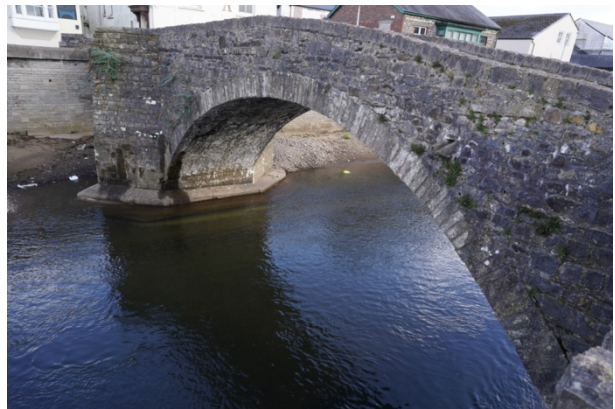
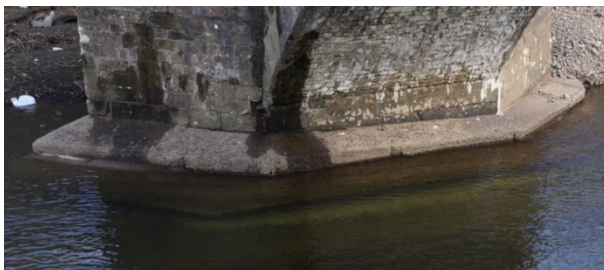
Close examination of this view from upstream, like that above from downstream, shows a patchwork of masonry, suggesting some degree of rebuilding.

The concrete skirt at the base of the pier isn't level. How did that come about? It rather looks as if the base of the concrete might be visible with clear space between here and the current river bed.

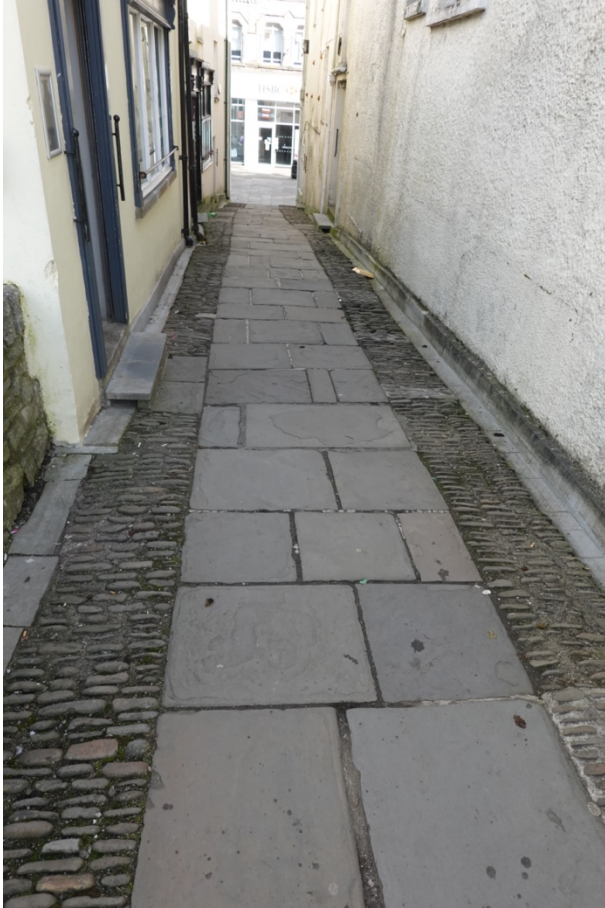
Looking to the east, an uneven walkway takes us back out to the street. Under here lies the main novelty in this bridge – the buildings either side were built hard against the bridge elevations, hiding further spans from view.
