## Bridge of the Month 150, June 2023

### Monastery Katholiko, Crete

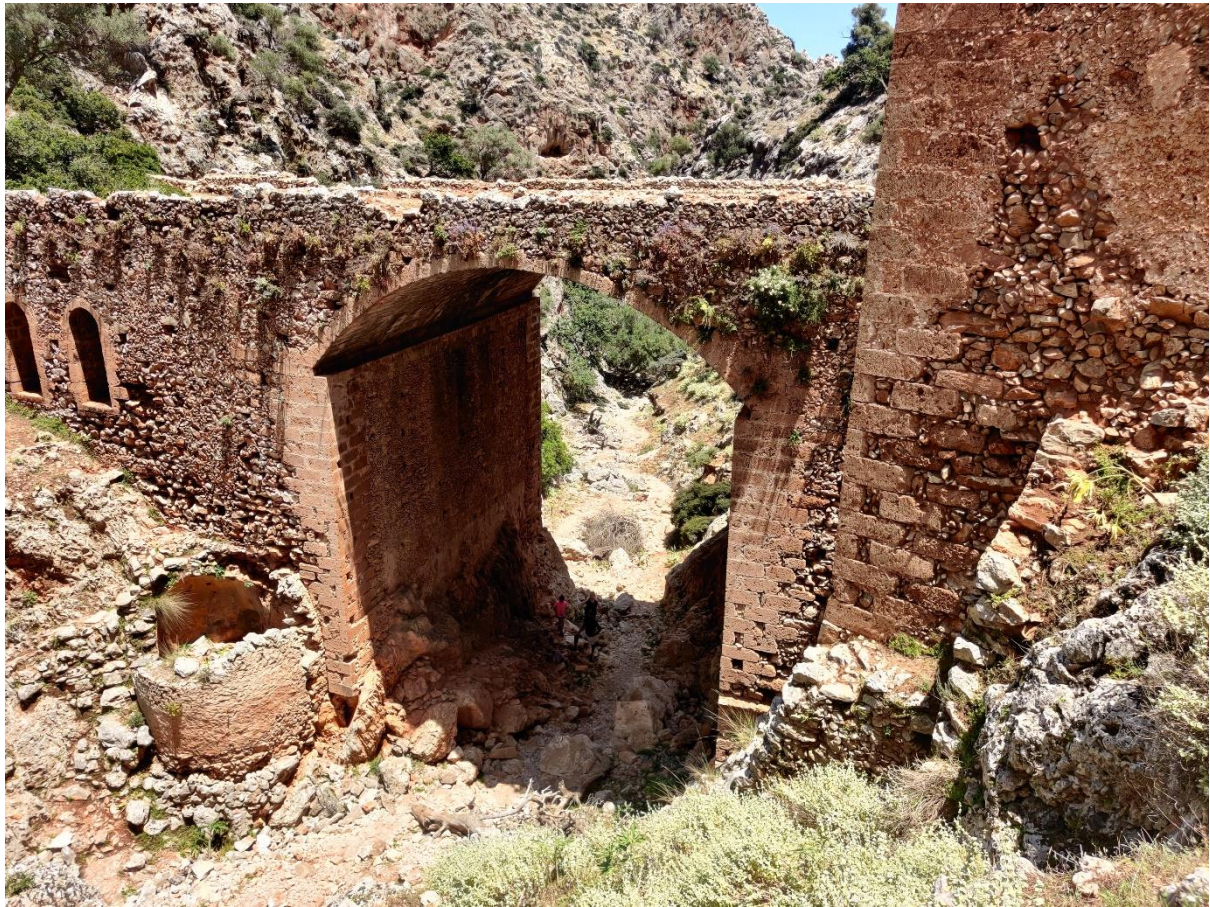
Diminutive people in the next photograph give an indication of the scale. These photographs are from my phone, and really don't stand enlargement. Note the evidence top right of render.

The right abutment in the photo above begins as a skin over the rock of the gorge, and springs from that rock. The way in which the irregular surface was accommodated is delightful. Where there is no solid platform to build on, we arch over.

Look closely at the corner to the right of the arch, and not one but two springers are visible for now-missing arches off to the right. The upper of those is highlighted by the sun in the photo above.

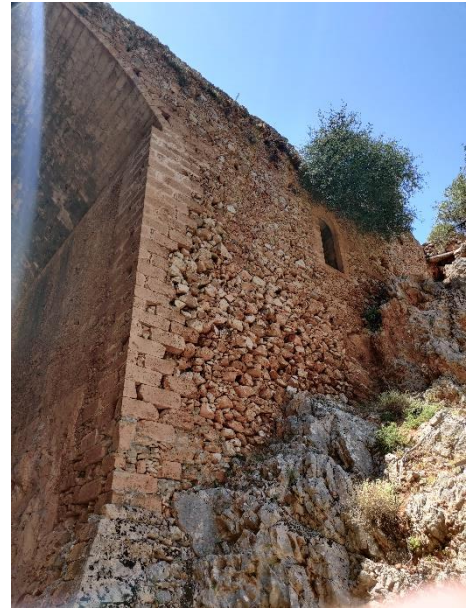
There is little sign of recent maintenance, except this odd superficial daubing with cement mortar (left).

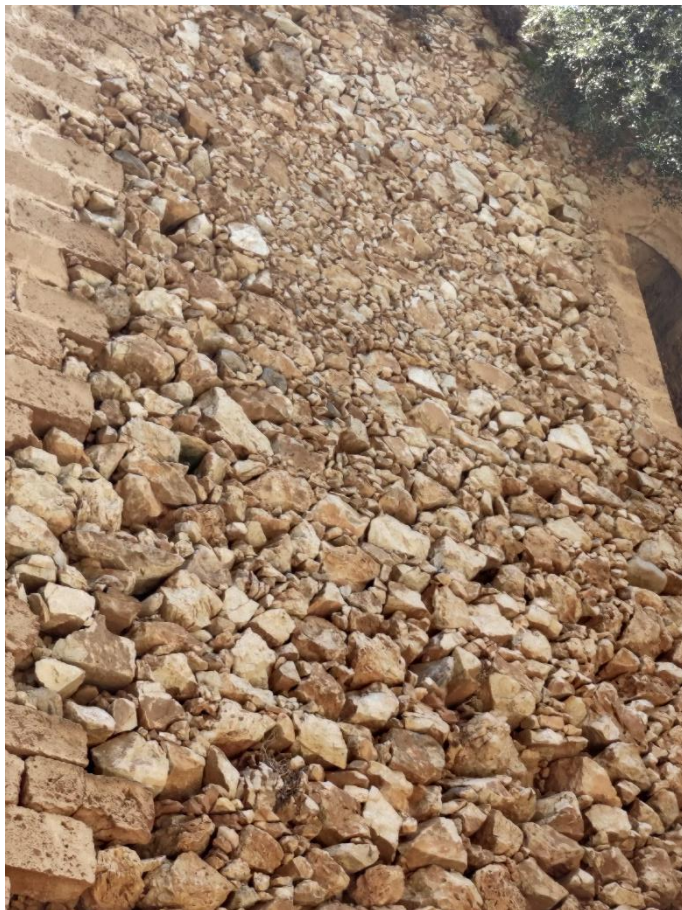
The wingwall (right) shows the construction well; unshaped stones away from the corners.

That is worth a closer view. There are a lot of walls around Chania not unlike this. The gaps were once filled, the surface smooth, the wall protected from gravity and the elements. Where that is not maintained, the stones are at risk. That this has survived as well is a testament to the builders' skill.

The big voids in the lower half of the wall were presumably filled with shards, still present higher up.

Notice the opening in the wall; the abutments are, of course, not full of hard to move material, but contain rather serviceable rooms.
