Bill Harvey Bill Harvey Associates Ltd and OBVIS Ltd
Telford's bridge over the Severn at Over, Gloucester.

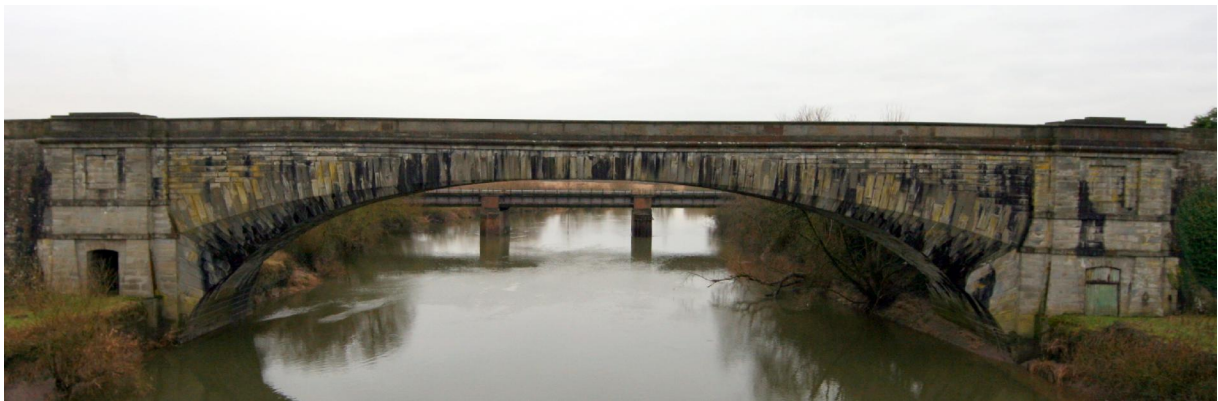
There is a story that one abutment of this bridge moved dramatically when it was decentred, requiring a lot of expensive remedial work. Even in this wide angle shot the sag is visible so it seems likely that the story is true, but where did I see it. I had it down for Ted Ruddock's book (Arch Bridges and their Builders 1735 to 1835) but it is not there so I will need to turn to Rolt, I think. And then I found Telford's own account which says not so... Anyway, the bridge is at: <http://bit.ly/OverBridge>.

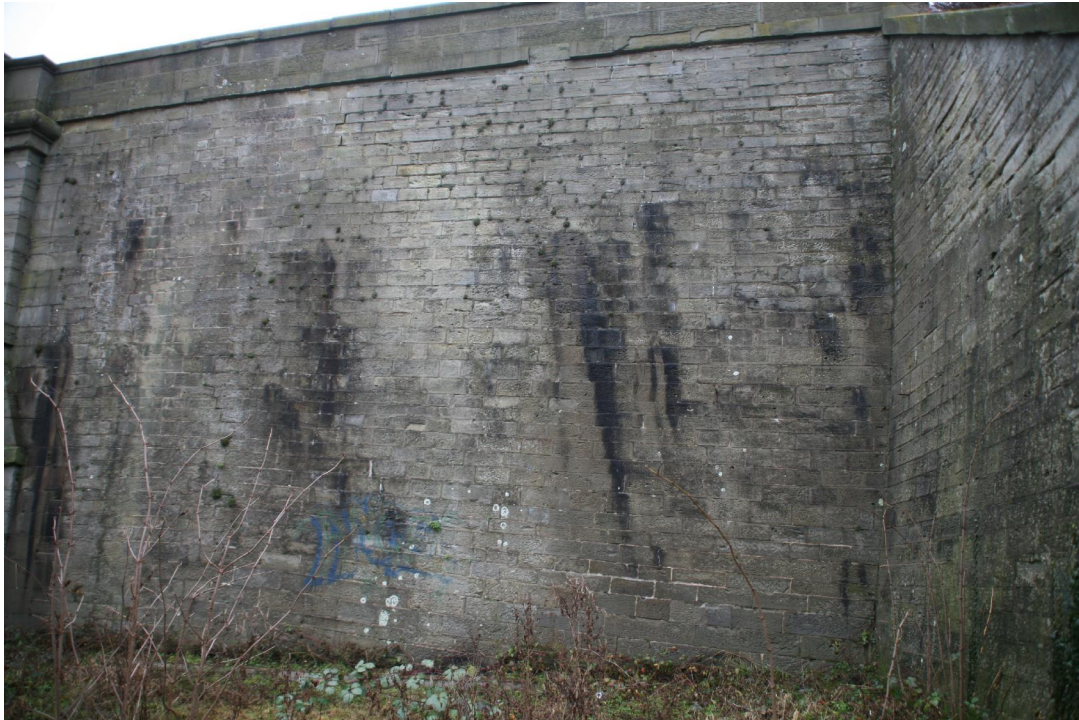
It is recorded that the crown of the arch dropped 10" (250mm) on decentring. Telford declared this to be a result of penny pinching on the abutments and the evidence of movement there is very obvious. The picture below shows the downstream, left hand wing wall which has sunk considerably and been made up to level in several tapered layers, especially at the top.

The core of this bridge is hollow, like the Dean Bridge in Edinburgh built a few years later, or the rather earlier Dunkeld bridge. There would, however, have been a solid masonry backing perhaps to the level of the second radius change from the end. Any settlement due to abutment spread would then be concentrated in the length between these points. The photograph along the parapet line suggest that is the case.

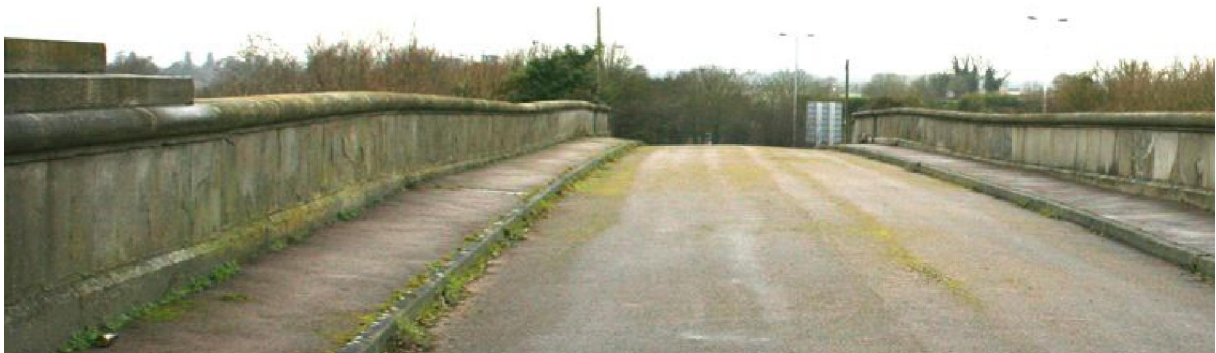
When the centering was removed, and the whole weight of the arch left to press against the abutments, its crown sunk about two inches, and afterwards, from the before-mentioned receding of the eastern wing-walls, the arch suffered a further depression of eight inches, making, in the whole, 10 inches. The arches of the Neuilly Bridge, of only 128 English feet, sunk 13 inches when the centering was lowered, and afterwards 10 $\frac{1}{2}$ inches more, making 23 $\frac{1}{2}$ inches; and that the sinking of Gloucester arch of 150 feet span took place from the pressure upon the upper part of the eastern abutment, when deprived of the resistance of the wing-walls, is evident from the front not having sunk, and the courses of the stone feeing towards the river remaining quite level. On the western side of the river, the abutment and walls, being upon firmer ground, remain unmoved.

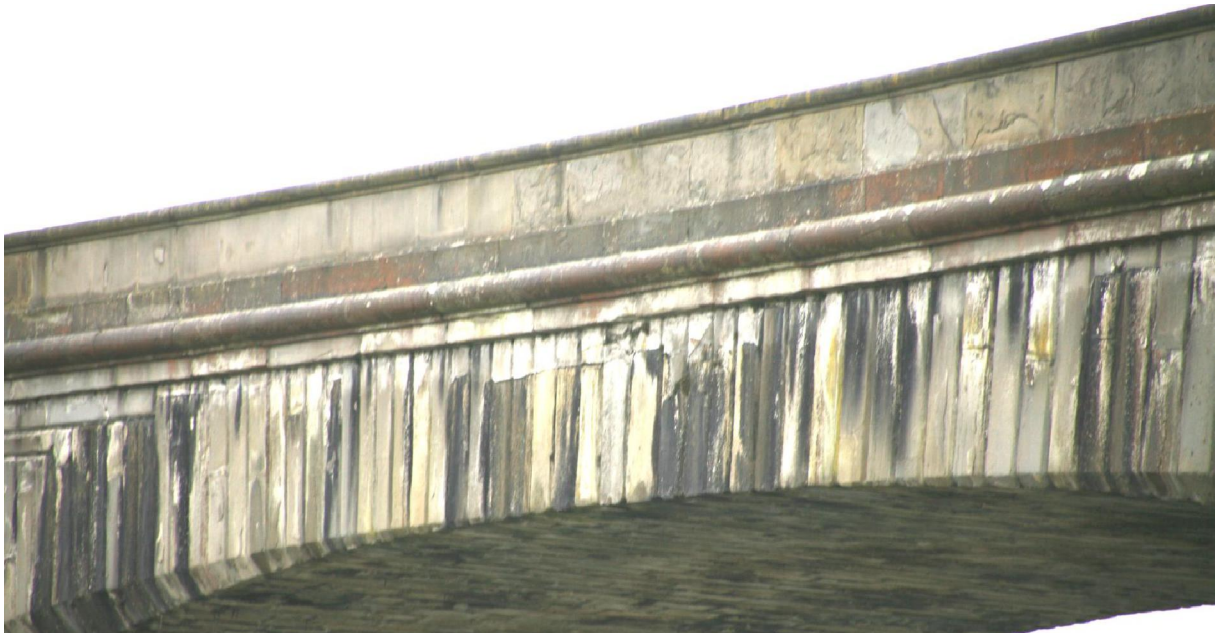
This picture suggests rather more than 250mm sag. As does the elevation on page 1.

A close look at the arch near the crown shows longitudinal splitting of the voussoirs. This is the result of a high concentration of compressive stress along a long run of the extrados. The arch, as the abutment spread, tended to open at every joint. The top edge then tended to

Here we can see how the thrust runs along the top edge of the arch for some considerable distance. This means that there is little out of balance moment across the width of a voussoir and the arch will bend by small cracks in each joint rather than one big one in the centre. As you can see in the photograph, the split in the voussoirs near mid span corresponds closely to the area where the thrust line runs parallel to the extrados.

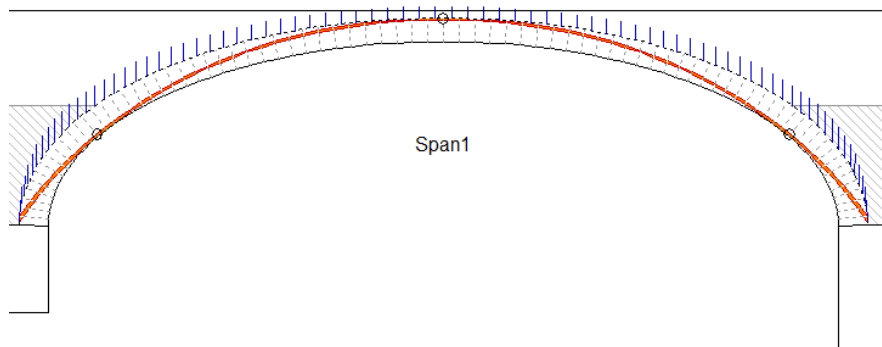
become close to uniformly stressed (plastic stress levels) with zero stress below and the voussoirs split along the division. The thrust picture from Archie, below, shows
