Bill Harvey Bill Harvey Associates Ltd and OBVIS Ltd

Calva bridge is both magnificent and common in that it is a typical mid 19th century structure. That is to say it is a thoroughly engineered construction. The interest here lies in the fact that its foundations were severely damaged by floods in November 2010. This note is chiefly about how it stood up until the engineers concerned were able to mobilise the effort to repair it. I will say nothing about those repairs because that is for others to describe. I hope they will bring forward a paper on the work.

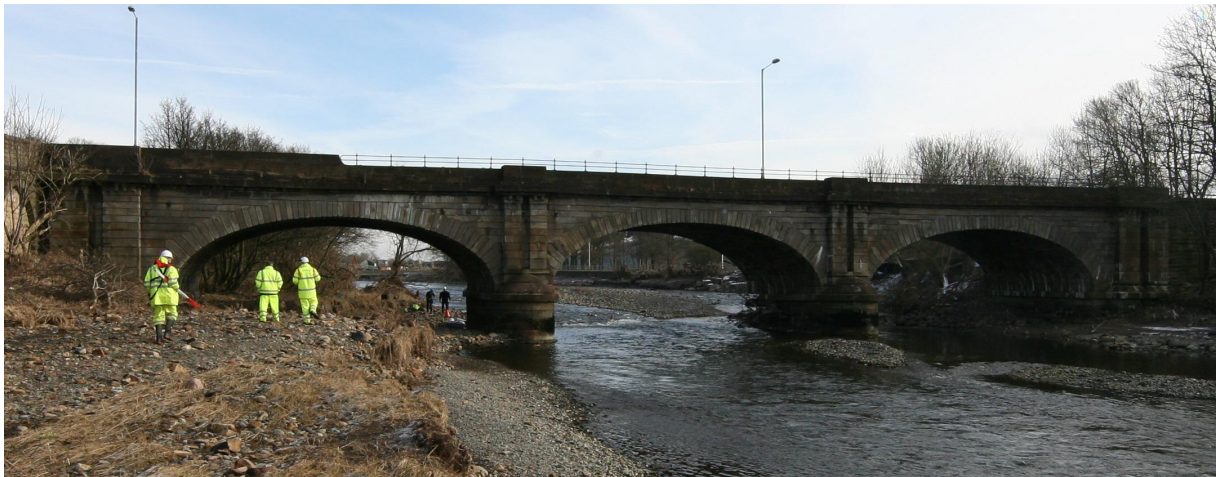
Here we see a very elegant structure of 3 spans each 48ft. The rise is almost certainly originally 12ft, though a little less now and the shape three centred which means the central radius is 48ft and the ends 9ft. In modern money that is 14.63m span, 3.66m rise and 2.74m end radius. To put this arch into Archie, use the three centred model and set the quarter span rise to 0.218x the span.

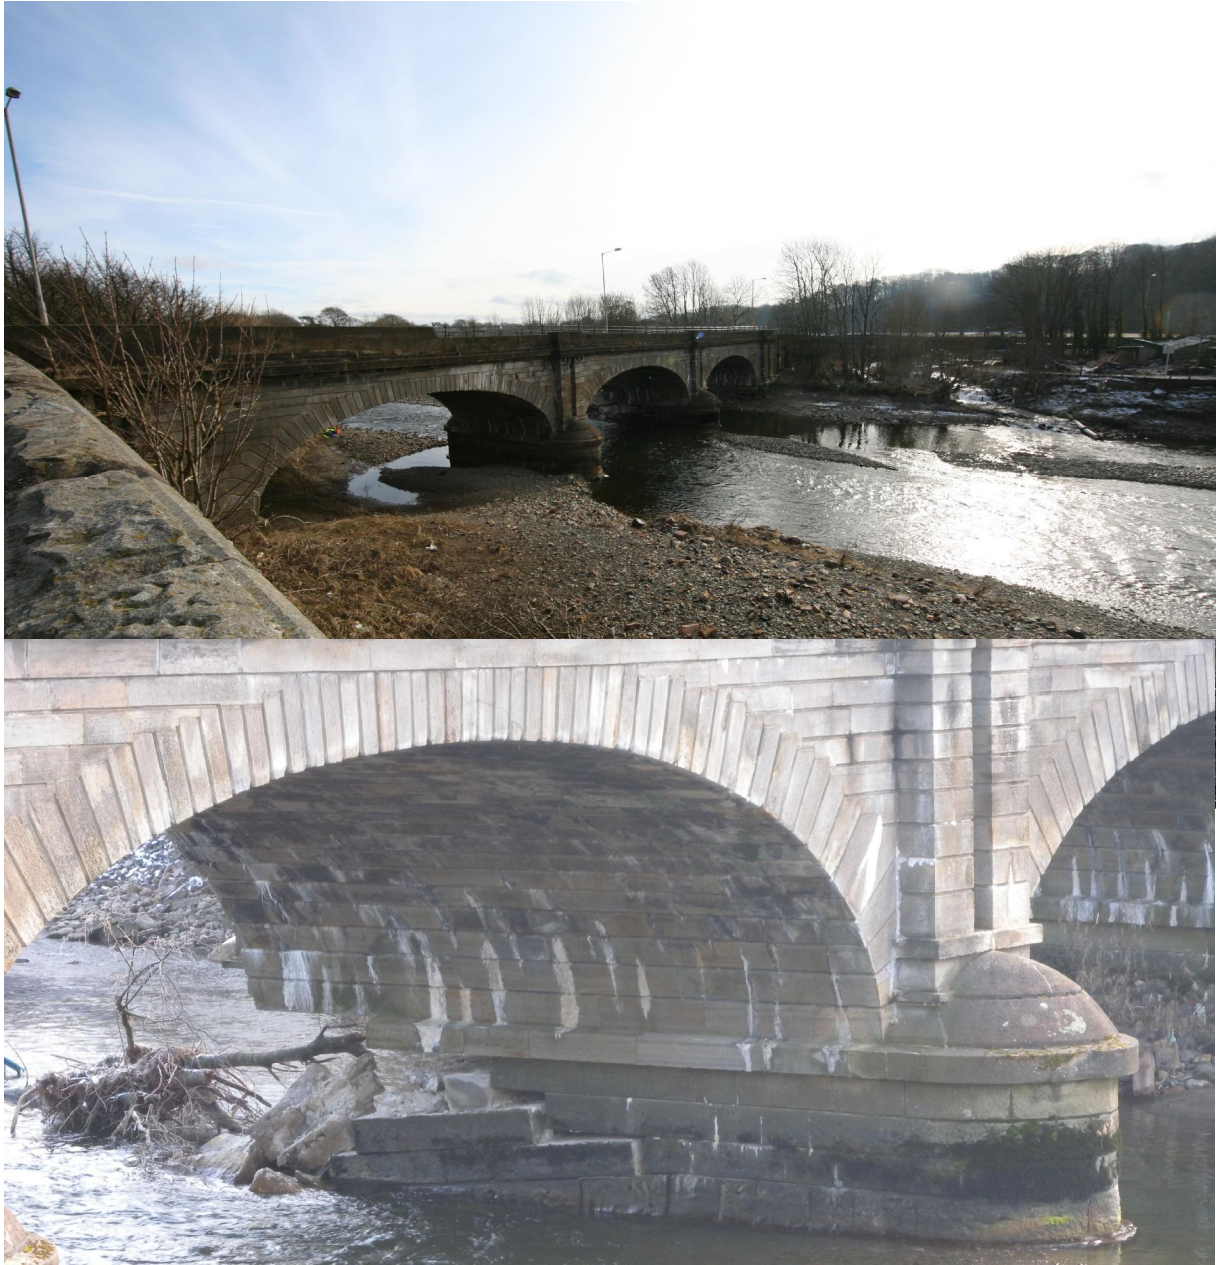
Here is a general view from the downstream side of the bridge with an inset showing the loss of support from the upstream end of the further pier. Look closely and you can also see a drop in the string course over that pier.

During the flood the water reached nearly to the crown of the arch, but it was almost certainly not the general flow that caused the trouble, but rather the cross flow caused by the river trying to change its channel slightly.

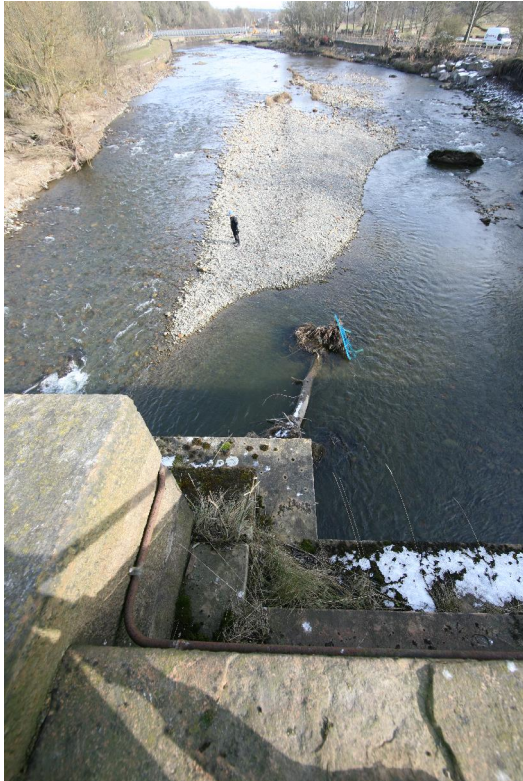
Here we can see erosion on the left bank of the river (to the right as it is flowing towards us). So the river came round the bend in the background swept across to the left bank and bouncing off that cut diagonally across the upstream end of the pier as can be seen by the river bed deposits here. The water flowed from right to left of the picture as the flow comes towards us.

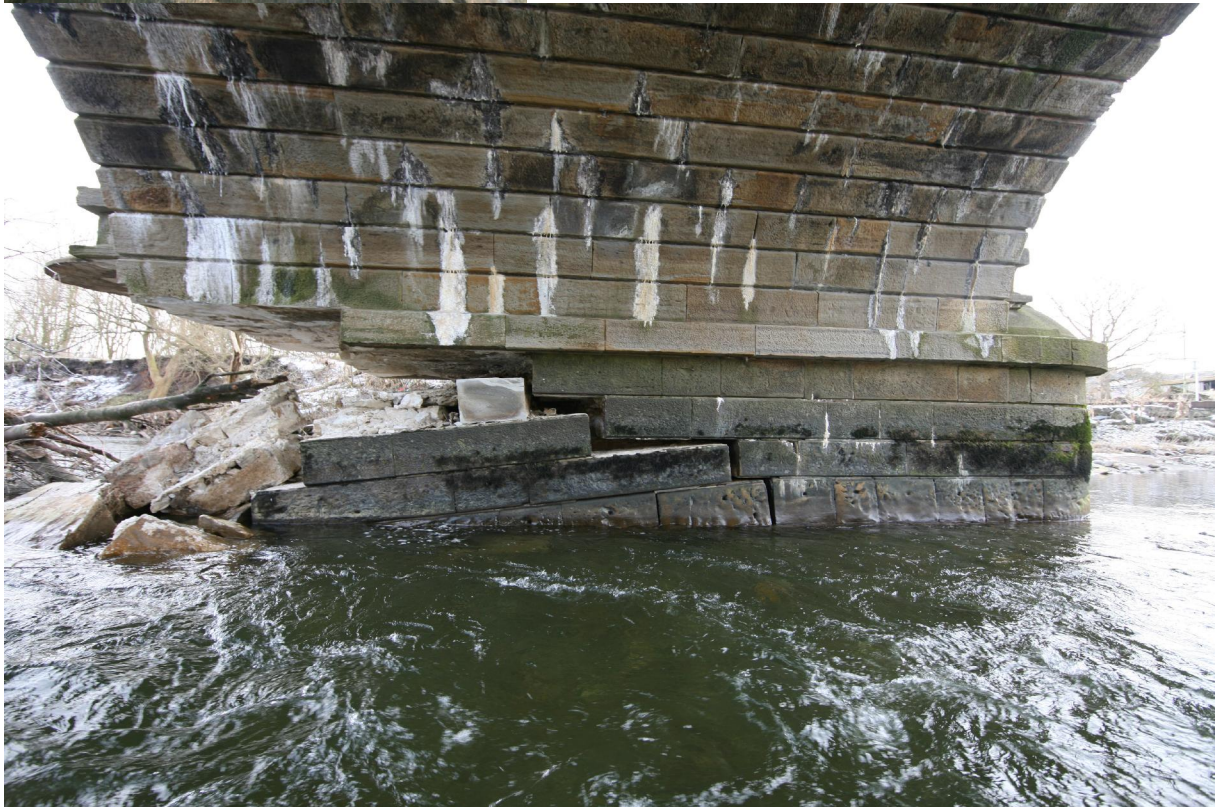
So much for the causes. Now to the extent of the damage. The river scoured away its bed from the upstream end of the pier until the bridge was supported on just the downstream end.

Below is the most spectacular view showing the the bottom of the upstream end dropping into the scour hole. I estimate that only about 1/4 of the support remains.

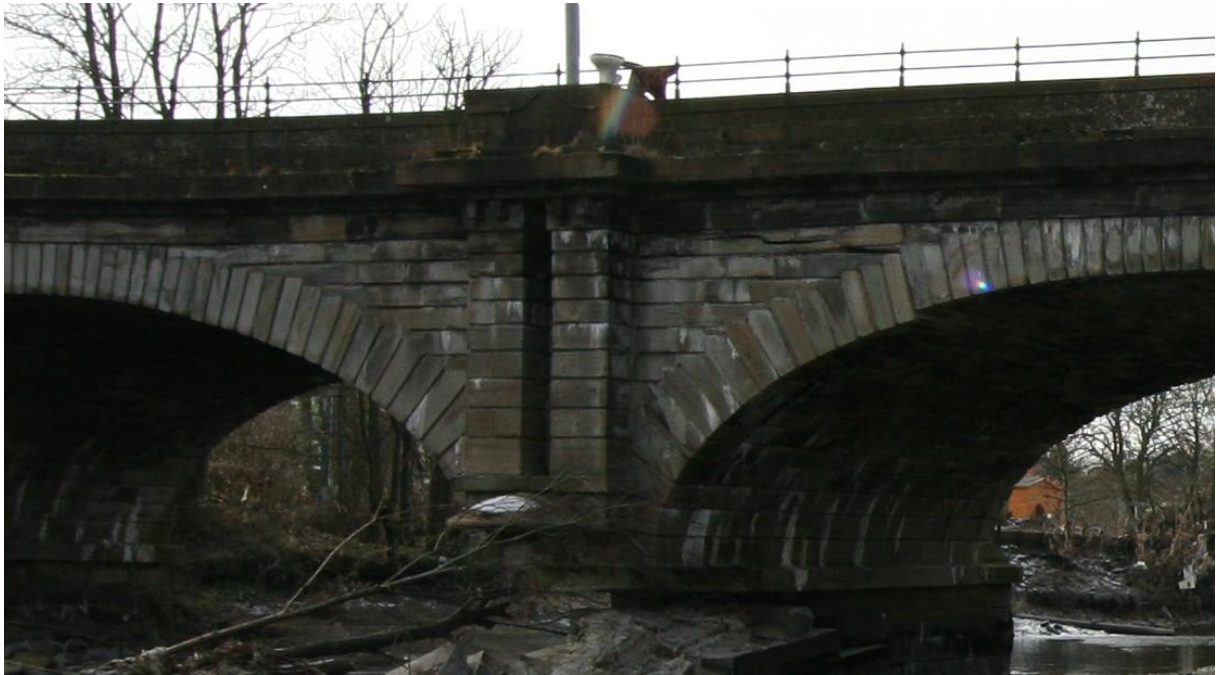
Looking from the upstream side of the bridge it is obvious that there is damage to the arch as well as to the pier the horizontal split shows the near surface region of the road and the parapet spanning across two spans while the pier section is dropping away below. It seems that this arching action is also contributing considerably to the support of the central section of the right hand arch.

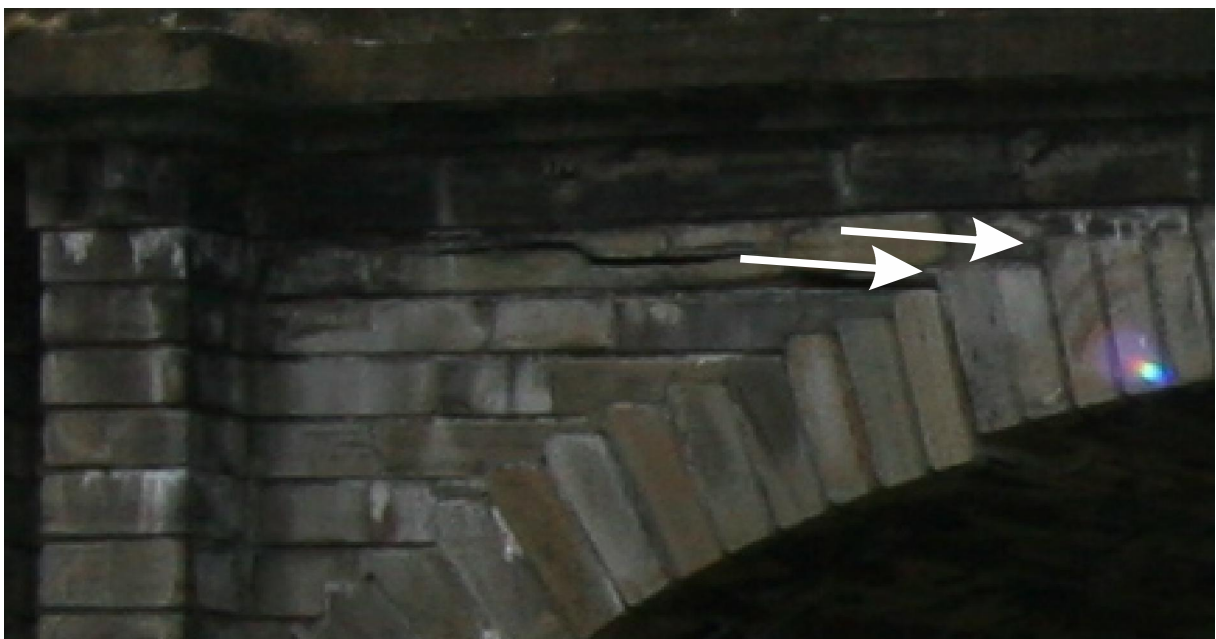
The enlarged view below shows how thrust from the upper elements can be brought to bear on the otherwise unsupported end of the main span section. The point at which the arch has split is a good indication of the extent of solid backing in the arch.

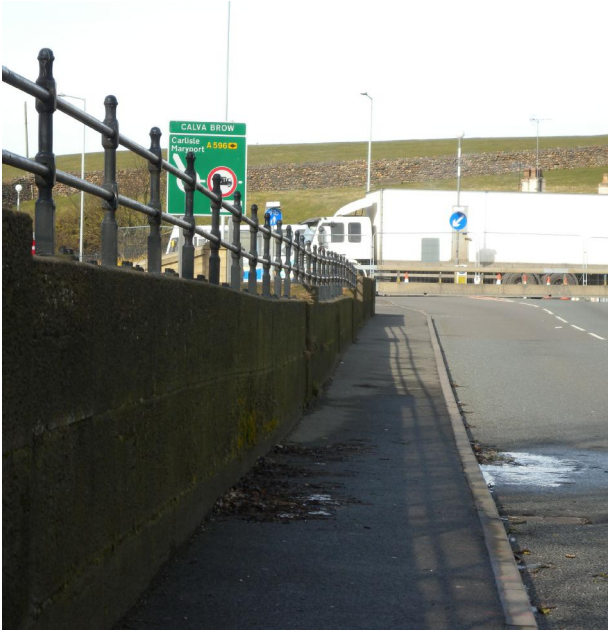
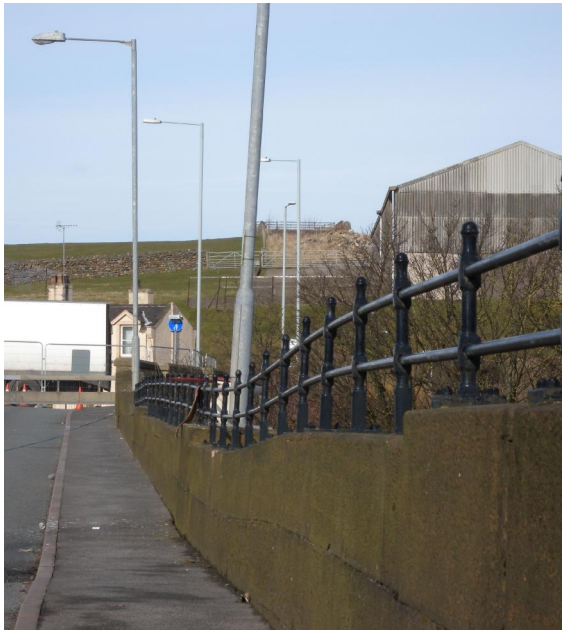
The two pictures below show the parapet lines. Upstream is to the right. The lean on the lamppost, directly over the pier is an indication of the movement that has taken place, but the drop is also evident in the parapet line. Much greater at the upstream side than downstream.

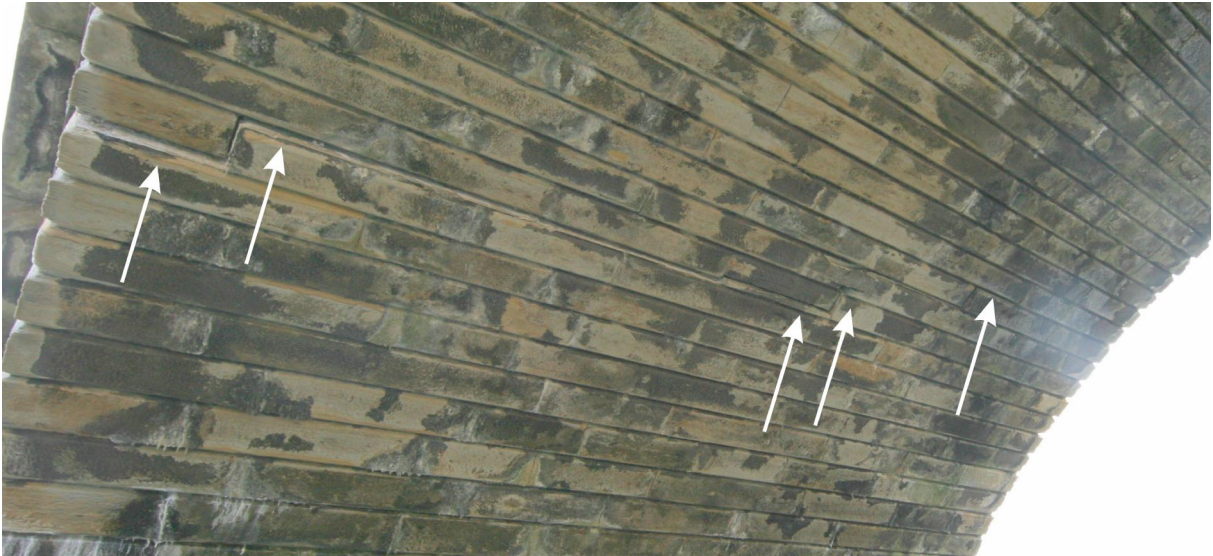
The picture below shows how the split extends across the arch soffit, tapering away to nothing, both in terms of opening and rotation about 1m from the downstream edge

Here we begin to see how the arch holds together and where the forces are transmitted.

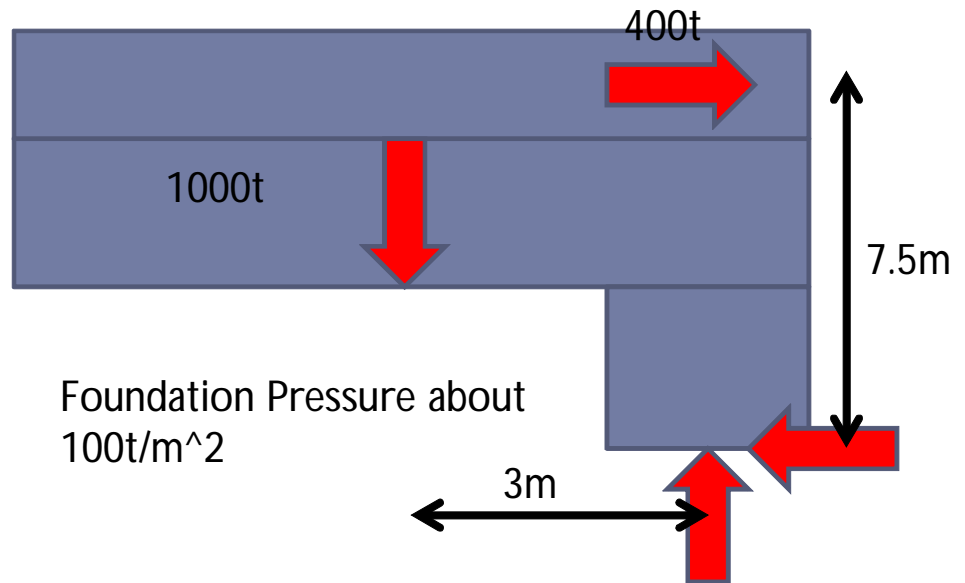
The vertical load on the pier is about 1000 tonnes. It is in the centre of the 30ft (9.14m) width and the only available vertical support is in the centre of the 25% of arch remaining so little more than 1m from the downstream edge. These two forces thus generate a couple of 1000 x say 3m or 3000 tonne metres. The bridge is standing, so it has found something to supply this missing moment. Shear on the river bed can provide one force but the second can only come from the deck arching in plan over three spans.

Here is a view of the cross section showing the forces applied and reactions required. So the question is: Where does the 400 tonnes come from.

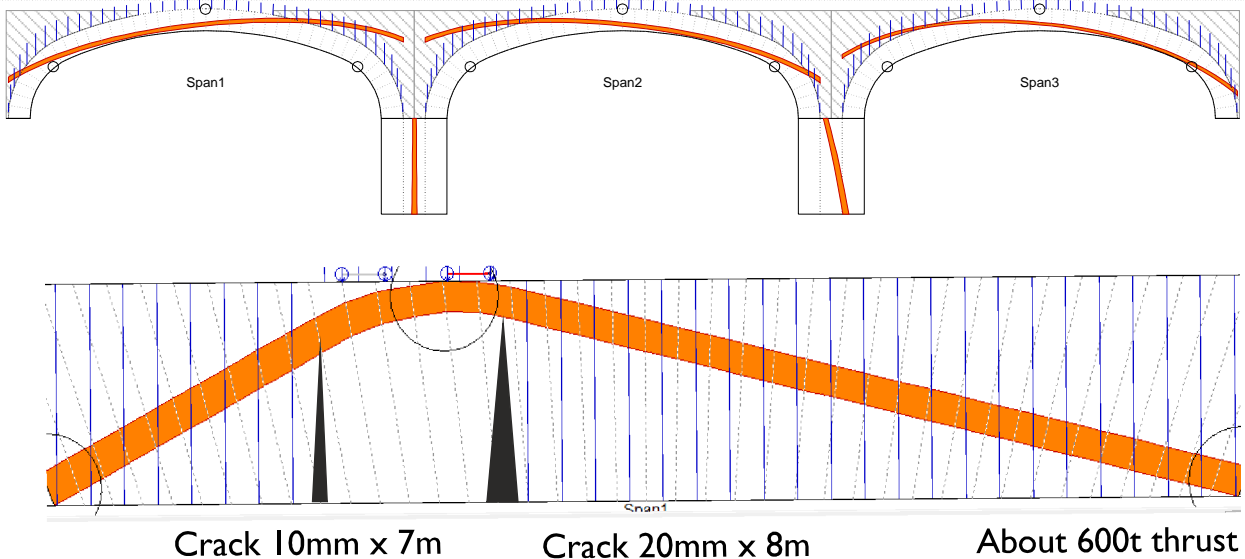
The picture below shows the whole bridge modelled as a flat arch in plan. "Self Weight" has been reduced to zero and the only loads are the four axles providing 100 tonnes each distributed over the width of the solid block of the arch haunches.

The 600tonne thrust is an addition to the basic arch thrust and is concentrated at the bottom corner of the abutment, being carried there by the arch thrust. At the right hand side there is

less need for concentration but at the left it is to be assumed that the abutment moved back plastically before developing this level of resistance. The crack widths are controlled by the eccentricity of the thrust at the edge of the solid pier block. The eccentricity reduces towards the abutments from this point and that ensures that the necessary rotations all occur in or about one joint.

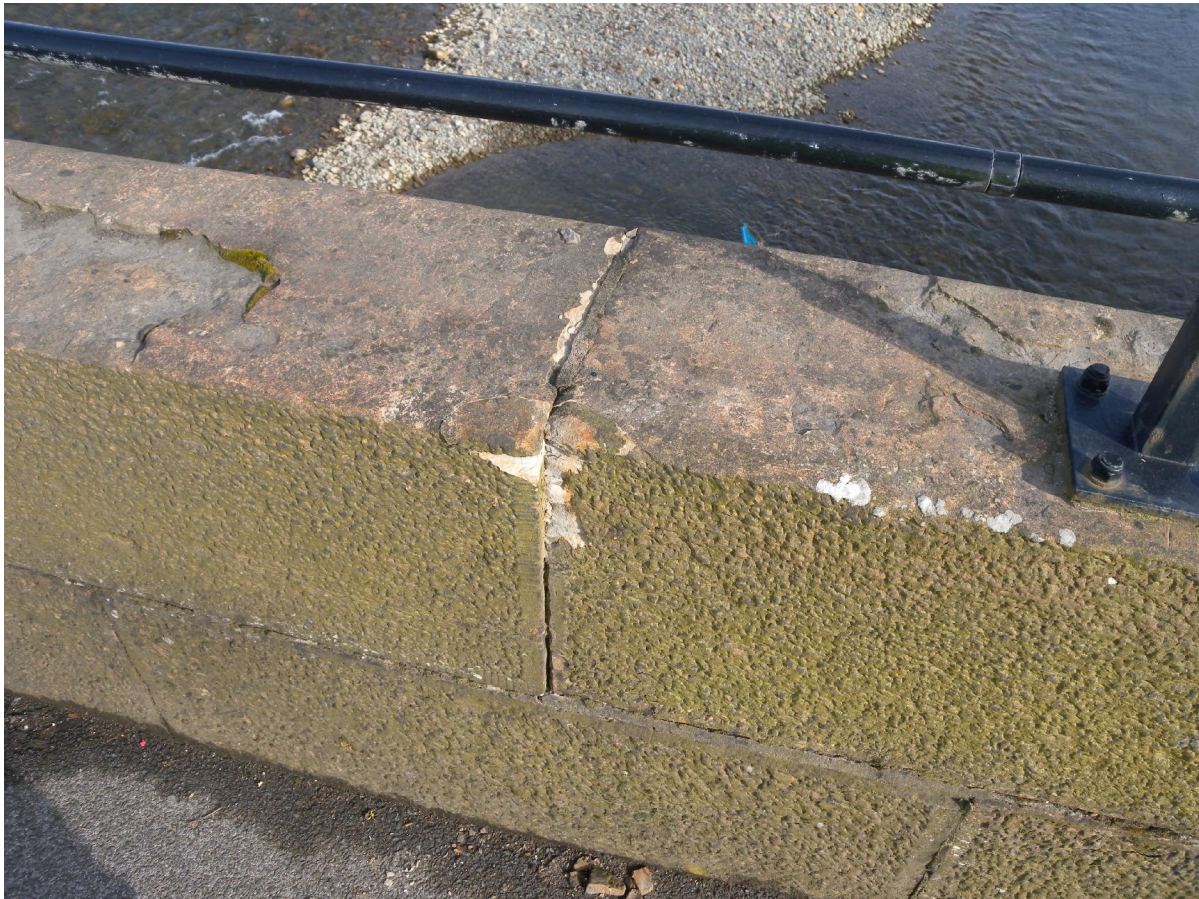
The spalling seen below is caused by high compressive stresses in the parapet where it is arching over a wide gap
