Bill Harvey Bill Harvey Associates Ltd and OBVIS Ltd

This bridge stood at <http://g.co/maps/mmn6g> Just off the A76 in Dumfries and Galloway. The G&SW was designed by John Millar. The railway was opened in stages around 1850 and this is in part of the last section. It was demolished some years ago and features here because that demolition was recorded and I have some photographs.

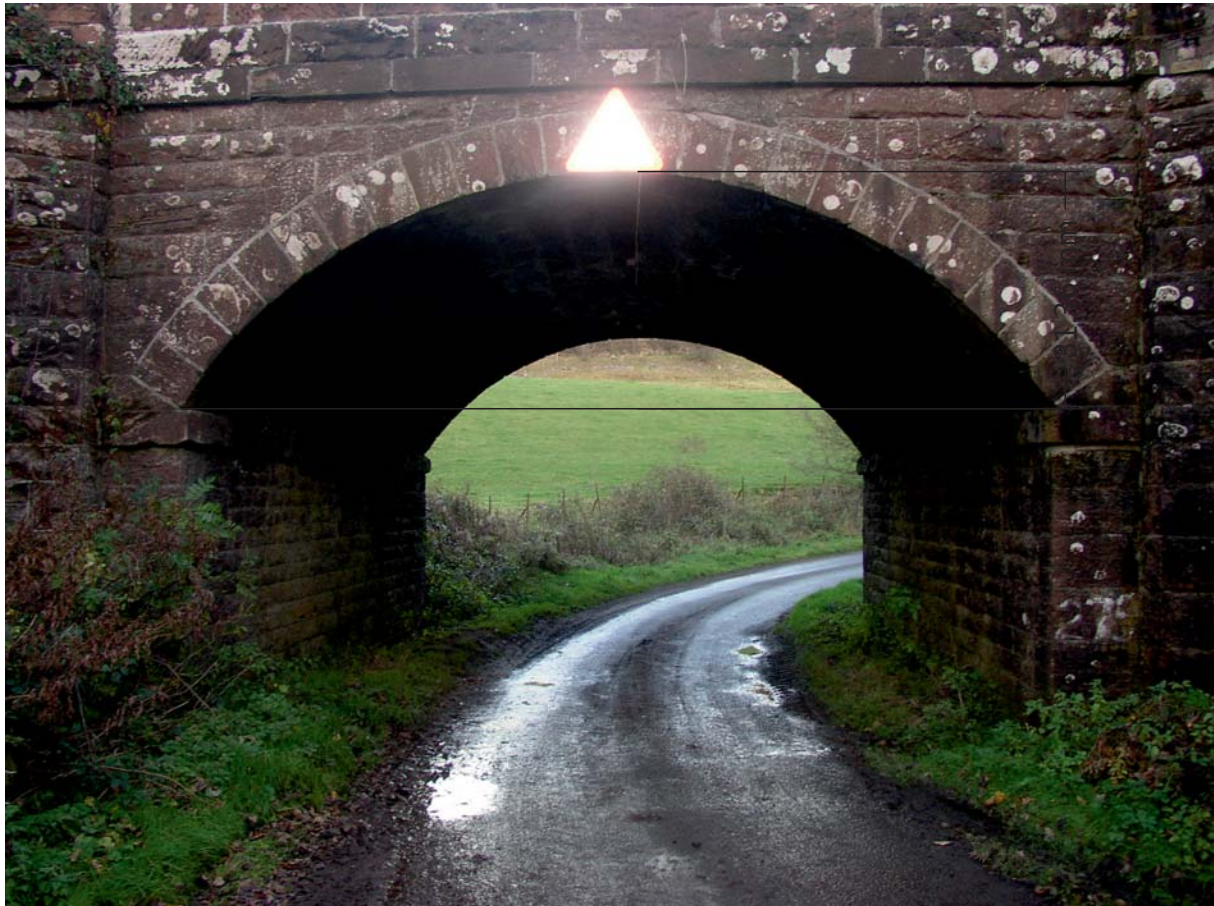
The bridge was 20ft span or 6.096m and like many other bridges on the line has a span rise ratio of about 4. Measuring off the photo above suggests that the rise is actually 6ft giving a radius of 11ft4in and an irrational span rise ratio. This seems unlikely, but I do not have actual dimensions to hand. The ring seems to be about 18in (458mm) thick. Using Rankine's rule for thickness of  $\sqrt{0.12 \times \text{radius}}$  would suggest a ring of only 14 in (356mm).

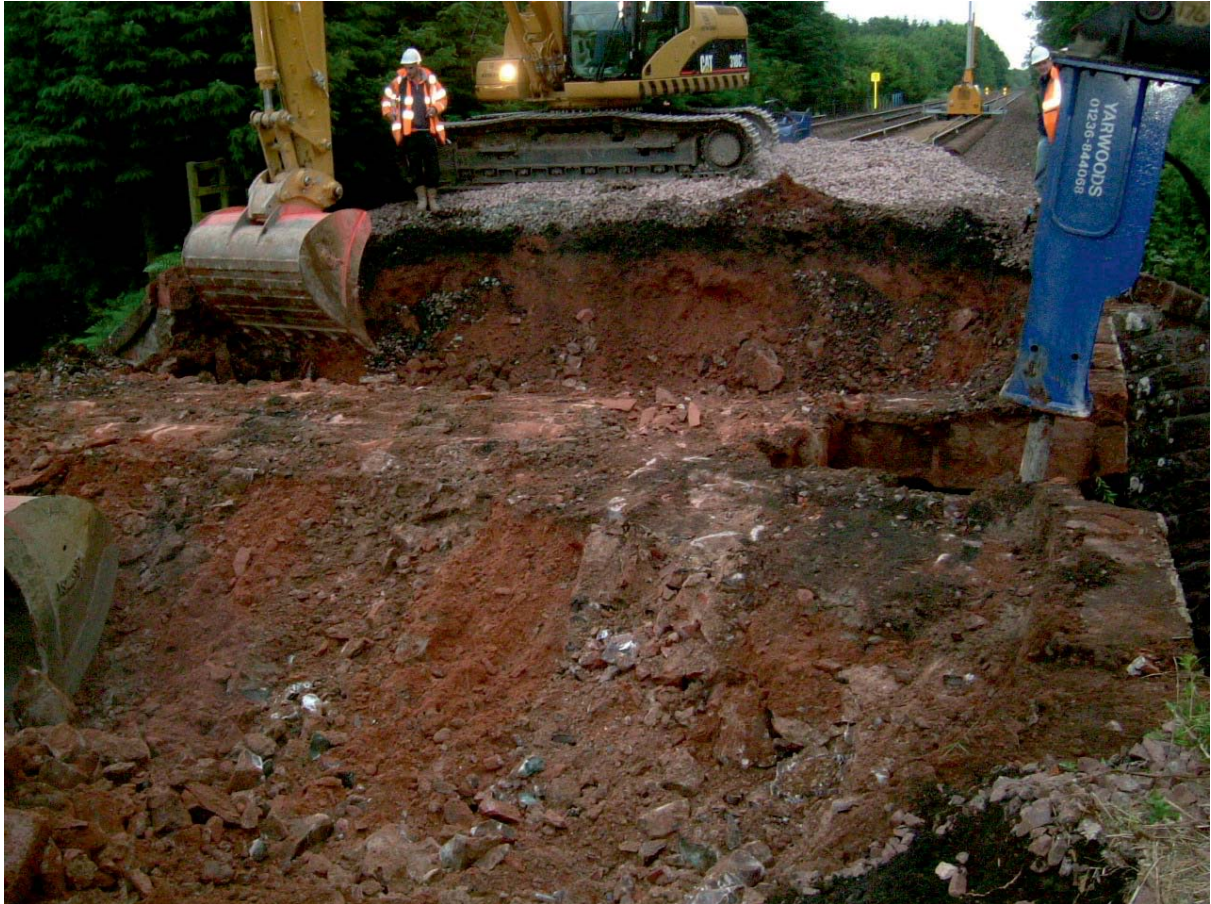
This photo is, though, very important, because it clearly shows internal spandrel walls buried in the fill.

More on that shortly, along with other photos, but look at that picture. On the right. There is absolutely no reason to use a pick to demolish an arch. Hook the bucket under the arch and lift, the arch will come apart in sensible pieces and the demolition is quicker, quieter and much more controlled.

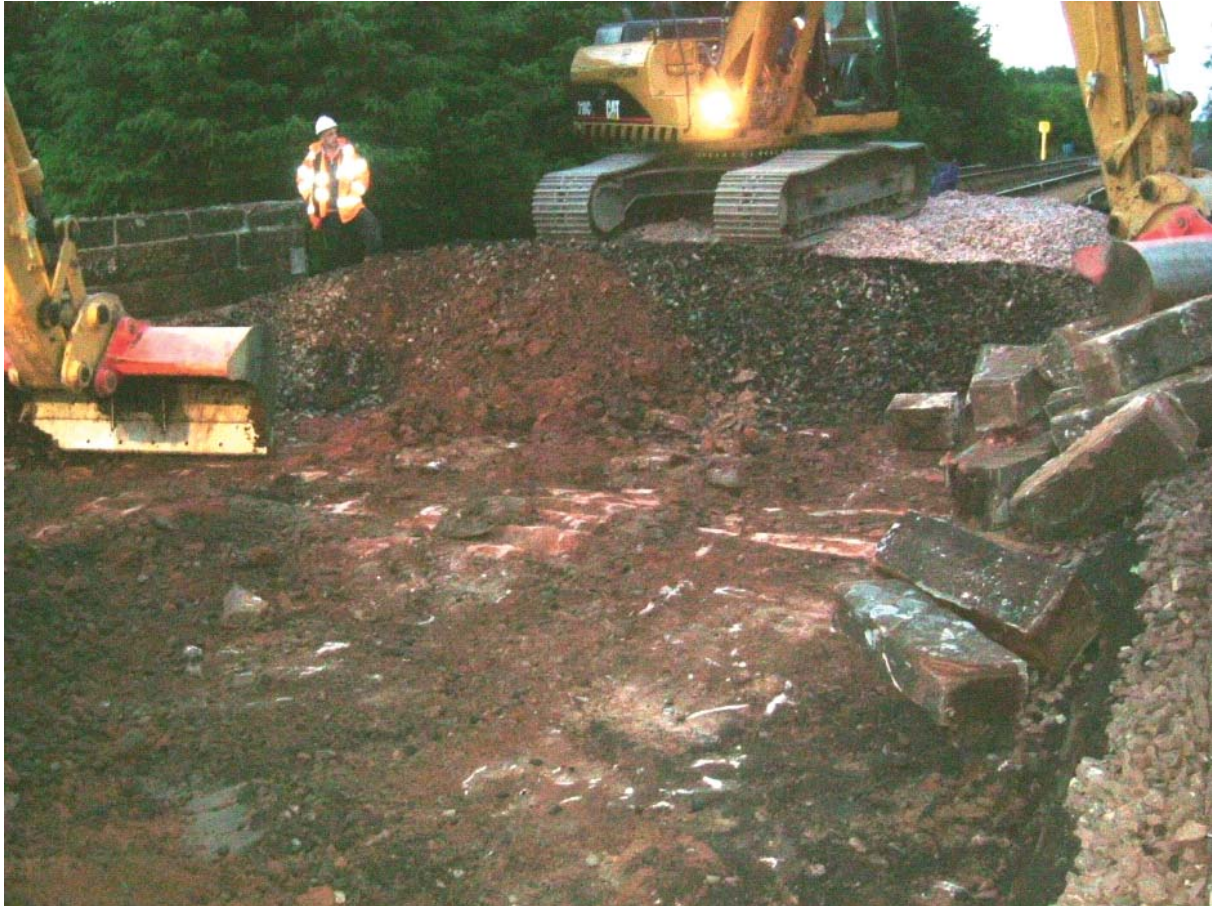
At first sight, this looks like the same picture again. Actually it was taken rather earlier. The light, and the fact that I had to brighten the pic a lot, says it was taken in the dusk the night before. Here, the excavation has just got down to the crown level and the bucket has scraped the top of the walls without breaking them up.

These walls are not beautifully dressed masonry like the exposed faces of the bridge or the arch itself. they are built from biggish shards left from the masons work. The walls are positioned under the rails and the ratio of wall to space suggests that they are about 2ft6in thick (760mm). I will say more about the strutcural significance of this shortly, but first a look at some more photos.

The skewback is cut as a solid piece with a string course and the string course has been removed from this abutment. Traces of stone shards are visible in the exposed face of the fill and the rather more random inner face of the outer spandrel wall are also visible.

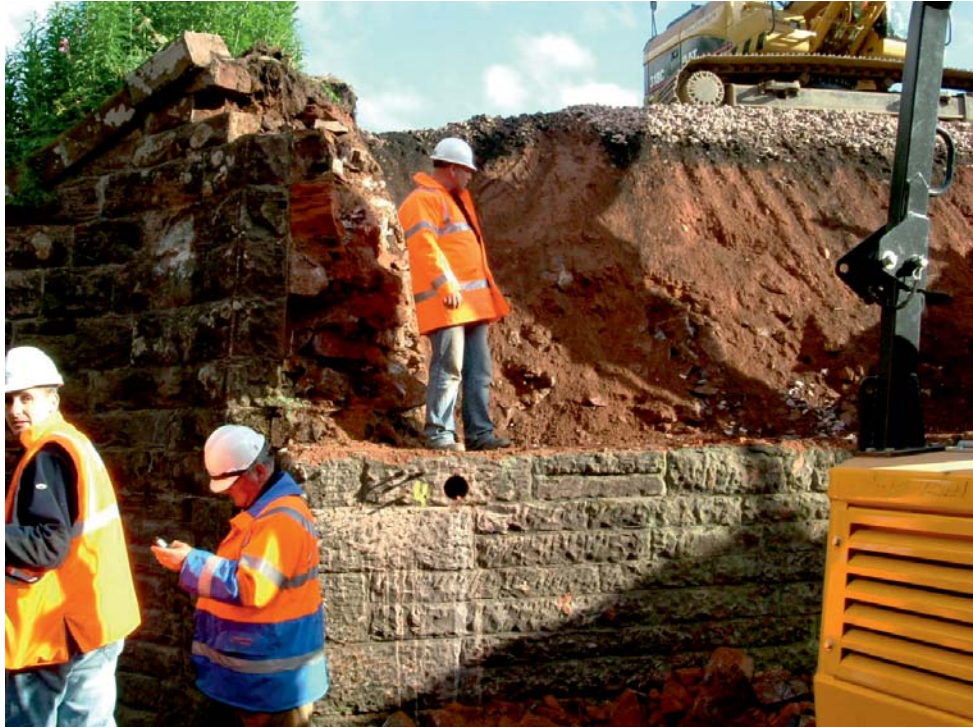
The picture below shows the vast expanse of the top of the abutment. Millar was not mean with that, though some of his (and his son's) bridges had very slender proportions. The platform exposed here is at least 6ft (1.83m) wide and the stone exposed in the soil face suggests that we are not seeing the whole abutment.

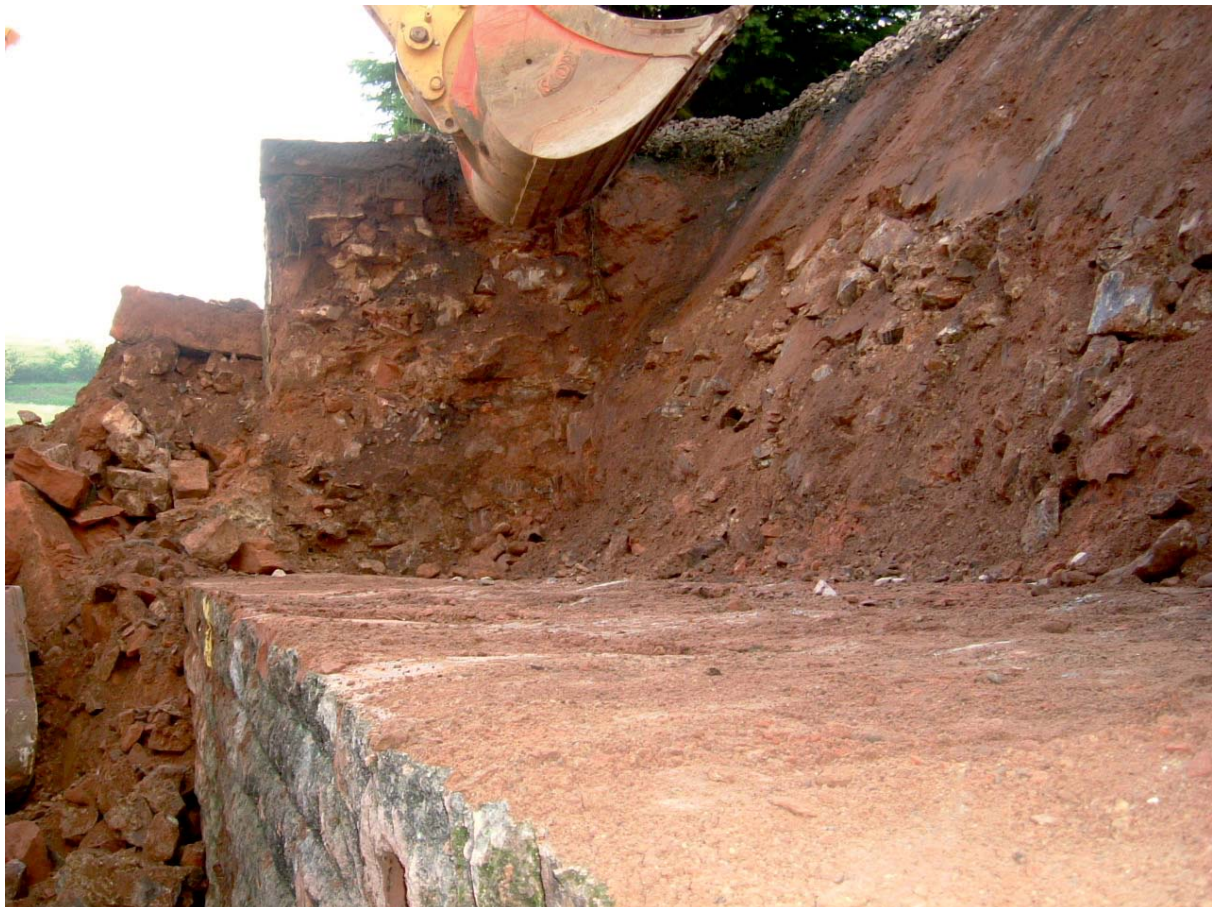
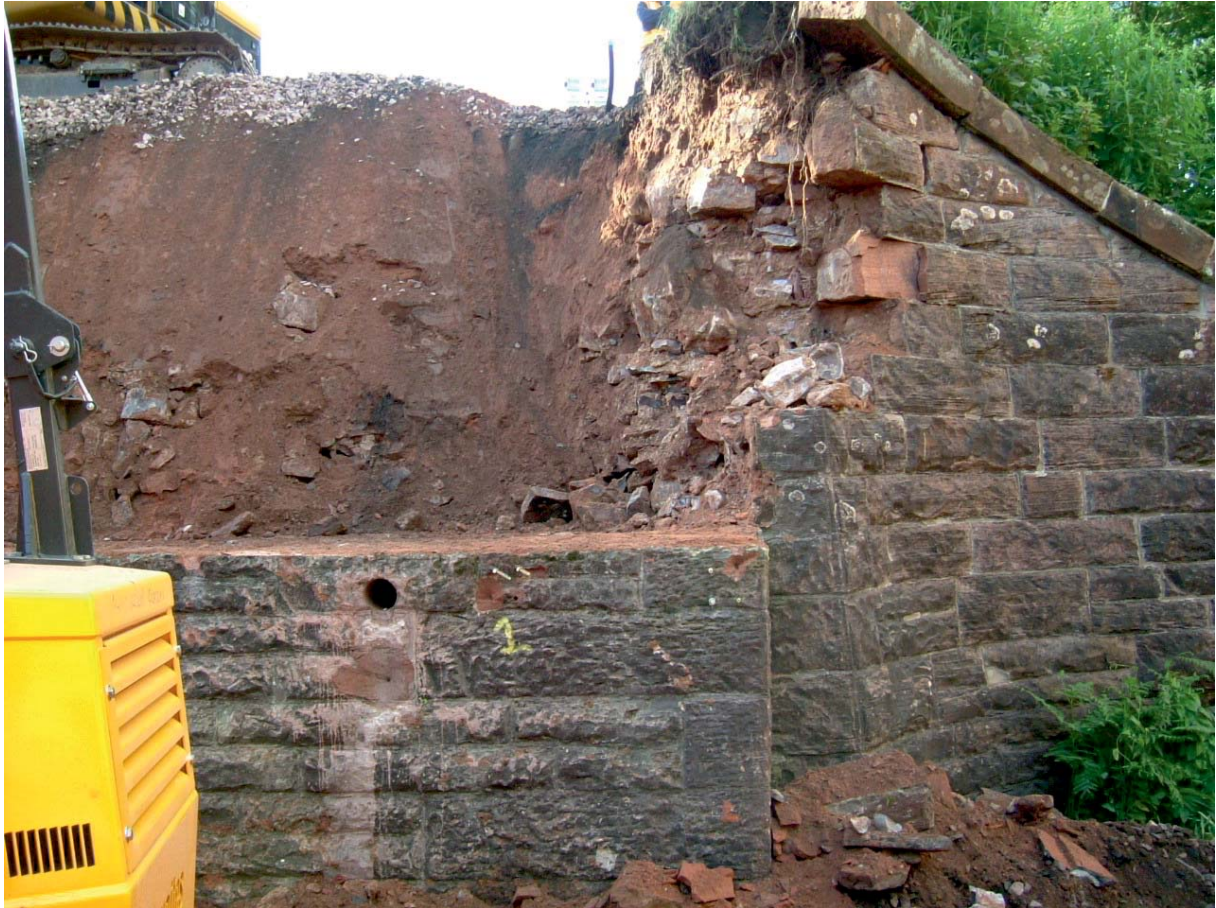
Here again is a wide shelf and an almost vertical face. The outline suggests to me that shard concrete fill was used behind the skewbacks and possibly to a dept of about 1m with internal walls above that. Looking back to the previous picture suggests that there is a back wall of shard concrete/masonry too.
