Bill Harvey Bill Harvey Associates Ltd and OBVIS Ltd

Bridgemill no longer exists. It stood on the A77 near Girvan at <http://goo.gl/maps/wxioU> (you can see the old road between the cottage and the new bridge. It was tested, notionally to destruction, in 1984. The test has been used as part of the justification for a number of non-sensical statements about arch bridge behaviour. The test is therefore worthy of serious review here. Other publishers are reluctant to present reviews of such old data, not least because they carry the stamp of the Highways Agency (HA) and the Transportation Research Laboratory (TRL).

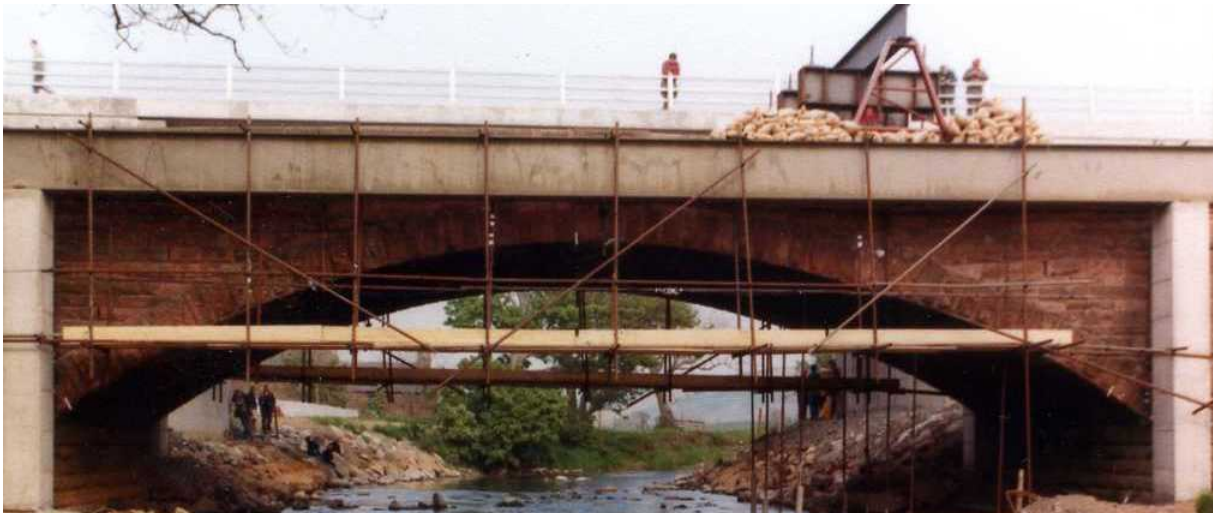
The bridge is recorded as having a span of 18.299m, rise of 2.845m and a ring of 0.711m Silly sounding numbers until they are re-interpreted as 60ft, 10ft and 28in. Of course, the arch sagged when the centring was struck so the rise measures 9ft 4in! The road surface was essentially flat and the cover a mere 200mm at the crown.

The 10ft rise gives a radius of 50ft which seems much more likely than the 52ft or so from the measured dimension. This photograph was taken before any load was applied. The slope of the beds in the spandrel, compared with the steel beam, is clearly visible at both ends of the span.

The test report declares the shape to approximate closely to a parabola but it is actually much close to a circular curve and there is no logical reason why the builder would produce a parabolic shape.

This is part of the first image, cropped to show detail. The overlaid white lines show the slope of the beds where the arch has sagged during construction of the spandrel walls.

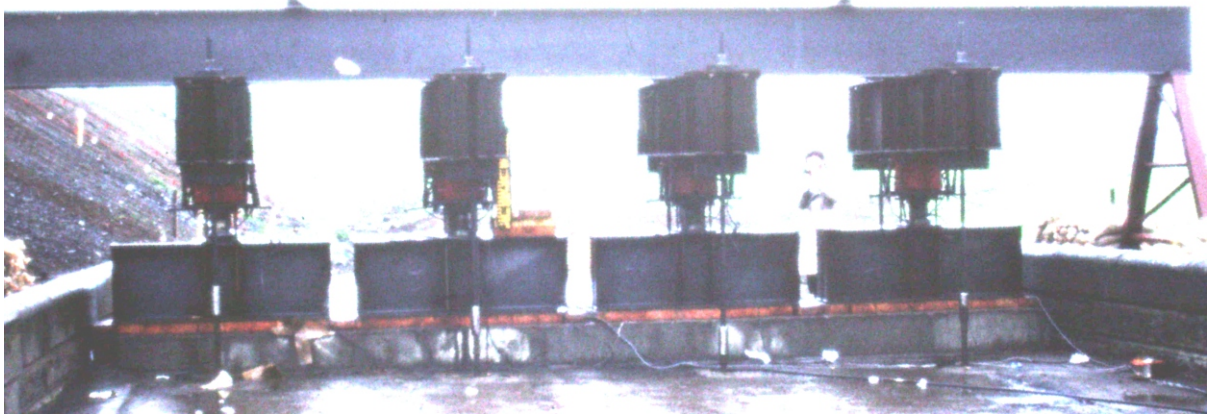
This photo has been pushed pretty hard but shows the loading system and the bridge width. The centres of the loads are 1.91m with a 0.96m edge distance so the overall width is 31.36ft which actually seems quite unlikely. Unless the width between parapets were a rounder number. Perhaps the most likely dimension is 31ft for the arch width and a spread of a little over 100mm at road surface level. Such a spread is normal in these frosty regions

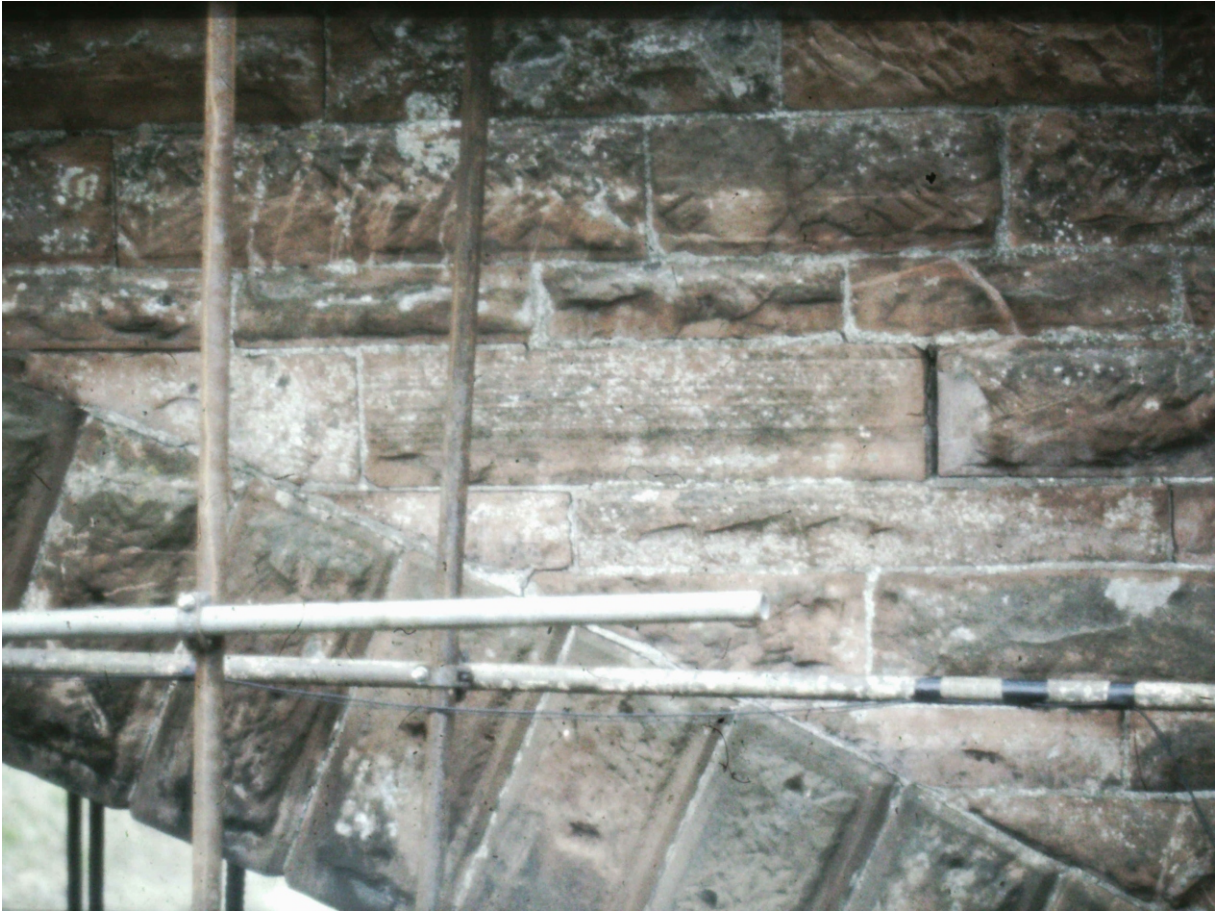
This enlarged image Shows an area of spandrel and arch directly under the load at an early stage in the test. Look carefully and you will see cracks between the two voussoirs to the left, which are nearest t the load point. In the top right there is a horizontal crack between two stones indicating a corbelling of the spandrel wall.

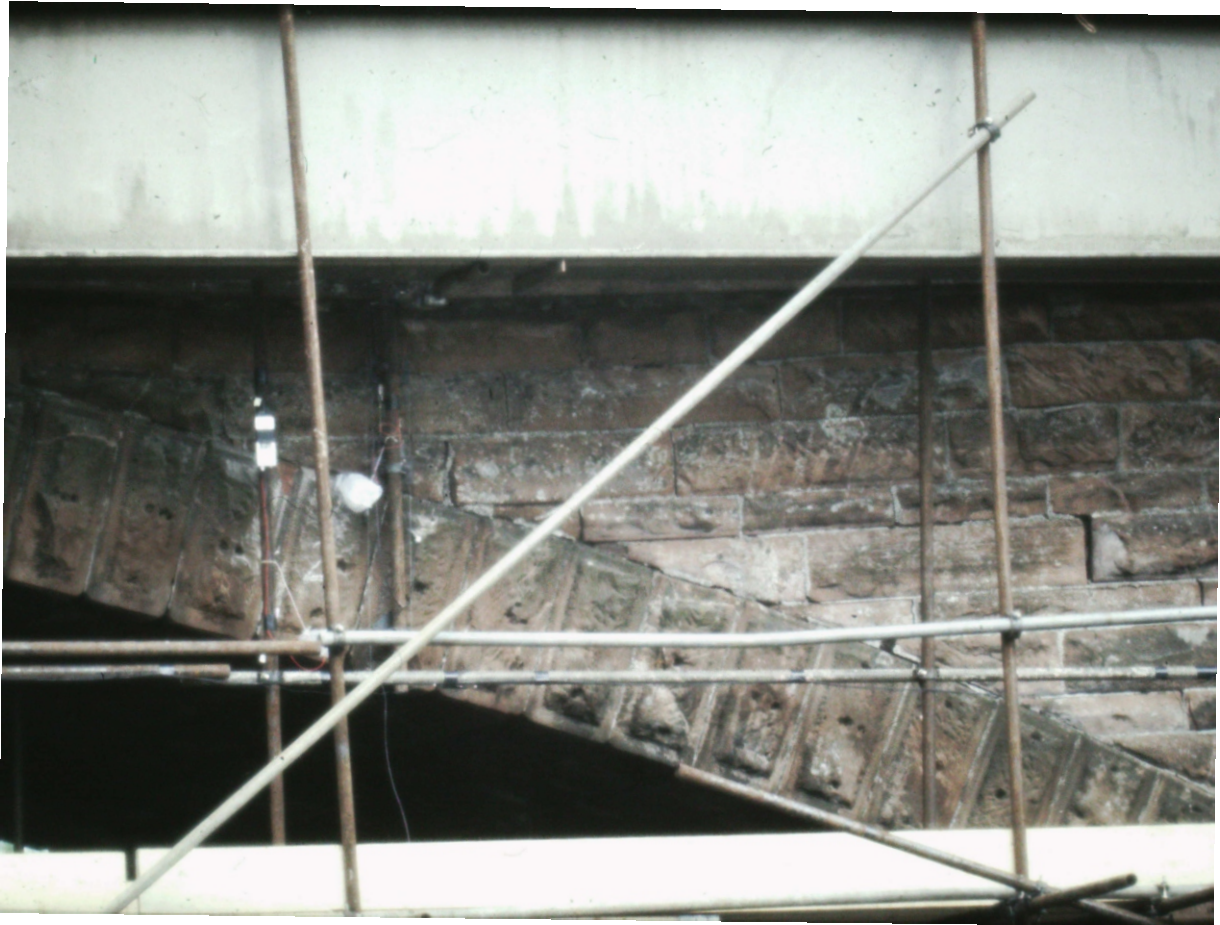
Here we see the same area rather later in the test. The joint between arch and spandrel is visibly damaged over a long length. The voussoirs are about 300mm thick so the picture shows 4m length of arch. The loaded 1/4 span point is behind the scaffold tube with the white tab attached.

Mortar will creep preferentially on a joint with a greater eccentricity of load so the centre of thrust must cross consecutive joints at very close to the same depth if the joint is to open on both sides. This provides a clear indication of the spread of load in this case, since only with a widely spread load can the thrust follow the extrados closely.
